Effect of Electric Fish Barriers on Corrosion of a Nearby Structure

Science and Technology Program

Final Report No. ST-2020-1722-01, 8540-2020-38

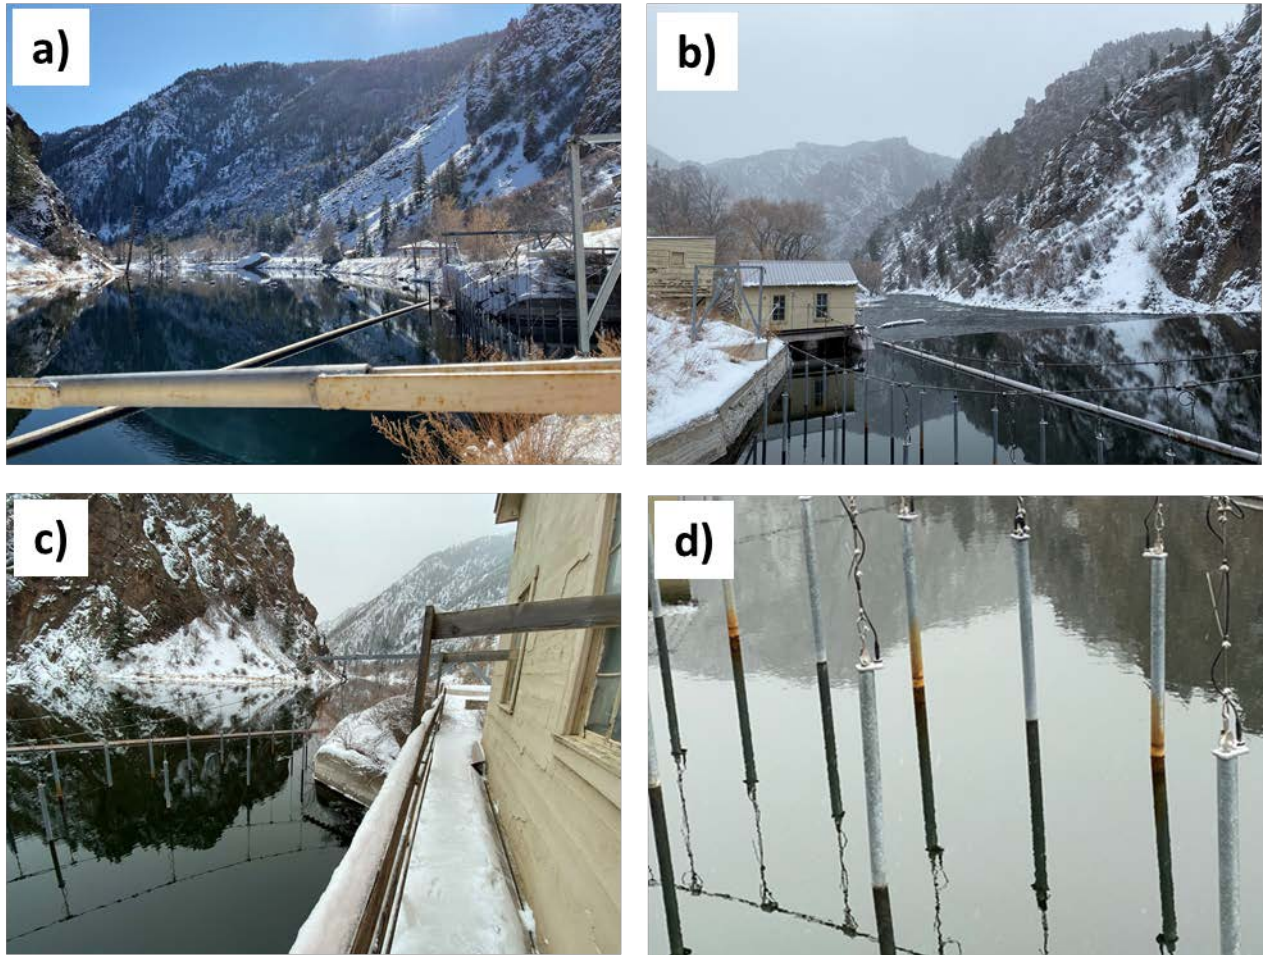
Image 2. The electric fish barrier installed at the East Portal of Gunnison Tunnel. Photos a) through c) show the fish barrier and log boom from various orientations. Photo d) clearly shows the vertical arrangement of the electrodes.

To determine the native potential of the temporary structure, measurements were made in the basin downstream of the closed gates shown in Image 2b approximately 150 ft from the electric fish barrier electrode array. The native potential after one hour was a stable $-0.321 \text{ V}_{\text{CSE}}$. The test apparatus was placed in five different locations at various distances from the electrode array, including between electrodes. Potentials were then measured on the temporary structure over the course of an hour. The five locations and distances from the east array are labeled in Image 7 and listed below:

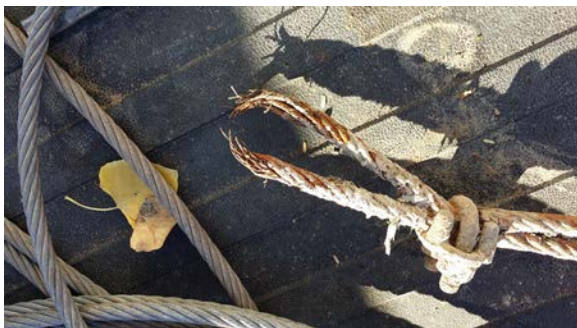
Image 3. Corrosion of log boom stranded wire anchor rope located at the Gunnison Tunnel's East Portal.

Prior to installation of the electric barrier, fish survival was thought to be low during the typical low and intermittent flows (100 cfs twice a month for 24 hrs to 48 hrs) through the tunnel in the winter months. However, a slow constant flow for one winter resulted in a much larger number of fish in the canal than expected due to survival of the entrained fish [13]. The electric fish barrier was installed to discourage the brood stock fish from entering the canal [12]. The electric fish barrier as observed in Image 2d was installed in a vertical arrangement to prevent spawning sized fish from entering the tunnel. Image 3 shows a corroded stranded rope used to anchor the log boom, however this was most likely due to galvanic corrosion caused from using dissimilar metals.

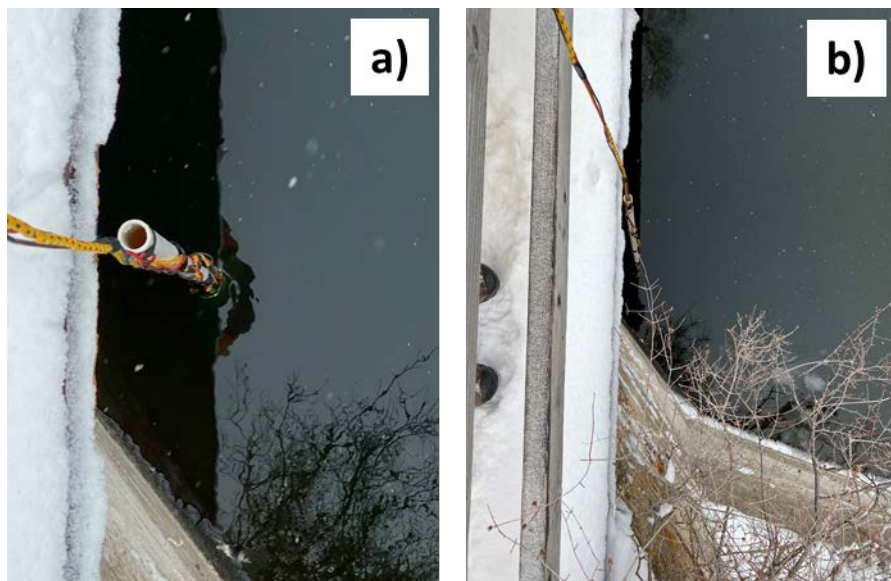
Image 6. Photo of immersed test apparatus. The temporary structure is on the submerged end of the PVC pole which was used for electrode placement and prevent excessive movement during the test.

The test apparatus was attached to a PVC pole to accurately place the temporary structure and prevent shifting or moving during the test. A photo of the immersed apparatus is shown in Image 6a and b.

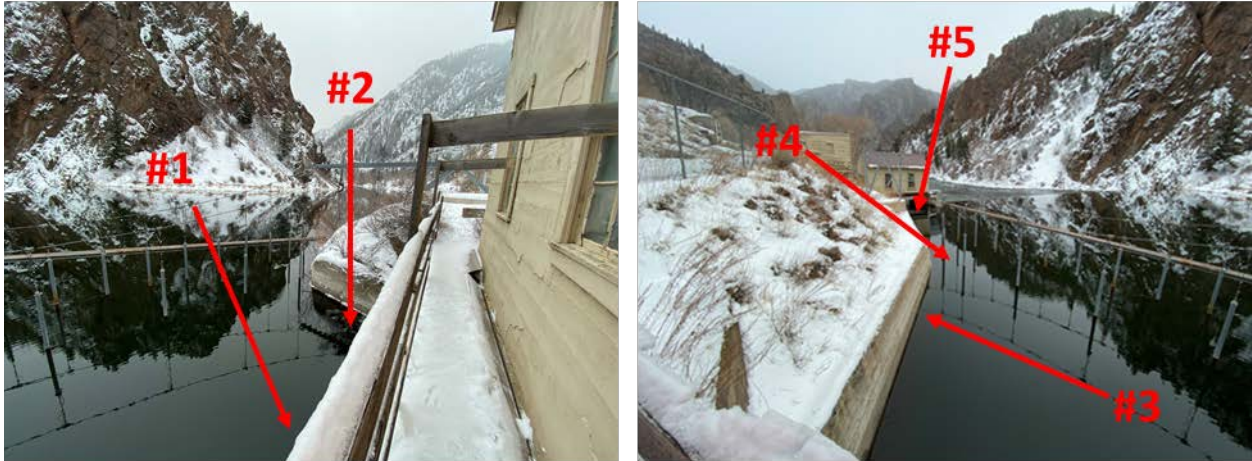
Image 7. The five different locations where structure-to-water potential were measured are shown in the photos.

- #1 was in front of the gate and approximately 20 feet from the east array,
- #2 was in front of the gate and approximately 15 feet from the east array,
- #3 was along the concrete wall 12 feet from the east array,
- #4 was between two anodes in the east array approximately 1.5 feet from each electrode,
- #5 was along the wall approximately 25 feet from the end of the east array.
