Durability of Concrete Containing Natural Pozzolans

**Science and Technology Program
Research and Development Office
Final Report No. ST-2021-21201-01**

7. PERFORMING ORGANIZATION NAME(S) AND ADDRESS(ES) Concrete and Structural Laboratory Technical Service Center Bureau of Reclamation U.S. Department of the Interior Denver Federal Center PO Box 25007, Denver, CO 80225-0007				8. PERFORMING ORGANIZATION REPORT NUMBER 8530-2021-27

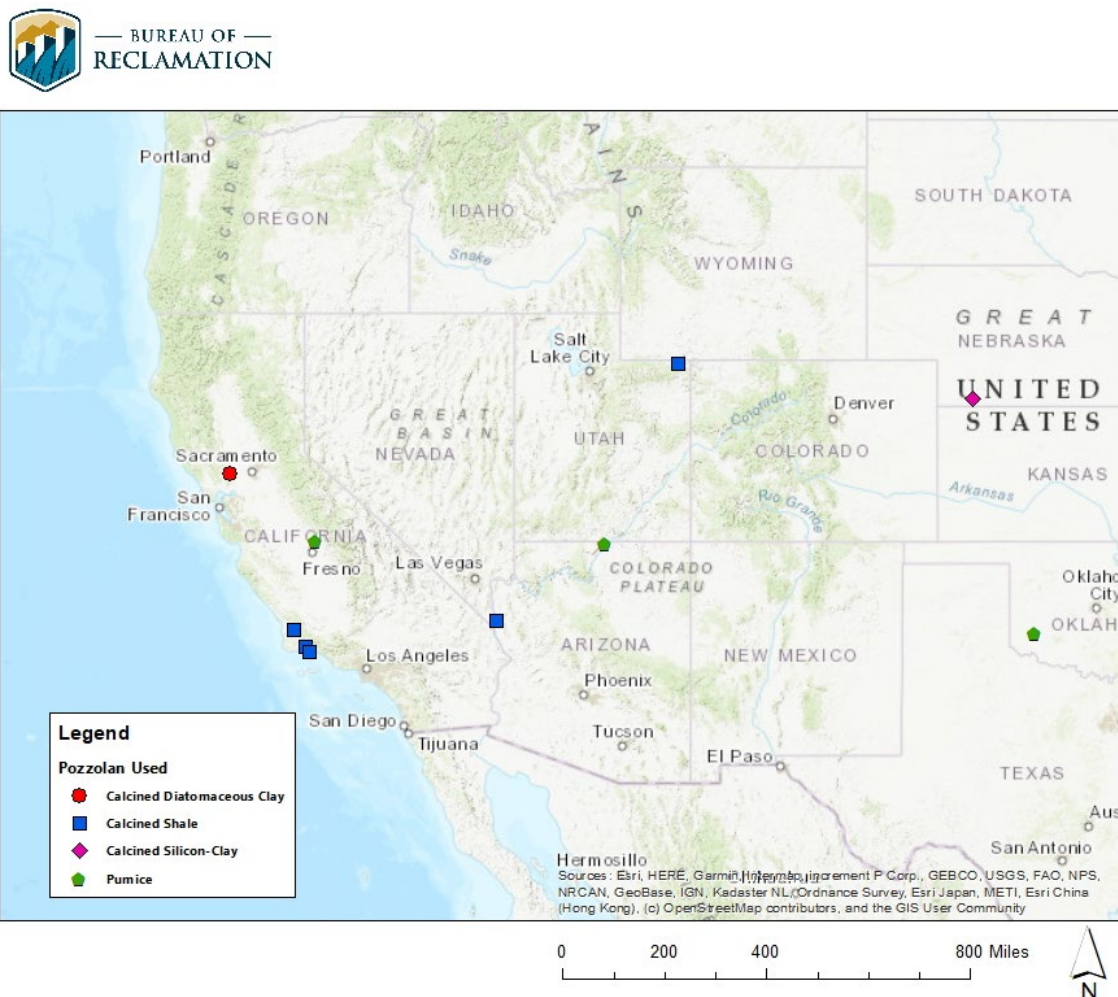
Figure 1. Location of dams constructed with natural pozzolans

Reclamation dams built with various types of natural pozzolans are summarized in Table 1 and shown on a map in Figure 1.

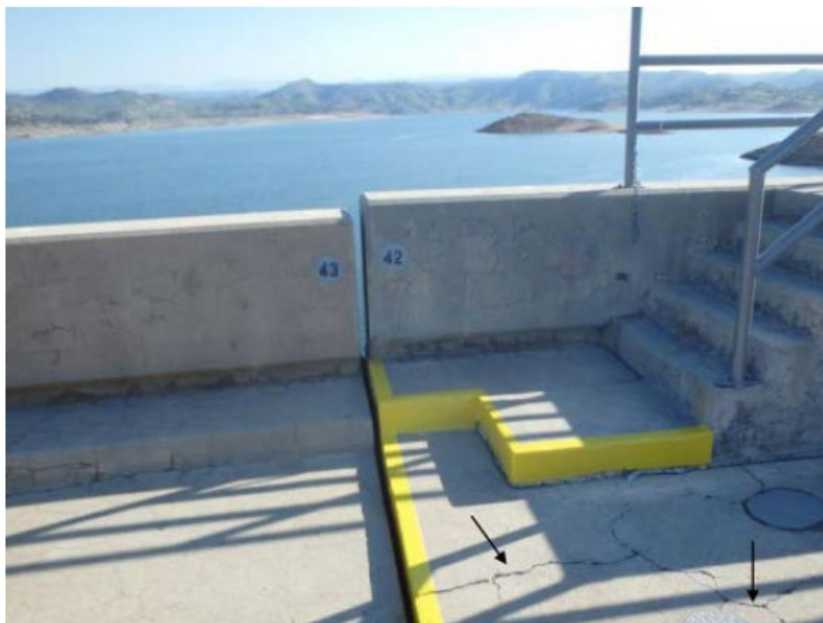
Figure 3. Concrete at Friant Dam with pumicite (left) and without pumicite (right). Arrows pointing to map cracking indicative of ASR.

Friant Dam was constructed between 1939 and 1942. Approximately 20 percent pumicite was to be used for all sections of the dam except for the 6-foot layer of concrete on the surface of the crest and the downstream slope of the spillway section. The pumicite was chosen to control the heat of hydration, improve workability and reduce segregation of the lean concrete. The pumicite deposit used is located three miles from the dam on land acquired by the Government. The aggregates used for the concrete are igneous varieties including andesite, syenite, and basalt as well as other sedimentary types including quartzite, which are now known to be susceptible to alkali silica reaction (ASR). In 1942 and 1945, cores were taken from Friant Dam to determine the presence of ASR after early reports of the phenomena were published [15, 16, 17]. The presence of ASR gel was confirmed, but the reaction was not considered significant because low-alkali cement was used. However, engineers at Reclamation noted signs of ASR distress such as displacement between blocks as seen in Figure 3, and wide cracks beginning in 1980 [18]. Cores taken in 1988 revealed deterioration due to ASR is more severe in placements using a high-alkali cement apparently without pozzolan. In placements using the low-alkali cement either with or without pumicite, damage from ASR was negligible [19].

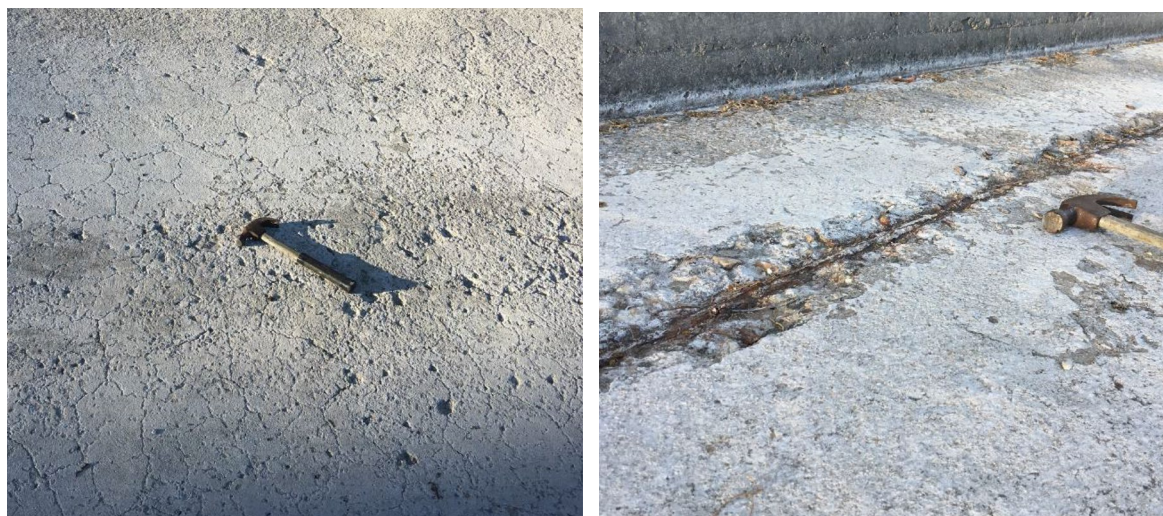
Figure 4. Typical cracking and deterioration along spillway chute at Bradbury Dam.

Bradbury (originally named Cachuma) Dam was constructed from 1950 to 1953. It is a zoned, rolled earthfill structure with a concrete spillway chute and stilling basin. Calcined shale pozzolan was purchased from the Airox Company in Los Angeles. The pozzolan was produced from a deposit near Casmalia, CA. Initial trial batches produced concrete with low strength and a poor aggregate to paste bond. The pozzolan was ground finer and the strength of the concrete increased “appreciably” [23]. There are no records of cores extracted and analyzed from Bradbury Dam spillway or other appurtenances. In the early 2000s, dam safety modifications were made to the spillway crest structure walls and piers. The most recent 2015 CFR did not note any serious concrete deterioration [24], but a 2019 inspection report describes cracking and small aggregate popouts on the spillway chute slabs in the original portion from the 1950s. Several locations had exposed reinforcing steel as seen in Figure 4. The authors recommended a petrographic examination to confirm presence of ASR [25].

The concrete in the spillway chute has some deterioration ranging from minor surface cracking to exposed rebar while other portions of original concrete are in good condition. Cores would be easy to collect from this location and could possibly be collected in conjunction with minor repairs.

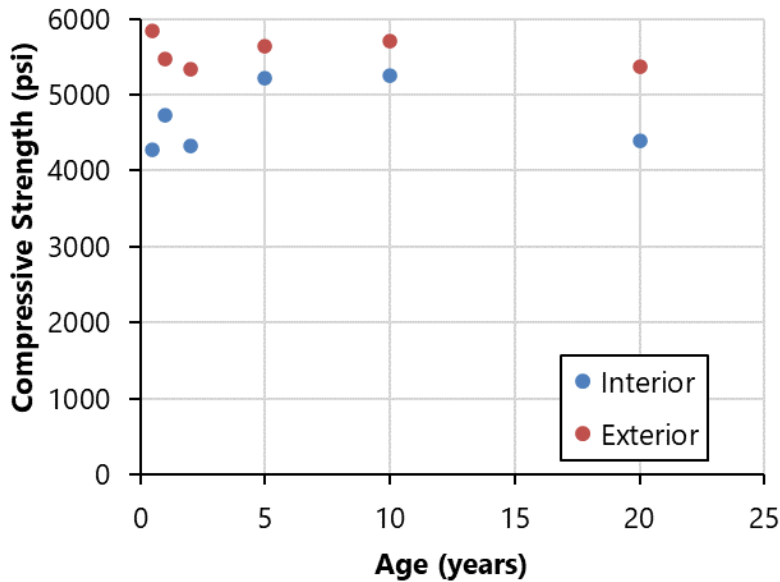
Figure 6. Average compressive strength of concrete cores from Glen Canyon Dam.

Glen Canyon Dam was constructed between 1957 and 1964. The pozzolan plant was located about 30 miles north of Flagstaff, Arizona. Material from the Bonner deposit was used until it was depleted in 1962. When the Bonner deposit was nearly depleted, the nearby Sugar Loaf deposit was investigated and accepted for use. At times there were insufficient quantities of pumice delivered to the site so the concrete mix was adjusted to contain less pozzolan. There were two primary mass concrete mixtures, one for interior and one for exterior. Both mixtures contained pumice, but the exterior had a higher total cementitious content [40]. A 1984 petrographic examination concluded that the concrete was in good condition with no signs of aging in the interior concrete, but slight signs of aging due to carbonation in the exterior concrete. There were no signs of chemical attack or freeze thaw damage [41]. There was an extensive 20-year core report published in 1986. A summary of the compressive strength results are shown in Figure 6 [42]. According to the most recent CFR, the concrete in the dam has generally performed well. There was an area of spalling on the downstream face of the dam that was repaired in 2001 [43]. Samples taken from the spalled area were examined and there was evidence of minor to moderate deterioration due to carbonation near the exterior surface. There was also very minor deterioration due to ASR. The paste was considered well hydrated with only minor amounts of ettringite and no evidence of sulfate attack or freeze-thaw deterioration. The deterioration appeared to be mechanical and unrelated to concrete quality [44].

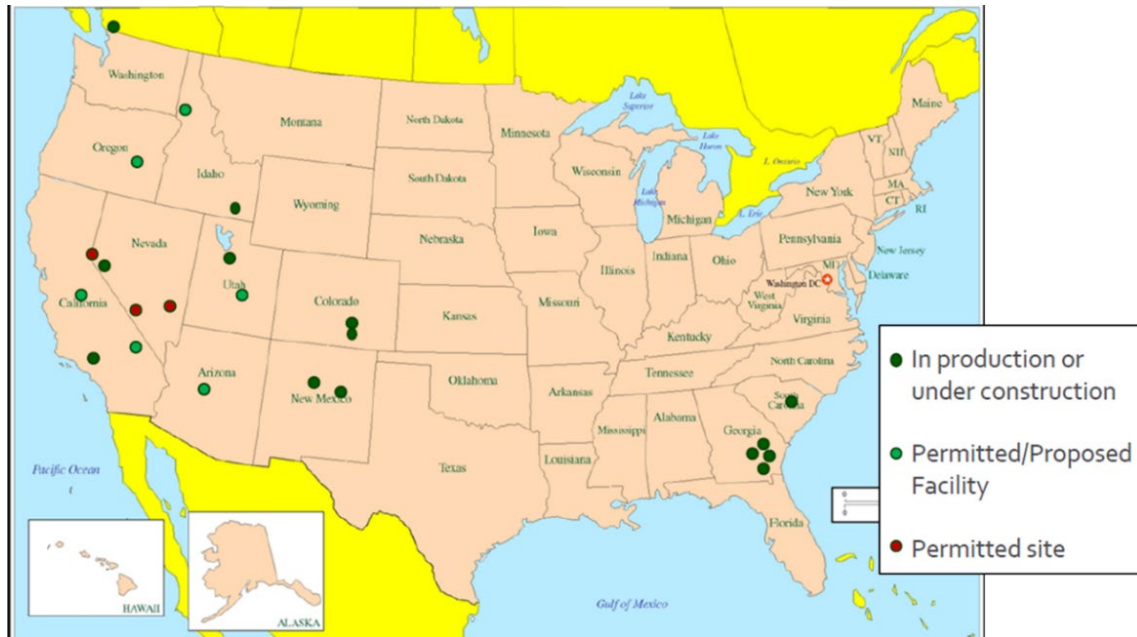
Figure 9. Current and future sites of commercially available natural pozzolans [50]

There is still a need to include SCMs in concrete as many state and federal concrete specifications require them for ASR mitigation, temperature rise mitigation in mass concrete, or other benefits to ensure a long service life. Some concrete suppliers are beginning to rely more on natural pozzolans. According to the Natural Pozzolan Association, there are natural pozzolan suppliers in eleven states, primarily in the West, with a few in the Southeast as seen in Figure 9.
