— BUREAU OF —
RECLAMATION

Advancement of Cathodic Protection Monitoring and Control for Water Storage Tanks

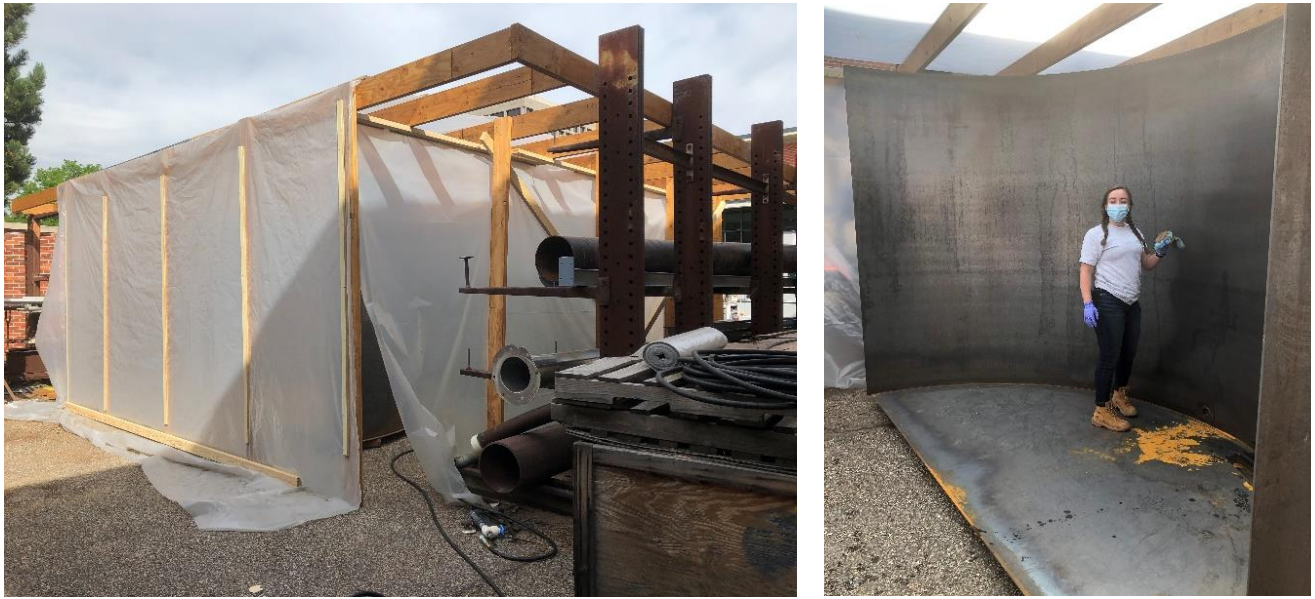
Figure 1.—Temporary confinement structure around tank halves for abrasive blasting and coating application (left) and a close-up of one tank half prior to abrasive blasting (right).

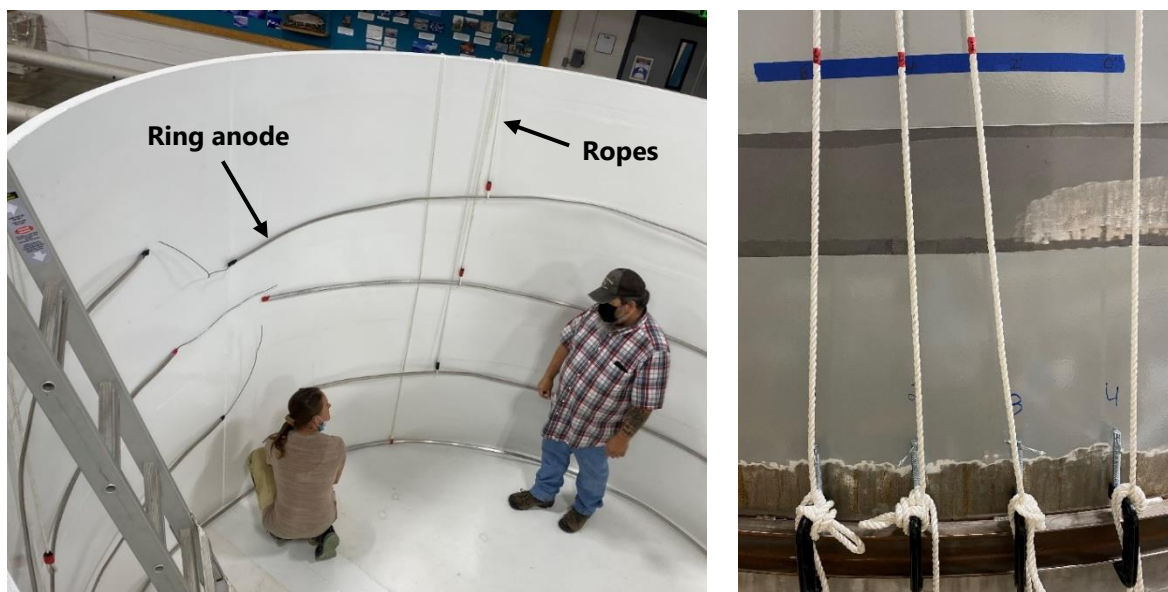
Figure 5.—Ribbon anodes suspended at precise elevations by ropes (left) and anchoring of the ropes on the exterior of the tank (right).

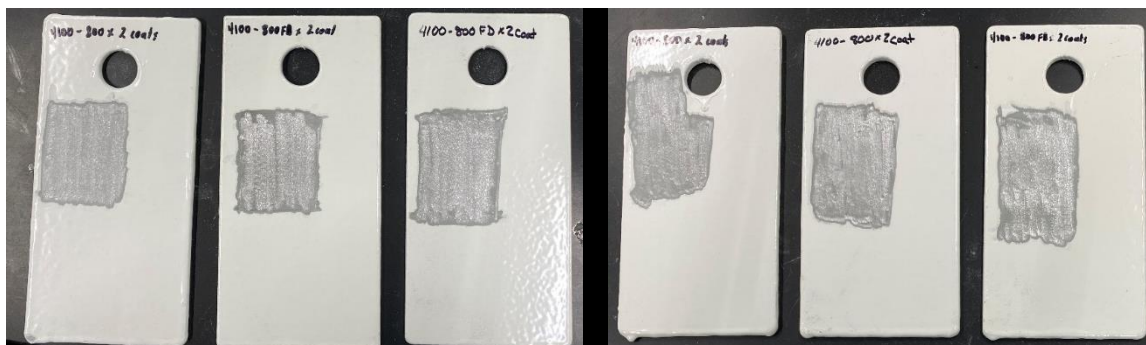
Figure 7.—Test coupons with bare metal area for exothermic welding of #12 AWG cable.

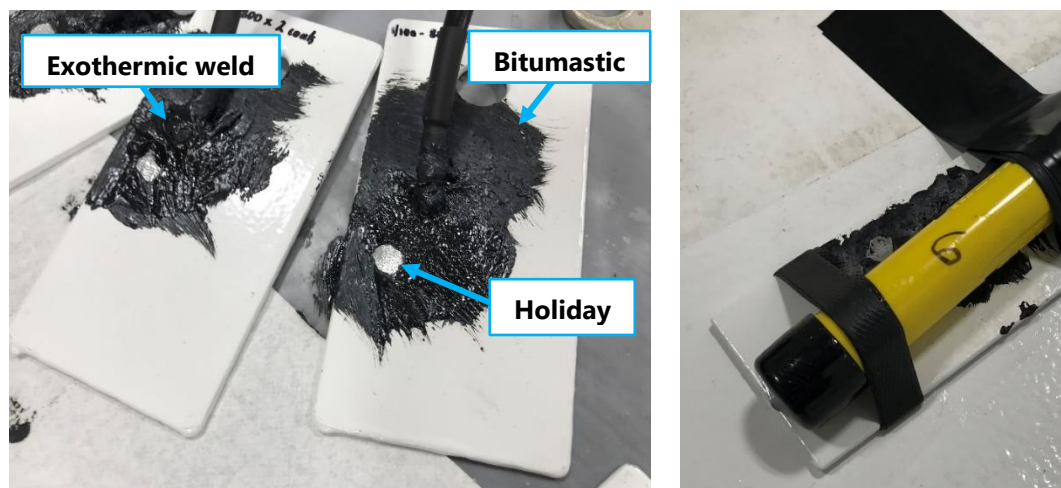
Figure 8.—Two test coupons with bitumastic coating repair over the exothermic weld, leaving a bare steel holiday of known size (left). A reference electrode strapped to a test coupon (right).

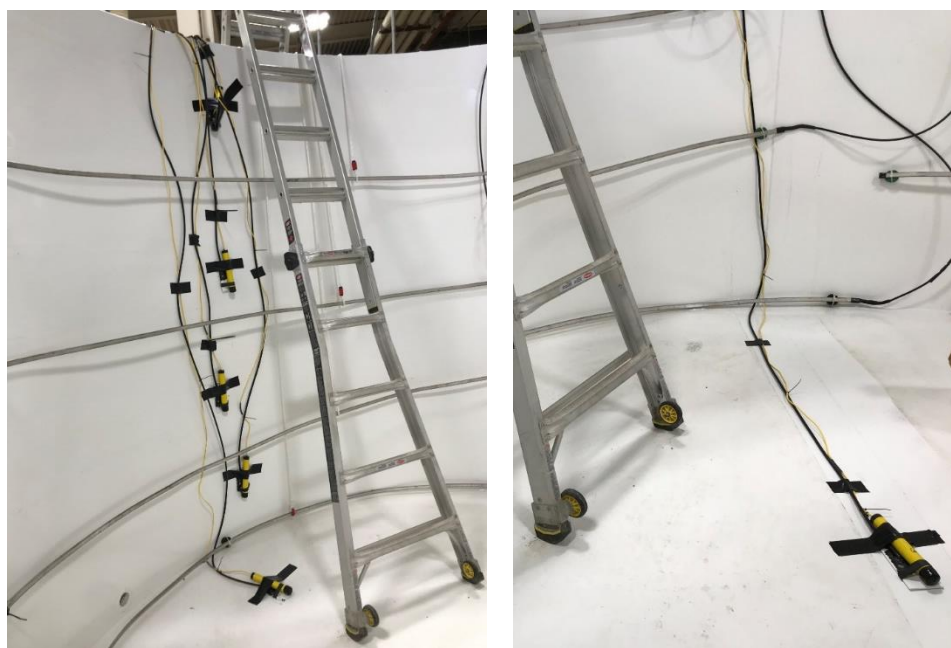
Figure 9.—Reference electrodes on the tank interior wall (left) and the center of the tank floor (right).

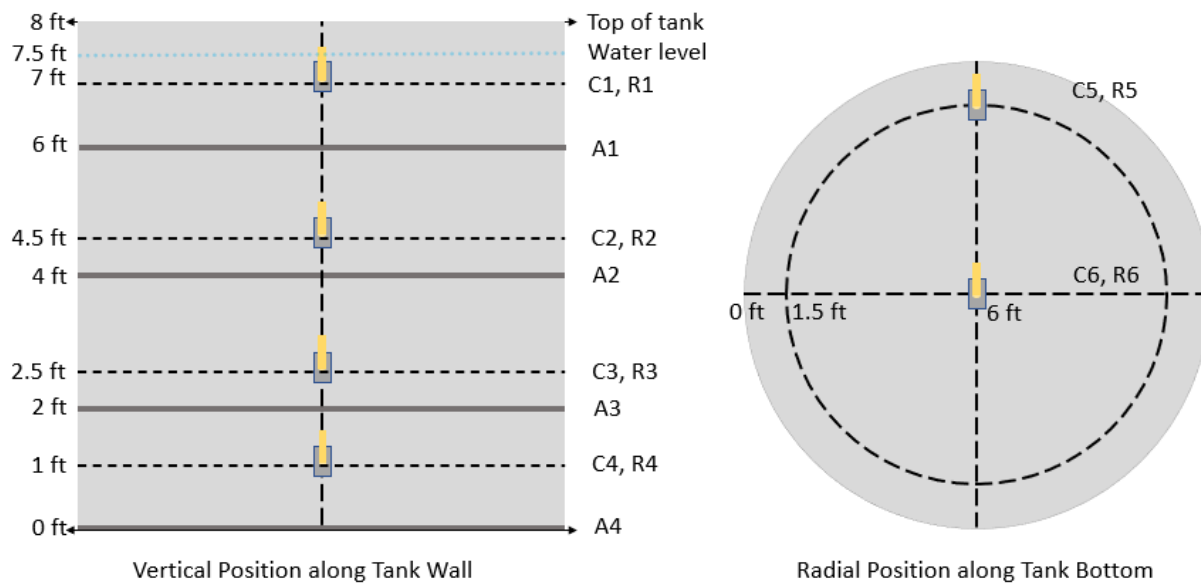
Figure 13.—Schematic of anodes (A), coupons (C), and reference positions (R) with respect to the 8-ft-tall, 12-ft-diameter model test tank.

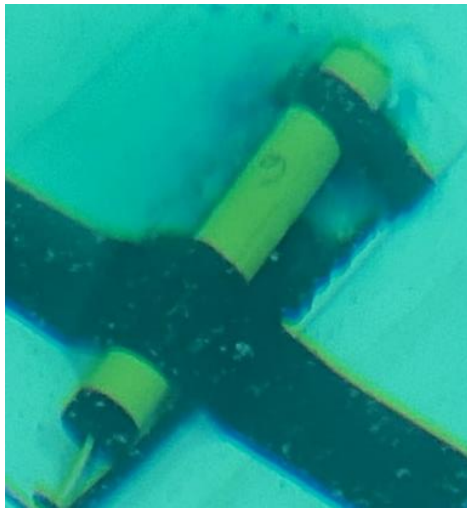
Figure 14.—Leaking reference electrodes as evidenced by blue copper sulfate crystals surrounding electrode.

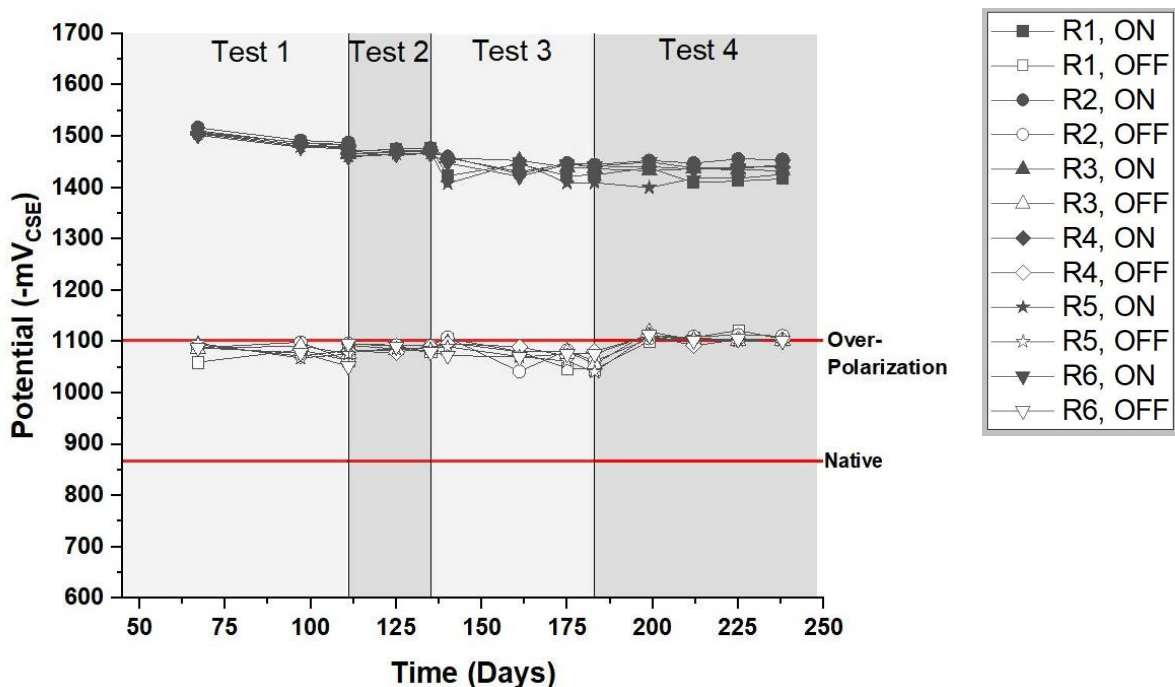
Figure 15.—Tank ON, instant-OFF, and native potentials for the four testing periods.

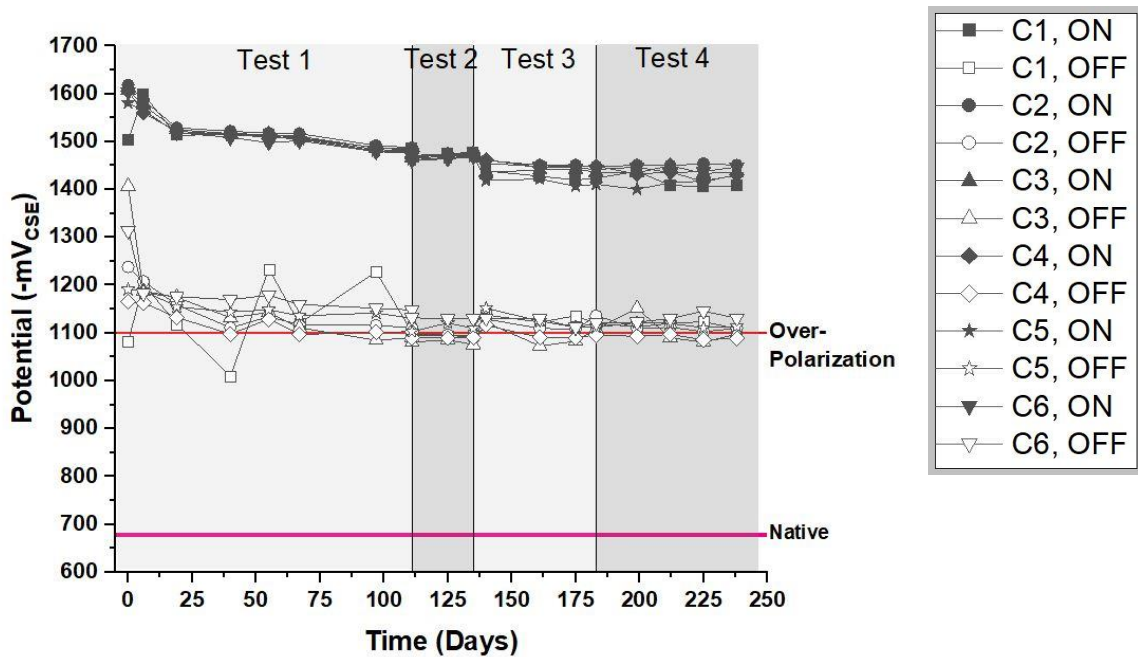
Figure 16.—Coupon ON, instant-OFF, and Native Potentials for test coupons.

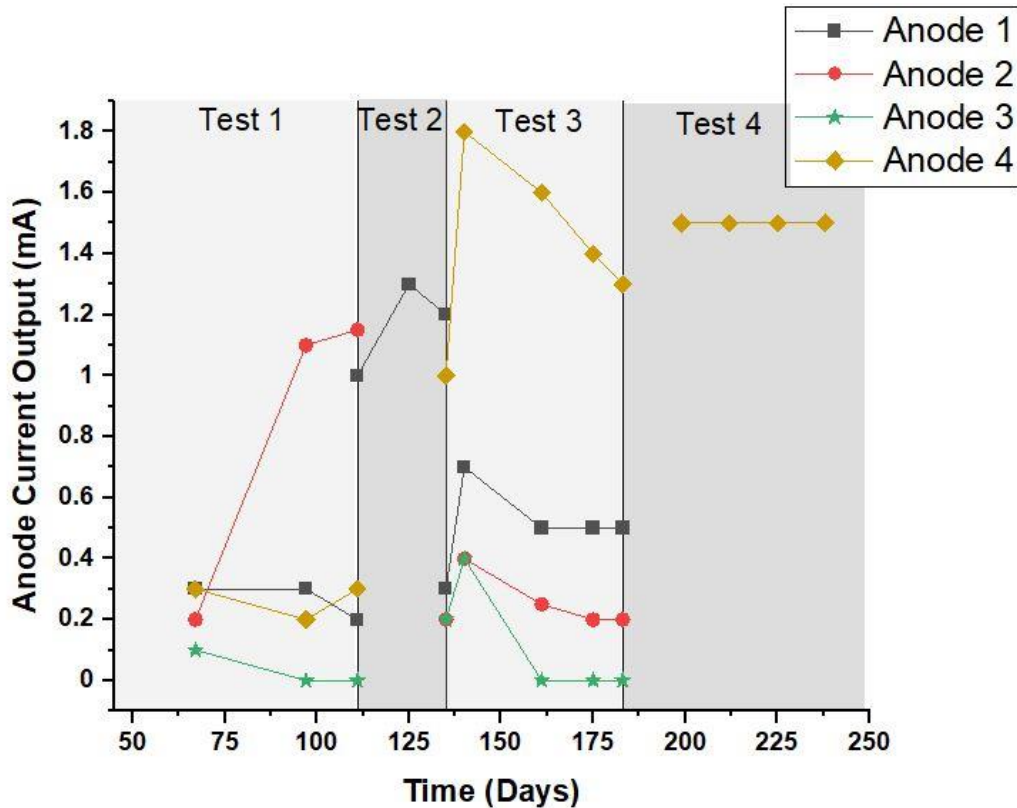
Figure 17.—Anode current outputs for each test.

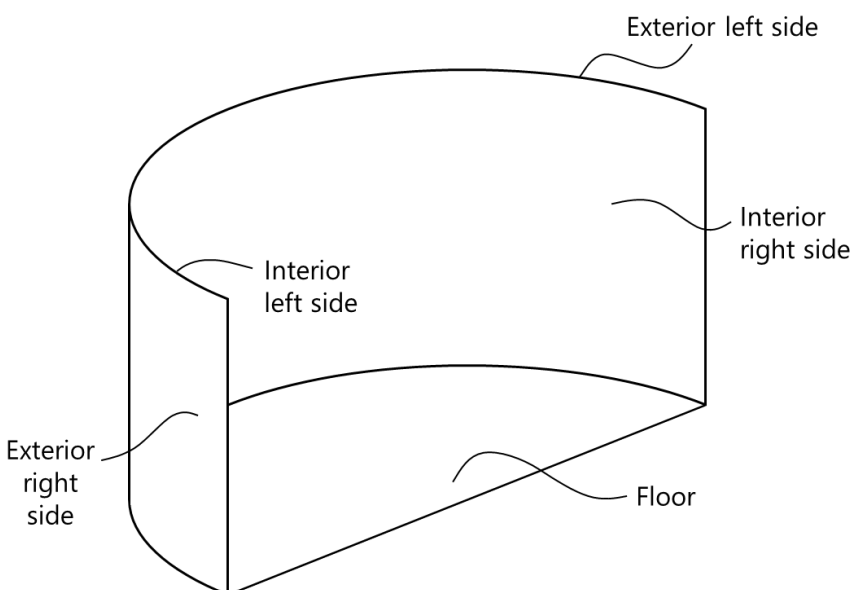
Figure A-1.— Diagram showing naming convention for tank half 1 for QA/QC measurements.
