Technical Memorandum No. MERL-2012-14

Laboratory Evaluation of Metalized Coatings for Use on Reclamation Infrastructure

U.S. Department of the Interior
Bureau of Reclamation
Technical Service Center
Denver, Colorado

May 2012

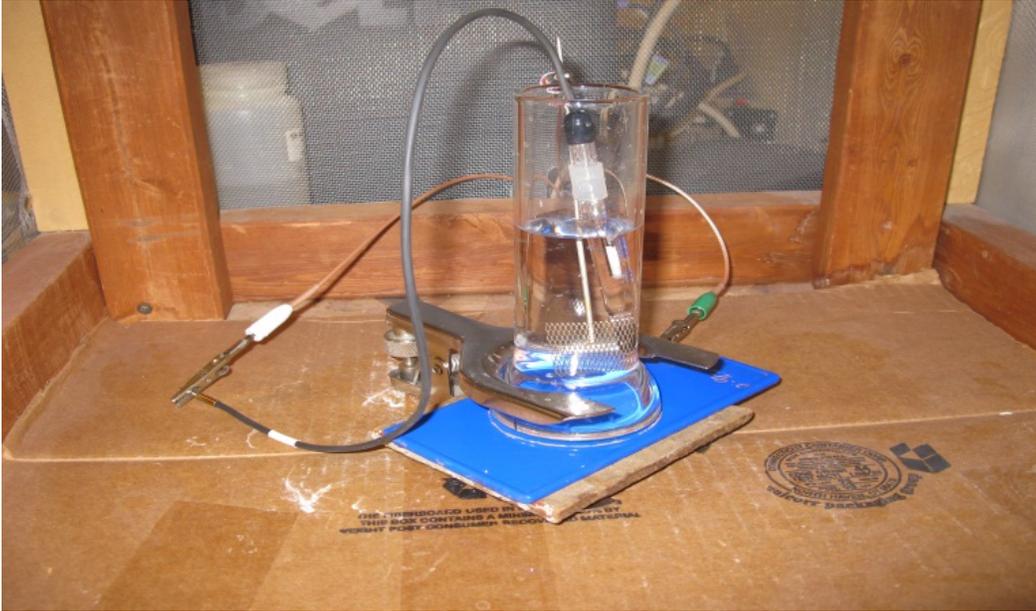
The samples were removed periodically to perform EIS measurements. A rubber *O*-ring and a 4-centimeter-diameter cylindrical glass cell were clamped to the sample to create an immersion surface area of 12.6 cubic centimeters. DHS is added to the glass cell along with a saturated calomel electrode (SCE) and platinum mesh to serve as the reference and counter electrodes, respectively. The working electrode is connected to the sample's steel substrate. The tests were performed within a Faraday cage to minimize electromagnetic interference. Figure 1 illustrates the experimental setup for EIS.

Figure 1.—Experimental setup for EIS.

Experimental testing can be used to measure the intrinsic corrosion potential of each metal. This is easily done using a bare steel panel and the setup given in Figure 1. The metals and alloys chosen as coatings for this experiment have corrosion potentials of approximately -1.00 to -1.15 volts versus saturated calomel electrode. Therefore, it is expected that the metalized coatings will provide cathodic protection to steel. The OCP is an effective method of identifying cathodic protection in a system (Felix, 1993). Sacrificial metalized coatings could serve as a useful means of corrosion protection for metal substrates over long service times.
