PLAN B REPORT

Alphabet Weirs Physical Modeling

Joseph J. Mercure

Fall, 2006

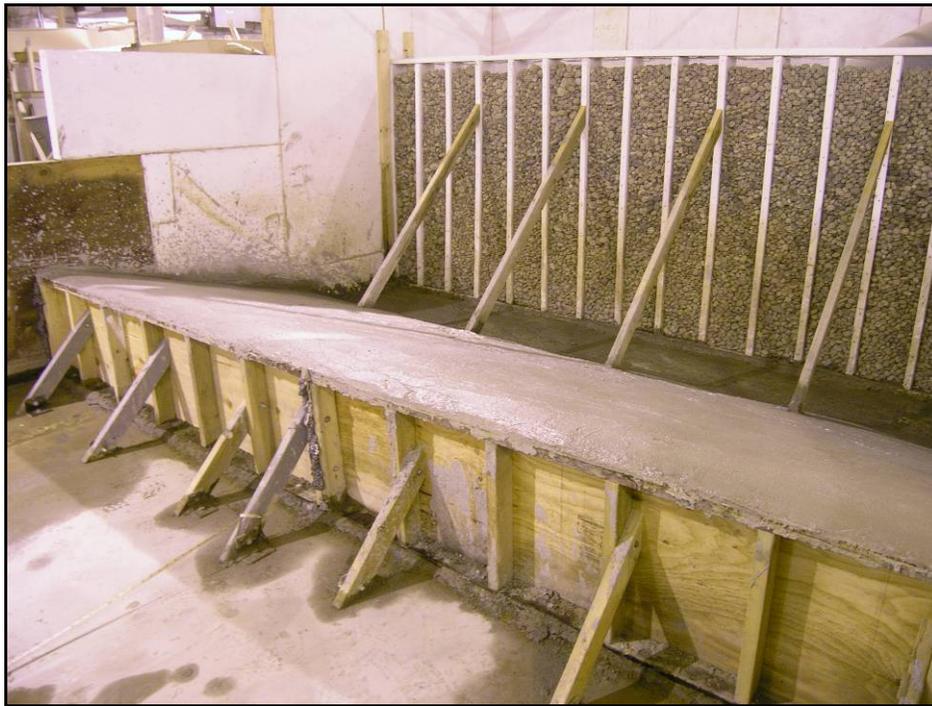
An inlet pipe baffle, drain, and transition ramp comprised the head box. The baffle was 6-ft high with a filter wall filled with small cobble. A drain was constructed that consisted of a threaded plate with a 6-ft high threaded polyvinyl chloride (PVC) pipe that acted as a plug. A concrete approach ramp was built to aid in flow transition from the head box to the test reach. It was constructed using sand as the base filler material overlaid with a 3-in. layer of concrete reinforced with a 1/2-in. wire mesh. A 16-ft wide retaining wall supported the approach ramp. Figure 2.3 presents a photograph of the approach section.

Figure 2.3. Photograph of Baffle and Upstream Transition

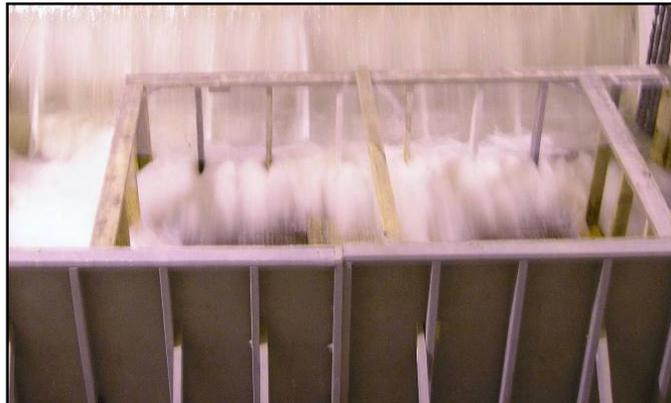
A grate cover was constructed to reduce the amount of sediment going into the sump. The cover initially consisted of 1/2-in. wire mesh wired to the grate. Catch walls were installed upstream of the grate to reduce the amount of sediment that could actually reach the grate. The catch walls were later removed and the grate cover was changed to a box-style grate cover consisting of a 3-ft high wooden frame outside of the perimeter of the grates with 1/4-in. wire mesh nailed to the frame. A photograph of the grate cover is presented in Figure 2.4.

Figure 2.4. Photograph of the Grate Cover

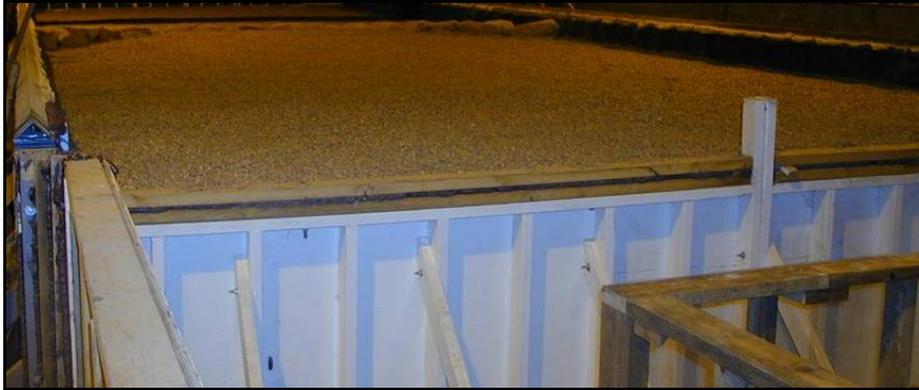
A system of stop logs was constructed at the downstream end of the model to control the water-surface elevation in the test section. Boards were bolted to the downstream retaining wall to provide downstream control. Backwater was adjusted by increasing or decreasing the number of boards or shims. Figure 2.5 presents a photograph of the completed stop-log system.

Figure 2.5. Photograph of Stop Logs

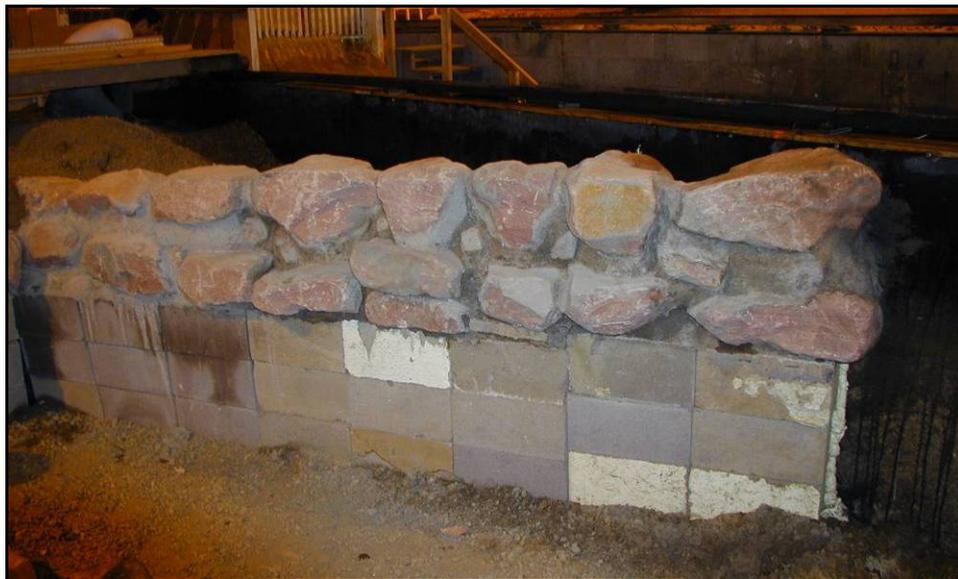
For Configuration 1, the weir was constructed without cementing any of the rocks. As determined by the BOR, subsequent configurations were conducted using weirs with crest rocks grouted together and supported with an anchor wall designed to minimize subsurface and interstitial flow underneath and through the weir. Figure 2.10 presents an example of a grouted weir.

Figure 2.10. Photograph of a Grouted Weir and Anchor Wall

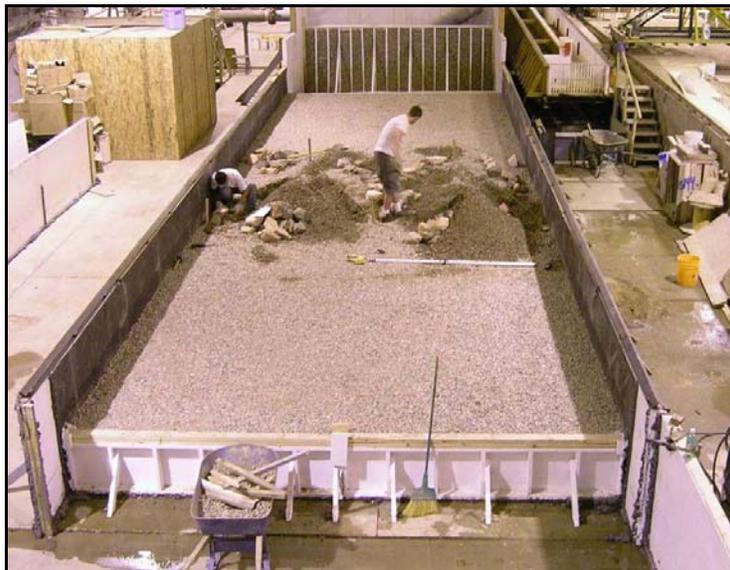
Configuration 1 was used as a shakedown run to determine what modifications were needed in the testing procedure or the model itself. Figure 3.1 presents a photograph of the W-weir installation.

Figure 3.1. Photograph of the W-weir Installation

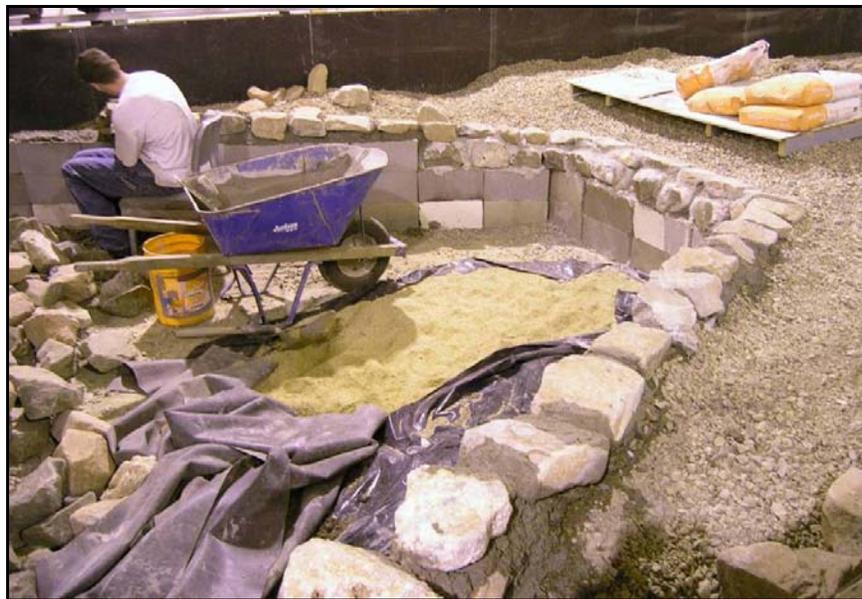
Construction of Configuration 2 (Tests 5 through 7) began on September 10, 2005 and incorporated modifications identified during shakedown runs. Bed material and weir-rock size were maintained from Configuration 1. The weir was grouted and an anchor wall was added. Black tarpaulin was installed to prevent subsurface and interstitial flow through the weir. A new method of measuring the slope of the weir was implemented, which involved measuring the elevation of the highest point of each header rock and plotting the elevations to make sure that the slope of the weir arms was satisfactory. Figure 3.2 presents a photograph of the grouted weir construction.

Figure 3.2. Photograph of Anchor Wall and Grouted U-weir Construction

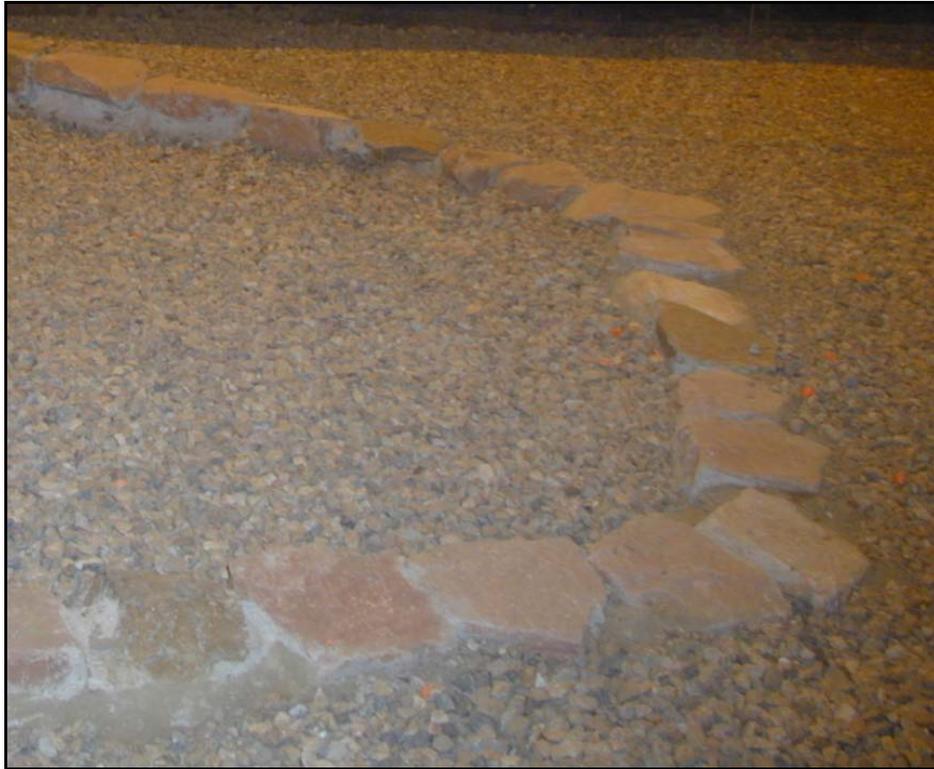
while maintaining the same weir height. This created a drop downstream of the horizontal sill of the weir. Figure 3.3 presents an example of the downstream drop.

Figure 3.3. Photograph of the Flume After Lowering Bed by 0.14 ft

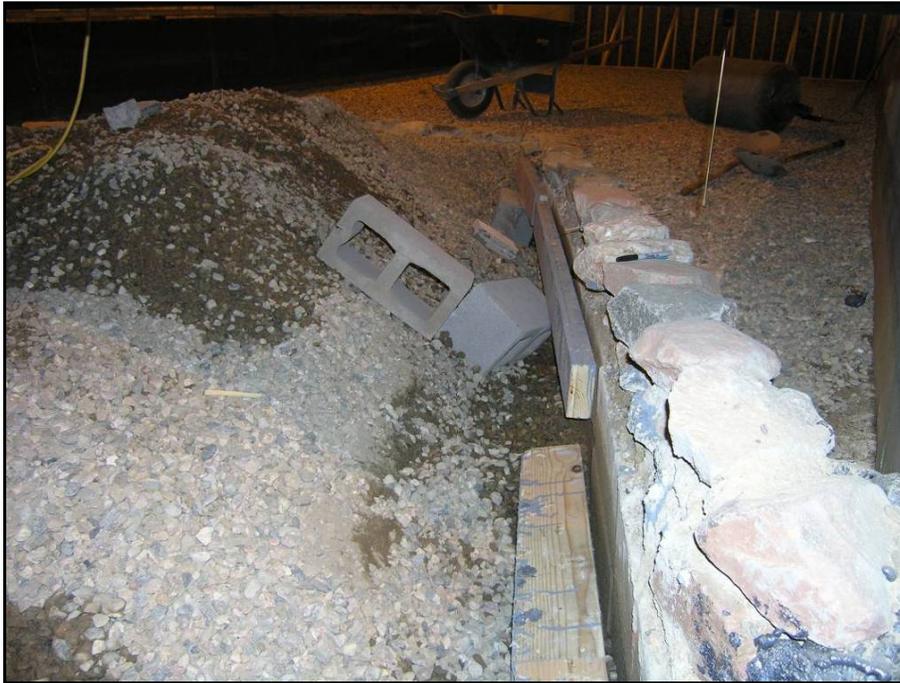
Construction of Configuration 5 (Tests 13 and 14) began on April 5, 2006 and involved installation of a 2-by-8 beneath the header rocks to act as a step. After Configuration 4 testing was completed, it was determined that we would need to test the effects of a step on scour at lower discharges. For Configuration 5, a step was installed using a 2-by-8 anchored beneath the header rock and installed at bed elevation. The step was anchored into the cinder blocks using concrete lag screws, and then sealed to the weir using Purifoam[®] waterfall foam and Great Stuff[®]. Figure 3.4 presents a photograph of the wooden-step construction.

Figure 3.4. Photograph of Construction of Wooden Step

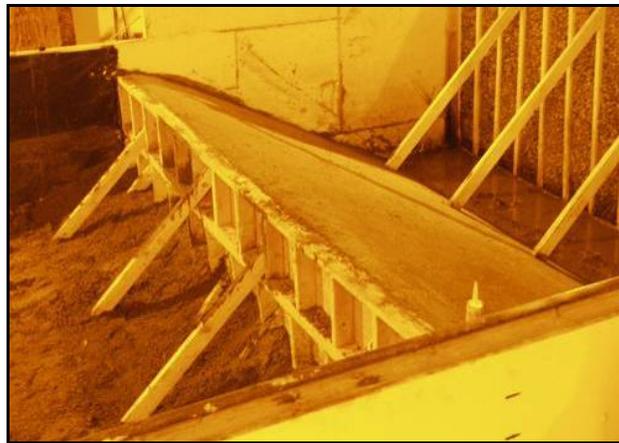
For Configuration 6, both the upstream transition and downstream flume wall were raised by 1.4 ft to increase bed-material depth. Figure 3.5 presents a photograph of the flow-transition wall addition. It was predicted that the bed-material depth would need to be increased because of the predicted increase in scour. The U-weir was constructed with the footer rocks offset by one-third the d_{50} of the weir rocks downstream of the header rocks. However, during the initial shakedown run, bowing was observed at the head-box walls and a few studs had broken along the flume wall.

Figure 3.5. Photographs of Flow-transition Wall Addition

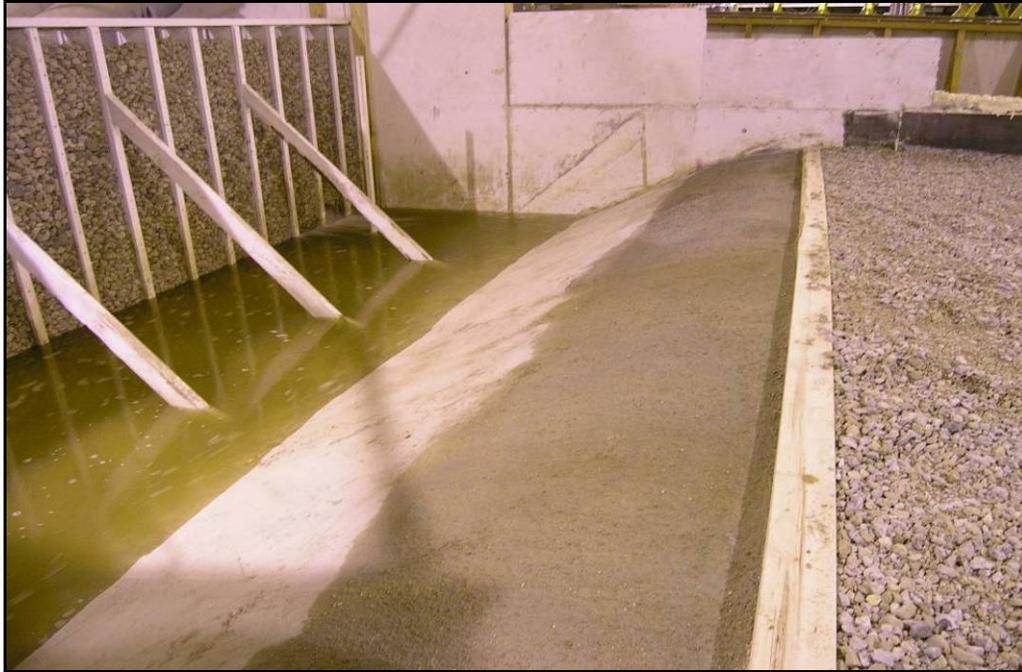
Construction of Configuration 7 (Tests 18 through 20) began on July 26, 2006 and involved installing 9.8-mm bed material to a slope of 0.0033 ft/ft and a U-weir with 8.8-in. rock. Both the flow-transition wall and stop-log wall were lowered by 0.5 ft to prevent overtopping at higher flows and improve approach conditions. Figure 3.6 presents a photograph of the modified upstream transition.

Figure 3.6. Photograph of Modified Upstream Transition

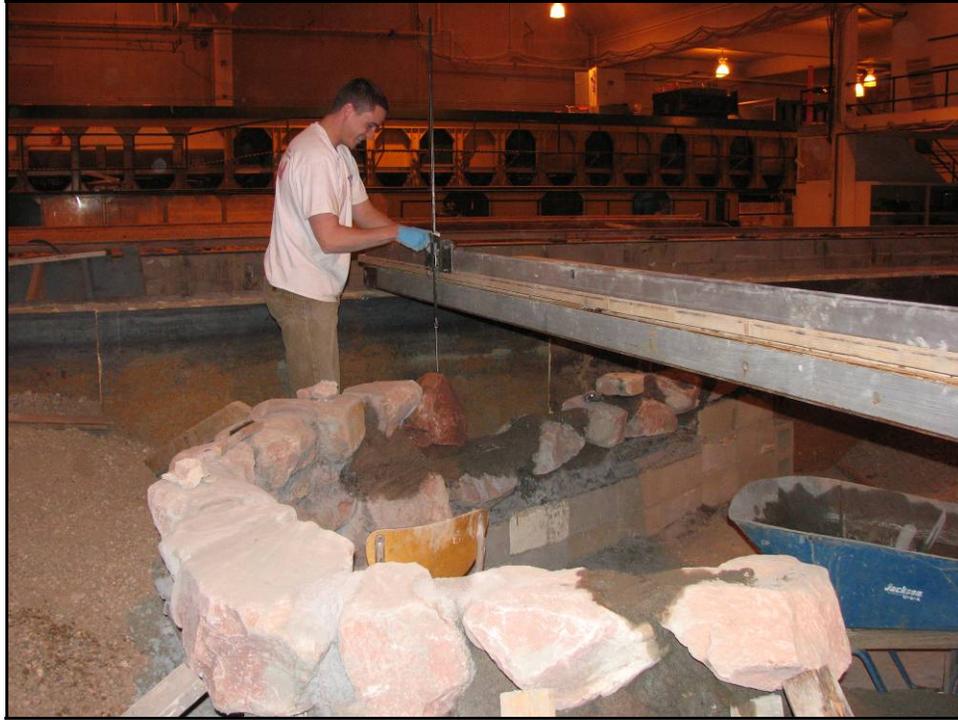
Data acquisition for the alphabet weir model was performed from a mobile test platform. A rope was installed above the cart to aid in moving the cart while testing. Rails for the cart were constructed the entire length of the flume. Point-gauge measurements of bed and water-surface elevations were taken from a rail attached to the upstream edge of the cart. Figure 4.1 presents a photograph of the cart and point gauge.

Figure 4.1. Photograph of Cart and Point Gauge

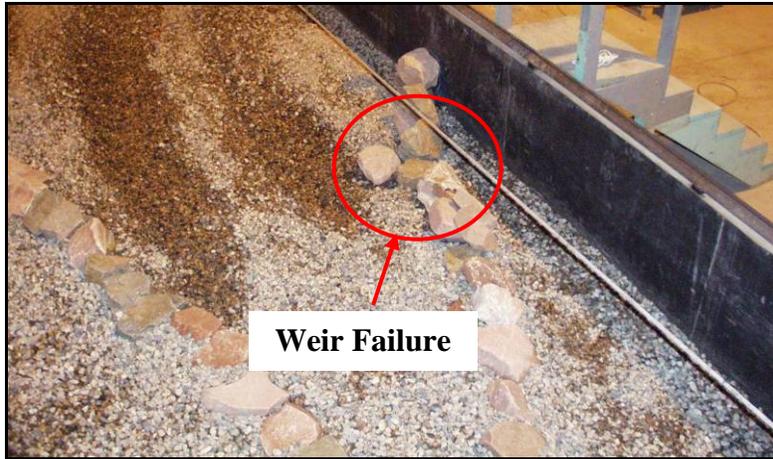
Figure 4.7. Photograph of Weir Failure During Test 3

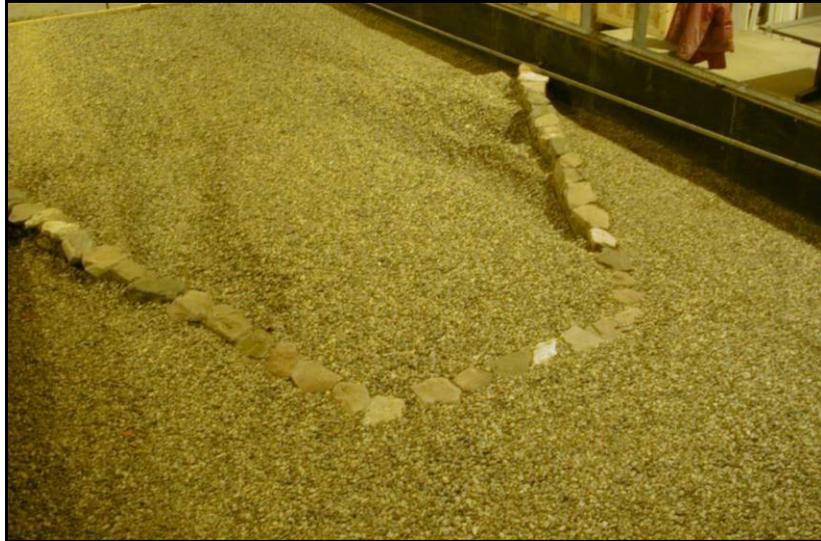
Two discernable scour holes developed as testing progressed with depositional bars along the outer edges. Figure 4.13 presents a photograph of the weir after Test 7. The scour holes looked to originate about one-third of the way down the weir downstream of the cross sill. The rate of scour also seemed to taper off between two-third and bankfull discharges.

Figure 4.13. Photograph of the Flume After Test 7

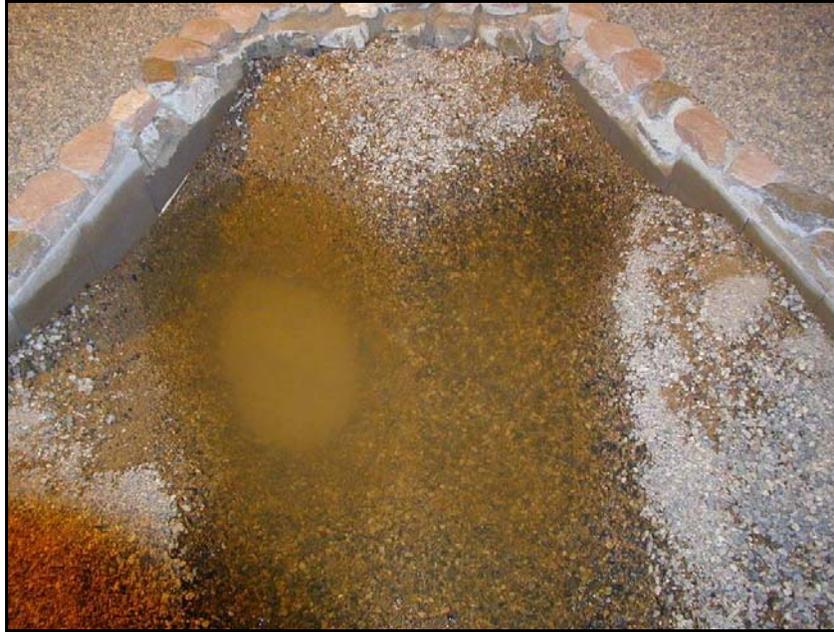
Creating the drop increased scour at each discharge significantly. At one-third bankfull discharge (13.33 cfs), scour depths were greater than previously seen at bankfull discharge (40.0 cfs). Two distinct scour holes were observed at the lower discharge tests that eventually began to merge at bankfull discharge. Test 10 (bankfull discharge) exhibited so much scour that it reached the floor of the flume. Figure 4.18 presents a photograph of the scour hole after Test 10.

Figure 4.18. Photograph of Scour Observed After Test 10 (Bankfull Discharge)

Compared to previous tests, the rate of scour was not only greater, it was also concentrated further upstream (approximately one-fifth of the way down the weir). It was observed that while the flume was running that there was a greater flow concentration through the throat of the weir as well as more turbulence downstream of the weir compared to previous tests.

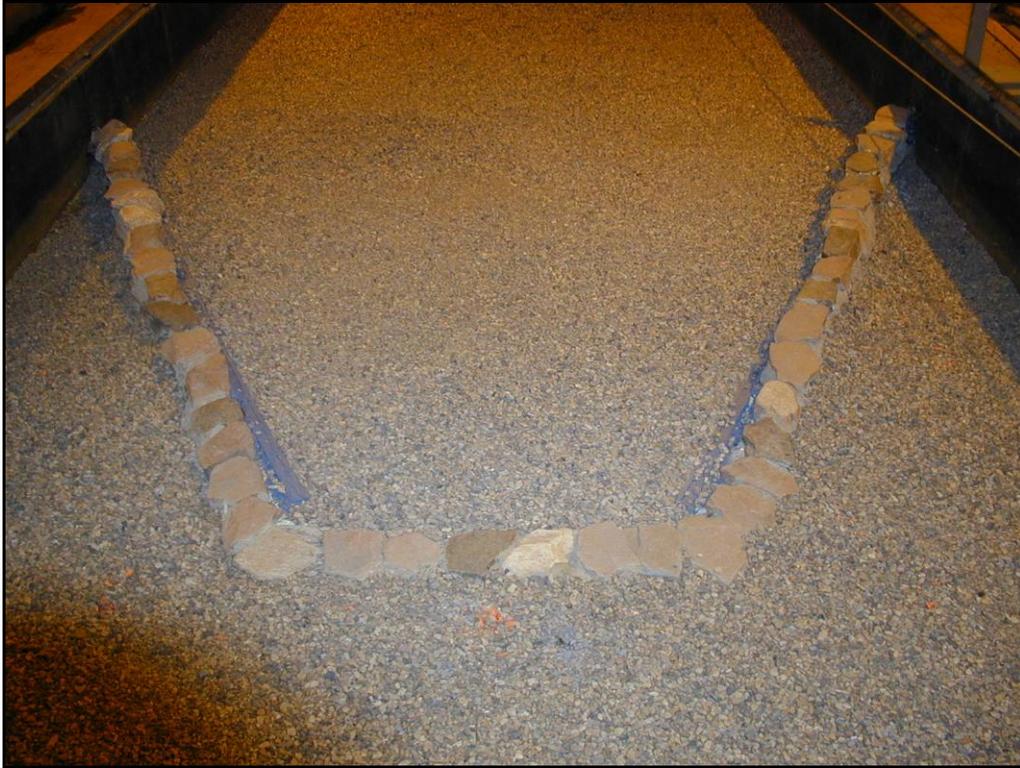
These tests were conducted to see the effects of an installed artificial step on scour development and velocities. It was found that the step did in fact effect scour. Two distinct scour holes were observed that had migrated further downstream and scour depth was slightly decreased compared to Configuration 4. At one-third bankfull discharge, it was observed that the water did fall onto the step and then onto the bed. At higher flows, the effect of the step was negated. Figure 4.20 presents a photograph of the flume after the step was installed. Table 4.5 summarizes the discharges and observed scour depths for each test. Bed contour plots generated with Surfer[®] illustrate the scour observed for each test and are presented in Figure 4.21.

Figure 4.20. Photograph of Installed Step (Test 13)

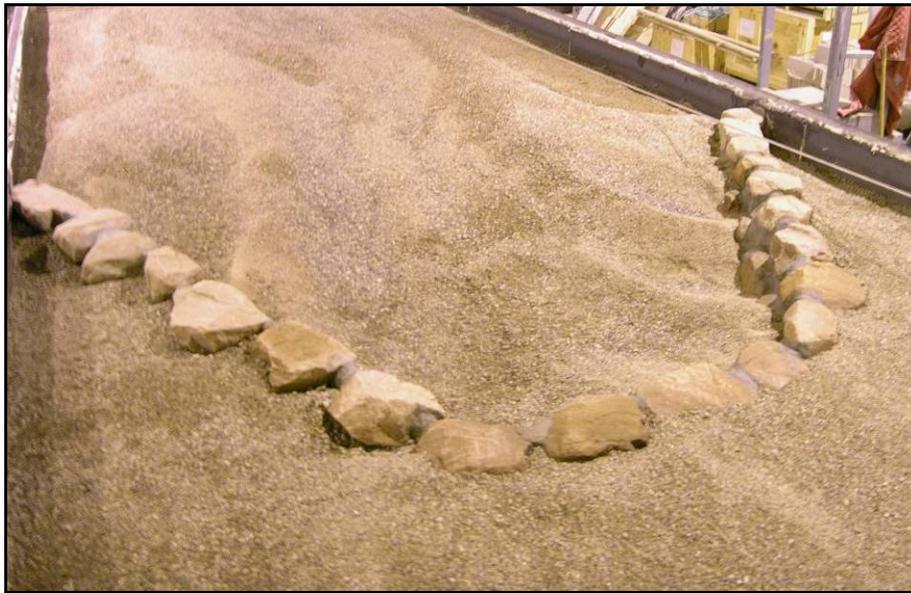
It was observed that rock geometry was important at low flows. Irregular rock geometry was more prevalent with the larger rock size of the weir and because of this, the weir crest was less uniform with more undulations. As a result of the low spots and undulations, scour holes were concentrated in these areas, particularly at the lower discharges. This, along with the smaller bed material, aided in the creation of more numerous scour holes. Scour developed much more asymmetrically during this configuration. Figure 4.25 presents a photograph of the

Figure 4.25. Photograph of Flume After Test 17

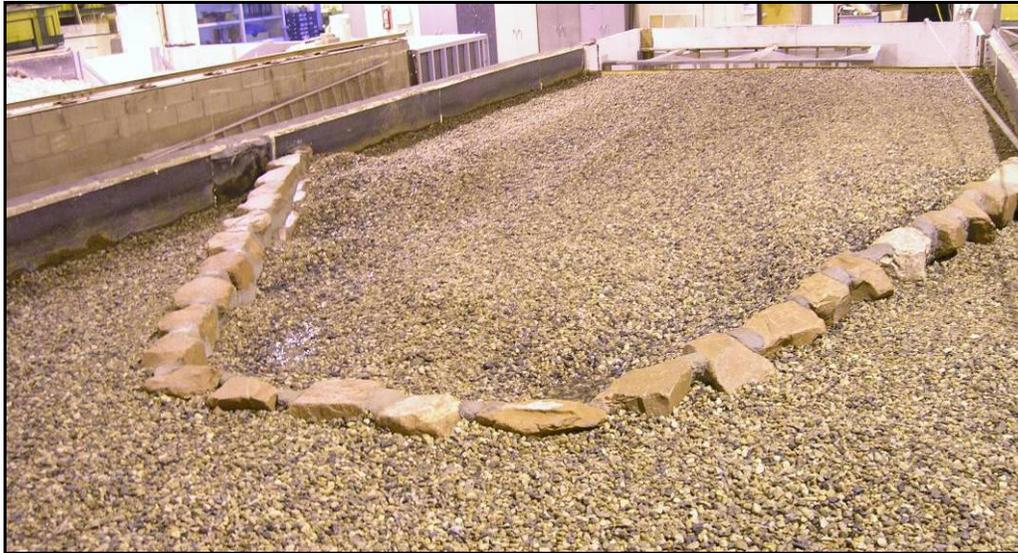
These tests were peculiar since the deepest scour was observed at the one-third bankfull discharge, 1.07 ft, and decreased with increasing discharge. This could be attributed to armoring of the bed or the weir may have been submerged at the higher flows. Testing procedures for this configuration remained the same as previous configurations. More data analysis on the velocities and water-surface profiles is needed. Figure 4.30 presents a photograph of the flume after Test 20. Table 4.7 summarizes the discharges and observed scour depths for each test. Bed

Figure 4.30. Photograph of Flume After Test 20

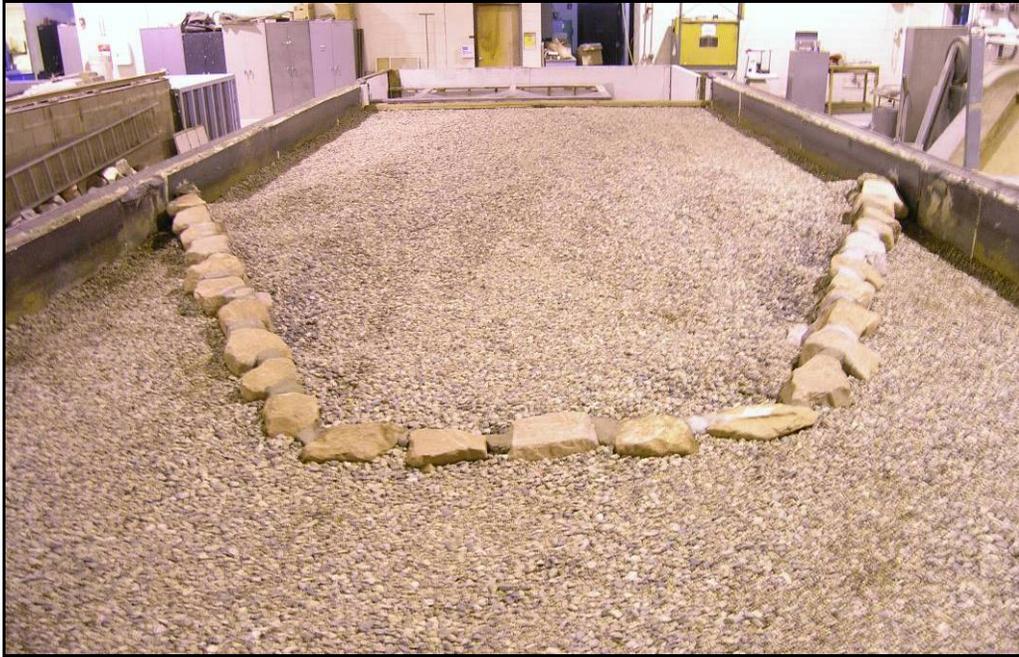
Despite efforts to set the normal depth of Test 21 equal to that of Test 18, the weir looked to be more submerged which might contribute to the fact that the observed scour depth for Test 21 was less than one-half of that observed for Test 18. However, the same trend of decreasing scour depth between two-third and bankfull discharges was observed. It is suspected that this trend might be due to the bed armoring. The weir may have also been submerged, which might account for the decreased scour depth. Differences between scour depth between two-third bankfull discharge and bankfull discharge were very small, 0.02 ft compared to 0.11 ft for Configuration 7. Figure 4.32 presents a photograph of the flume after Test 23. Table 4.8 summarizes the discharges and observed scour depths for each test. Bed contour plots generated with Surfer[®] illustrate the scour observed for each test and are presented in Figure 4.33.

Figure 4.32. Photograph of Flume After Test 23

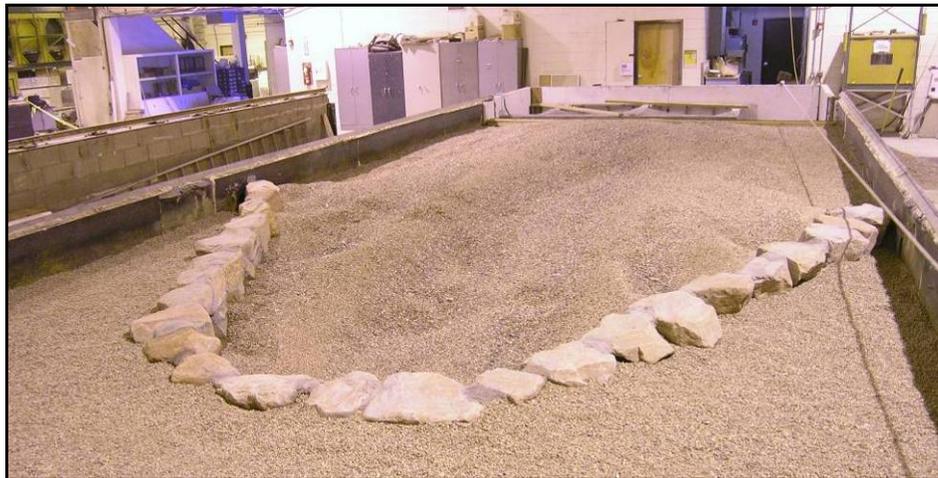
scour for this configuration was more symmetric than for Configuration 6. This can be attributed to the grout between the weir rocks being more uniform and level with the rock-surface elevation. Figure 4.37 presents a photograph of the flume after running Test 26. Table 4.9 summarizes the discharges and observed scour depths for each test. Bed contour plots generated with Surfer[®] illustrate the scour observed for each test and are presented in Figure 4.38.

Figure 4.37. Photograph of Flume After Test 26

During these tests, it was observed that rock geometry was important at low flows. Irregular rock geometry was more prevalent with the larger weir rock size and because of this the weir crest was less uniform with more undulations and low spots. As a result of the low spots and undulations, scour holes were concentrated in these areas, particularly at the lower discharges. This, along with the smaller bed material, aided in the creation of more numerous scour holes. Scour developed much more asymmetrically during this configuration. However,
