## Extending the Useful Service Life of Wire Hoist Ropes using Nondestructive Testing

Research and Development Office  
Science and Technology Program  
ST-2015-3973-1

September 2015

**Technical Memorandum No. MERL-2015-087**

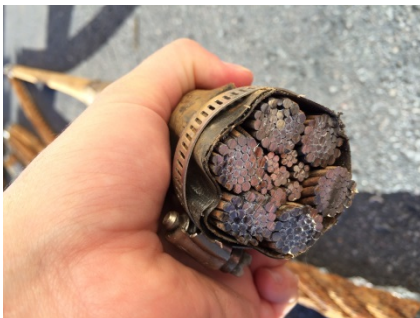
**Figure 1: Inside Construction of a Wire Rope**

Steel wire ropes have a disadvantage in that only the outer strands of the rope can be visually inspected. The metallic rope core itself accounts for about 50% of the wire rope's area and is surrounded by a second layer of wire rope, as shown in Figure 1. The wire ropes used at Shasta Dam are constructed of 6 outer strands consisting of 19 wires each, along with a steel core consisting of 7 bundles of 7 wires each. In Figure 1 corrosion has begun to damage many of the outer and inner strands. The only wires that can be visually inspected on a wire rope in service are the outer wires. Visual inspection of the interior strands is not possible without destructively taking apart the rope. As shown in Figure 2, when the wire rope was unraveled, the undetectable inside region was so damaged that it broke. This damage would go undetected if a visual inspection was the only method employed.

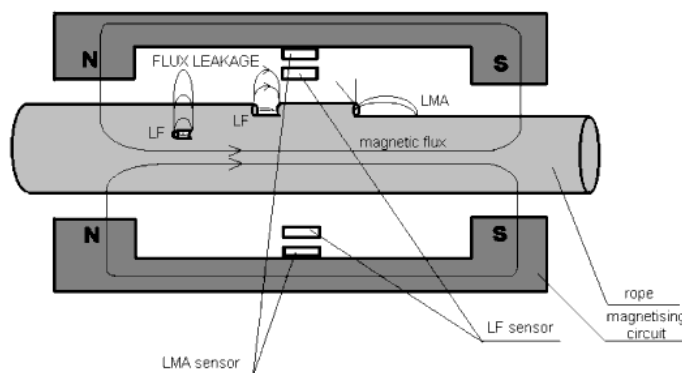
**Figure 3: Magnetic NDT Schematic**

The principle behind Magnetic NDT is the detection of changes in an induced magnetic field. As seen in Figure 3, a set of magnets are moved along the wire rope and the magnetic flux (total magnetic field passing through a given surface area) changes based on the presence of damage, loss of rope, and corrosion pits. At areas of damage, flux leakage occurs and is picked up by the sensor [1]. Whenever the flux decreases, it is an indicator of some type of damage to the rope: loss of wire, pit corrosion, etc. [1].

Magnetic NDT works by placing permanent magnets longitudinally to magnetize the rope as it passes through the sensing head. Direct current (DC) excitation coils are used. Both local fault (LF), also called low flow, and Loss of Metallic Cross-Sectional Area (LMA) sensors can be used individually or together depending on the desired testing information [1]. Simplified auxiliary testers, as shown in Figure 4, use signals to detect localized flaws. Computer recordings, shown in Figure 5, are also used to help determine loss of cross sectional area. A constant magnetization of the rope must be strong enough to create magnetic saturation of the rope. This method is portable and can be used in the field.

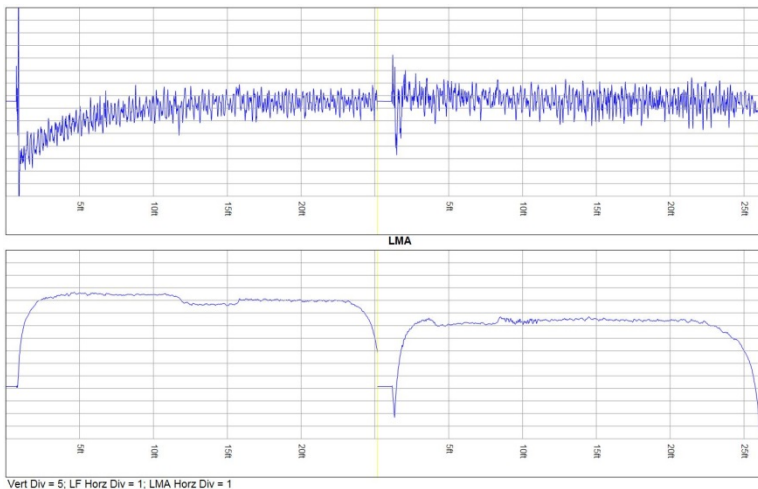
**Figure 6: Scan of New Wire Rope**

Magnetic NDT scans during ideal conditions can identify a lot of useful information. Figure 6 depicts the scan result from a new wire rope tested by Silver State Wire Rope. The flat line gaps between testing segments is where the testing head was removed from the wire rope and retesting of the same wire rope was conducted. This checks for reproducibility in the scans. When reading scans, the LF and the LMA coincide. The LF section (top scan box) will typically have noise associated with corrosion products and wear. The LMA section (bottom box) will generate dips and spikes that coordinate with the LF to indicate if broken wires are present. Using the values in the scans a loss of breaking strength can be ascertained. In order to determine loss of breaking strength (loss) of the wire ropes based on this NDT test method the following relationship is used:

$$"loss" = \sqrt{\frac{LF(worst)}{LF(best)}} \times LMA(worst)$$

The LF worst and LF best are pulled from the graph and used with the coinciding LMA value to obtain a theoretical loss in breaking strength. Criteria listed in the U.S. Code of Federal Regulations CFR 30 allows for a loss of breaking strength up to 10% before replacement is required.

The scans in Figure 7 show examples of some issues that can show up on a scan. In the scan of the new wire rope it can be noted that the noise is fairly low compared to the scans in Figure 7. In fact, the scans in Figure 7 have so much

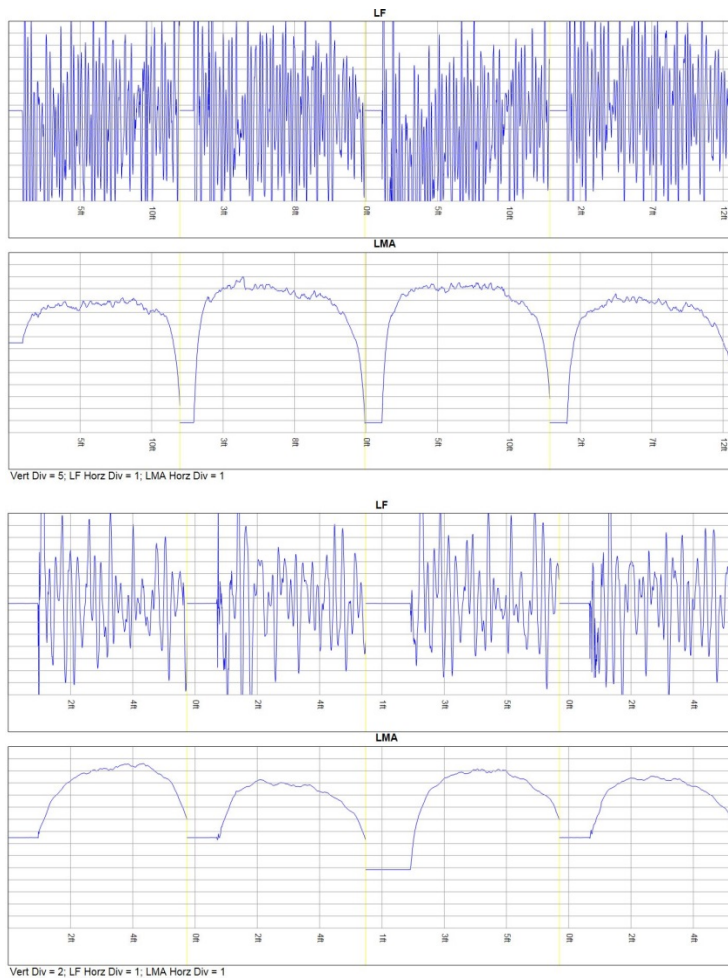
noise that reasonable assumptions can no longer be made. The dips and spikes no longer have meaning and the data can not be interpreted to determine internal damage to the wire ropes. Based on visual inspection of the tested wire ropes, the reason for such large noise is the accumulation of corrosion products. The significant amount of corrosion of the rope masks the signal of any internal wire rope damage.

**Figure 7: Scans of Damaged Shasta Dam Wire Rope a) Lower Gate 2 b) Pressure Relief Gate 5**

Based on the Magnetic NDT scans performed by Silver State Wire Rope we are unable to draw any conclusions on the conditions of the wire rope. It would be more qualitative if the wire ropes were assessed regularly using this method beginning shortly after installation. This would provide a baseline for comparisons and a better interpretation of results. The wire ropes at Shasta Dam had not been previously tested using the Magnetic NDT method and therefore provided no baseline for comparison.

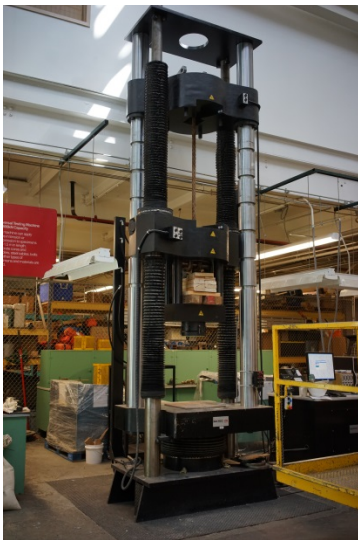
Tension tests were performed on two of the corroded Shasta Dam wire ropes along with a new wire rope from Silver State Wire Rope. All the ropes were approximately the same thickness and length and had spelter sockets on each end. Figure 8 shows the testing set up using the Instron 3MN Universal Testing Machine. Figure 9 shows the new wire rope during the break point. Visually, the rope can be seen separating as well as sparking from the individual strand breaks against the plexiglass shield. The plexiglass shield used in the first test failed due to impact from the wire rope. Subsequent tests used a thicker shield, as shown in Figure 9.

**Figure 8: Pre-testing initialization of wire rope on Instron 3 MN Universal Testing Machine**

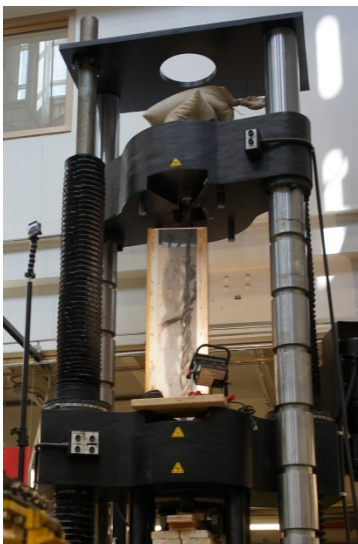
**Figure 9: New wire rope break during test**

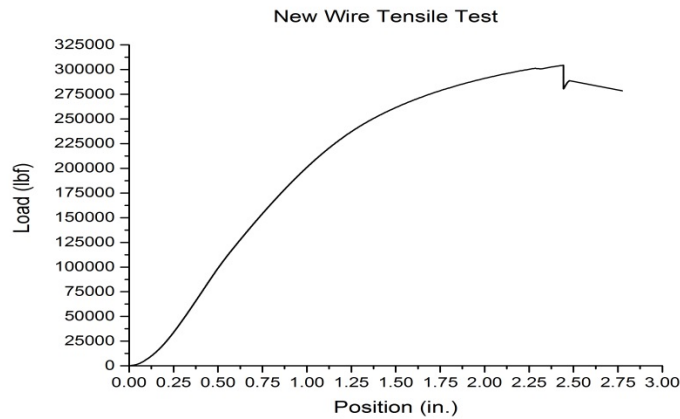
**Figure 10: Tension test results for new wire rope**

Results in Figure 10 show that the ultimate tensile strength of the new wire rope was 304,384 lbf. The manufacturer stated that the ropes had a strength of 250,000 lbf. Testing was performed at a loading rate of 50,000 psi per minute. The new wire rope failed by a mechanism of un-winding as well as individual strand breakage as seen in Figure 11.

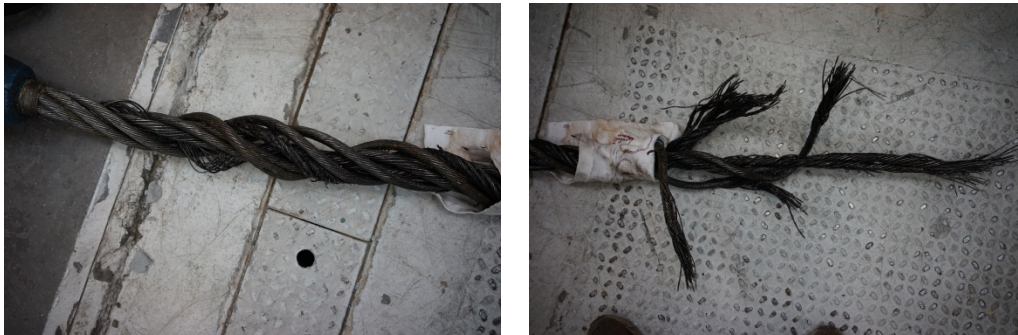
**Figure 11: Broken new wire rope after testing: a) Strand un-winding and b) Severed ends**

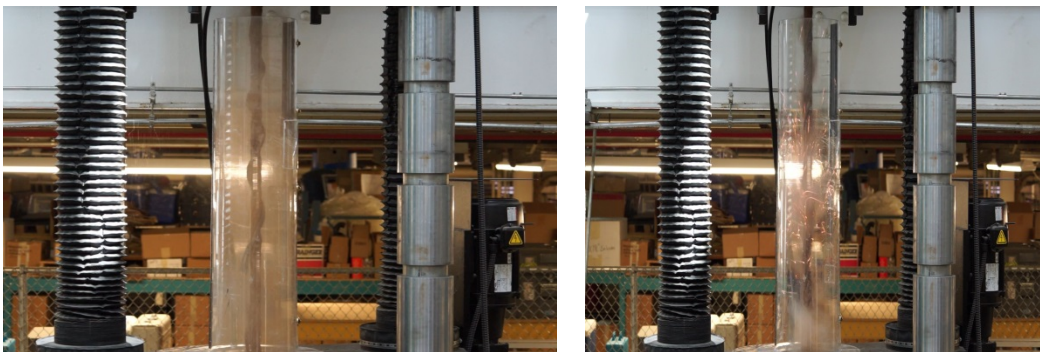
**Figure 12: a) Breaking point during tension test of corroded wire rope and b) Sparks due to individual strand breaks.**

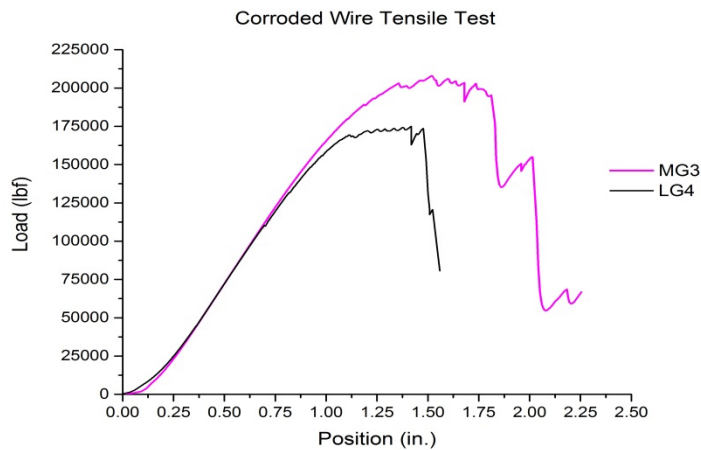
**Figure 13: Tension test results of corroded wire rope**

Results in Figure 13 show that the ultimate tensile strength of the corroded wire ropes was 174,992 lbf and 207,840 lbf. The corroded wire rope failed by individual strand breakage as seen in Figure 14, as opposed to the mechanism involved in the new wire rope. It should be noted that a typical design safety factor is at least 5:1 for wire ropes. At failure, even the most corroded rope achieved a safety factor of 3.5:1. This assumes an in-service working load of 30,000 lb for each of the wire ropes based on calculations under normal balanced lifting. A loss in strength of 10 percent is also assumed due to bending of the ropes at the drums/sheaves as well as galvanizing.

Under tension testing, the most corroded wire rope still maintained a safety factor of 3.5:1 as compared to operational loads. Magnetic NDT suggested that the ropes were too badly damaged to remain in service, but also did not contain any comparable data. We were unable to establish a strong correlation between the tension test results and the Magnetic NDT results.

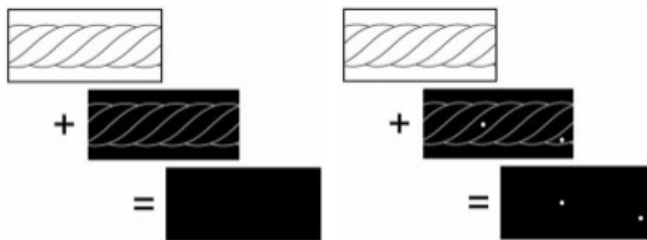
**Figure 16: Superimposed images for Photographical Comparison Method**

*Photographical Comparison* is a testing technique used to determine if there are flaws in the outer rope. Pictures are taken using a strobe light triggered by a high-speed sensor. The high-speed images taken by a slit aperture camera from different directions are superimposed with the positive black and white image of one lay length with the negative black and white image of the next lay length [5]. One of the images is of a known undamaged strand. Damaged areas appear as white flashes on the images. Figure 15 demonstrates the camera layout and Figure 16 shows how the images are superimposed to show defects [5].

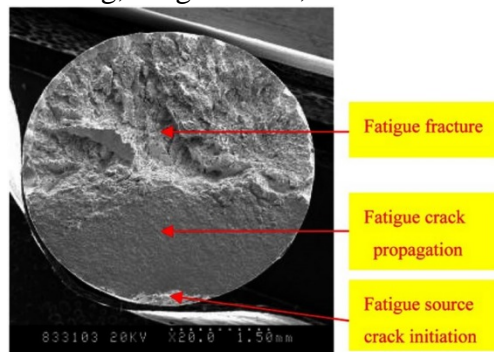
Figure 17: Scanning Electron Microscopy image of fatigue fracture

of AE reflect the changes of material performance and its relationship with the strain energy of dislocations, fractures, and crack propagation. Fatigue fractures have three different morphological characteristics zones, including fatigue source cracking, fatigue crack, and failure as shown in Figure 17 [6].

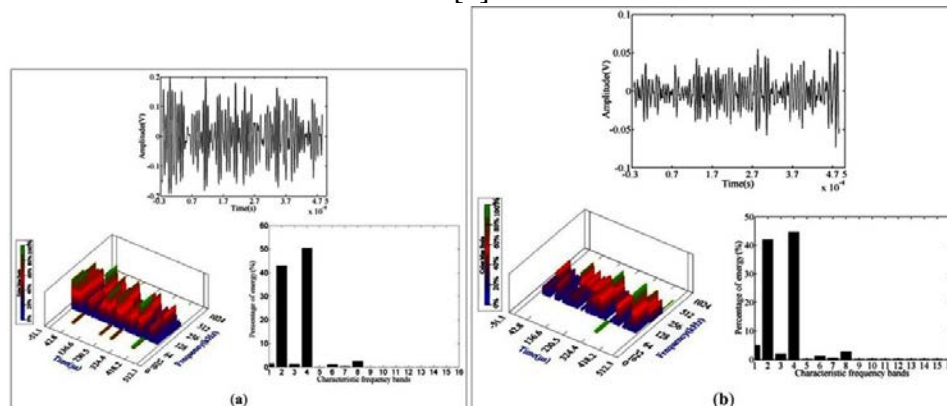
Figure 18: Fatigue Source Crack Initiation AE Waveform

AE signals can be generated from cable fatigue damage, plastic deformation, crack formation, crack propagation, and fractures. Each damage mechanism has a unique AE signal waveform and frequency characteristic. Figure 18 displays a fatigue waveform that occurs at a low-amplitude wide pulse with a narrow frequency scale and energy concentrated at frequency bands 2 and 4, and which are located at 100 kHz to 200 kHz [6].

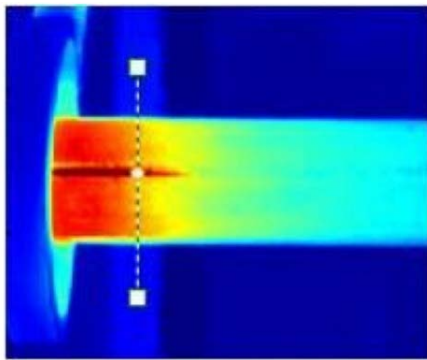
**Figure 19: Infrared test for defects on a wire rope**

The *Thermographic Method* utilizes cameras that measure infrared radiation emitted from the surfaces of objects, which in turn are related to surface temperatures. Subsurface data is gathered via the surface temperature because internal anomalies affect the heat flow through the body. Advantages of this method include low danger due to the equipment and speed of inspection. Due to large coverage of cameras, large horizontal defects can be identified. Disadvantages include effects on the environment from the surface temperatures; emission factor and depth of flaws are not provided [8]. Figure 19 depicts an example of an infrared test on a wire rope [9].
