Rehabilitating Habitat Complexes in Side Channels

Understanding a case history of channel changes downstream of Yellowtail Dam will help facilitate the restoration of side channels

This study provides a comprehensive history of side channel formation and loss and associated channel changes before and after the construction of Yellowtail Dam and Afterbay, Montana, to determine the cause of habitat loss in side channels of the Bighorn River.

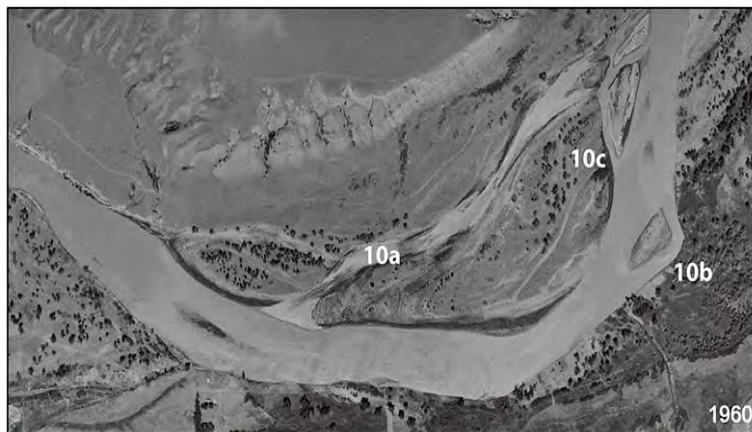
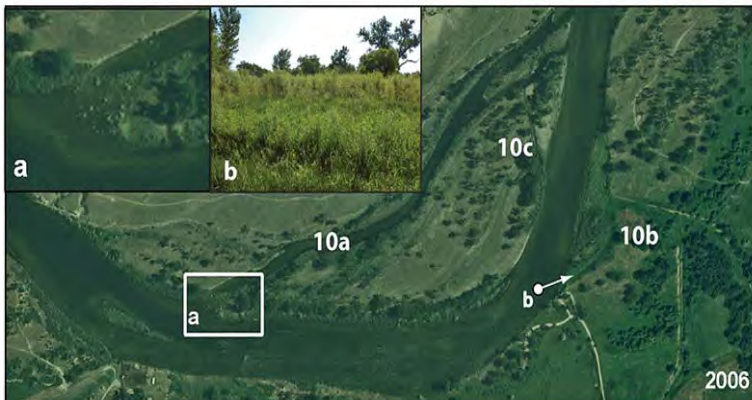
Channel changes at side channel complex 10 showing a comparison between 1960 and 2006; (a) vegetation establishment and sediment deposition in side channel 10a entrance; (b) vegetation growth in side channel 10b entrance.

Side channel habitat has been lost due to a combination of sediment deposition at side channel entrances, decreased flow magnitudes, loss of sediment supply, and vegetation encroachment. Previous studies on the downstream effects of large dams document decreases in flood peaks, sediment concentrations, and suspended load as well as degradation of channel beds, channel armoring, and increases in vegetation along river channels (e.g., Williams and Wolman, 1984). These changes tend to concentrate flow in the main channel while side channels are dewatered or receive flow only seasonally during larger flow releases, which may or may not be the corresponding time of year for spawning and rearing. Solutions are needed to rehabilitate side channels that have been progressively abandoned downstream from Reclamation structures and to prevent further losses of side channel habitat.

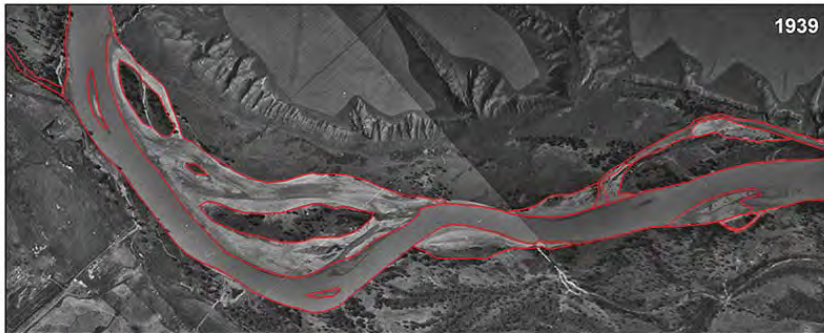
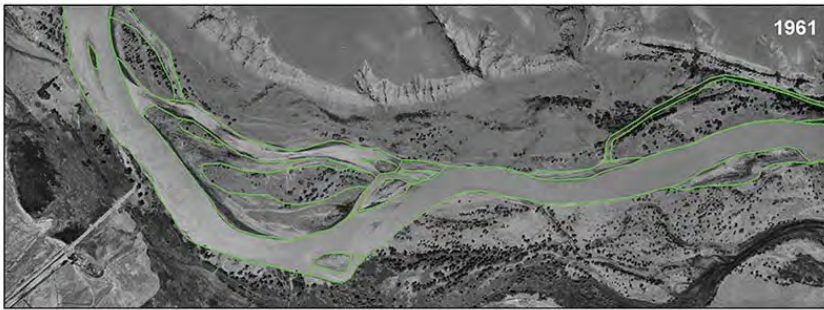
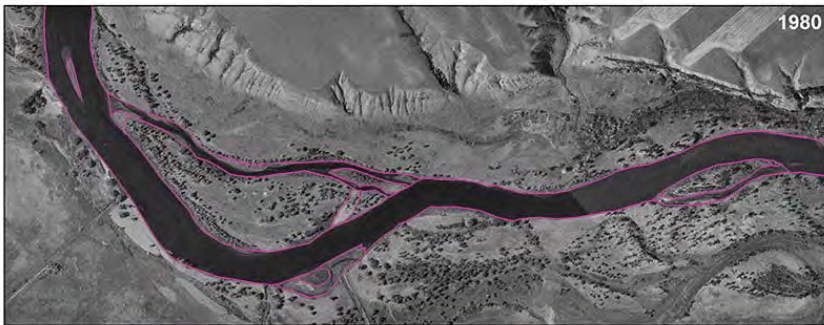
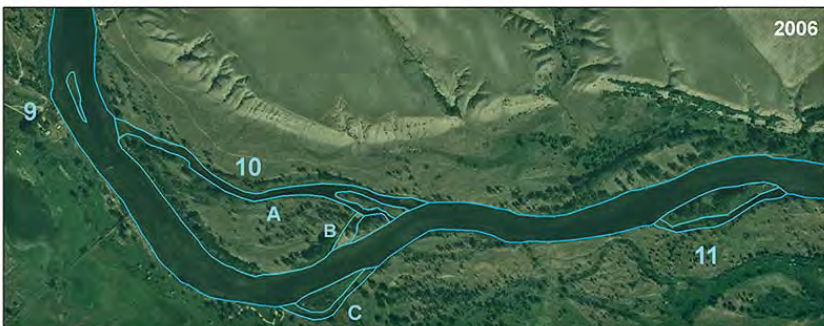
Historical channel mapping for side channel complexes 9, 10, and 11 from 1939 to 2006.
