Research Update

Summer 2016
Bulletin 2016-13

Using Photogrammetry to Assess Reclamation's Structures

*Applying specialized three-dimensional modeling to analyze
Reclamation's structures more efficiently*

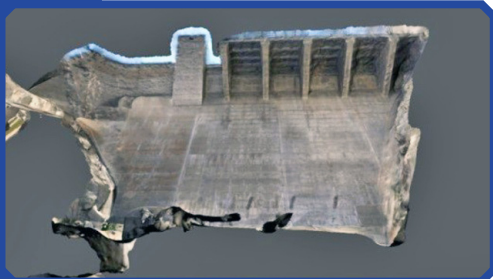
*The photogrammetric model
of Kortes Dam, Wyoming,
using data collected from
a smartphone.*

- 2. Smartphone Camera Data Collection.** Photogrammetry is best performed using quality camera sensors and lenses; however, technological advances now enable photogrammetry to be performed on images collected from smartphones. For example, during a facility review, data were collected from Kortes Dam, Wyoming, using an iPhone 6S Plus. The images were used to create a detailed 3-D model of the structure, including the downstream face and spillway.

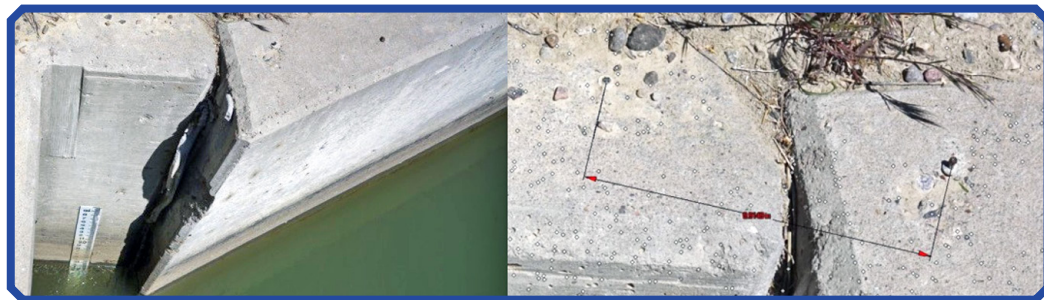
Left: An offset joint at the Upstream Canal Control Structure at Tunnel No. 5 near Farmington, New Mexico.

Right: Measured distance is 9.149 inches between the two survey points.

- 3. Measuring Extent of Damage.** Measuring volumes of damage and distances of movement within structural elements is often time consuming and inaccurate. Using photogrammetry, however, permits volumes, areas, and distances to be measured quickly and accurately. Typically, only a few pictures are required to determine the volume of a spill or settlement distances. Using pictures from Webster Dam (Kansas) and the Upstream Canal Control Structure at Tunnel No. 5 near Farmington, New Mexico, the volume of a concrete spill and distance between survey pins on offsetting concrete canal walls was determined with efficiency and accuracy.

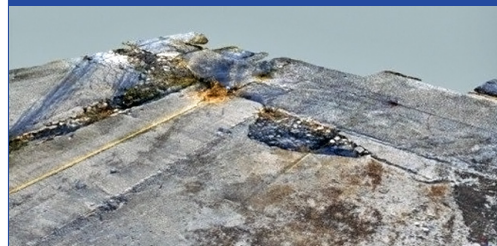
3-D rendering of the concrete spillway damage at Webster Dam, Kansas.
