## Research Update

Fall 2016  
Bulletin 2016-19

## Going Where No Human Can: Inspecting Inaccessible Features at Reclamation's Glen Canyon Dam

*Determining the feasibility of using autonomous unmanned aerial vehicles for penstock inspections in inaccessible areas*

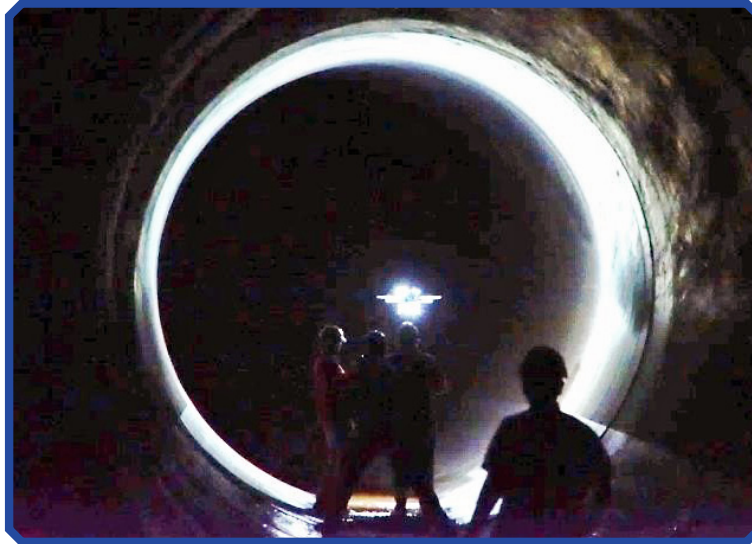
*Autonomous UAV inspection at Glen Canyon Dam, Arizona.  
The UAV provides the light, illuminating the tunnel.*

The Unit 2 Penstock at Reclamation's Glen Canyon Dam in Arizona was used for the demonstration. The penstock begins at a fixed wheel gate at the upstream face of the dam and terminates in the generator turbine scrollcase. The penstock is about 400 feet long and features a 285-foot, 60-degree inclined section and a 100-foot-long horizontal section leading to the scrollcase. The inclined section has a 15-foot diameter, which is reduced to 14 feet in the horizontal section. The penstock is steel-lined with portions encased in concrete and others buried in soil. It is coated with a coal tar enamel that has been in service since the mid-1960s. This configuration is representative of many Reclamation and USACE structures.

Only the horizontal section of the penstock was inspected autonomously, as time was limited.

A small portion of the inclined section was inspected using manual control. The post-processed video included a stitched panorama from four cameras of the 360-degree circumference of the penstock. A point cloud of the penstock was also generated using two Light Detection and Ranging (LiDAR) sensors. However, the video resolution was too low to accurately identify all potential defects in the penstock coating. In addition, the point cloud was also lower resolution and could not be used to measure loss of coating.

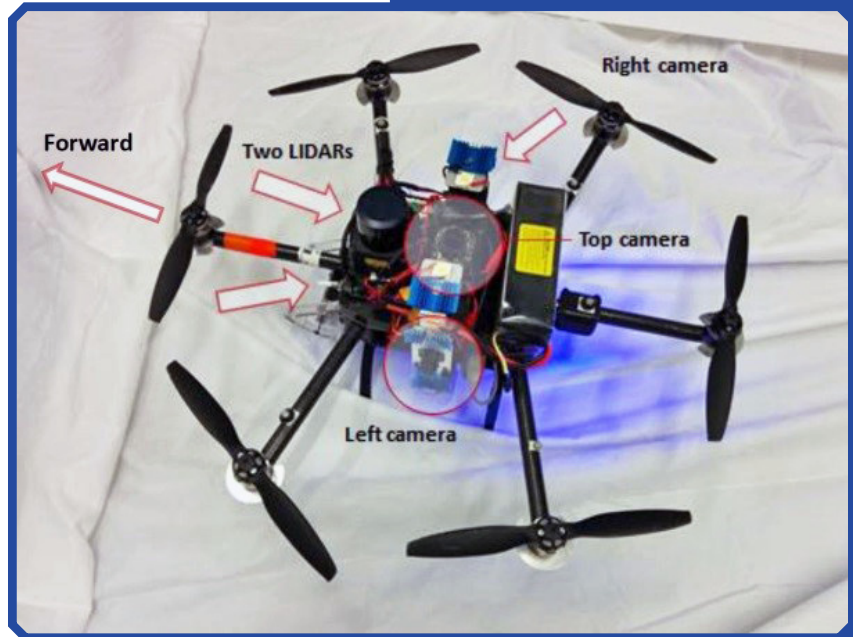
*Autonomous UAV and sensors.*

The U.S. Army Corps of Engineers (USACE) recognized the potential and has been collaborating with the University of Pennsylvania's Robotics Laboratory to develop a UAV for inaccessible features inspections. The UAV's functions include autonomous navigation, 3D mapping and modeling capabilities, and 360-degree video.
