Power System Safety

Research and Development Office
Science and Technology Program
(Final Report) ST-2017-613-00

Appendix A – ABB VisiVolt™ Applications and Limitations

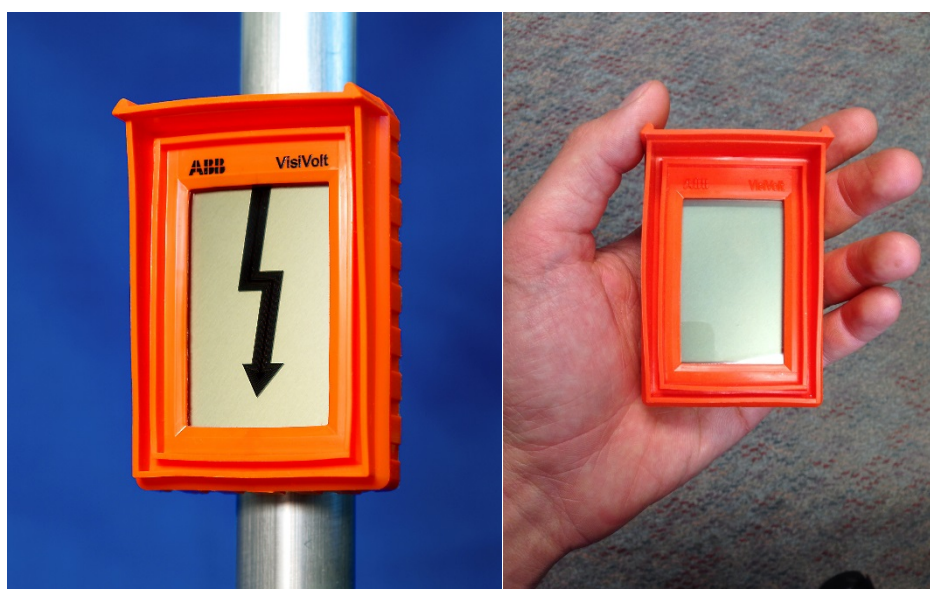
Figure 1: Image of ABB Group's VisiVolt™ passive voltage indicator. The lightning bolt image appears in the presence of strong electric fields (left). Image courtesy of www.abb.com. VisiVolt™ shown in hand for scale (right).

The VisiVolt™ is comprised of a 2.25 x 1.4 inch liquid crystal display, which is adhered to a hard plastic base for mounting, and is encapsulated in high-visibility orange silicone for environmental resistance (see Figure 1) [3]. There are two models available: VV-A and VV-B as described in Table 1 [3].

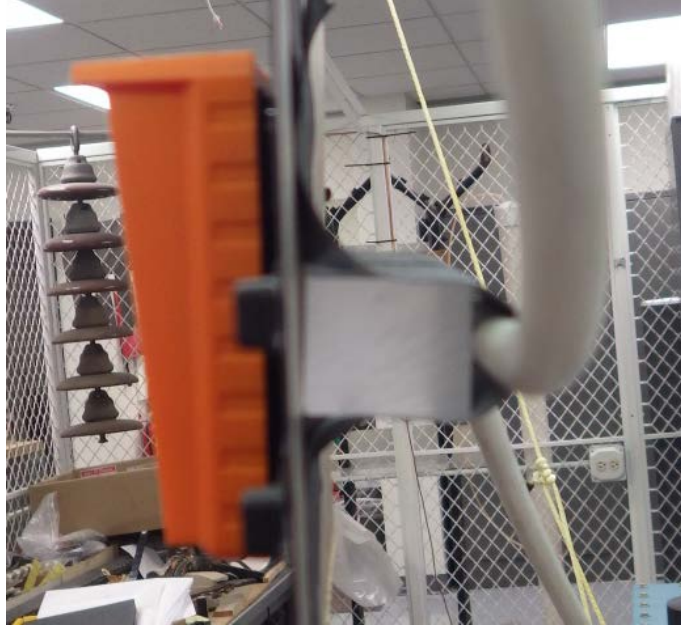
Figure 4: Image showing the test setup for determining the effect of insulation thickness on sensitivity. The VisiVolt™ was again mounted on non-conductive paper, and an insulating block was placed between it and the conductor. Total thickness between the VisiVolt™'s mounting plane and conductor was a little over one inch. First voltage indication was observed at approximately 7 kV AC. This test was performed on model VV-B.

Installation on insulated bus is a possible application in many power plants. Because insulation effectively increases the distance from the conductor, and therefore decreases the field density at the VisiVolt™, we tested threshold sensitivity at relatively large thicknesses from the conductor. Figure 4 shows the setup with approximately 1.15 inches of insulating material between the VisiVolt™ mounting plane and the conductor. The voltage indication threshold was observed to be about 7 kV AC on model VV-B, or about 75% higher than when mounted to the high-potential plate.
