Using Robotics Technology to Reline Large Diameter Piping on Steep Slope

Research and Development Office
Science and Technology Program
(Final Report) ST-2018-8107-01 8540-2018-50

This case study documents a 2016 relining project at the Central Arizona Project Mark Wilmer Pumping Plant. This work demonstrated the state of the art for the use of robotics on steep inclined structures, with the 105,000 total square feet (SF) of the 12-foot diameter pipe being relined in less than 90 days. Contractor personnel guided and monitored the robotic equipment from inside the pipe while the robots prepared the surface and relined the structure. The physical labor required by employees was reduced significantly because the robots did the majority of the work. The approximate production rates during this project for each robot are as follows:

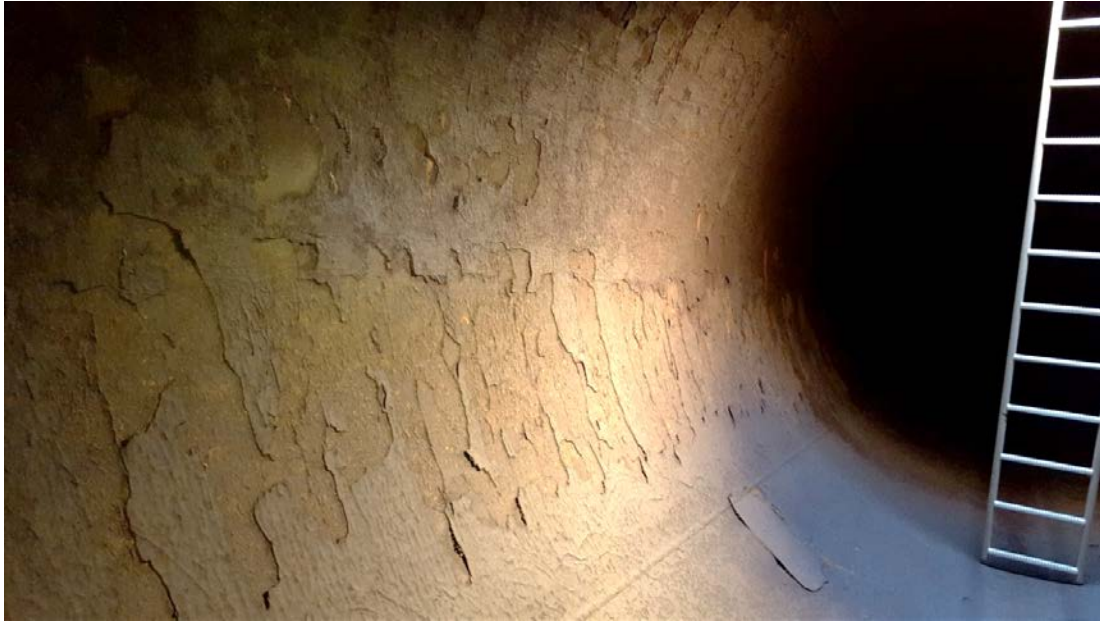
The Mark Wilmer Pumping Plant, built in 1981, is located on the south side of Lake Havasu, Arizona. The discharge tubes were originally coated with coal tar enamel. The service life was 35 years, which is on the short end for coal tar enamel. The existing coal tar enamel was in very poor condition shown in Figure 1. It was uncertain why the coal tar enamel failed prematurely when two miles away the coal tar enamel in the Parker Dam penstocks is 80 years old and still in excellent condition.

Figure 1. Existing condition of coal tar enamel, large areas of damaged coating.

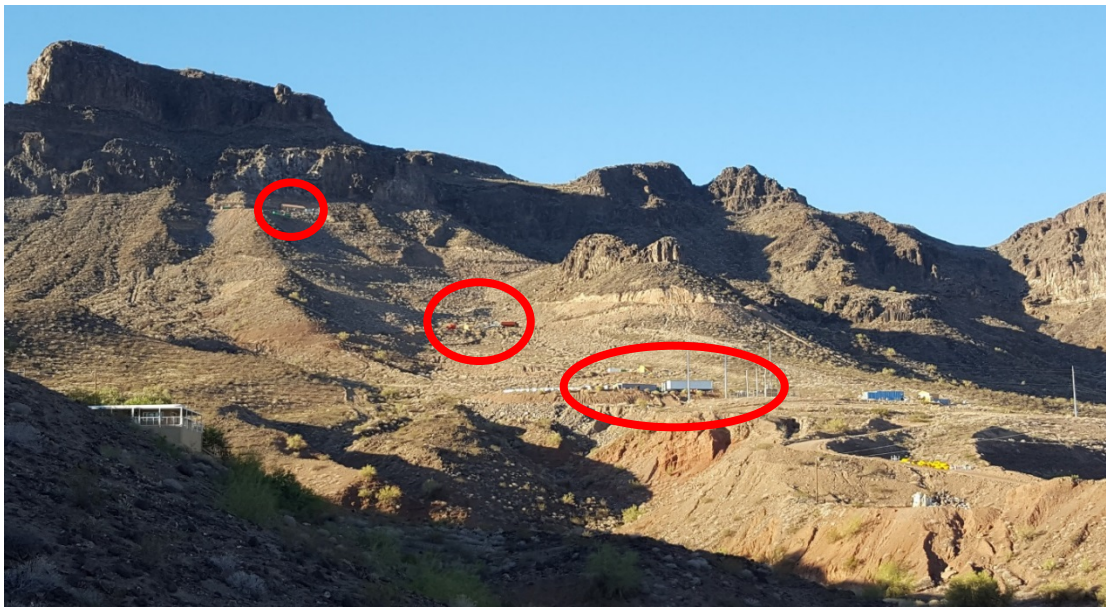
In 2016 and 2017, the two 12-foot diameter, 2600-foot long discharge pipes were relined. The total surface area per discharge tube was 105,000 SF. The CAP was limited to a 90 day outage from June 1 to August 30. There was an 824-foot change in elevation with slopes ranging from 16% to 77%. Figure 2 shows the terrain of the buried twin barrel discharge tubes, with three staging and access areas to the pipes. The fourth access point is inside the pumping plant. There were approximately 900 linear feet (LF) between access points and all blast media and coating materials were delivered to the robotic equipment via hoses. The contractor used a winch system anchored inside the discharge tube to control the robot at a given rate on the steep inclines as seen in Figure 3.

Figure 2. Site and terrain conditions at the Mark Wilmer Pumping Plant discharge tubes; access points and staging areas are circled in red.

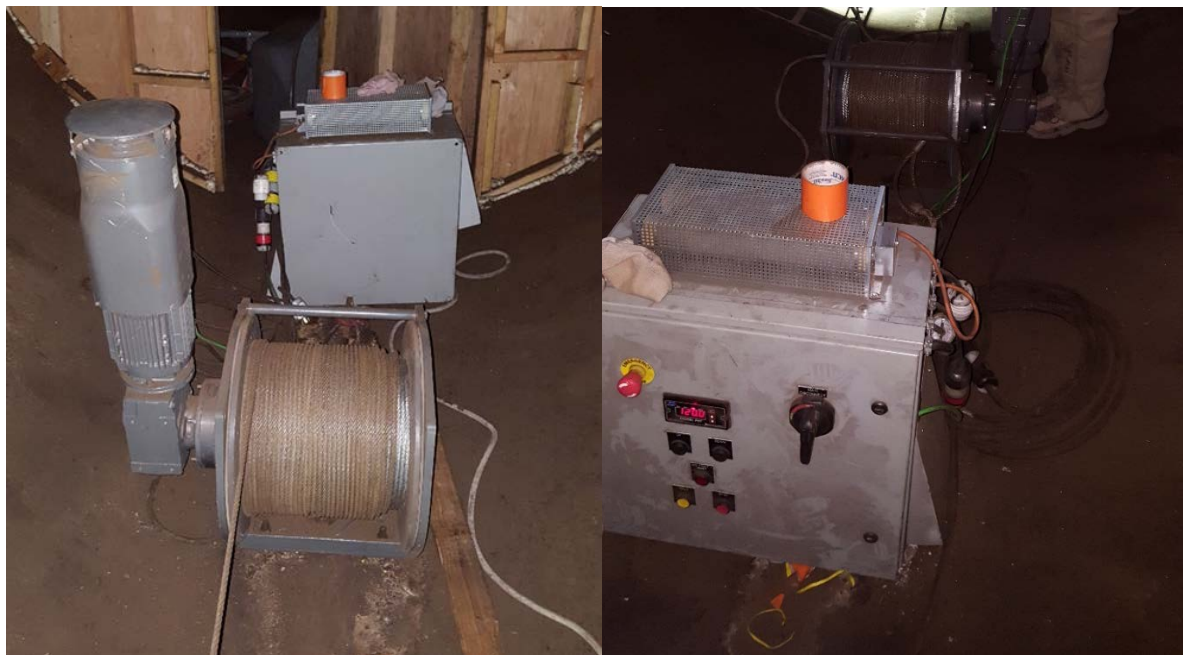
Figure 3. Electronically controlled winch system to allow the robot to work on steep inclines.

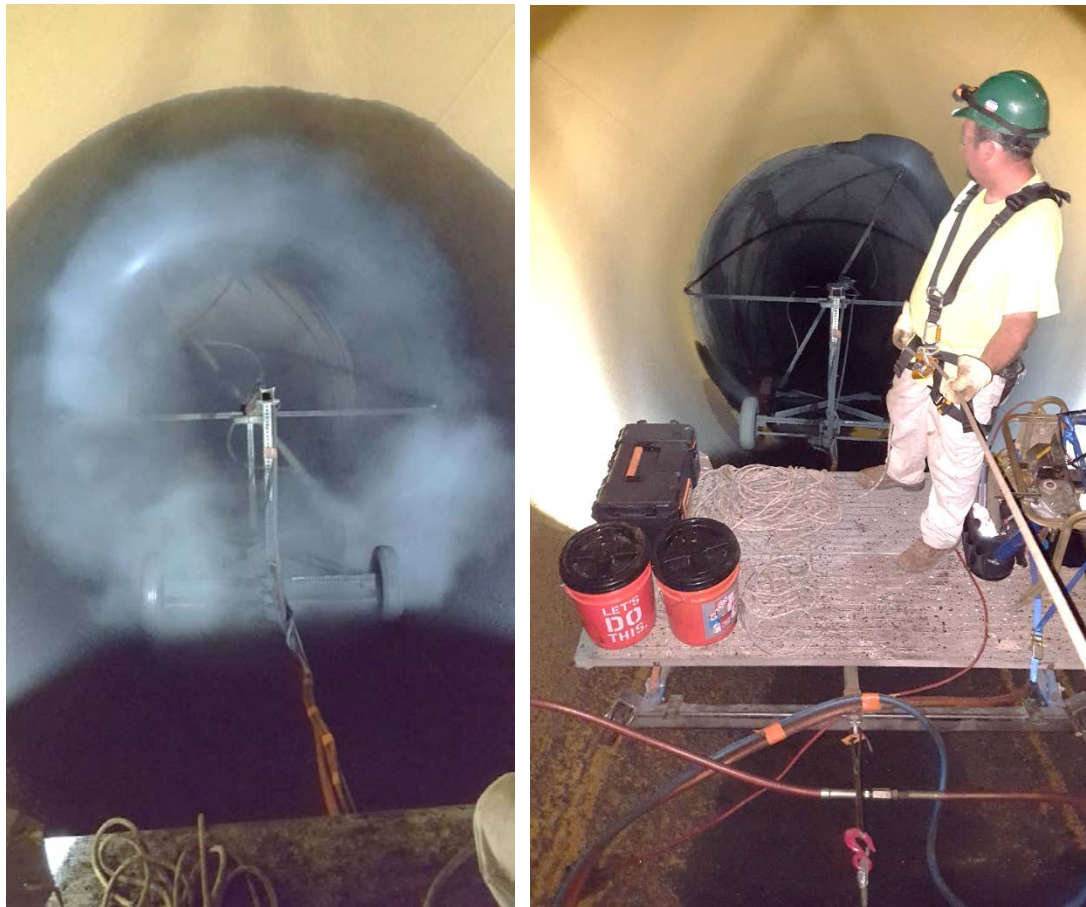
Severely degraded coal tar enamel is easily removed by water jetting methods, and a water jetting robot was used to remove coal tar enamel. Dust levels were significantly reduced, and the coating was removed without having the workers wear respirators. The workers use rope access equipment for safety, and eliminating the need for supplied air respiratory protection prevented the risk of entanglement with the rope access lines. Figure 4 show the water jetting robot at work removing the coal tar enamel. An average production rate of 3600 SF per 8-hour work shift was achieved for this job. The humidity levels were high while the water jetting procedure were conducted and caused instantaneous flash rusting of the steel surface. Once the water jetting robot was far enough into the penstock, the contractor ran the abrasive blast robot behind it. Bulkheads were used to isolate sections of the discharge tube to control the environmental conditions to prevent flash rusting of freshly blast cleaned steel.

Figure 4. Water jetting robot removing existing coal tar enamel.

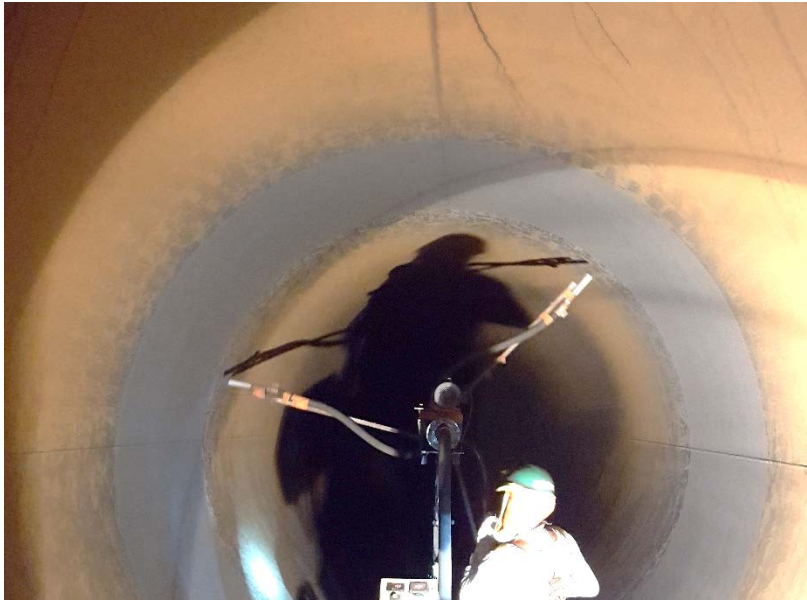
The abrasive blast cleaning robot was used to obtain a white metal blast with a 3 mil profile as seen in Figure 5. Coal slag blast media was used for cleaning. The media travelled through a 3-inch blast hose to the robot, where it splits off into three smaller 1.5-inch diameter hoses. The average production rate for this job was 1800 SF per 8-hour shift. These production rates were lower than prior work on minimally inclined surfaces. Generally, abrasive blast cleaning is always the slowest process in recoating or relining, so it is the rate limiting step. The faster the abrasive blasting, the faster the entire job is completed. The robotic process is continuous and only stops when the abrasive blast pot needs to be refilled. This is significantly more efficient than manually cleaning on a steep slope. In addition, less abrasive is wasted due to a continuous process than a manual process. Figure 6 shows a close-up of the surface of the blasted steel. The metal loss areas look like alligator skin due to the degradation pattern of the coal tar enamel. The flash rusting of the white metal blast was prevented by using dehumidification equipment and blowing in dry air into the pipe. This was a requirement because many LF can be coated in a

Figure 5. Abrasive blast cleaning robot achieving a white metal blast.

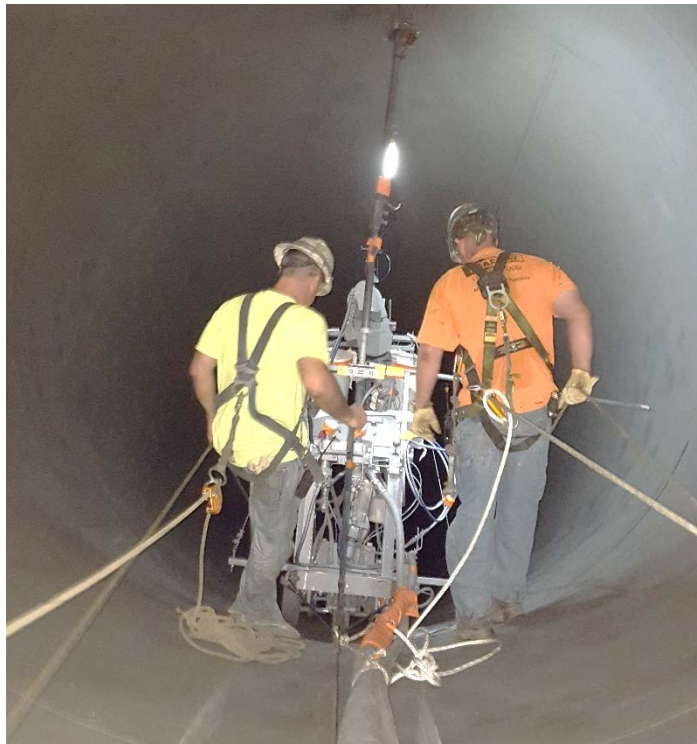
The coating robot was the most critical piece of equipment for this work. The contractor has developed their own robotic sprayer that meets their requirements, as seen in Figure 7. Coating material is pumped from a trailer using a plural component pump, as seen in Figure 8. The coating is pumped through heated dual plural component lines until about 20 feet from the robot, where it goes through a mixing blocks to a single whip hose that feeds the robot, as seen in Figure 9. The contractor used solvent-free coatings and replaces the mixing blocks and whip hose after each work stoppage exceeding the material pot life. This eliminated the use of any solvents in the confined space, thus greatly reducing the flammability hazard.

Figure 7. Coating application robot set up.

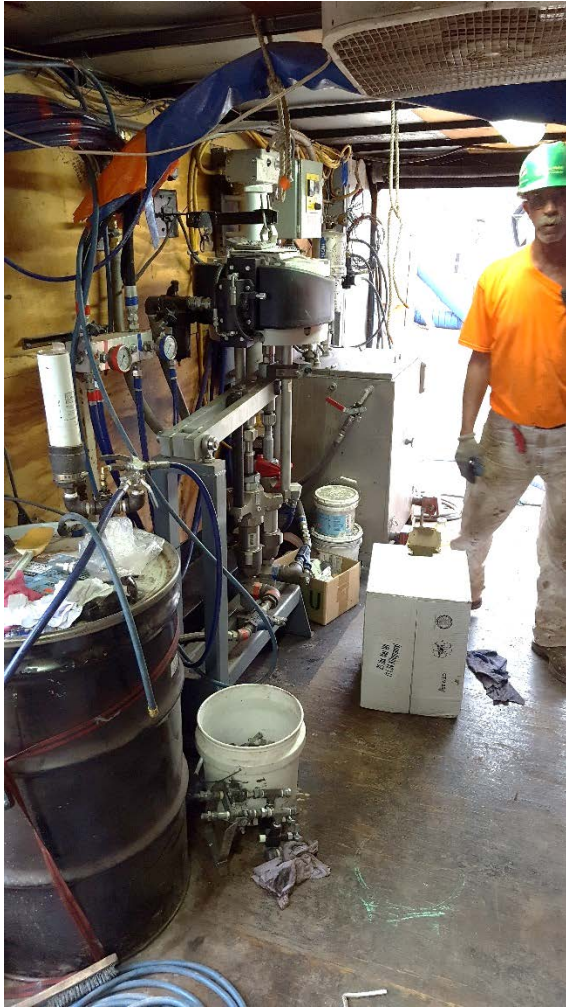
Figure 8. Plural component pump trailer that pumps the materials through the heated hoses to the coating robot.

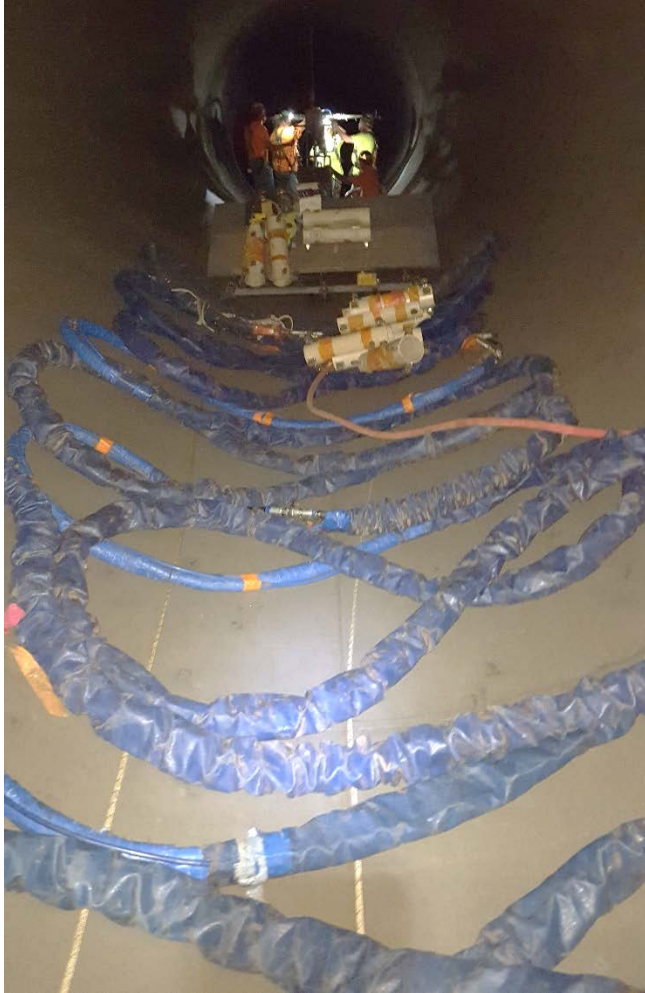
Figure 9. Dual heated plural component hose bundles for feeding the coating robot with material to apply.

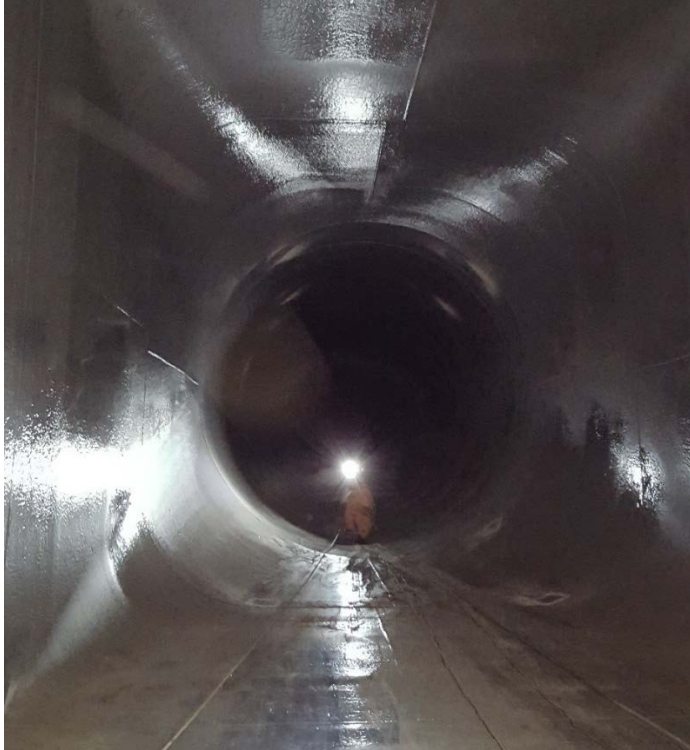
The average production rate was 6,000 SF per 8-hour shift applied at 60 mils dry film thickness (DFT). This equates to 150 LF of 12-foot diameter pipe, and four 55-gallon drums of coating material applied. Compared to conventional application methods, the robot provided high production rates with better quality control. Figures 10 and 11 show the final product and coating appearance. Notice no sags, runs, drips, or similar undesirable features and a uniform coating thickness. The one year inspection showed no signs of wear or defects.

Figure 10. Final coating inspection after curing.

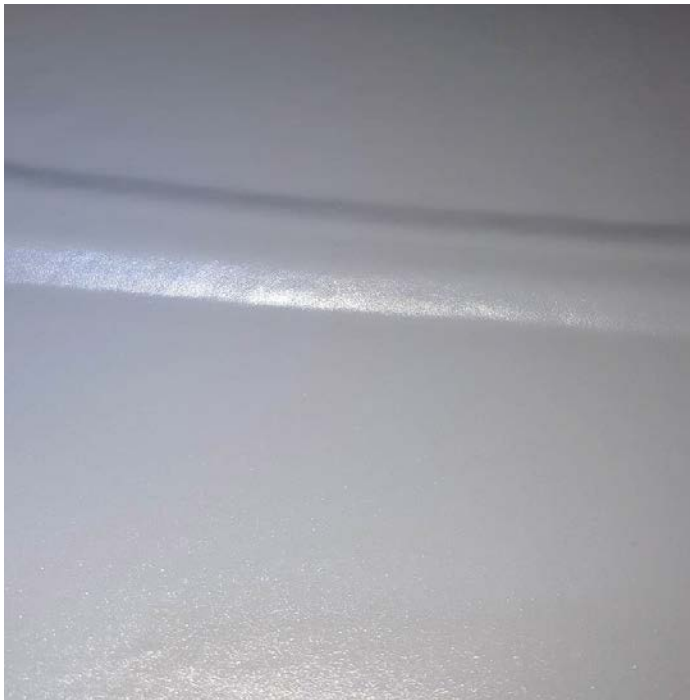
Figure 11. Close-up of final coating appearance.
