## **Demonstration Project to Implement Electro-Osmotic Pulse Technology to Stop Water Leaks Through Concrete**

**Research and Development Office  
Science and Technology Program  
(Final Report) ST-2018-4553-01, 8540-2018-51**

**U.S. Department of the Interior  
Bureau of Reclamation  
Research and Development Office**

**September 2018**

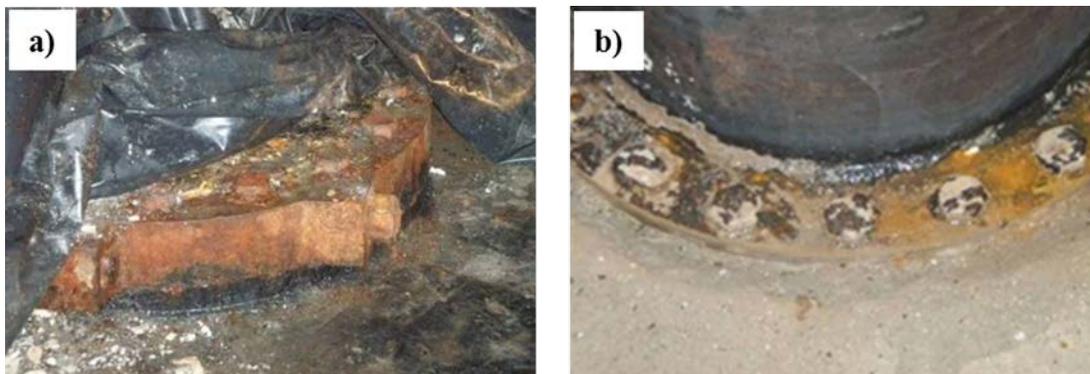
Figure 1. Corrosion of the bonnet cover and air inlet pipe due to the standing water.

Due to the seepage, there is standing water in the bonnet chamber, resulting in corrosion of the bonnet cover and air inlet pipe, as shown in Figure 1a and b. Failure of the air inlet pipe would result in complete flooding of the chamber and shaft. This would cause water to run down the tunnel to the powerplant yard if the door was not sealed shut due to both corrosion and calcium carbonate build-up.

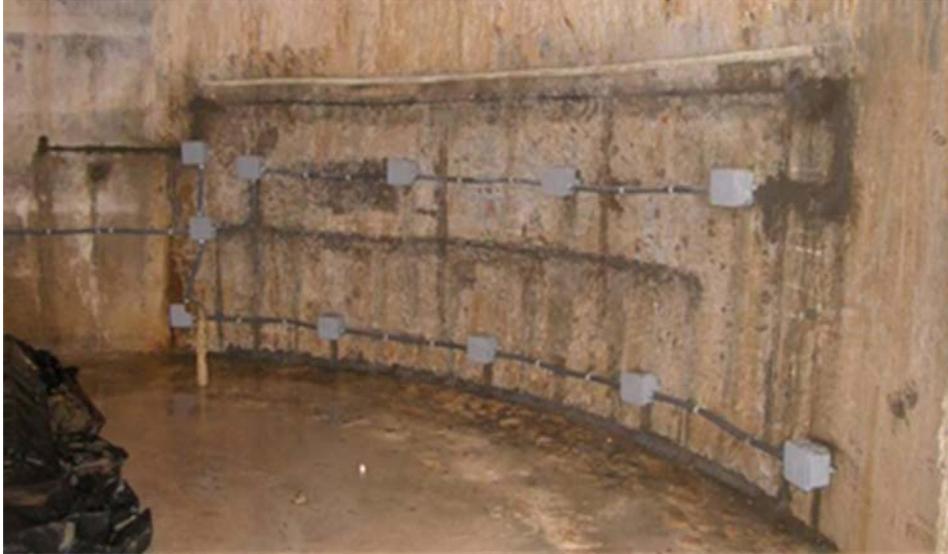
**Figure 11. Completed installation with junction boxes and conduit.**

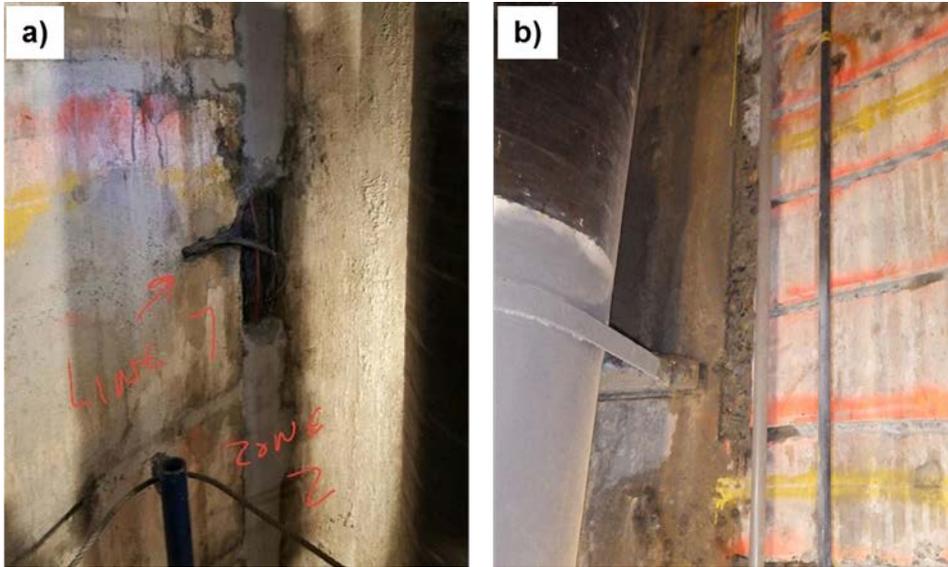
**Figure 27. Cable trench for terminating anode ribbons, cathode cables, and sensor probe cables from each section. Trenches were packed with mortar to embed the cables.**

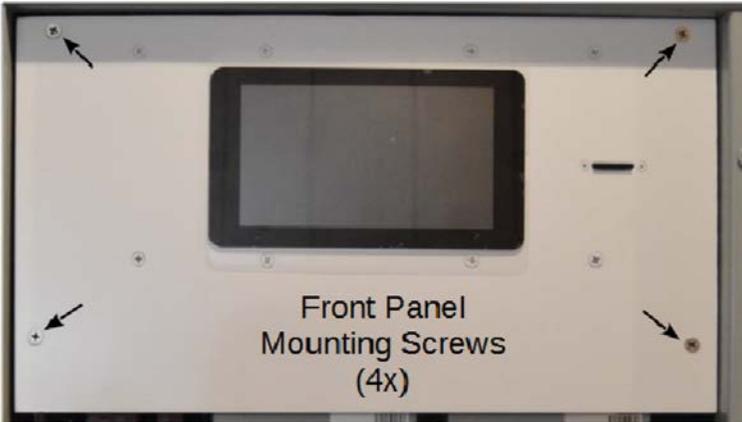
Figure 32. Controller front panel mounting screws.

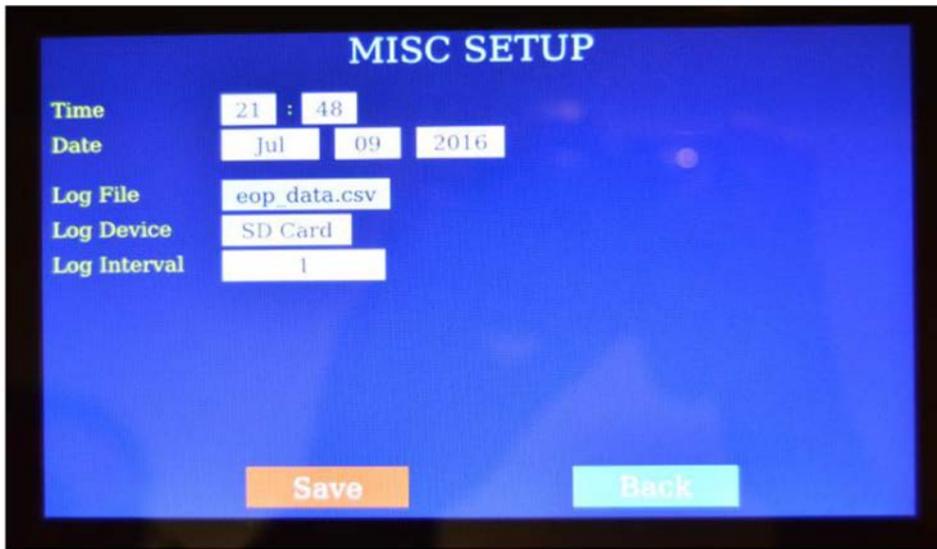
Figure A-8. MISC SETUP menu for changing controller configuration.
