## Control of Biofouling in Hydropower Cooling Systems using HOD Ultraviolet Light

Research and Development Office  
Science and Technology Program  
(Final Report) ST-2018-1712-01

October 2018

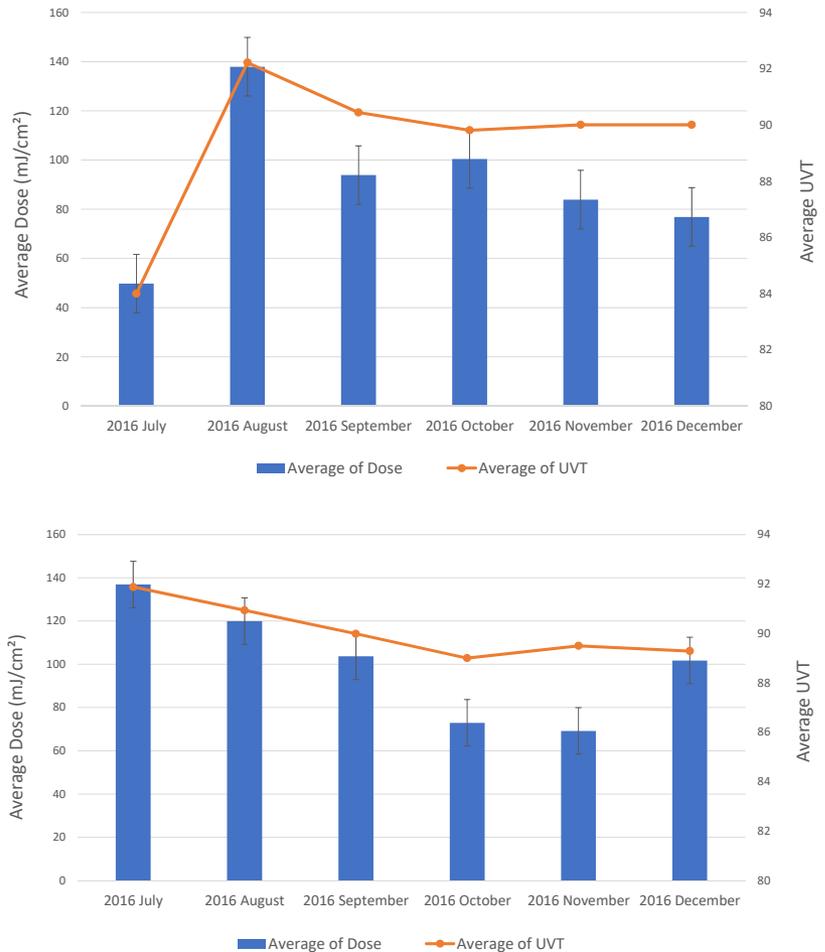
**Figure 1.** Average monthly HOD UV dose with standard error, and UVT on Parker Dam generator cooling lines 3 (top) and 4 (bottom) during 2016 testing.

The monthly average UV dose and UVT readings from each cooling line is presented in Figures 1 and 2. The average UV dose fell below the 100  $\text{mJ}/\text{cm}^2$  target during the study. The dose on Unit 5, plumbed in to the raw water supply line to the onsite water treatment facility was expected to be higher than other units because the water flow rate was 200–650  $\text{gpm}$  lower (Figure 2). Average UVT readings across all units were between 84% and 92% during the two-year study.

Monthly HOD UV dose and flow monitoring indicated periods of time when untreated water was flowing into the treated bioboxes during the first year of testing. The HOD UV units were designed to automatically shut off when cooling water flow was stopped. During the study, flow to the cooling water lines was stopped for operational or maintenance activities on several occasions, and the HOD UV units performed as designed and automatically shut off. However, untreated water continued to back-flow into treated bioboxes due to head pressure in the pipes. The amount of untreated back-flow entering each biobox was variable. Untreated water entered the Unit 4 biobox for approximately 192 hours and the Unit 3 biobox for five hours out of the approximately 5,136 hours during which testing occurred in 2016. Additionally, there were periods of

time when the lamps malfunctioned, and the dose dropped to zero. During this time, untreated water entered the Unit 4 biobox for seven hours and the Unit 3 box for nine hours. These results prompted installation of automated shut-off valves in 2017 that automatically closed and prevented flow into each biobox in the case of lamp or cooling water shut-down.

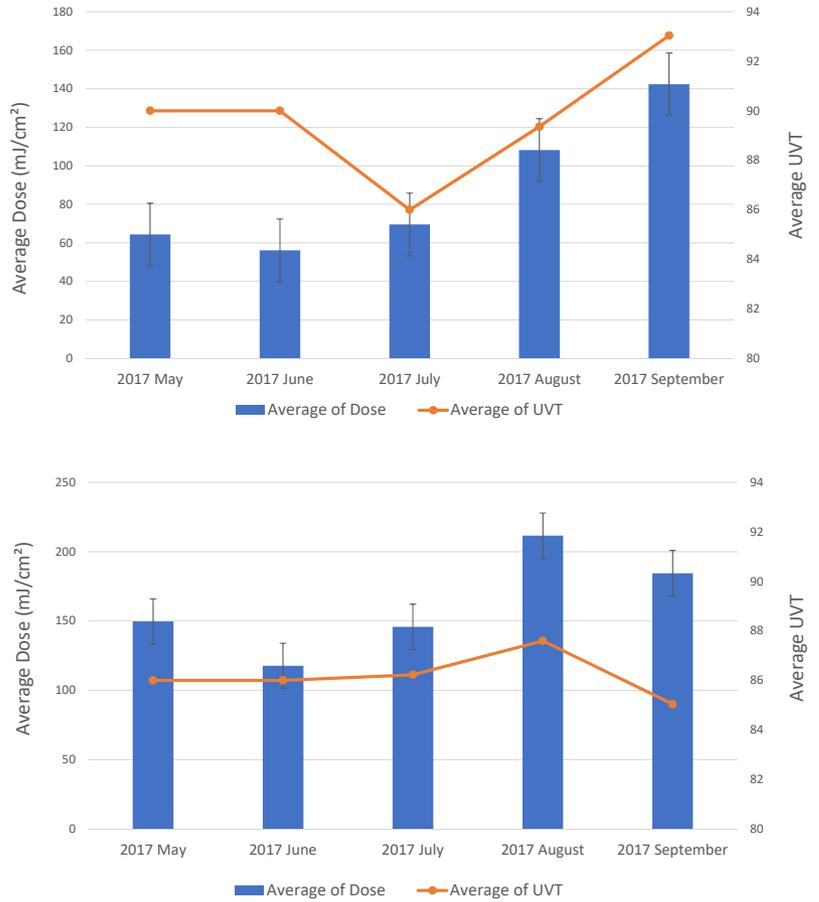
**Figure 2.** Average monthly HOD UV dose with standard error, and UVT on Parker Dam generator cooling lines 3 (top) and 5 (bottom) during 2017 testing.

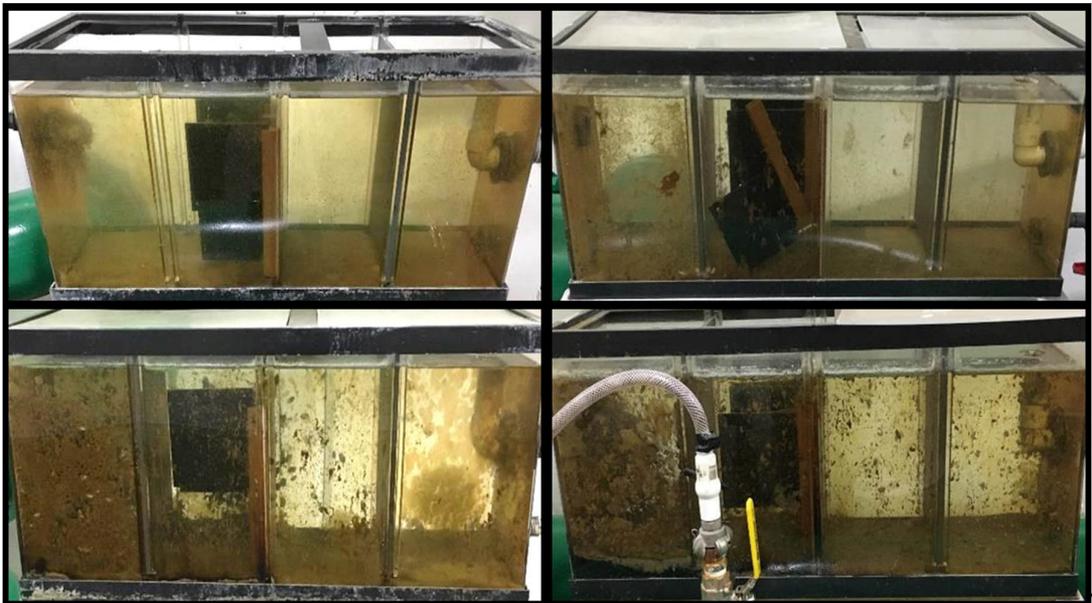
**Figure 3.** Settlement after six months during 2016 in bioboxes receiving HOD UV treated water (top left and right) and control bioboxes receiving untreated water (bottom left and right) on cooling lines 3 (left) and 4 (right). Photographs by Sherri Pucherelli.

Despite contamination of bioboxes with untreated water in 2016, visual observation of the HOD UV treated bioboxes indicated a reduction of overall biofouling compared to the untreated control bioboxes (Figure 3). Dense quagga mussel, hydroid, and sponge settlement were found on control settlement plates (Figure 4, top) and reduced settlement was observed on plates in the HOD UV treated bioboxes (Figure 4, bottom). The greatest density of

A 5.08–7.62-cm layer of black sludge-like biofilm was observed at the bottom of the untreated control bioboxes but not in the HOD UV treated bioboxes

(Figure 3, bottom left and right). Microscopic examination showed the sludge collected from the control bioboxes consisted primarily of cocci and rod bacterial cells, with a lower density of cocci and many whole veliger shells (without tissue) in the treated bioboxes. A loss on ignition test was performed on the material deposited at the bottom of the control biobox. The test confirms that 95.92% of the sample was organic. The remaining 4.08% of the sample was clay sediment. There was not enough material in the bottom of the treated biobox to conduct a loss on ignition test.

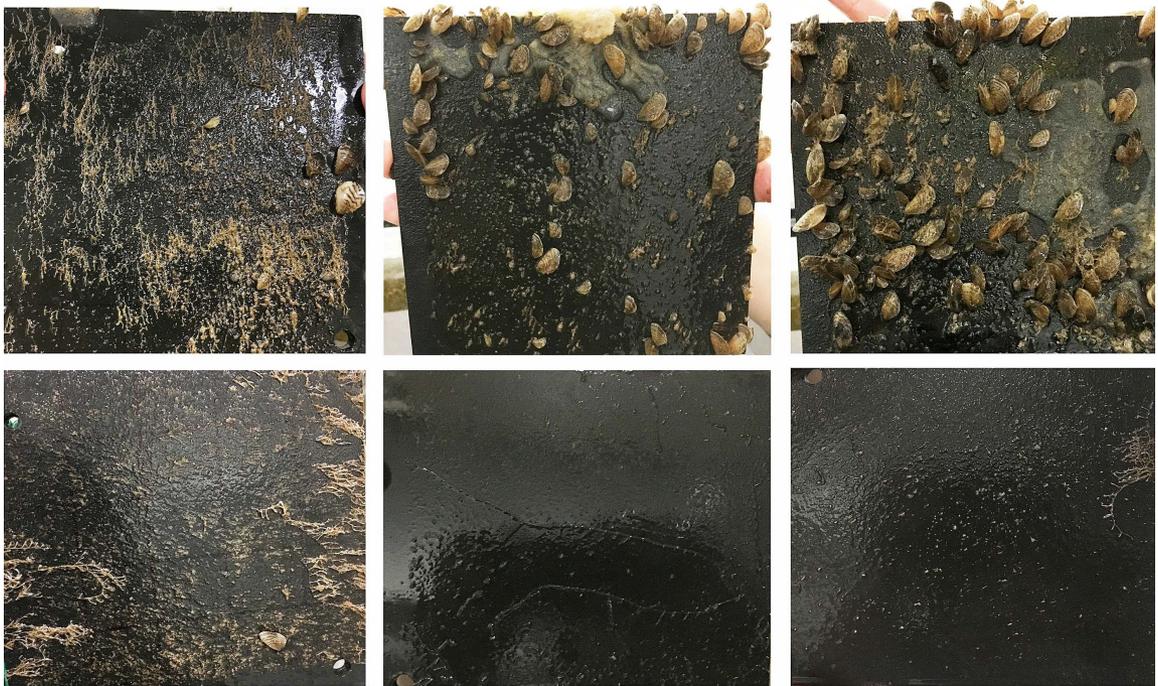
**Figure 4.** Mussel, hydroid, and sponge settlement, after 6-months, on plates from the control biobox receiving untreated water (top). Hydroid and mussel settlement after 6-months on plates from the biobox receiving HOD UV treated water (bottom). Photographs by Sherri Pucherelli.

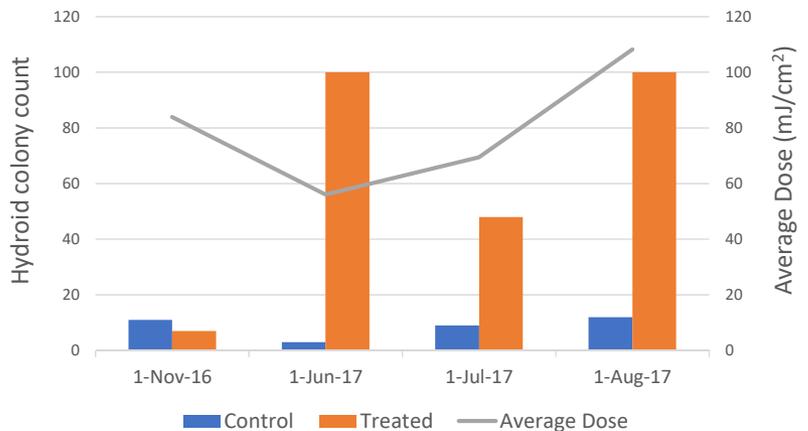
**Figure 5.** Total monthly hydroid colony settlement on three plates in control and treated bioboxes on cooling line 3. Colony counts were set at 100 when settlement was too dense to distinguish individual colonies.

Hydroid settlement was visibly reduced after HOD UV exposure in 2016, but in 2017 settlement was generally greater in the treated bioboxes, especially in the final months of the study. Hydroid colony counts were greater in treated bioboxes on cooling line 3 during June–August 2017 (Figure 5) and treated biobox 5 in July–August (Figure 6) despite

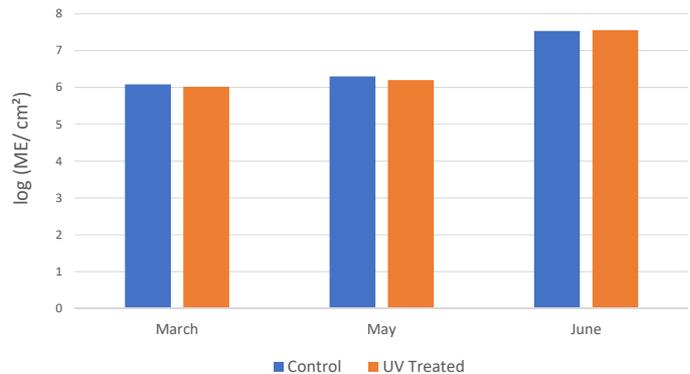
**Figure 8.** Average monthly microbial abundance, presented as log (ME/ cm<sup>2</sup>), observed in control and HOD UV treated bioboxes after one-month periods.

ATP and microbial equivalent (ME) concentrations were not considerably different between the treated and untreated bioboxes, despite higher bacterial accumulation in the control biobox. Microbial abundance ( $\log [\text{ME}/\text{cm}^2]$ ) values were similar between control and treated samples after each one-month exposure (Figure 8). Bacterial reaction tests from the control and treated bioboxes on Unit 4 and 3 were conducted to ascertain differences in bacteria communities and concentrations that may be resulting in sludge formation. Similar bacterial groups

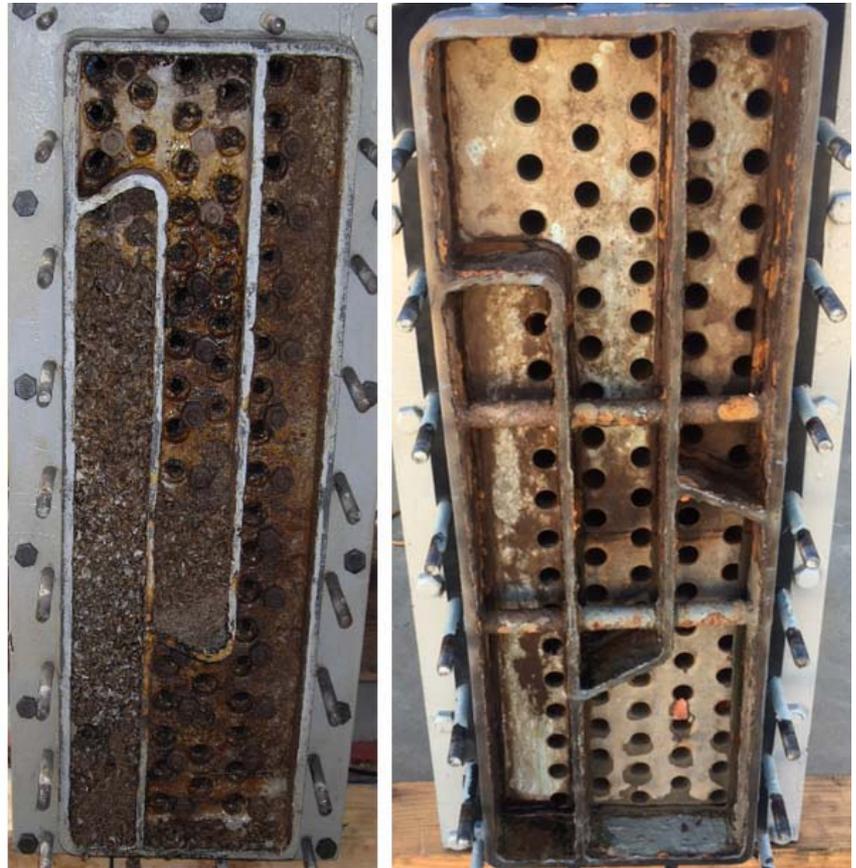
**Figure 9.** Parker Dam heat exchanger (left) with significant biofouling prior to implementation of HOD UV treatment, and heat exchanger (right) with no visible biofouling after same exposure time with HOD UV treatment. Photographs by Parker Dam Staff.

Prior to HOD UV installation, all sixteen coolers required yearly cleaning and maintenance due to biofouling induced overheating. This maintenance required around 640 staff hours, equating to approximately \$80,000 in additional labor costs per year (personal communication with Parker Dam management). In the first year after the HOD UV installation, only four coolers required maintenance, some of which unrelated to biofouling. In 2017 and 2018, none of the coolers required maintenance, resulting in an estimated savings of \$80,000 per year. Figure 9 shows two heat exchangers, the unit on the left was pulled for maintenance due to biofouling prior to HOD UV treatment implementation, the unit on the right was examined after a similar exposure time but with HOD UV treatment.
