Investigating Phosphoric Acid Pretreatments and Additives to Improve Polyurethane Adhesion

Research and Development Office
Science and Technology Program
Final Report ST-2018-1804-01, 8540-2018-49

U.S. Department of the Interior
Bureau of Reclamation
Research and Development Office

September 2018

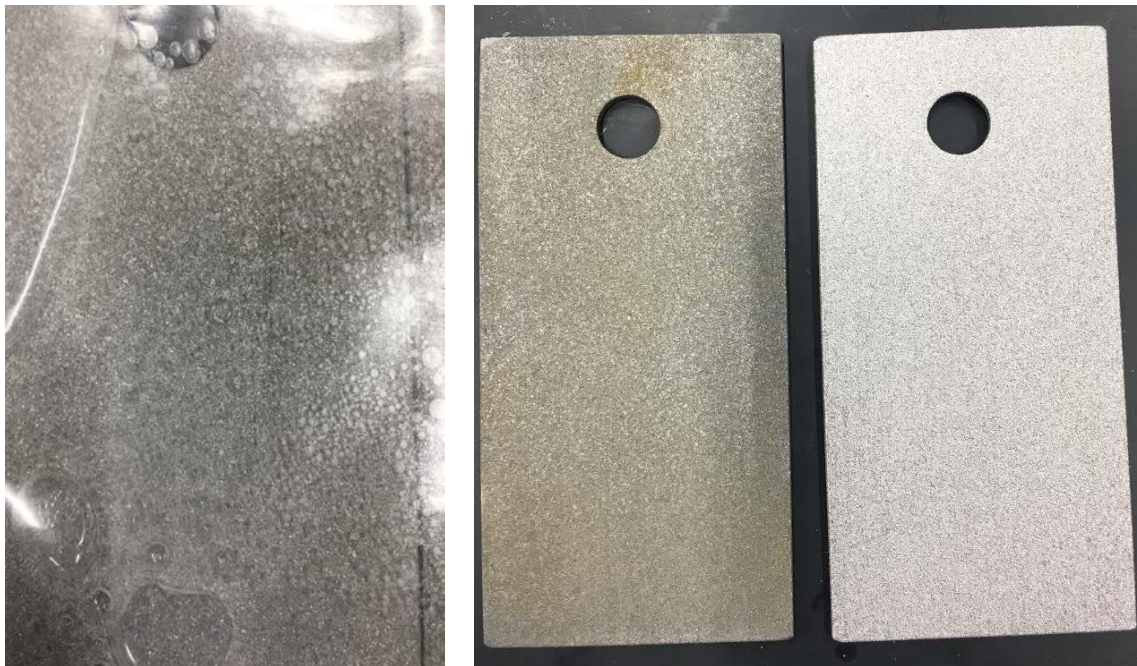
Figure 4: (left) Hydrogen gas formation on a PA-P coupon during immersion in phosphoric acid solution, and (right) phosphated PA-P coupon shows darker hue compared to white metal blast at right.

Several observations made during the phosphating process aided in the evaluation of the experimental results. As shown in Figure 4 (left), bubble formation due to hydrogen gas evolution was seen on the surface of the PA-P, MPA-P, and PPA-P coupons, as expected per the iron phosphate equation shown in Figure 3. However, the hydrogen gas bubbles were not observed for EPA-P.

The surfaces of the PA-P and MPA-P coupons changed color after drying. Figure 4 (right) shows a comparison between the darker phosphated coupon and the white metal blasted coupon at right. This color change is attributed to the formation of an iron phosphate film on the surface. The EPA-P and PPA-P coupons did not produce a noticeable change in color.

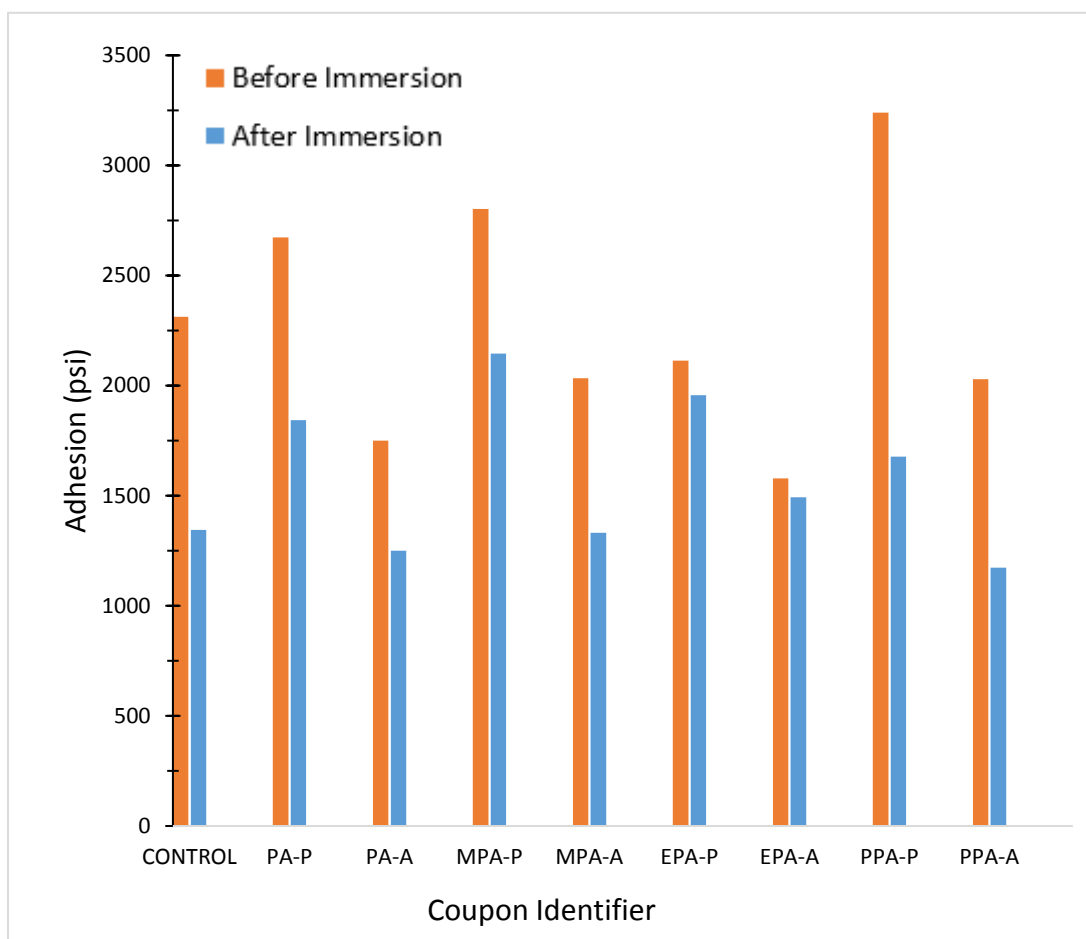
Figure 5: Adhesion results for all coupons before and after immersion.

Three out of the four phosphated coupons resulted in higher adhesion values than the control. However, the control coupon adhesion values were higher than all of the additive coupons. Figure 5 shows all raw adhesion values for each acid derivative and the control coupons, i.e., before and after immersion exposure. The data represents the average of three pull-off replicates per coupon.

The adhesion trends seen in Figure 5 indicate that acid derivative may have the effect of increasing adhesion values. Before immersion, PPA-P (longest carbon chain) gave the highest adhesion results followed by MPA-P and PA-P (shortest carbon chain). These trends suggest a possible correlation between chain length and adhesion energy for phosphoric acid adhesion promoters. Other types of adhesion promoters (e.g. silanes) have been found to have increasing or decreasing adhesion energy trends based on chain length [30]. EPA-P gave the lowest initial adhesion values out of all pretreated coupons. Absence of gas bubble formation during the phosphating process and lack of a significant adhesion improvement compared to the control coupon suggests an incomplete or erroneous phosphating process.

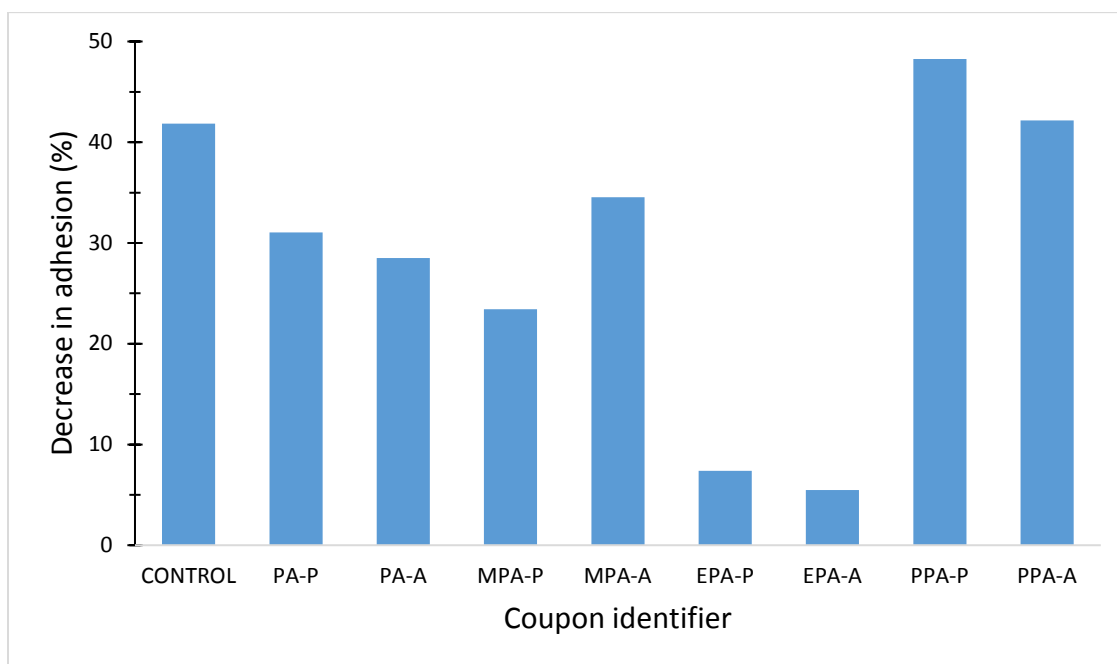
Figure 6: Percent decrease in adhesion for each coupon after immersion.

Adhesion values for all coupons decreased after immersion. Figure 6 shows the percent decrease in adhesion for each coupon. Percent decrease was calculated by subtracting the final adhesion from the initial adhesion and dividing by the initial adhesion. A low value for decrease in adhesion is preferred because it suggests that immersion in water has minimal effect on the coating's adhesion strength. All phosphated coupons performed better than the control coupon, i.e., a low value for decrease in adhesion. The coupons with the additives performed similarly to the control.

The results for both approaches using the amino ethyl phosphoric acid derivatives, EPA-P and EPA-A, showed less than a 10 percent decrease in adhesion following immersion. Figure 7 shows EPA-P and EPA-A along with the control coupon after immersion and adhesion testing. The glue failures observed in the EPA-P coupon suggest that the reduction in adhesion is even less than the 7 percent shown in Figure 6. The results for EPA-P and EPA-A are promising evidence that these approaches support an increase in the durability of the adhesion strength.

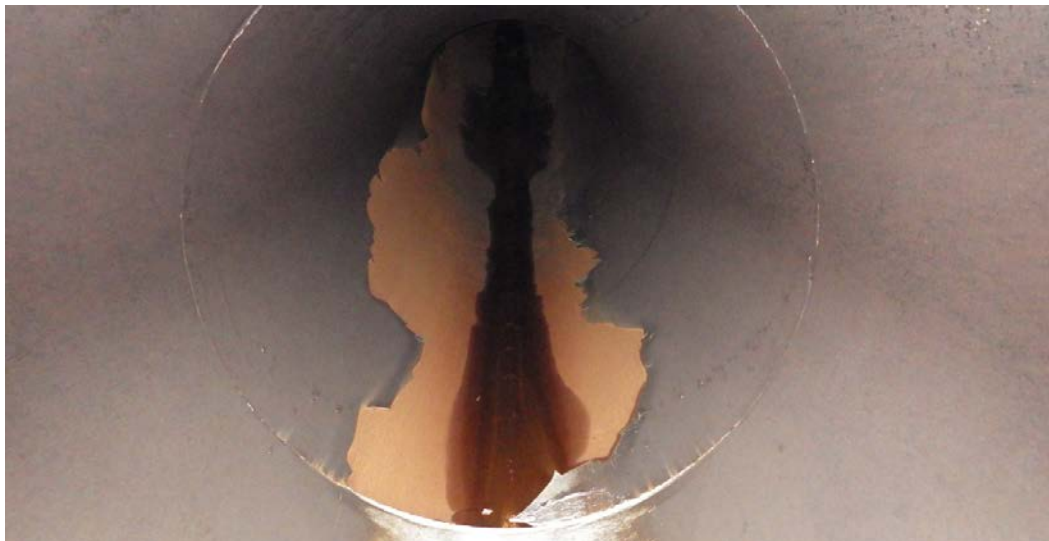
Figure 2: Delaminated elastomeric polyurethane lining in the Unit 2 penstock at Flatiron Penstocks.

In 2015, MCL coatings specialists inspecting the Unit 2 penstock at Flatiron Penstocks in Loveland, Colorado discovered a catastrophic lining delamination in a buried portion of the pipe. Approximately 933 square feet (sq. ft.) of a total of 111,000 sq. ft. of lining was missing—including two sections that were 40-ft. long [19]. The joints in the affected area were older-construction sleeve-type couplings that are designed to move with thermal expansion and contraction and the area had been subjected to the highest amount of head. Figure 2 shows one area of delaminated lining that required emergency repairs.

The coating in question, an elastomeric polyurethane (Polyurethane B) which had been applied just four years earlier, failed well before the end of its expected 20 to 30-year service life. During prior inspections of the penstock, cracks had been observed in the area but they were not rectified. The delaminated lining was repaired with a 100 percent solids epoxy and low temperature cured vinyl esters.

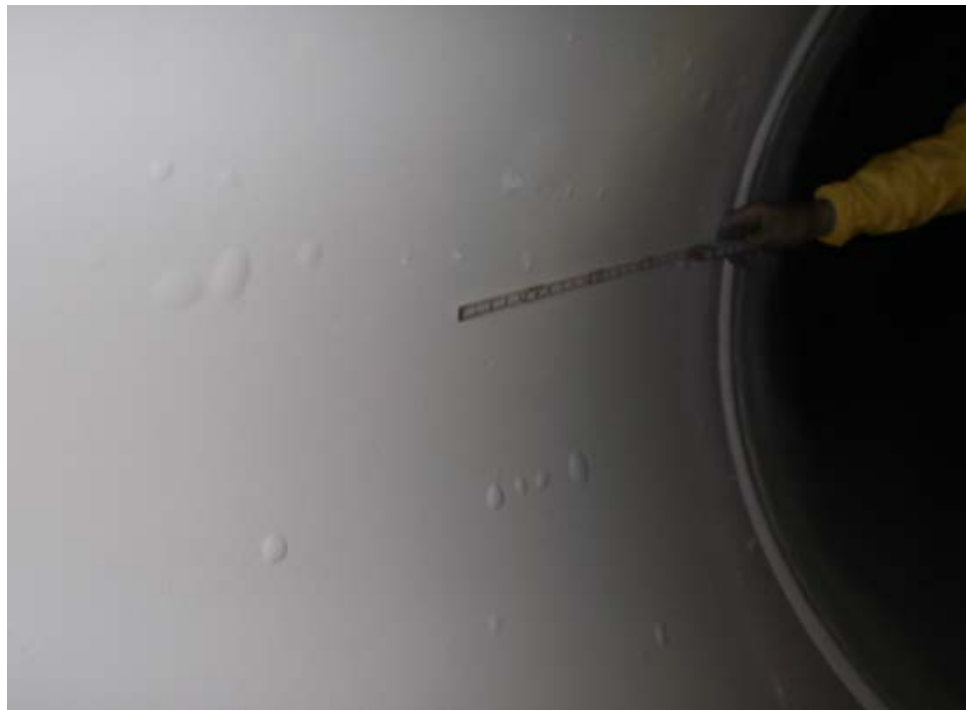
Figure 3: Extensive blistering shortly after the application of a fast set polyurethane lining caused by a heat-sink phenomenon. Flatiron Penstocks, 2017.

Additional emergency repairs of delaminated areas were made using a fast set, rigid polyurethane (Polyurethane A). Photographs taken shortly after application of the lining show the formation of blisters throughout the repaired area. An application guide from one polyurethane manufacturer states that spray application of some fast set urethanes onto cold metallic substrates may cause blisters to develop [20]. This heat-sink phenomenon occurs when the first coat does not cure properly due to the exothermic reaction being stunted by the cold substrate. Additional coats cure properly, but blisters develop between the substrate and the partially-cured first coat or within the first coat. Figure 3 shows one area of extensive blistering of the newly applied polyurethane.

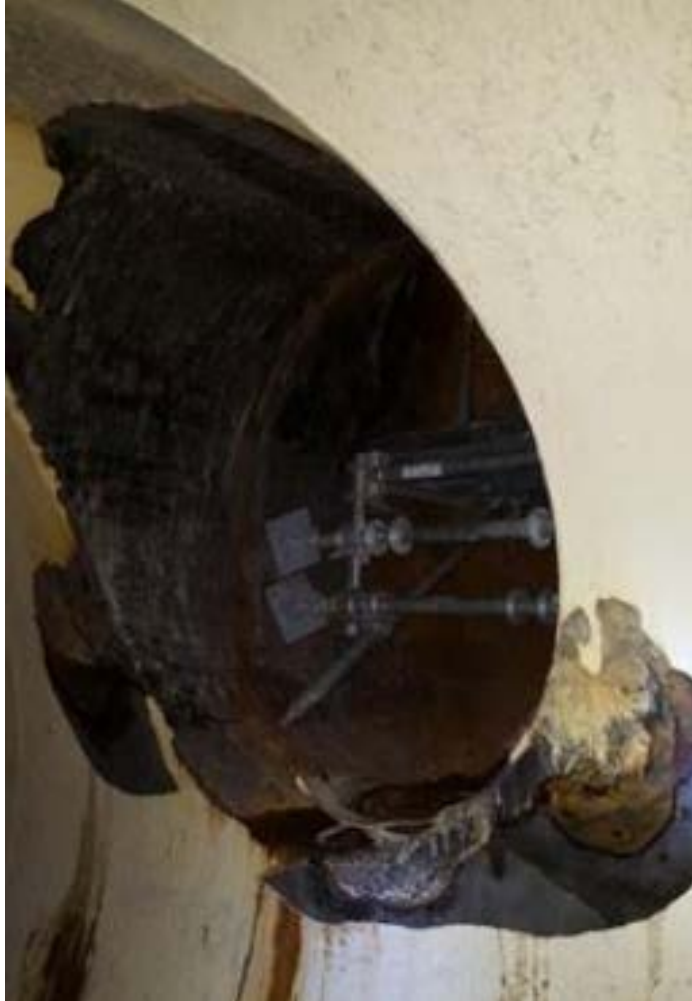
Figure 4: Damaged lining around a manhole at Enders Dam after one year of service.

The polyurethane lining failure in the Flatiron penstock was not an isolated incident. Inspection reports from Enders Dam in Enders, Nebraska show that disbonded lining was discovered in the outlet works in 2011 [21]. The lining, an elastomeric polyurethane (Polyurethane C), had only been in service for one year. The damage, located around two manholes, was repaired with a 100 percent solids epoxy. Figure 4 shows damaged lining around the interior of a manhole.

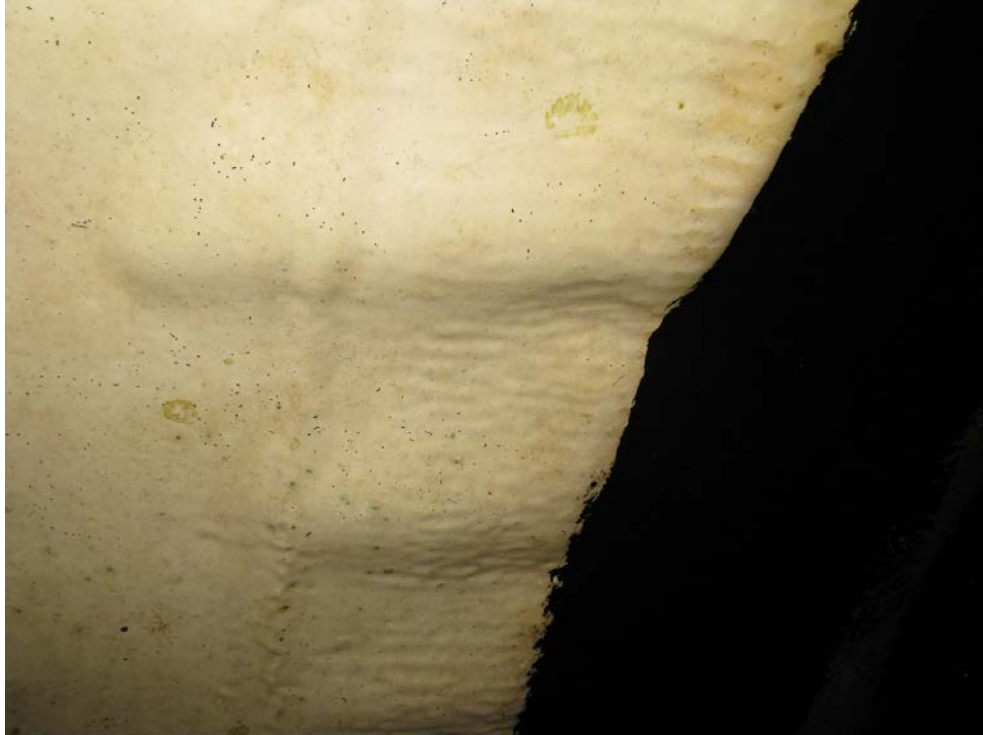
Figure 5: One area of disbonded elastomeric polyurethane in the outlet works at Enders Dam [7]. Disbonded polyurethane was found after one and six years of service.

In 2016, another inspection of the polyurethane lining at Enders Dam revealed additional regions of disbonded lining at expansion joints and near valves. Cracked and damaged coating with underlying corrosion was also found at other transition points within the pipe. Figures 5 and 6 show regions of disbondment near a jet valve [21].

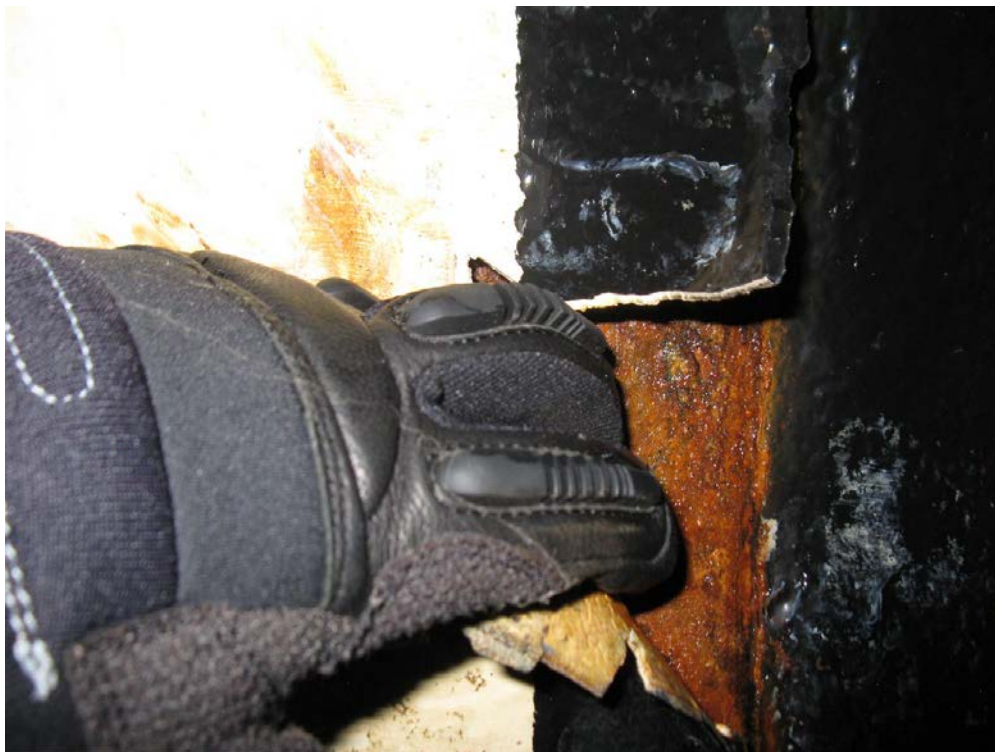
Figure 6: Polyurethane termination point near a jet valve. Cracking and subsequent corrosion undercutting caused the lining to disbond and lift off the pipe surface.

At both Flatiron Penstocks and Enders Dam, inspection reports noted that regions of delamination and disbondment occurred near termination points of the coating—the point where the spray coat ends. They found that polyurethane failure occurs when cracks develop near the termination points. Corrosion then develops in the cracks and advances underneath the lining. This undercutting results in a slightly lifted edge of lining that can be delaminated by flowing water. Findings of one laboratory study showed that polyurethanes have much poorer corrosion undercutting than coal tar enamel and epoxies, particularly when in immersion service [16].

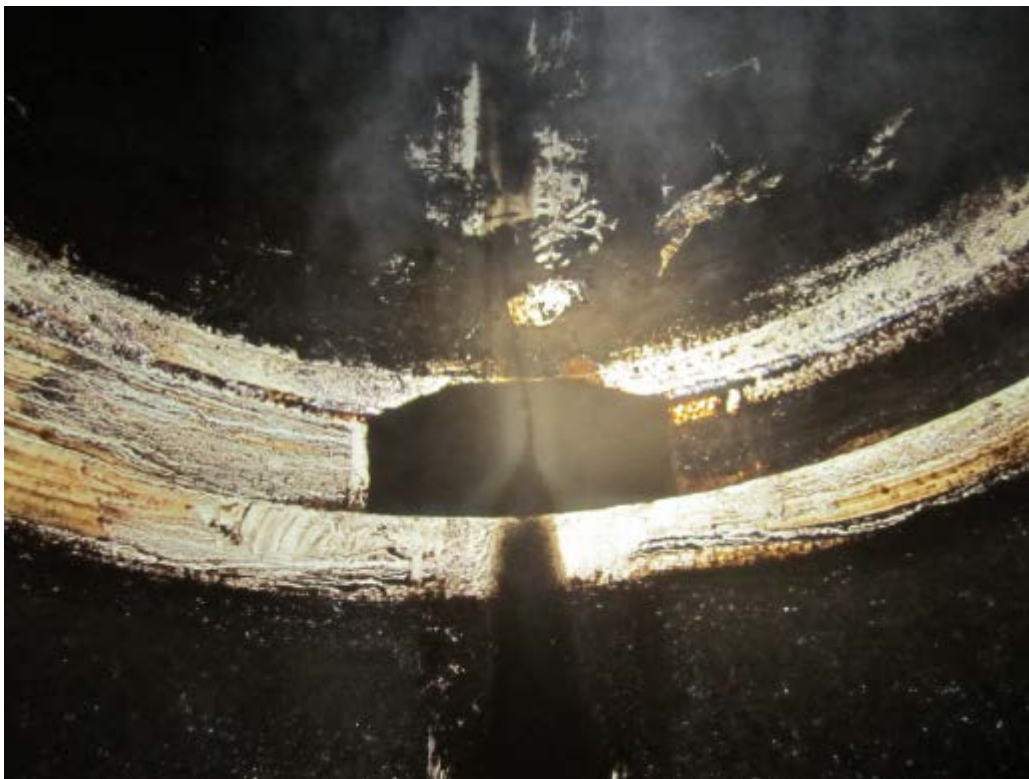
Figure 7: Typical coating condition at an expansion joint in the outlet works at Platoro Dam. The polyurethane lining had been in service for five years.

Reclamation also used Polyurethane B to line the outlet works at Platoro Dam in southwestern Colorado. A subsequent inspection report showed that the lining was performing well with no observable issues after five years of service [22]. Figure 7 shows the condition of the polyurethane around an expansion joint. No signs of blistering or delamination were observed.

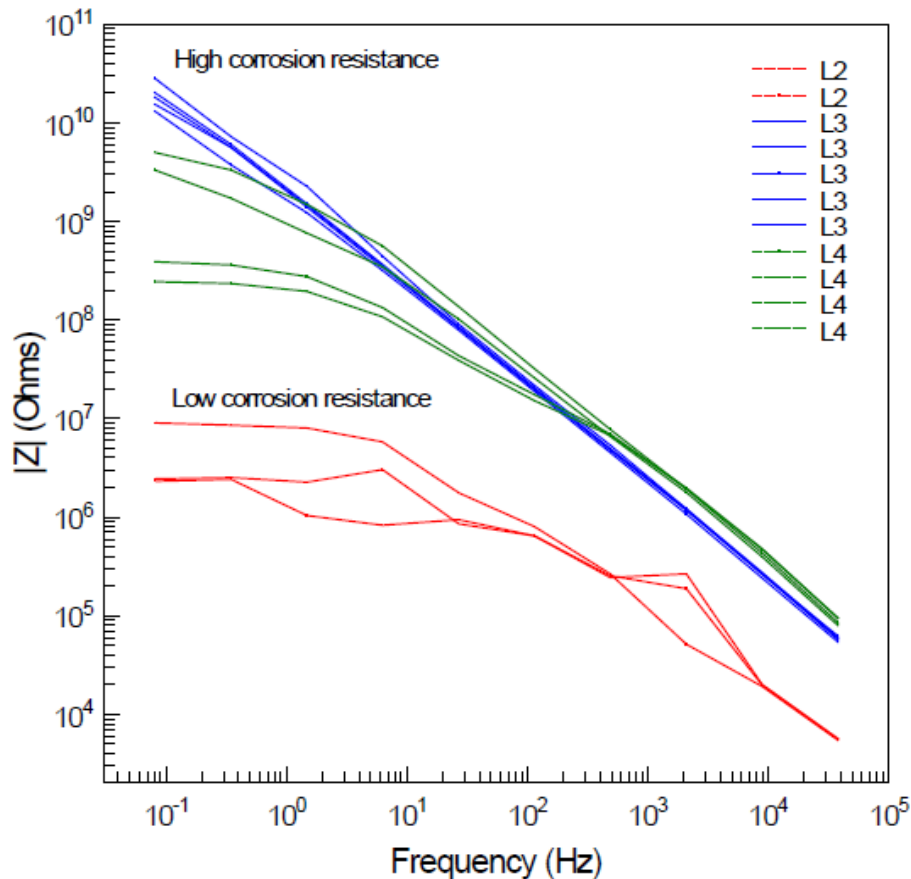
Figure 8: F-EIS bode plot of a rigid polyurethane lining in a water bypass. After nearly 20 years in service, two locations had excellent barrier protection and one location suggests lining degradation [24].

The visual inspection of the bypass found the lining to be in generally good condition with regions of lining delamination near pipe joints as well as clusters of blisters that the inspection report attributed to application defects [24]. F-EIS results from three locations within the bypass showed that the lining has remarkably high barrier properties in some locations, while other locations suggest lining deterioration despite visually appearing to be in good condition. F-EIS results are shown in Figure 8.

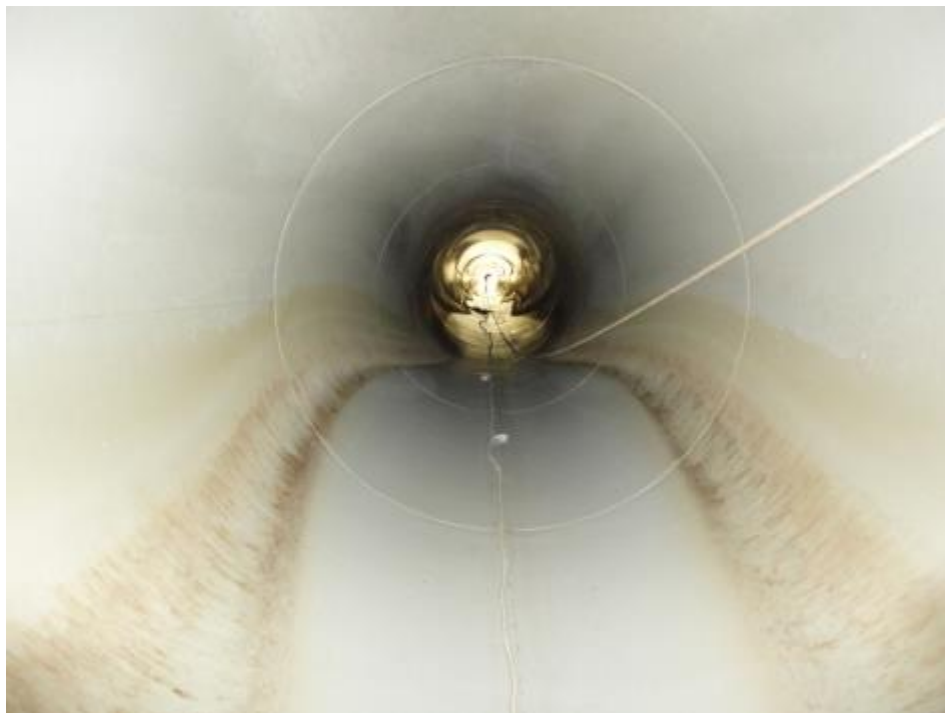
Figure 9: General condition of an epoxy lining after one year of service in the outlet works at Shadehill Dam.

The epoxy lining the outlet works at Shadehill Dam near Lemmon, South Dakota, has been in service for eight years—longer than any other epoxy specified by Reclamation as a full coal tar enamel replacement. The service conditions and how frequently the outlet works is used is unknown. An inspection report after one year of service showed that the lining was in good condition with one small area of delamination and minor rust deposits at the expansion joints [25]. The report attributed the expansion and contraction of the joints as cause for the damage and did not suspect the coatings to be faulty. A brief follow-up inspection in 2017 found no major issues. Figures 9 and 10 show the general condition of the lining and detail of the rust deposits at the expansion joints, respectively.

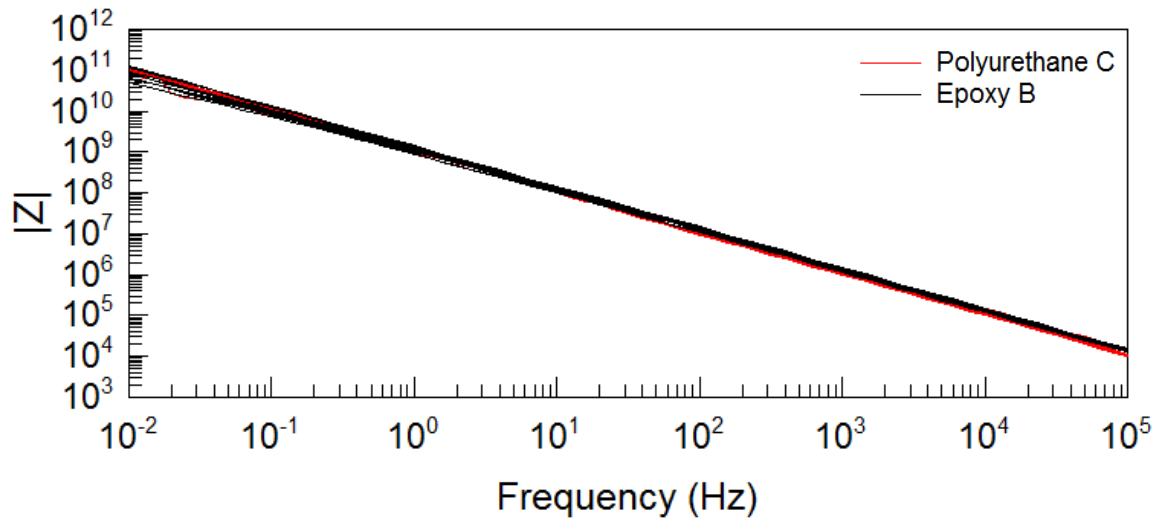
Figure 13: Bode plot comparing Polyurethane C and Epoxy B over one year in immersion. Newly developed Epoxy B has similar, if not slightly better, barrier properties to Polyurethane C.

Laboratory EIS results provide a method of comparing the barrier properties and rate of degradation of polyurethane and epoxy coatings over time. Figure 11 compares the barrier properties of Polyurethane B and Epoxy A over a period of six years in immersion. Polyurethane B shows higher initial impedance with a smaller change over time compared to Epoxy A. Figure 12 shows the bode plots for Epoxy C and Polyurethane C during a period of two years. The rate of degradation of Epoxy C is greater than that of Polyurethane C due to the epoxy's water uptake over time. Newly developed epoxies like Epoxy B (bode plot shown in Figure 13) have similar

barrier properties through one year in immersion compared to Polyurethane C. Further monitoring is needed to determine the extent of Epoxy B's water uptake over time.
