Using Self-Healing Concrete for Concrete Structures, Laboratory Report

Research and Development Office
Science and Technology Program
(Final Report) ST-2019-1791-01

Using Self-Healing Concrete for Concrete Repairs on Aging Concrete Structures, Laboratory Report

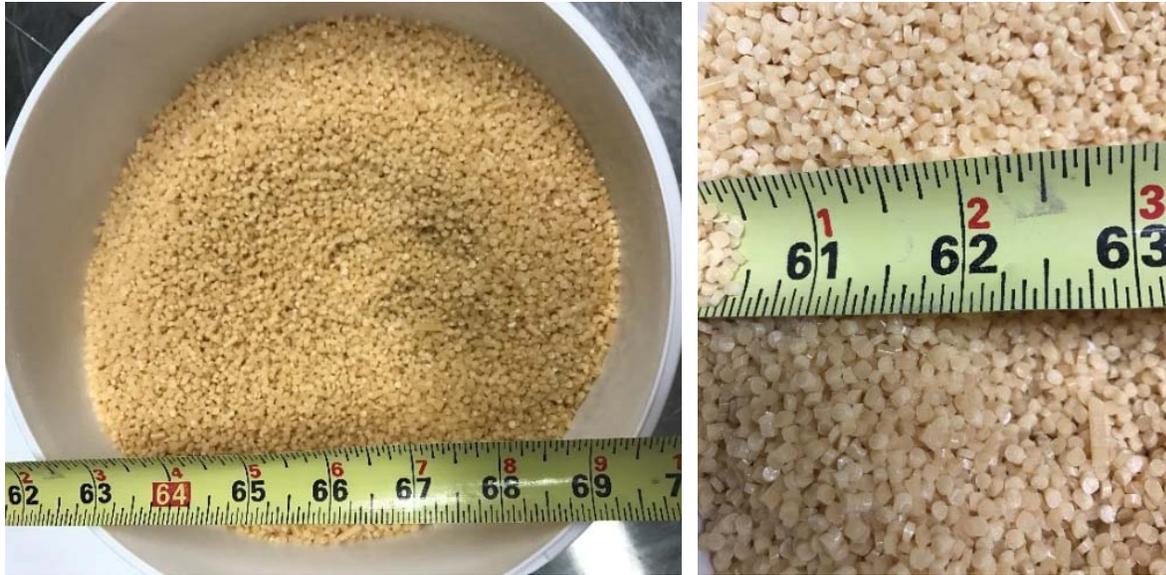
Figure 1. Basilisk Self-Healing Concrete (SHC) Agent pellets.

According to Basilisk Concrete the addition of the SHC Agent does not impact or cause a reaction with the concrete ingredients or admixture products. Because the SHC Agent is comprised of a polymer pill, the bacteria spores and their food source (calcium lactate) are protected within the pill during the mixing process and shielded from the presence of water which acts as the activator (Figure 1). Concern was expressed by Reclamation engineers on the use of the bacteria and their impact on both humans and wildlife. According to Basilisk Concrete the bacteria are food grade [12] and are safe to handle, however potable water regulations do not allow the introduction of bacteria in drinking water installations. Otherwise, the best potential for this technology is for water infrastructure.

The scoping study report ST-2016-7064-1, briefly discussed the advantages of a higher content distribution of the SHC Agent within a concrete mixture. The higher distribution would have the ability to heal cracks extending through the entire depth of the concrete panel. However, information on the actual distribution content was not available during evaluation of the SHC through research publications. During discussions with Basilisk Concrete and supplemental data gathered from their SHC Agent brochure [12] the ideal dosage amounts are as follows: the recommended dosage of SHC Agent in a concrete mix design is 17 lb/cyd with a theoretical maximum healing benefit at 25 lb/cyd. Other topics not covered in ST-2016-7064-1 included more details on the chemical reactions when the bacteria spores are activated. According to Basilisk Concrete, the bacteria spores are aerobic and when activated consume oxygen in the area of the crack. This chemical reaction is a positive trait as the reduction of oxygen within the concrete matrix would lower the potential for corrosion of the reinforcement by exposure.

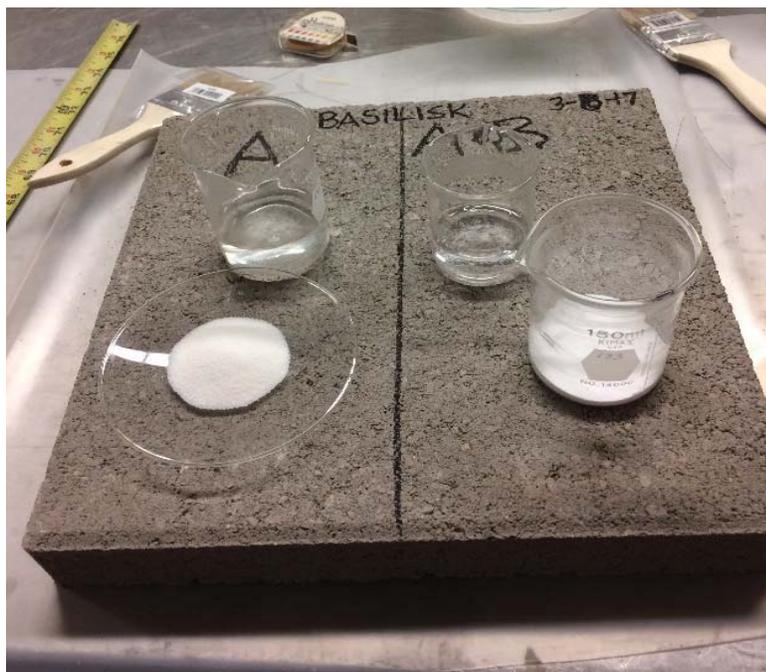
Figure 2. Liquid Self-Healing Repair System (ER7) prior to mixing.

Basilisk Concrete offers three variations of their SHC technology, report ST- 2016- 7064- 1 focused on the SHC Agent and during the visit to Basilisk Concrete’s home office further information was provided on the other variations. The Liquid Repair System ER7, a 2- component low viscosity solution with the first component containing the bacteria spores penetrating deep into cracks and pores, while the second component acts as the activator. The

reaction between both components produces a gel formation that seals cracks and pores (Figure 2). According to Basilisk Concrete's laboratory trials and field application at Parking Garage Apeldoorn [1], the product permanently seals, and waterproofs cracks up to 0.0315- inches wide after 2-3 treatments. The Self-Healing Repair Mortar MR3 is a 1- component repair mortar modified with the SHC Agent. Typical applications of the mortar are actively leaking cracks, as these are typically difficult to repair with traditional methods (including bitumen). After application, the mortar will start to react within 24 hours and according to Basilisk Concrete is suitable for permanent and durable repair of cracks larger than 0.0394-inches. Information on these two products was collected by the Principal Investigator and provided to Reclamation's Concrete, Geotechnical, and Structural Laboratory engineers for consideration for laboratory testing alongside the SHC Agent.

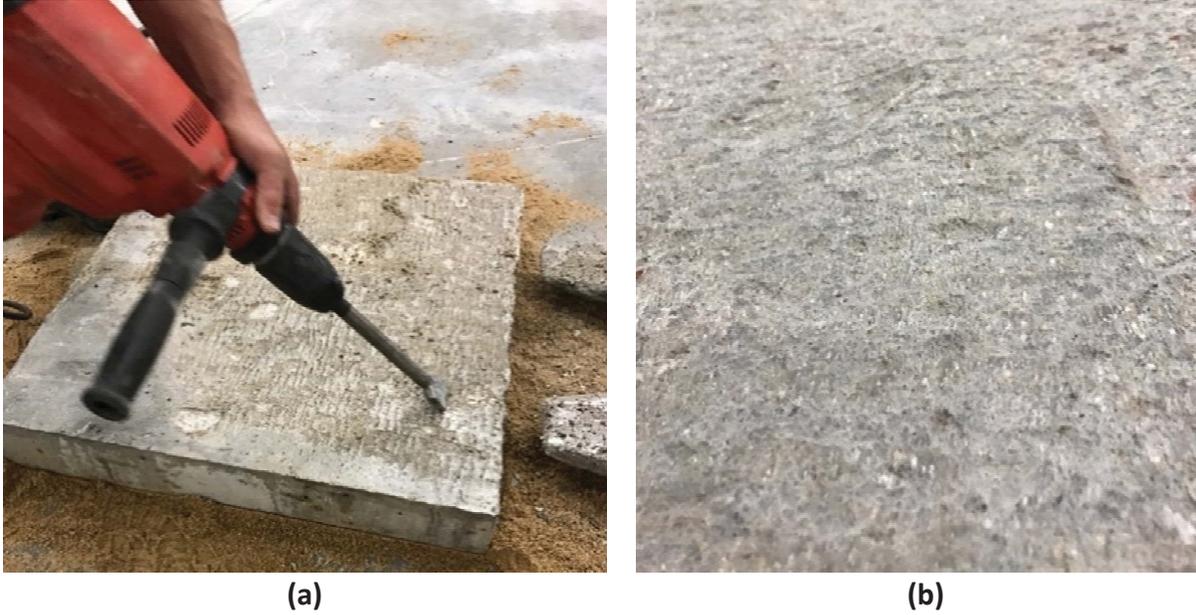
Figure 3. (a) Surface preparation for interface between substrate and overlay slab and (b) a close-up of substrate profile.

The test specimens were cast along with the bottom slabs to be used in the bond test program. Six of the bottom slabs were cast using an ordinary Portland cement (OPC) mixture, and two of the slabs were cast incorporating the SHC into the same base concrete mixture. The base slabs were fog cured for approximately two and a half months before application of the topping slabs. To mimic typical field concrete repair situations, the base slabs were chipped, and the surfaces were prepared to a CSP 5 to CSP 7 [14] surface profile as shown in Figure 3 and then powerwashed; no sandblasting of the surface was performed. A variety of surface treatments and overlay situations were fabricated as shown in Table 4.

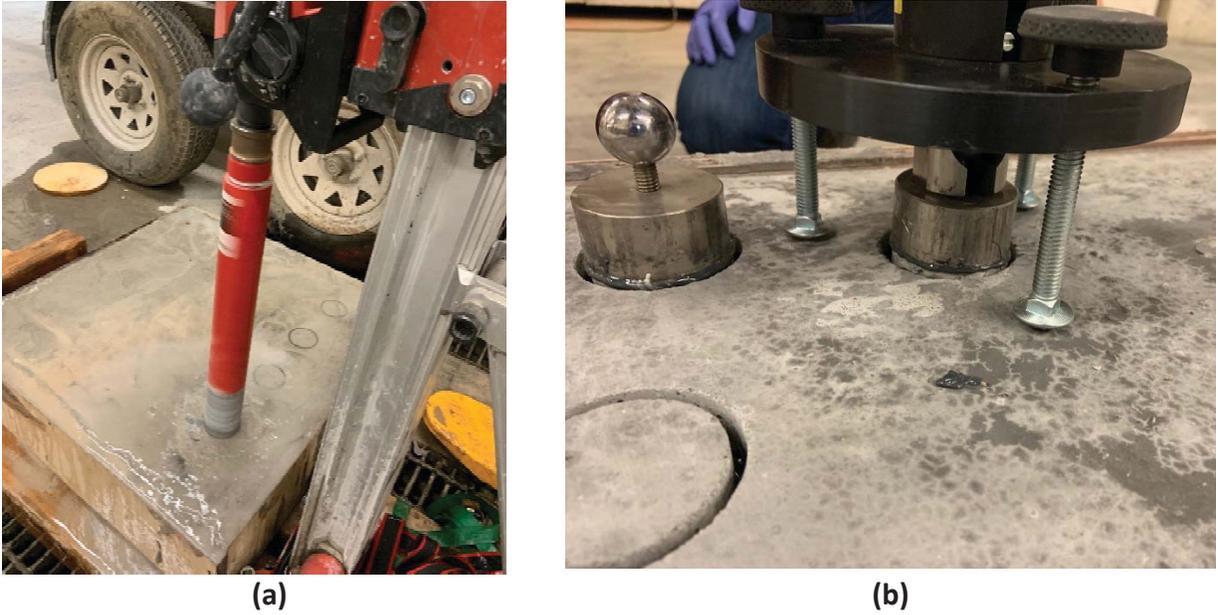
Figure 4. (a) Core set-up for pull-off bond testing and (b) bond test-set up.

In August of 2017, the coring configuration was modified to prevent vibration and the core barrel size was increased from a 2-inch OD to a 2-inch ID (approximately a 1/4-inch increase). These modifications were made to improve the chances of having testable specimens, see Figure 5. The change resulted in improvements to the coring operations with results listed in Table 5, however, in no case was bond achieved in the two slabs that attempted to use the combination of the Liquid Self-Healing Repair System (Part A plus B) as a bonding agent. Only the specimen that was pretreated with the Liquid Self-Healing Repair System (Part A) provided a measured bond strength. It is now thought that the Liquid Self-Healing Repair System (Part A plus B) should be allowed to heal over some duration prior to applying the topping concrete.

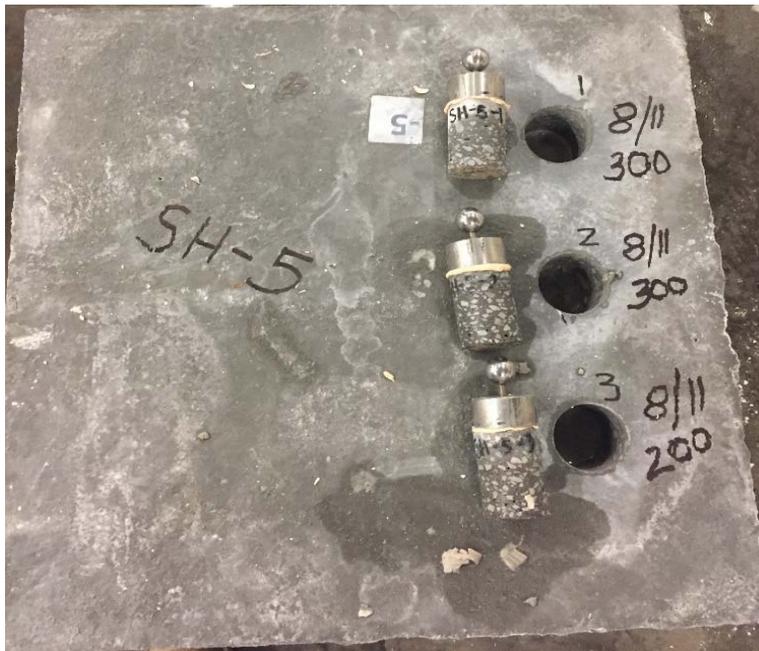
Figure 5. Tested specimens; all fractures at overlay/substrate interface

In an effort to increase the bacteria activity, the tested slabs were placed in a 100 °F chamber and kept moist for approximately two months. A second set of cores were taken from these slabs and compared to the previous 56-day test results with observations listed in Table 6. Those results indicated that there was still no bond between the two slabs with the Liquid Self-Healing Repair System.

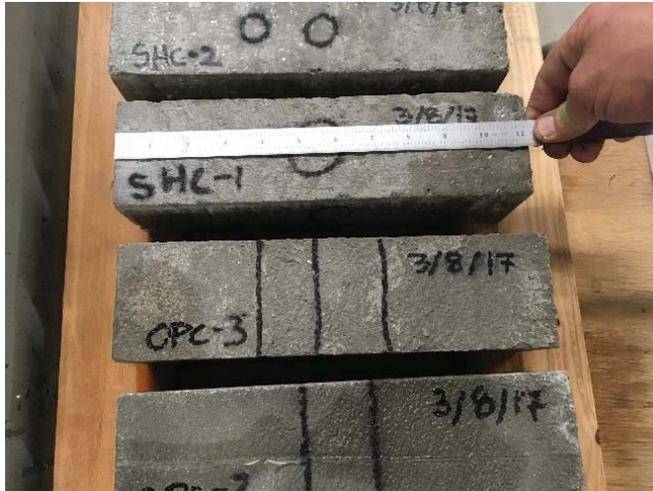
Figure 6. Freeze-thaw bars prior to testing

Freeze/Thaw durability testing would evaluate the performance of the self-healing material when exposed to the degradation mechanisms of frost, see Figure 6. The specimens were comprised of: three specimens of the SHC and three OPC control specimens. Recordings were taken until 50% damage was reached for both sets of specimens, in accordance with ASTM Standard 666, “Standard Test Method for Resistance of Concrete to Rapid Freezing and Thawing” [15]. Mass loss measurements were taken for both sets of specimens at 33 cycles (see Figure 8) and 175 cycles (see Figure 7).

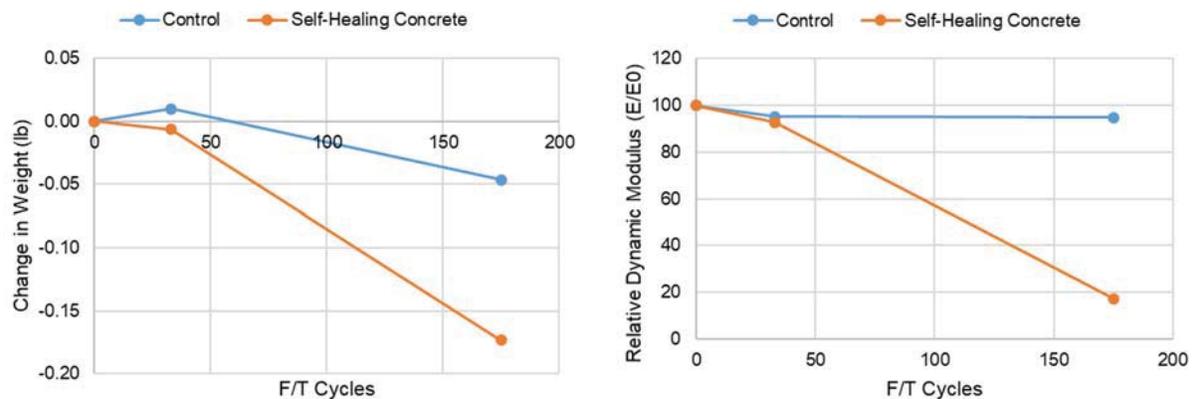
Figure 7. Change in weight and relative dynamic modulus for concrete with and without integral bacteria pellets after 175 freeze-thaw cycles

Based on analysis the SHC specimens exhibited a higher degree of deterioration as compared to the OPC specimens after 175 cycles. The cause was not immediately known but the average degree of mass loss in the SHC specimens indicated that the addition of the self-healing bacteria was a factor. It was theorized that the SHC agent polymer pills may have absorbed water and caused expansion within the concrete matrix leading to accelerated deterioration during the freeze/thaw testing.

A joint meeting with the supplier Basilisk Concrete in September of 2017 resolved that the swelling evident in the laboratory testing trials was due to a chemical reaction when the bacteria metabolized the calcium lactate. Changes to the SHC Agent ingredients had already been made by Basilisk Concrete to address this issue and a new version was available that produced more robust results. It was recommended that the current version of the SHC Agent provided to Reclamation be ground down to powder form as this would improve freeze/thaw testing results.

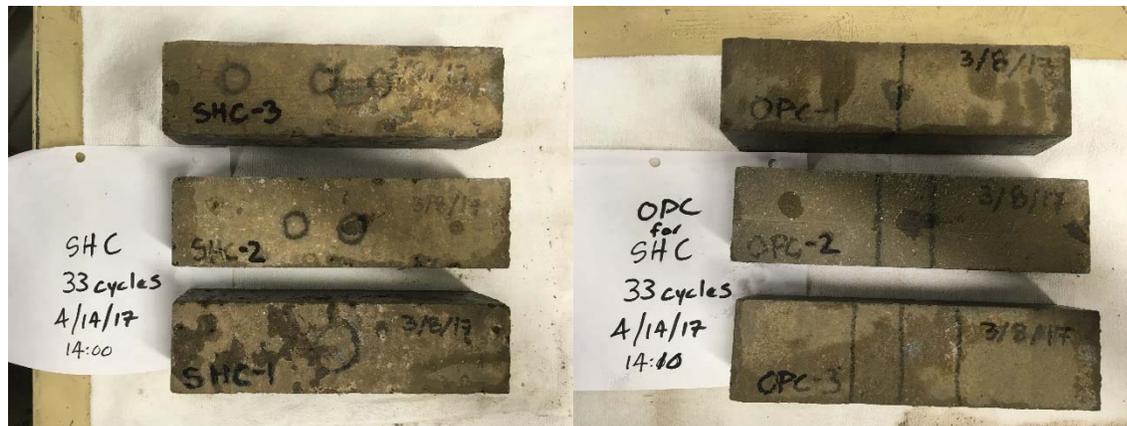
Figure 8. SHC specimens after 33 cycles (left), OPC specimens after 33 cycles (right). Surface scaling can be observed in the self-healing concrete specimens

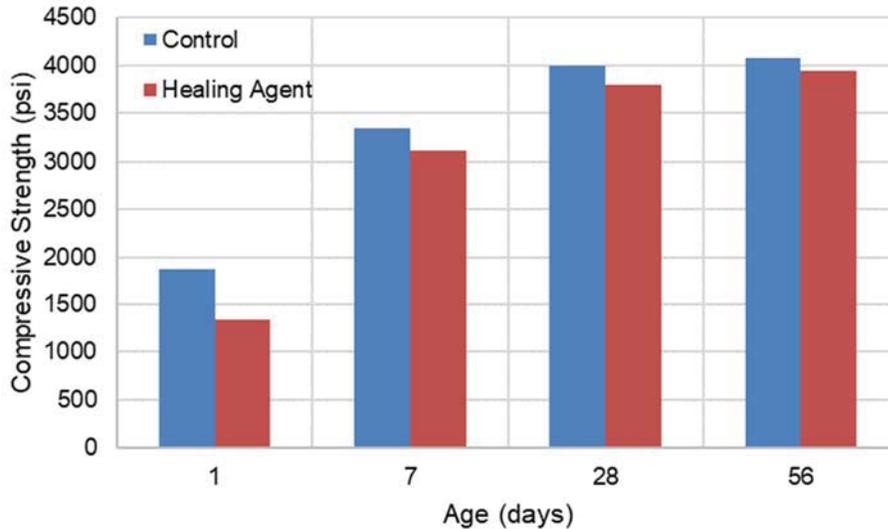
Figure 9. Compressive Strength Development for Control Specimens and SHC Agent Specimens

Figure 9 reflects the difference in strength development between the conventional concrete control specimens and the SHC Agent specimens. The most notable difference in strength is evident at the 1-day strength testing where the SHC Agent specimens reflect a 30% difference. At 7-day and further out to 56-days the difference between the control specimens and the SHC Agent specimens is far less apparent. It is concluded that although the SHC Agent specimens have a less gradual early strength development it promptly develops strength and maintains close correlation with the control specimens. Therefore, this test program believes that there is no significant impact to compressive strength when using the SHC Agent.

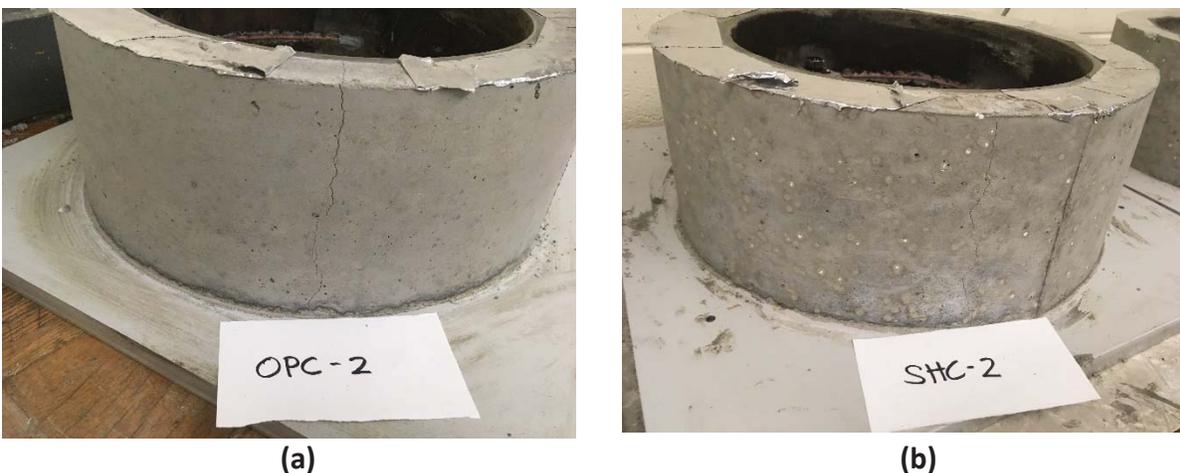
Figure 10. Example of cracked shrinkage specimens of (a) plain concrete (OPC-2) and (b) concrete containing SHC pellets (SHC-2)

Restrained shrinkage was evaluated in accordance with ASTM C1581. Three specimens were prepared with the same concrete mixture as the freeze-thaw bars. The two mixtures performed similarly, which is expected since they contain the same volume of paste. The average crack width for both mixtures was 0.007-inches, and the average time to cracking was 13 days for the Control and 14.25 days for the Self Healing Concrete. As shown in Figure 10(b), bacteria pellets are exposed on the surface of the sample. From Figure 11, the Control has a maximum strain of $42 \mu\epsilon$ while the SHC sample averaged $50 \mu\epsilon$ before cracking.

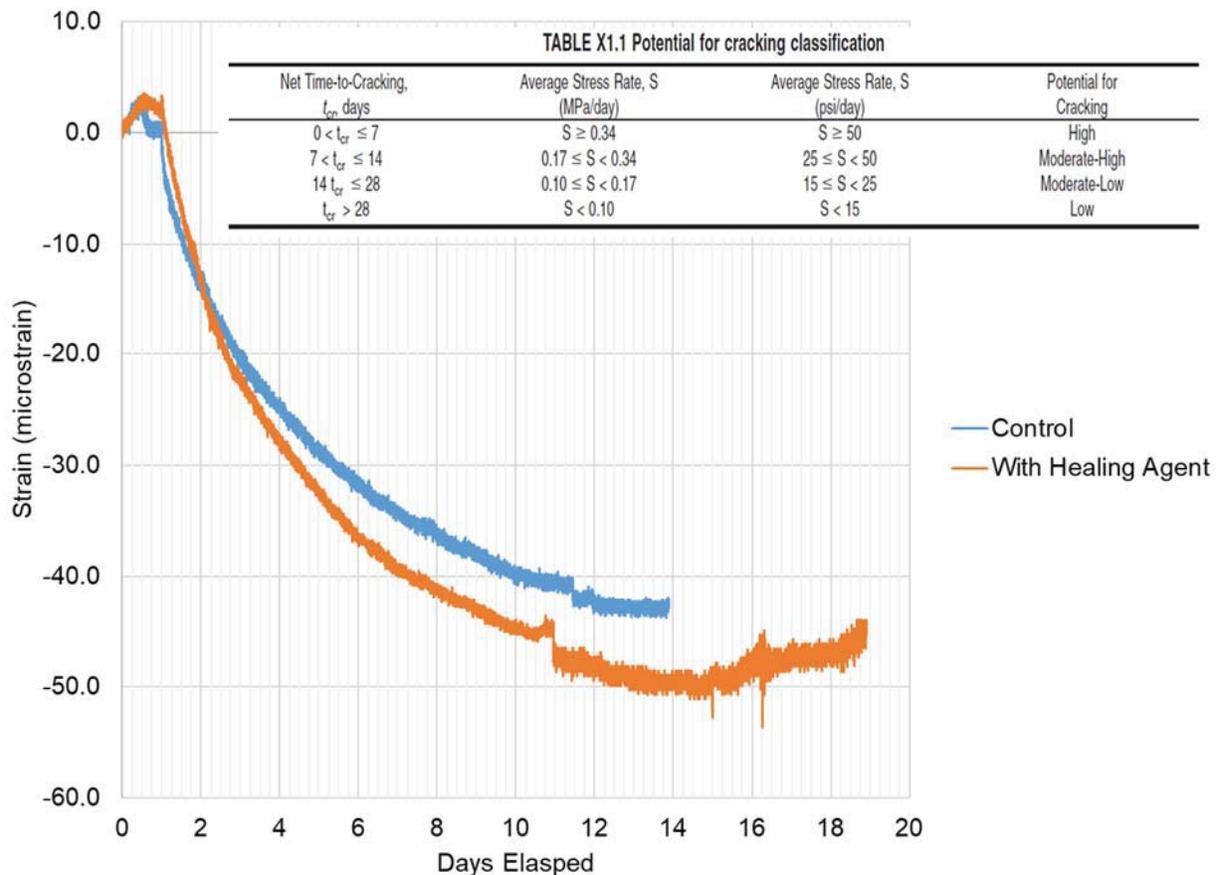
Figure 11. Strain development for concrete with and without Self-Healing Bacteria pellets
