Evaluation of Field Repairable Materials and Techniques for Cavitation Damage

**Research and Development Office
Science and Technology Program
Final Report ST-2019-8452-01
Technical Memorandum No. 8540-2019-39**

**U.S. Department of the Interior
Bureau of Reclamation
Research and Development Office**

September 2019

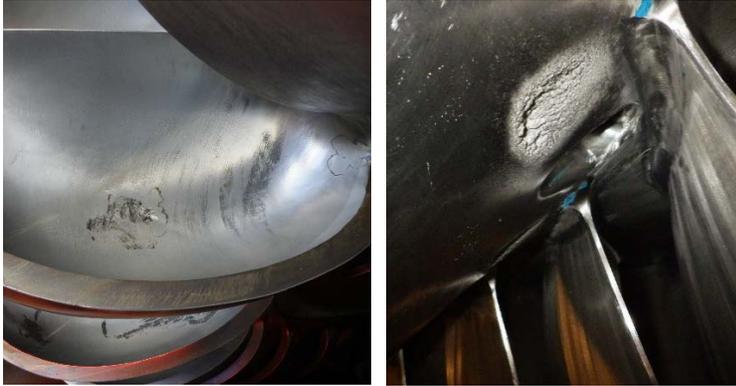
Figure 2. Examples of cavitation damage in turbine runners: (left) Upper Molina powerplant (right) Flaming Gorge powerplant.

Over time, the cavitation damage becomes visible in the form of pitting. Once cavitation has begun, the pitting rate becomes exponential due to the increasing surface area which creates new areas of low pressure, resulting in an increasing erosion rate. Over time, erosion of the material will decrease the performance of the equipment, and eventually wear through the material entirely. At that point, complete replacement is inevitable. Cavitation also creates an increase in vibrations of the hydropower equipment, generating significant noise and reducing the efficiency of the unit [2]. Examples of cavitation damage in turbines are shown in Figure 2. Costs of equipment repair, replacement, and downtime are high; therefore, mitigation of cavitation effects on water management structures is a high priority.

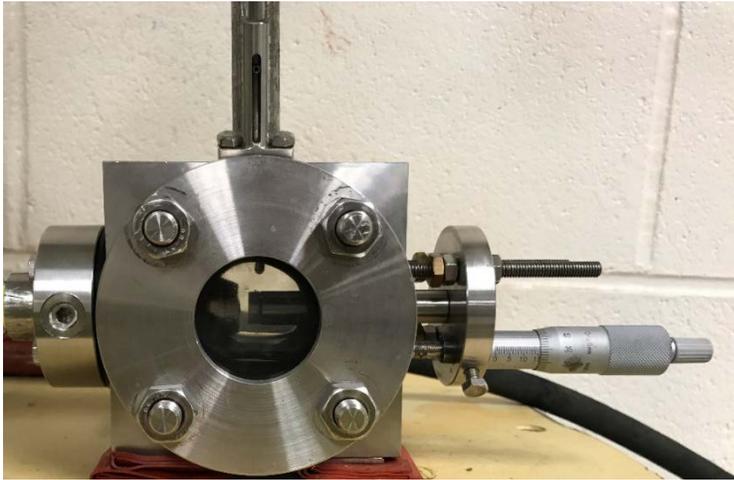
Figure 6. Cavitation testing chamber.

Cavitation in the apparatus is controlled by the upstream pressure, downstream pressure, stand off distance, and duration of the test. The stand off distance can be adjusted using a micrometer, and the orifice of the nozzle is 0.4 mm in diameter. The cavitation chamber, shown in Figure 6,

was constructed with stainless steel following the guideline schematics provided in the ASTM G134 standard.

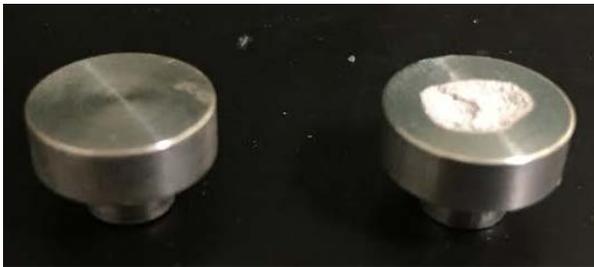
Figure 7. A 12-mm diameter aluminum specimen before (left) and after (right) cavitation damage.

The test specimens are solid 12-mm diameter discs. Coatings are not recommended for this testing procedure because the material could disbond and plug valves or drain lines. Figure 7 shows an aluminum specimen before and after cavitation damage has occurred. Notice that the area of cavitation damage is approximately 6 mm in diameter.

allowed for the entire specimen to be subjected to cavitation (Figure 13), whereas the previous method ASTM G134 only focused cavitation on the central portion of the specimens (Figure 7).

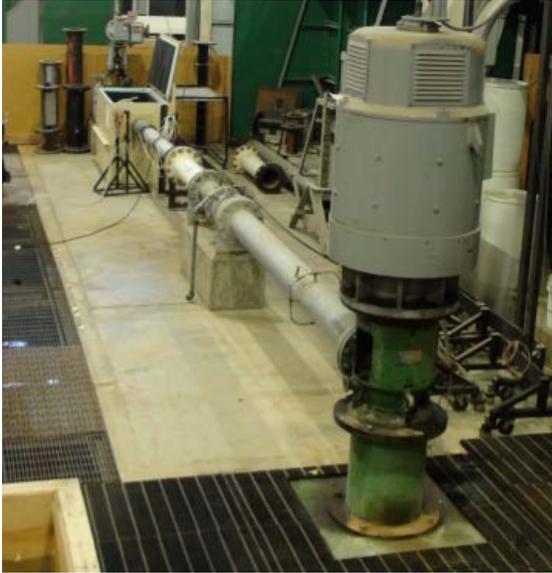
Figure 8. 60 HP electric motor and 7 stage vertical lift pump used for testing in the venturi cavitation device.

As the next testing approach, researchers chose a venturi device that was developed by Reclamation in the 1960's which induces cavitation using flows that are almost parallel to the specimen [16]. This device was originally developed and used to test cavitation damage on concrete but has been used to test various coatings as well. The device uses a high-head pump with a variable frequency drive and a downstream control valve to adjust flows and pressures to optimum test conditions (Figure 8 and Figure 9).

The device is equipped with a 60 horsepower (HP) electric motor and 7 stage vertical lift pump to drive 2.1 cubic feet per second discharge of water through a 0.25-inch by 12-inch venturi opening to induce cavitation [16]. Figure 10 shows a drawing of the venturi device and Figure 11 shows the pressure gradient and location of the cavitation zone. Specimens were exposed to cavitation for up to 180 hours and were evaluated approximately every 8 hours.

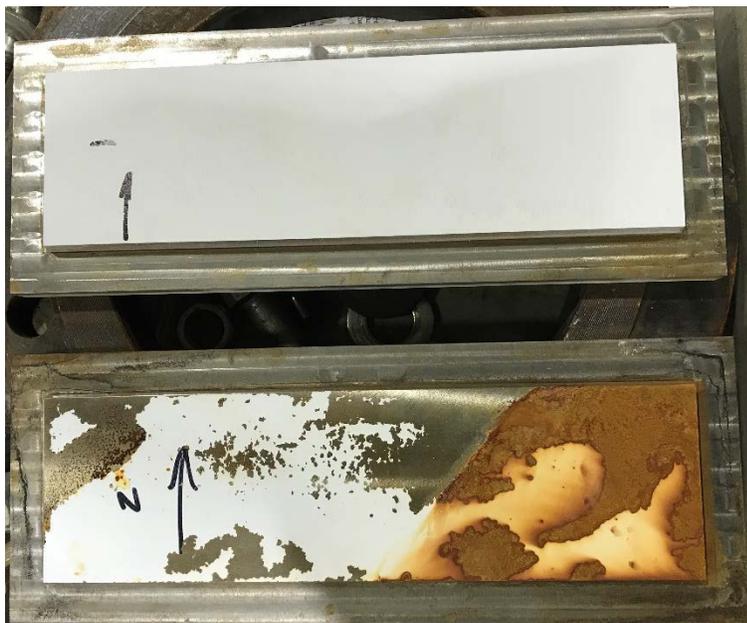
Figure 13. Mild steel test specimen with spray painted surface before (top) and after (bottom) cavitation by the venturi-style cavitation tester.

Figure 13 identifies the results of a calibration test on the venturi style cavitation tester. A mild steel sample was sprayed with a white spray paint on the top surface and used inside of the cavitation tester. The purpose was to confirm that cavitation damage would occur on the face of the test sample during subsequent testing. An aluminum sample was also tested and used in comparison to the submerged jet test method, discussed in the next chapter.

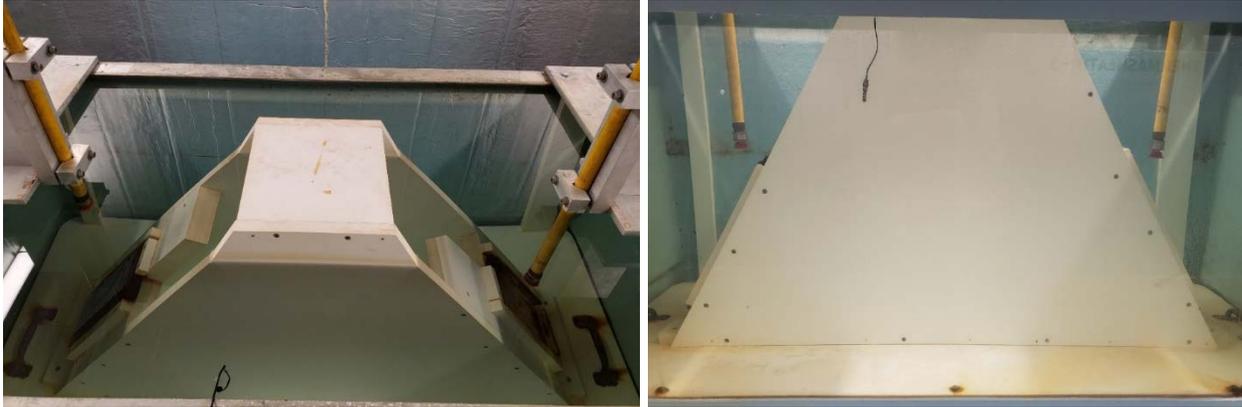
Figure 15. Top view (left) and side view (right) of submerged jet test set-up.

The test set-up was arranged so that two specimens could be tested simultaneously as shown in Figure 15. During testing, flow was supplied to each of the two jets from 10 HP pressure pumps (one jet per pump).

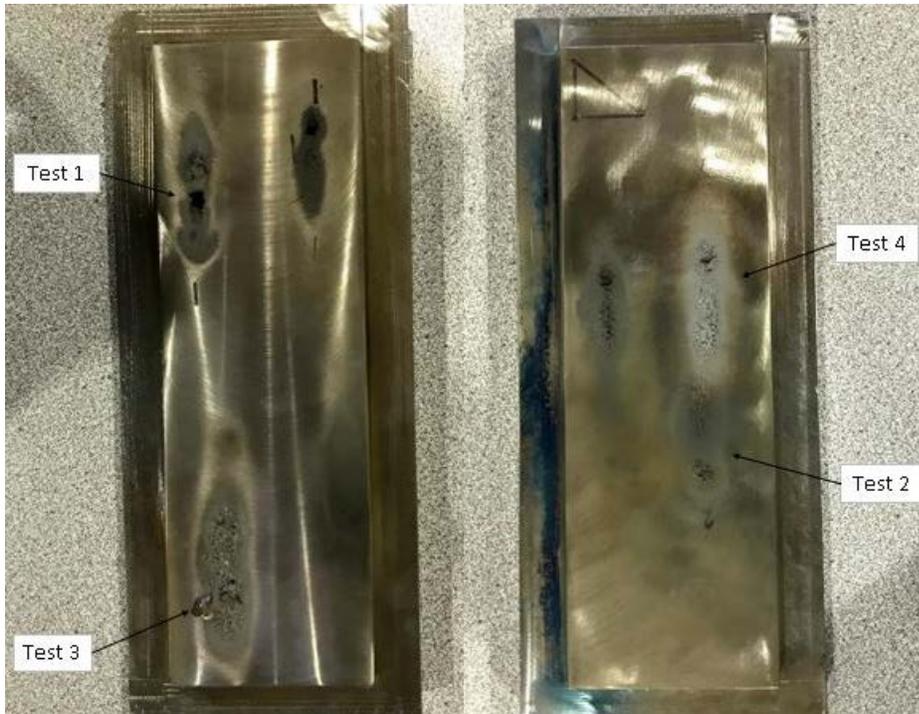
Figure 18. Stainless steel baseline test specimens with test locations.

Four test repetitions on two stainless steel specimens were performed to establish a baseline. The test consisted of two test locations on two plates, as shown in Figure 18. Test results are shown in Figure 19. There was a large range in mass loss data for all four specimens, but in general the stainless steel specimens saw a mass loss of no more than 7 grams after 140 hours. This aggressive submerged jet method produces high impact pressures that typically erode a single hole that then becomes a source of cavitation itself, resulting in pitting on the surface immediately downstream. This can be seen by the elongated damage pattern downstream of the deepest hole which is similar to cavitation damage patterns observed in prototype penstocks and spillways. Figure 18 shows that Test 2 exhibited less drilling action of the initial hole, which could explain why it has the lowest mass loss. Test 1, Test 3, and Test 4 exhibit prominent cavitation damage within about an inch of the initial jet location of impact. These three tests track more closely to each other, with variability.

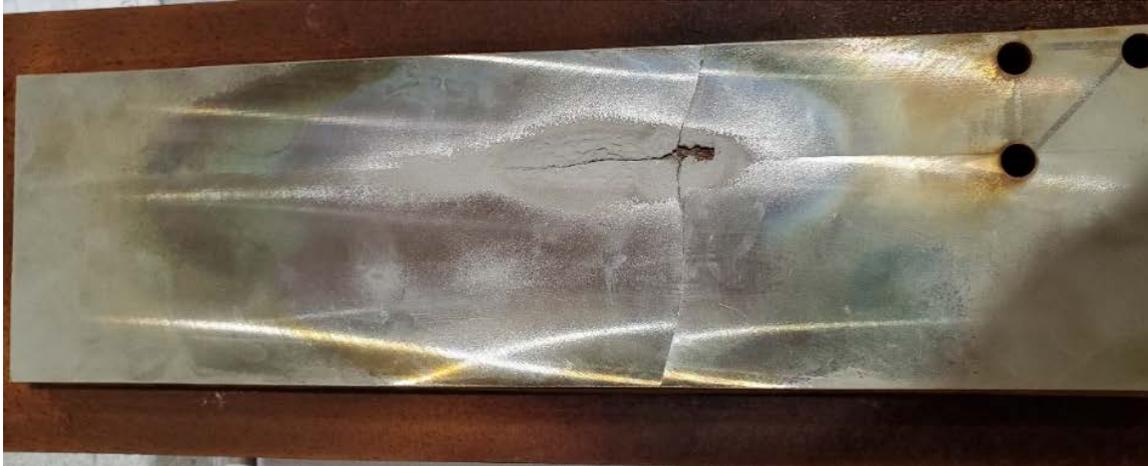
Figure 20. Crack in tested cold spray specimen due to aggressive test conditions.

Cold spray specimens were tested using two test locations on the same specimen. Figure 20 shows a cold spray specimen that cracked due to the aggressive testing conditions. Test results are shown in Figure 21. Test 2 was inconclusive because of difficulty with the jet pump that required repair. Therefore, only Test 1 could be examined and compared to the baseline tests. Test 1 was only run for approximately 80 hours before a significant crack developed, as shown in Figure 22, which produced delamination of the cold spray, seen in Figure 23. A mass loss of only about 2 grams occurred prior to the significant crack development, which is comparable to stainless steel baseline Tests 1, 3, and 4 at 80 hours. However, the cold spray was effectively unable to be compared to the baseline tests because of the crack and resulting delamination that occurred.

The cause of the crack in the cold spray sample is unknown. One possibility is fatigue cracking due to rapid stress oscillations of the material due to the impact pressures caused by the jet. Or perhaps a cavitation hole was first eroded through the cold spray lining which allowed for high stagnation pressures between the lining and the parent steel material. This uplift pressure could account for the crack formation as well as the delamination that is clearly shown in Figure 23.

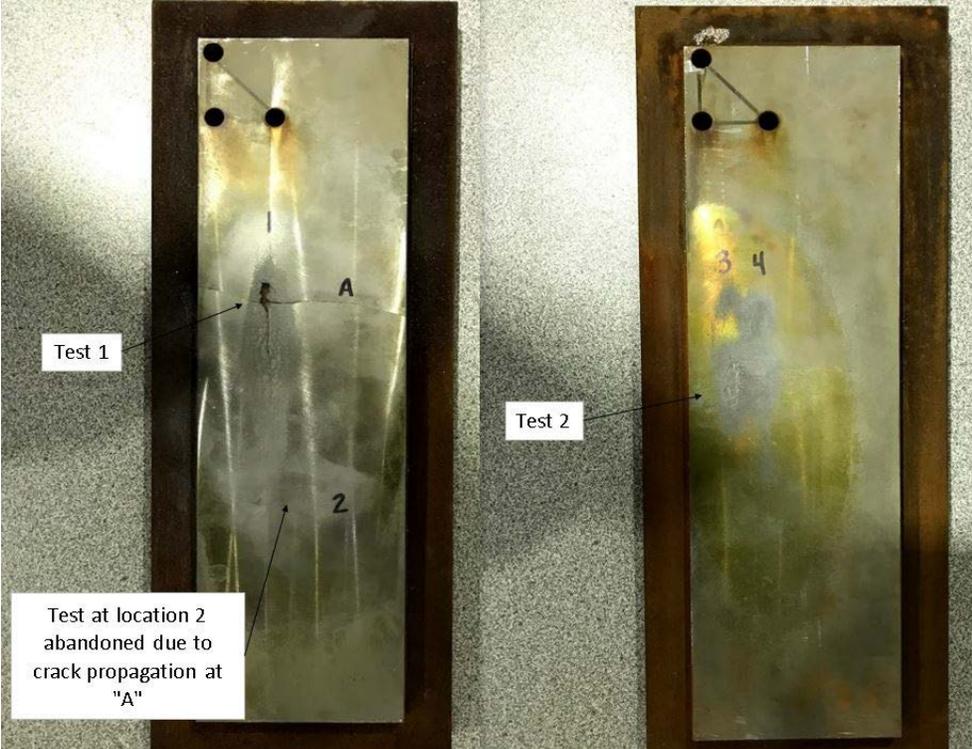
Figure 22. Cold spray test specimens with test locations.

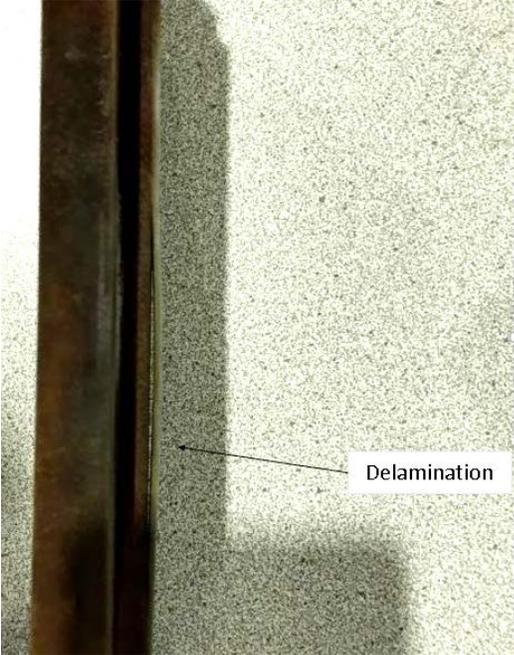
Figure 23. Side view of delamination in cold spray specimen.

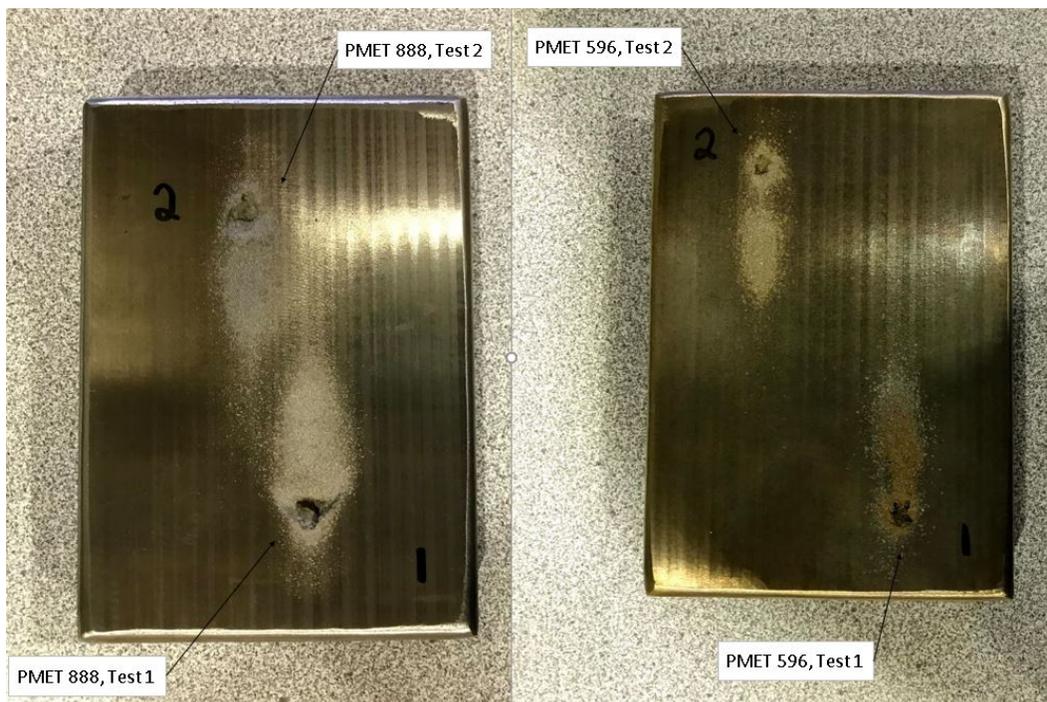
Figure 24. Thermal spray test specimens with test locations.

Thermal spray specimens were tested using two test locations on two specimens, as shown in Figure 24. Test results are shown in Figure 25. During Test 1, it was discovered that the thermal spray specimens presented a unique problem of mass gain due to porosity. Test 2 for the thermal spray PMET 888 and PMET 596 specimens were allowed a longer dry time in between weight measurements, preventing the mass gain problem and allowing results to be compared to the other test results. For future testing the issue of mass gain can be addressed by oven drying specimens prior to each weight measurement.
