Evaluation of Field Repairable Materials and Techniques for Cavitation Damage

Developing a test method to evaluate materials for cavitation resistance

Research Bulletin
Science and Technology Program

S&T Project 8452

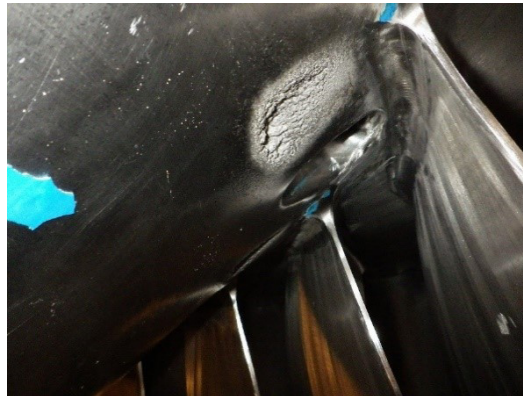
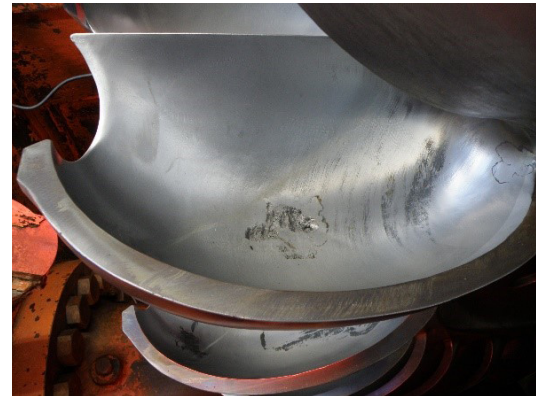
Turbine runner damage from cavitation (left) Upper Molina powerplant and (right) Flaming Gorge powerplant.

The Bureau of Reclamation utilizes hydraulic structures to generate power and collect, convey, and store water. As a result of the hydraulic conditions within these structures, many of them, such as hydro-turbines, can be subject to extensive damage from cavitation. Currently, Reclamation's primary method for mitigating cavitation on hydro-turbines is the use of stainless-steel weld overlays. However, this procedure is time-consuming and expensive, costing \$100k - \$250k per each unit repair, every 1-3 years. This estimate does not include lost revenue due to unit downtime, which can be even more costly.

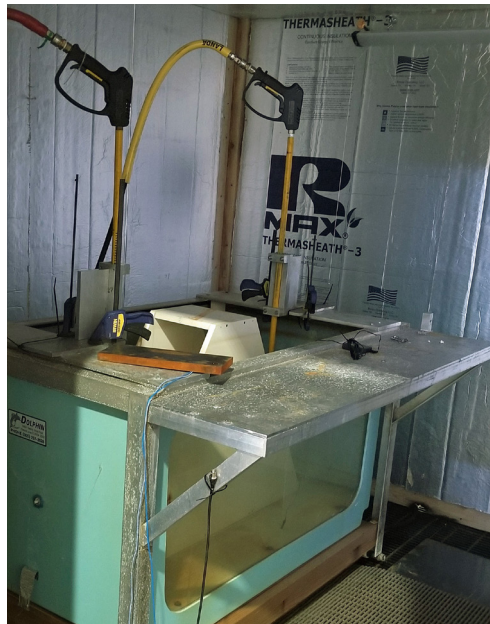
Submerged jet testing apparatus.

This project work focused on establishing a viable test method with specimen sizes that were representative of field conditions, as well as test durations that were feasible to perform in the lab. Researchers investigated three test apparatuses: an ASTM G134 rig, a 1960s Reclamation-designed venturi facility, and a submerged jet cavitation/erosion apparatus. Ultimately, researchers found that the submerged jet apparatus was the most representative and viable test method to use moving forward.

Using the submerged jet apparatus, researchers tested three specimens: bare stainless steel, cold-spray-coated, and thermal-spray-coated. It was found that the testing conditions were too aggressive for the specimens, and that further optimization of the test set-up will need to occur prior to further testing. Under the aggressive testing conditions, the stainless steel specimen outperformed the cold spray and thermal spray specimens, with the thermal spray specimen performing the worst. However, results were inconclusive due to the testing conditions, and future work is required to obtain valid results.

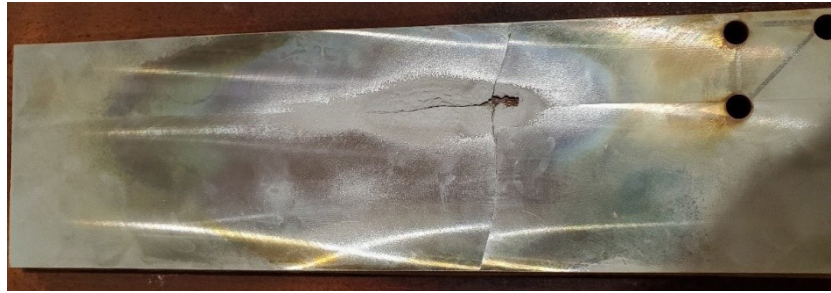
Cold spray specimen with crack, due to aggressive testing parameters.
