Concrete Fabric for Concrete Canal Lining Repairs – Scoping Study

Research and Development Office
Science and Technology Program
(Final Report) ST-2019-9227-01 (8530-2019-50)

September 2019

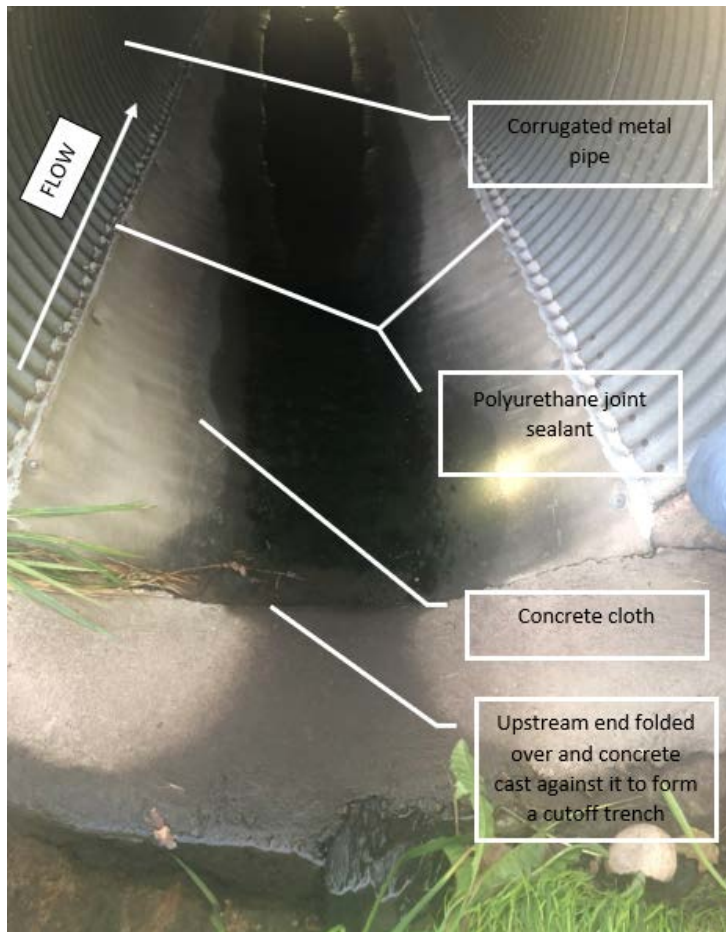
Figure 1. Repair of corrugated metal pipe with concrete fabric

Figure 1 shows a typical local application for repairing the corroded invert of a corrugated metal pipe. A single wide row of ½ inch thick concrete fabric was rolled out down the length of the culvert. The upstream end was folded down the upstream face of the culvert and concrete was cast against the fabric to create a cutoff trench. The concrete fabric only covered the damaged area of the pipe and did not come up to the top of water surface. The edges of the cloth were sealed using either polyurethane joint sealant or cementitious grout.

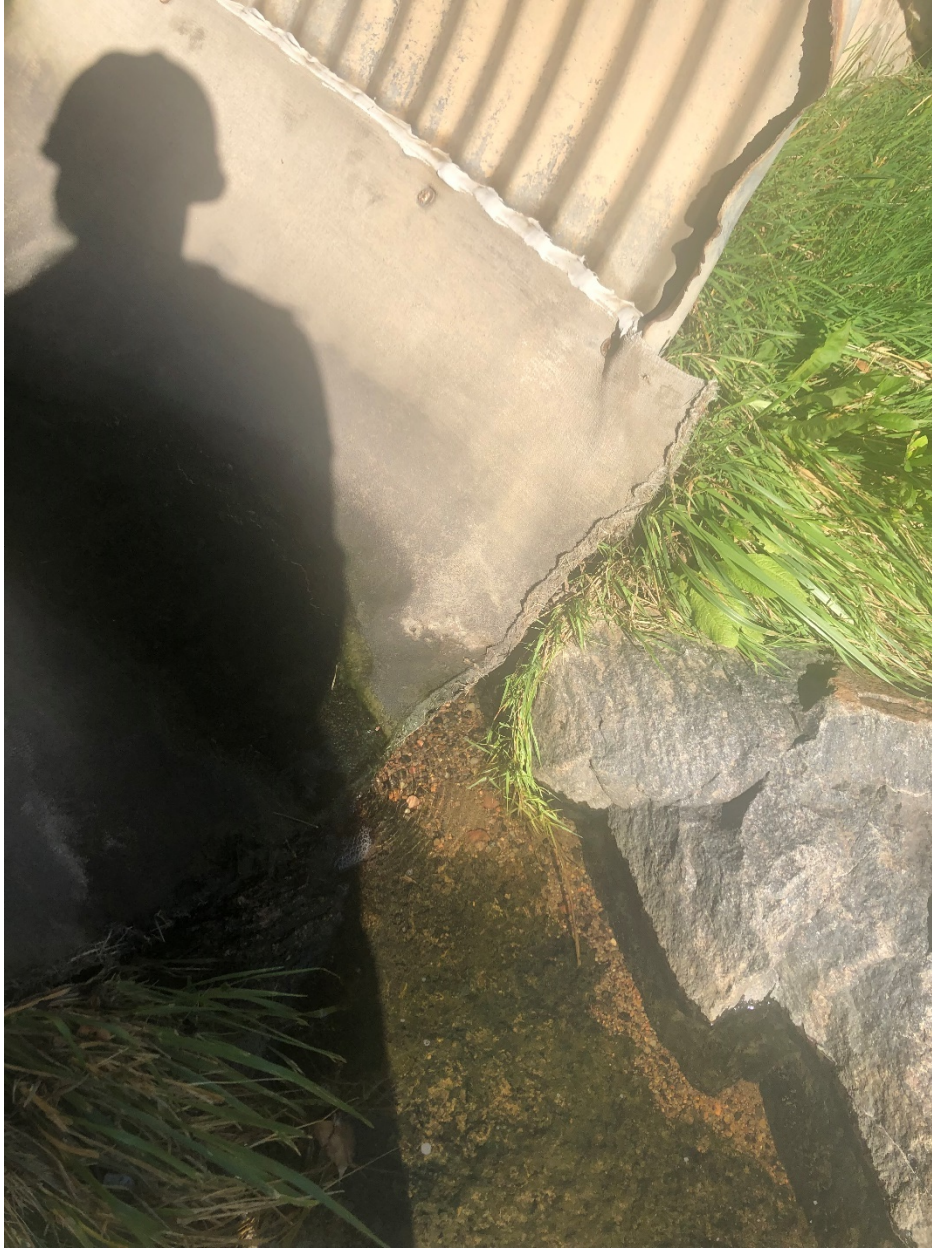
Figure 2. Downstream end of concrete cloth repair of corrugated metal pipe

The downstream end of the Concrete Cloth™ did not receive any special treatment other than cutting the ends off straight. Figure 2 shows the cloth was extend about two to three inches from the end of the corrugated metal pipe. The cloth at the end was hydrated with the rest of the cloth and it hardened to create a stiff end. There did not appear to be any deterioration of the Concrete Cloth™ at this location.

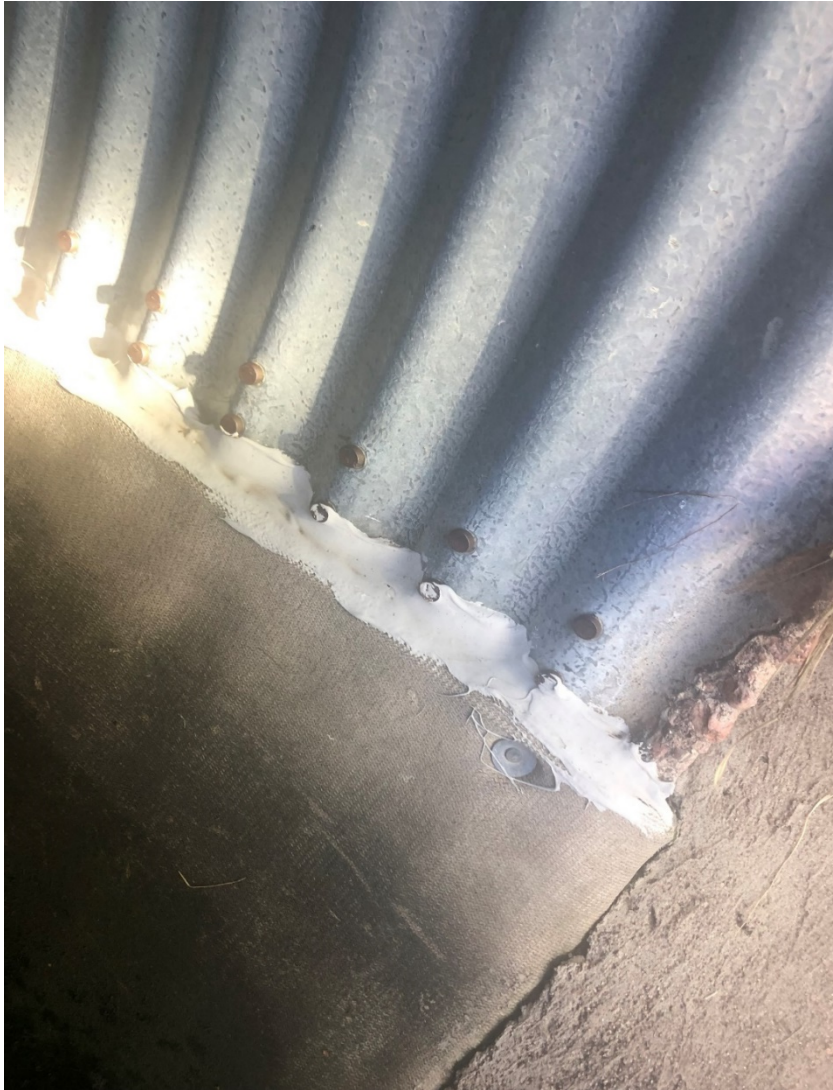
Figure 3. Joint seal detail using polyurethane joint sealant

The local government using Concrete Cloth™ used two different details to seal the edges of the cloth from water getting trapped between the cloth and the metal pipe to prevent possible uplift. The first and most effective can be seen in Figure 3 where polyurethane joint sealant was used. The Concrete cloth was fastened to the corrugated metal pipe with screw fasteners at approximately 12-inches o.c. and the gaps were then sealed with the joint sealant. It was noted that in some cases, the fabric pulled away from the metal leaving a larger gap that was harder to seal. The local government has started placing fasteners closer together to avoid this issue. The

concrete cloth was approximately 4 years old and had no noticeable deterioration or defects that would affect the performance of the repair.

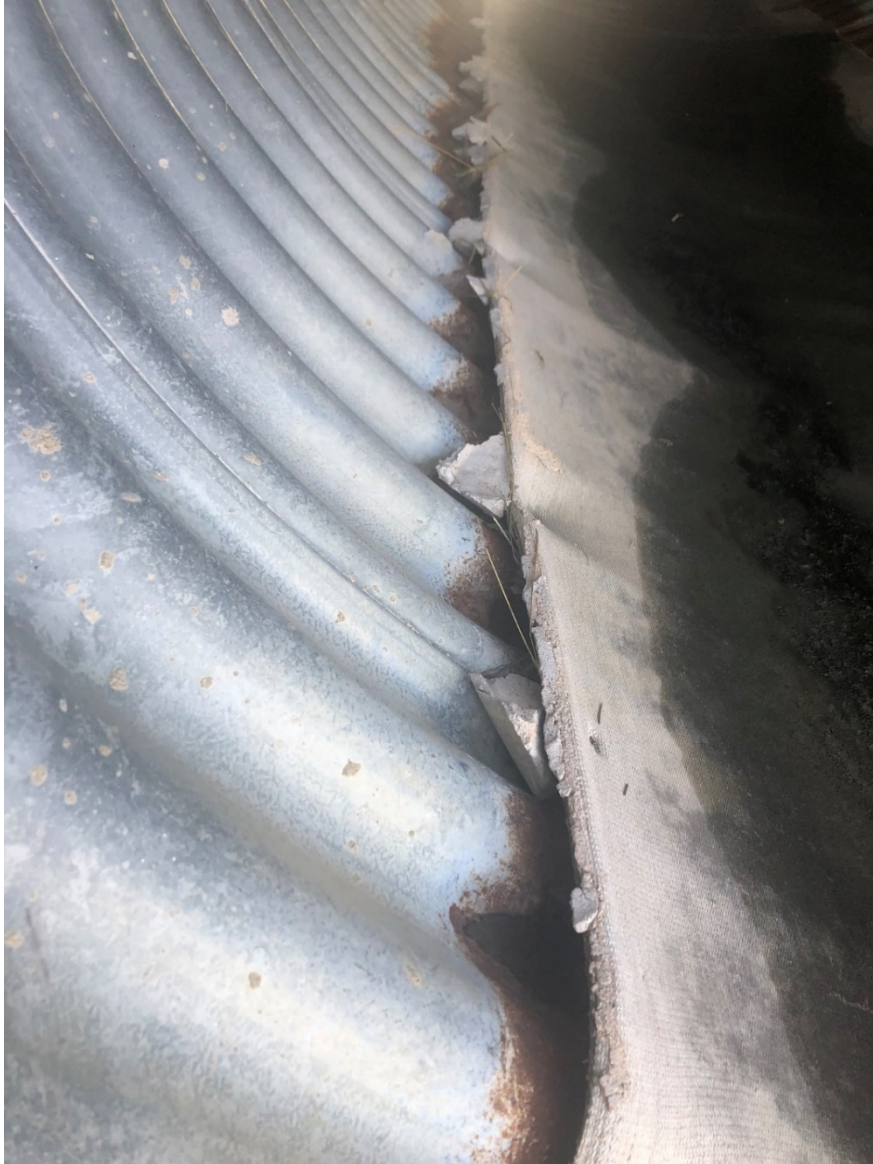
Figure 4. Joint seal detail using grouted joint

Figure 4 shows the alternative detail used to seal the edges of the Concrete Cloth™. The cloth was still fastened to the corrugated metal pipe, but the edges were filled with grout. However, the seal was failing throughout the culvert due to freeze-thaw deterioration and lack of bond of the concrete grout to the metal pipe. The local government plans to strictly use the polyurethane joint sealant for all future repairs and will repair the seal shown in this figure using the polyurethane joint sealant.

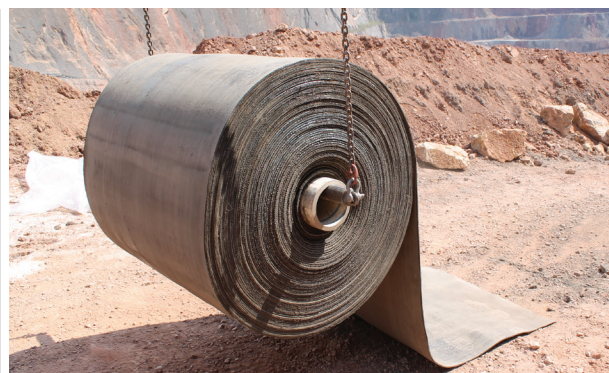
The Concrete Cloth™ material is a three-dimensional flexible cement impregnated fabric that hardens after hydration to form a durable concrete layer. Classified as a Geosynthetic Cementitious Composite Mat (GCCM), it is used in a variety of civil infrastructure markets including: transportation, oil & gas, stormwater, landfill, mining, and erosion control. Typical applications for use are ditch lining, slope stabilization, shoreline armor, secondary berm protection, culvert invert protection, and geosynthetic liner protection
