Impacts of Grade Control Structure Installations on Hydrology and Sediment Transport as an Adaptive Management Strategy

Science and Technology Program
Research and Development Office
Final Report No. ST-2017-1751-01

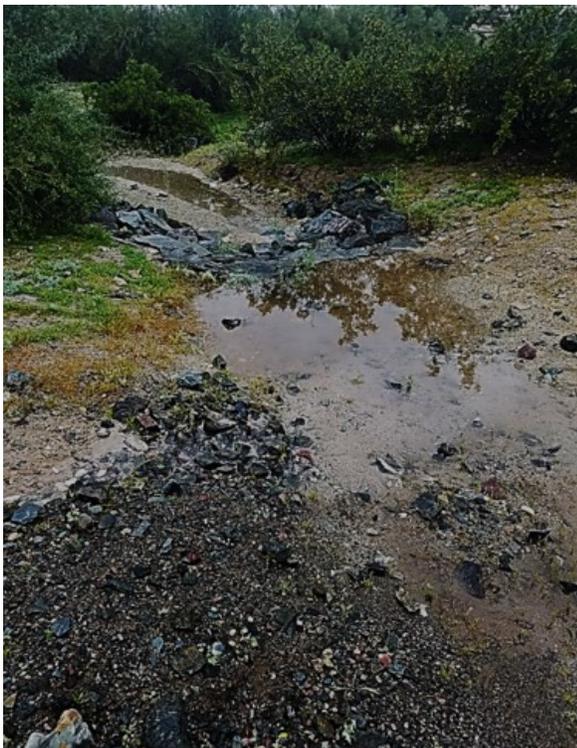
Photo: Grade Control Structure #10 looking downstream, March 11, 2020 (Photo credit: Boy Scouts of America, Heard Scout Pueblo, Cameron Thomas)

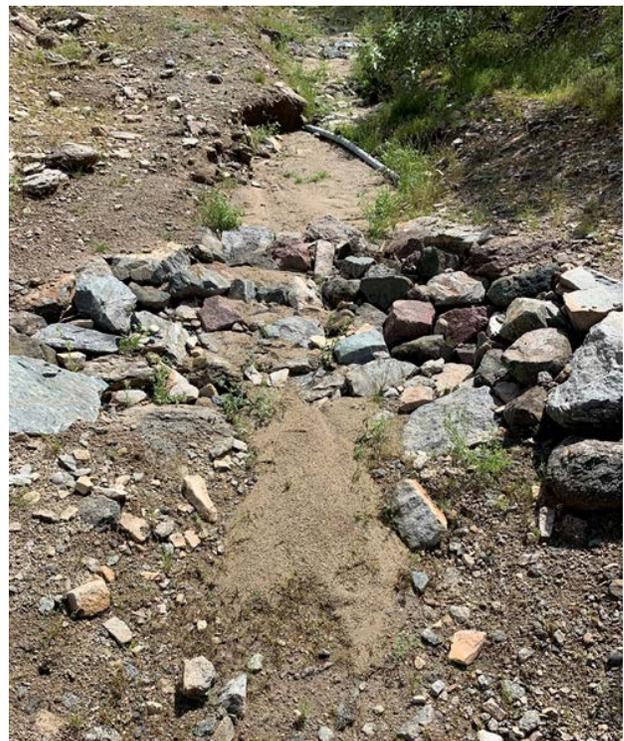
Photo: Grade Control Structure #2 looking upstream, March 13, 2020 (Photo credit: Bureau of Reclamation, Phoenix Area Office, Deborah Tosline)

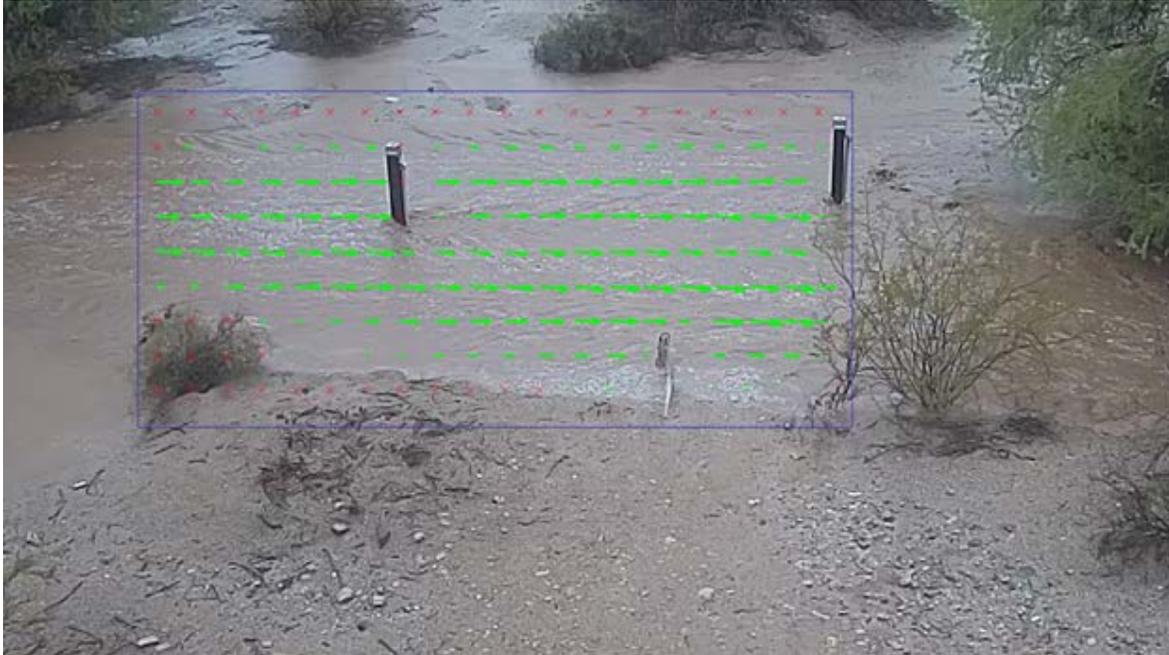
Figure 6. Surface water velocity vectors computed from video collected during a flow event on October 2, 2018 at an unnamed wash at Heard Scout Pueblo near Phoenix, AZ. (USGS image)

For video collected at HSP, specific periods of interest in the stream hydrograph, including peak flow, were identified and a 10- to 20-second segment of the video was processed for each interval. The clipped segment was subsampled at a lower frame rate; typically, the subsampled frame rate was between 2 and 6 fps depending on the surface velocity. Depending on the segment length and subsampled frame rate, between 100 and 150 image pairs in a 10 to 20 second segment of video are analyzed. A mean velocity field is then computed for the analyzed pairs. Orthorectification of the images was done using the known geometry between HSP-1, HSP-2, the gage orifice, and a reference mark on the right bank adjacent to HSP-1.

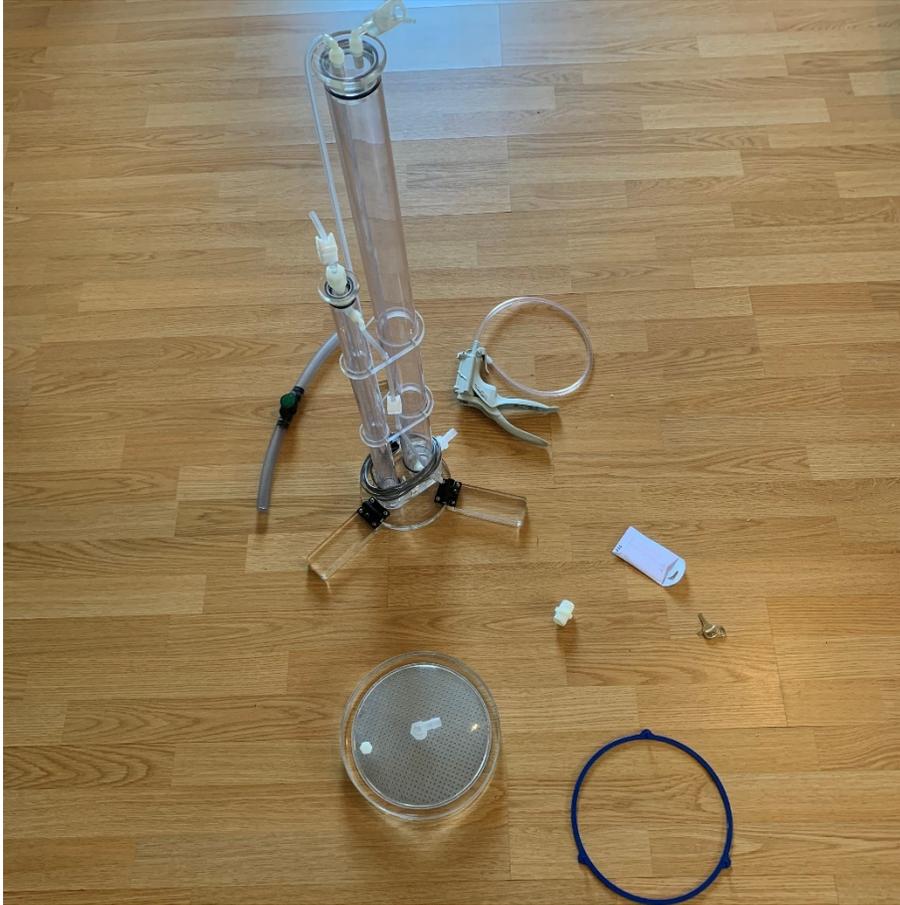
**Figure 8. Tension Infiltrometer, Soil Measurement Systems, LLC.
(Bureau of Reclamation photo, Phoenix Area Office, Deborah Tosline)**

A tension infiltrometer (Soil Measurement Systems, LLC) was used to measure infiltration flow rates at different matric potentials for a variety of channel conditions at HSP. Two sites at the lower end of the study area were assessed. Site 1 (INFIL-1) was located at 33.364001, -112.040759, just below the most downstream GCS. Site 2 (INFIL-2) was located at 33.364701, -112.039854, just upstream of the streamflow gage. At each site, three complete measurement sets were collected at three different locations, each separated by about 2 meters. At each location, the tension infiltrometer was set up (Figure 8) and a variety of matric potentials, e.g., the height of water in the reservoir, was measured, which ranged from a minimum of -11.6 cm to a maximum of -4.4 cm. Although the instrument is capable of measuring over the range of -30 to 0 cm, given the sandy nature of the soils and goals of the Study, the focus was on obtaining measurements in the higher portion of the range. It was impractical to measure at tensions greater than about -4 cm given the turbulence and rapidity of the water level drop in the reservoir. Changes in reservoir volume over time were then converted to estimates of saturated and unsaturated hydraulic conductivity using steady-state solutions to the unsaturated flow equation (Gardner, 1958).

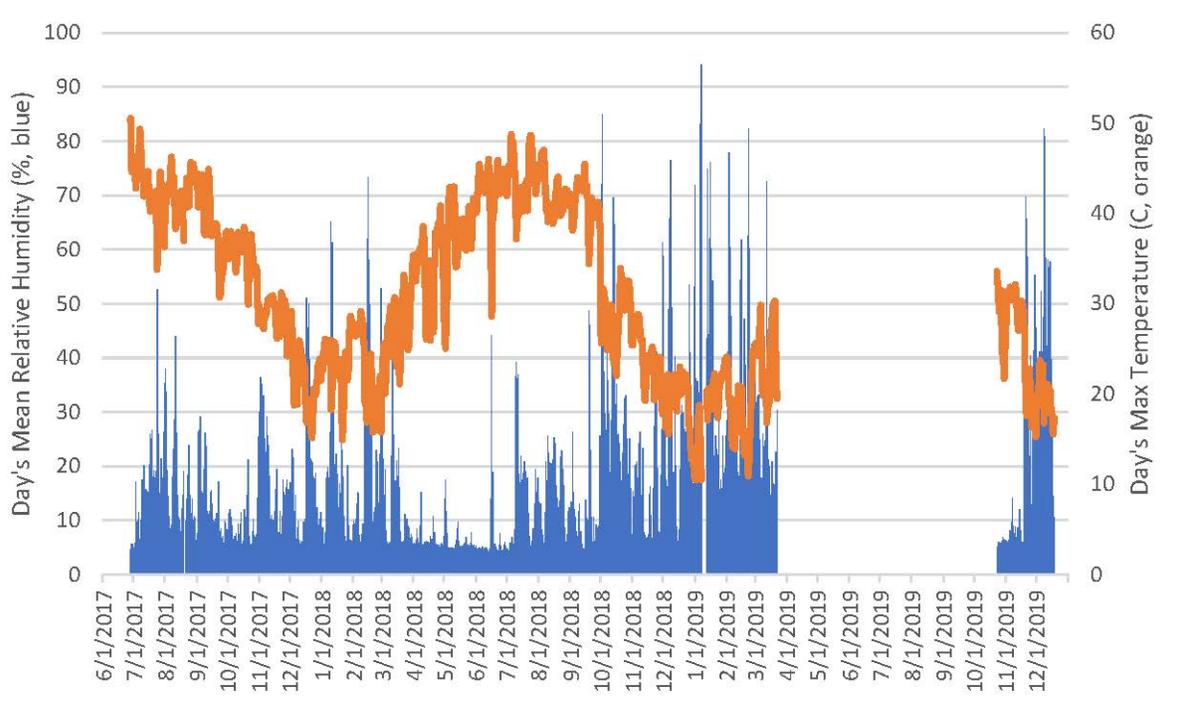
Figure 24. Daily mean relative humidity (blue) and maximum air temperature (orange) (2m AGL) for the upgradient weather station.
