Economic Analysis of Prestressed Concrete Cylinder Pipe Maintenance

Science and Technology Program
Research and Development Office
Final Report No. ST-2021-20059-01

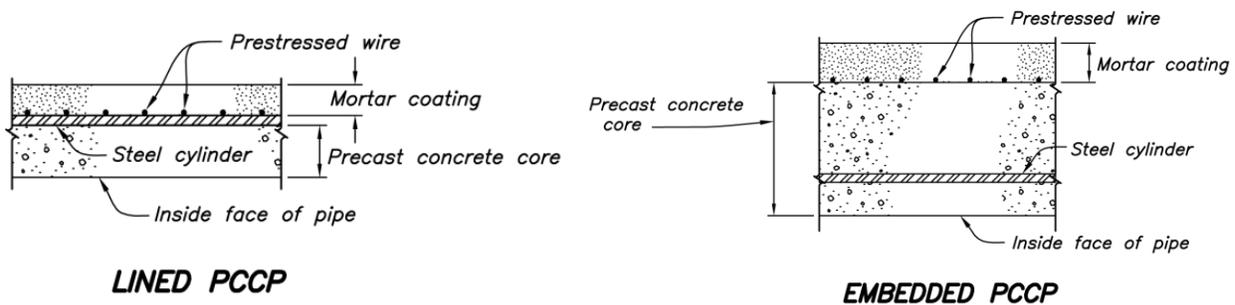
PCCP is a composite pipe consisting of a concrete core helically wrapped by a pre-stressed wire that is covered with a layer of mortar. Frequently, a steel cylinder either lining the concrete core or embedded within it is used as an impenetrable membrane. Both types of PCCP containing cylinders can be seen in Figure 2-1. In either design, the compressive stresses generated by the pre-stressed wires wrapping the concrete core are utilized to offset the internal pressures generated in service. The mortar coating plays a critical role in providing corrosion protection to the wires.

Figure 2-1. PCCP cross sections. Left: Lined cylinder type PCCP, Right: embedded cylinder type PCCP

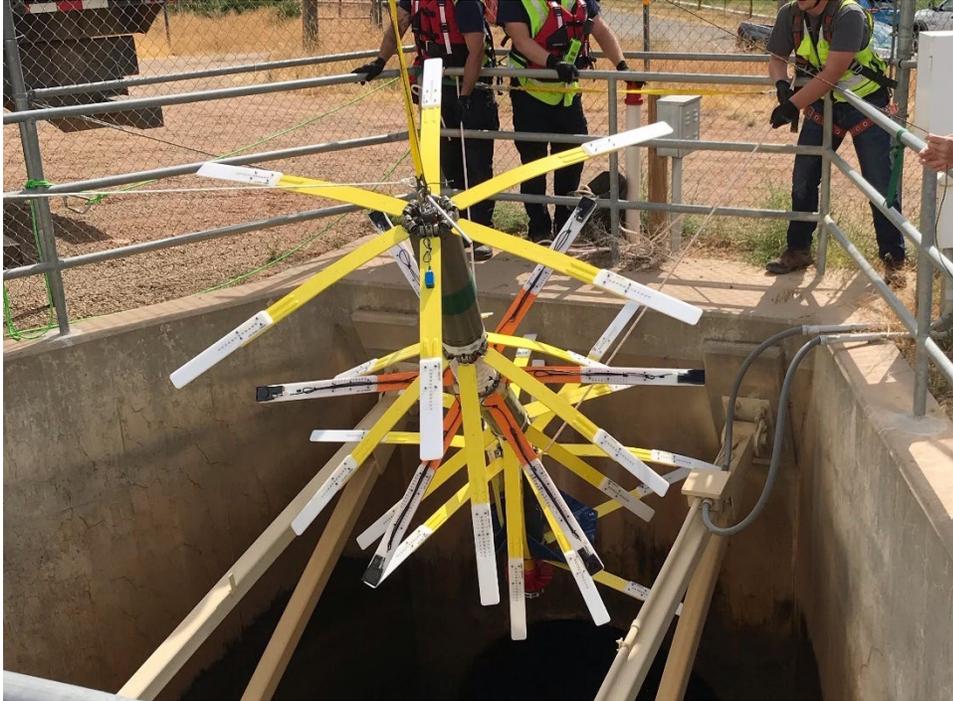
EM inspection is widely used for quantitative condition assessment of PCCP assets. The inspection requires specialized equipment that trained personnel use to identify both the location and number of broken prestressing wires in an asset. For this technique, alternating current is applied to the asset that induces a current in the prestressing wire; that current can then be detected and analyzed to determine the state of distress in the prestressing wires (United States Patent No. US6127823A, 1997). Using this data to inform structural analysis, the overall condition of an asset can be estimated. The inspection can take place either in service using unmanned equipment, as shown in Figure 2-2, or manually, as shown in Figure 2-3.

Figure 2-2. EM inspection tool being lowered into Dolores siphon for unmanned EM inspection

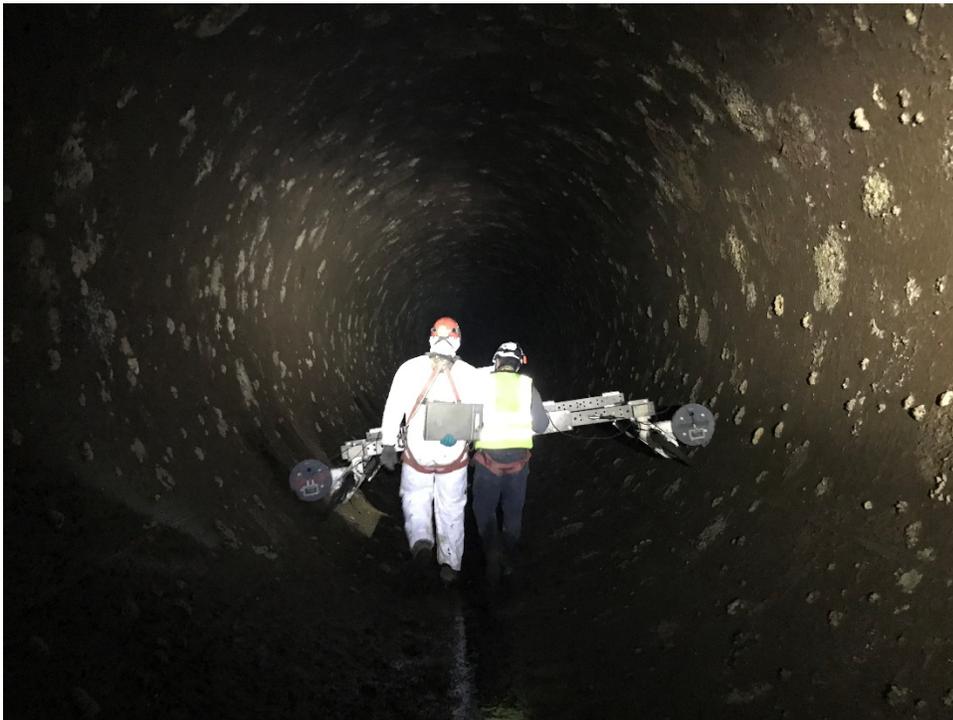
Figure 2-3. EM inspection of Pleasant Valley Discharge Line

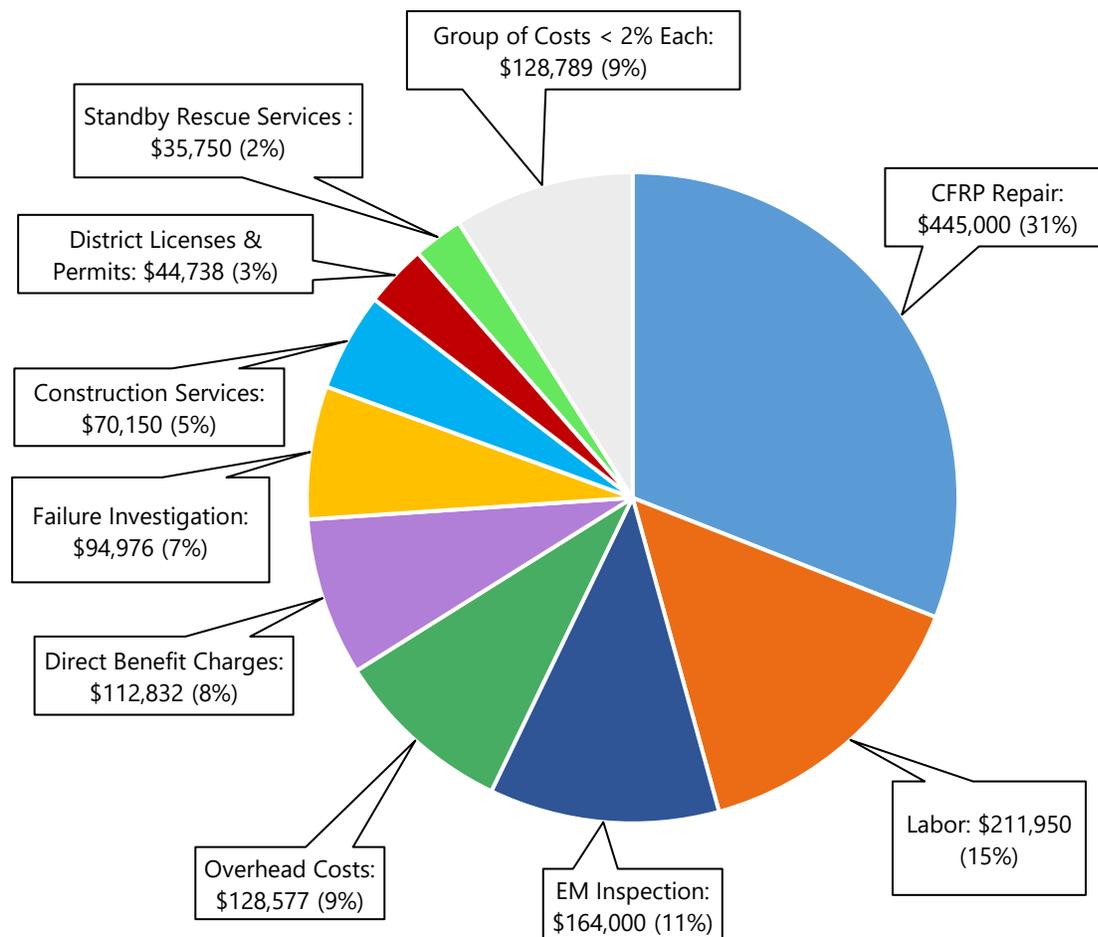
The costs associated with the 2015 failure of the SCC were provided by Valley Water, formerly Santa Clara Valley Water District. The data collected is summarized in Figure 3-1.

Figure 3-1 Summary of direct costs associated with the 2015 SCC failure

In total, the costs directly associated with the failure were \$1.4 million dollars. Nearly one third of the costs associated with the failure were related to use of CFRP for repair of two of the damaged sections, and nearly twenty percent of the costs were attributed to the subsequent investigation and EM inspection.

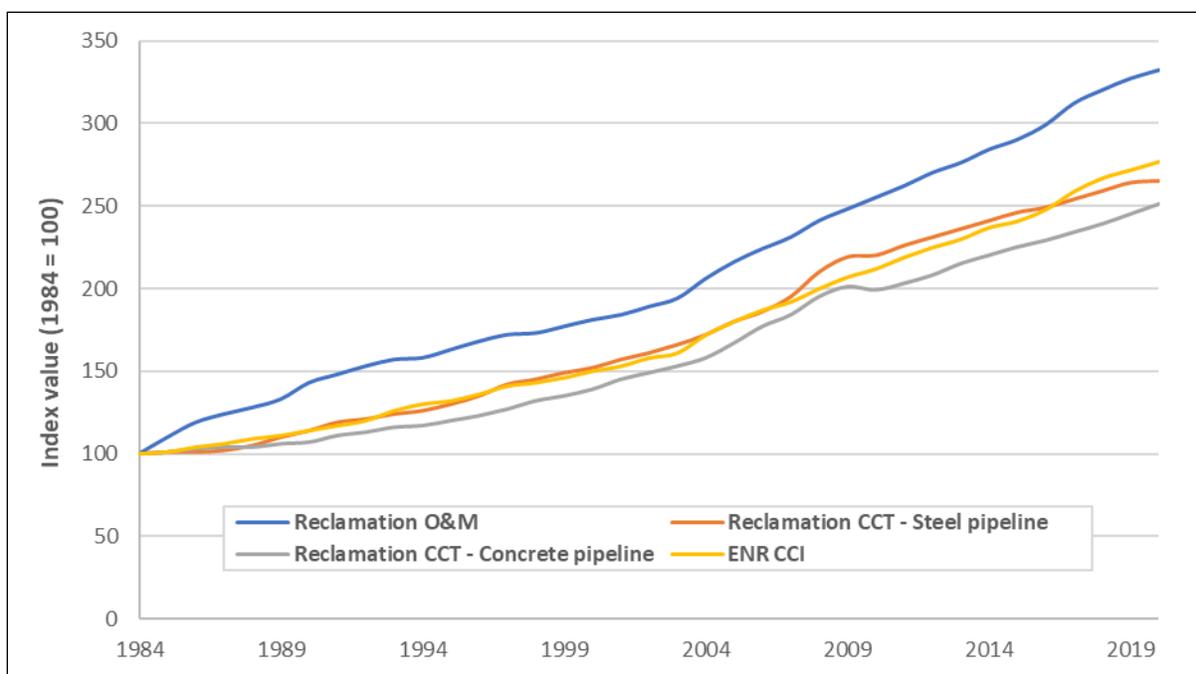
All costs used in this analysis are indexed to 2020\$ using the ENR CCI. This is because the ENR CCI incorporates costs beyond materials prices (as opposed to the Reclamation CCT steel pipelines or concrete pipelines category indices) and is more inclusive of the types of costs that might be incurred for typical construction contracts, such as labor, mobilization, and equipment.

Figure 4-1. Comparison of four pipeline-related cost indices from 1984–2020

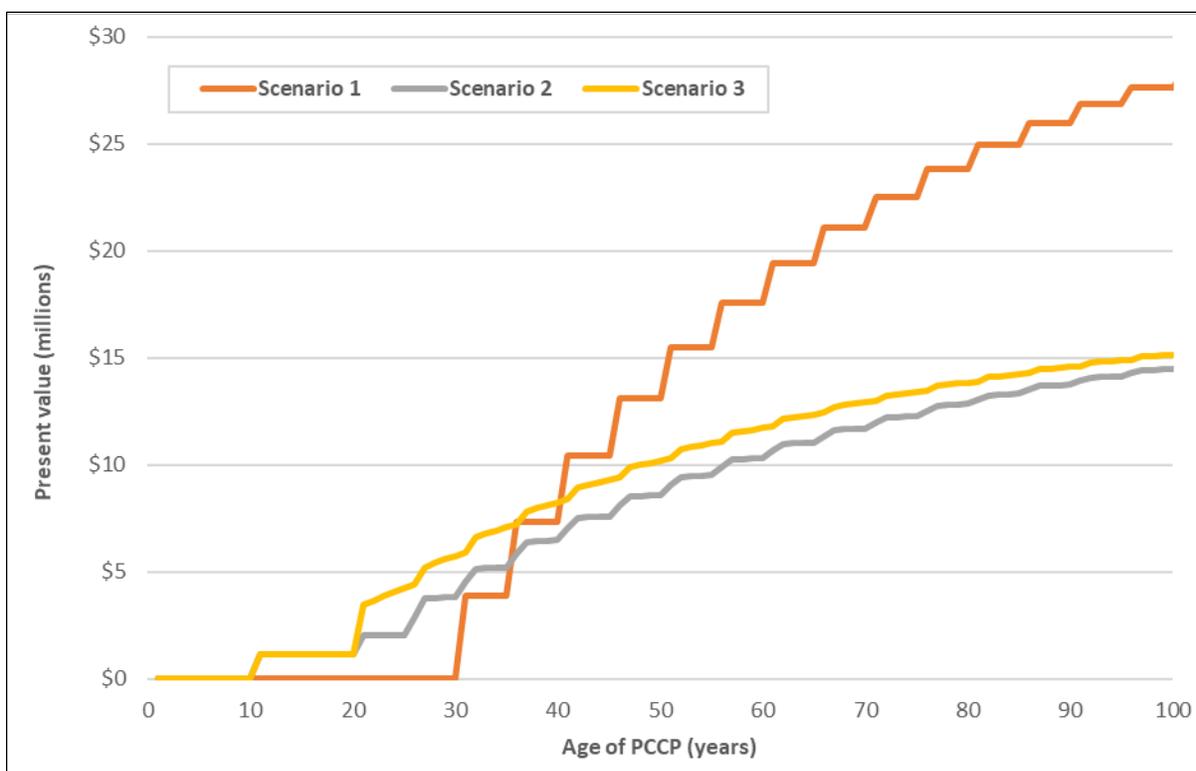
The cumulative present value over the POA for each scenario at the mid-range cost inputs is illustrated graphically in Figure 4-2. Note that Scenario 1 has the least costs through year 30, which is expected as no proactive measures are taken. However, after experiencing only two unexpected failures (in years 35 and 40) the cumulative costs exceed those for scenarios 2 and 3, and Scenario 1 costs continue to significantly outpace those under scenarios 2 and 3 for the duration of the POA. An important takeaway is that avoiding proactive monitoring and repair measures saves on upfront costs but can cost considerably more in the long run, even when adjusting for the time value of money.

Another interesting finding illustrated by Figure 4-2 is that Scenario 3 (wholesale early adoption of AFO) costs more than Scenario 2 (gradual implementation) throughout the duration of the POA. One of the effects of discounting is that large costs incurred relatively early in the POA disproportionately impact the present value compared to those incurred further into the future. The installation of 21 miles of AFO in year 20 under Scenario 3 therefore outweighs the impact of higher periodic costs under Scenario 2 for EM inspections and higher unit costs of short stretches of AFO installs, as they are spread over the POA rather than incurred as a lump sum.

Figure 4-2. Cumulative cost under the three scenarios over the POA using mid-range cost inputs

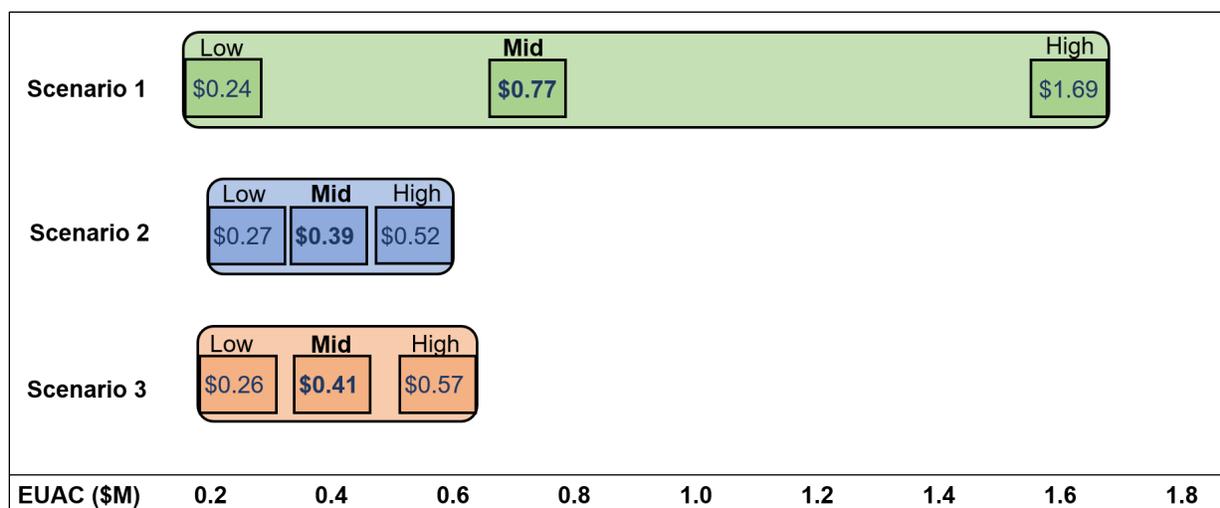
Figure 4-3. Comparison of EUAC across case study scenarios using low, mid, and high range cost inputs
