# Laboratory Comparison of Polysiloxane and Vinyl Coatings and Polysiloxane Field Inspection

Science and Technology Program  
Research and Development Office  
Final Report No. ST-2021-19227-01  
Technical Memorandum No. 8540-2021-55

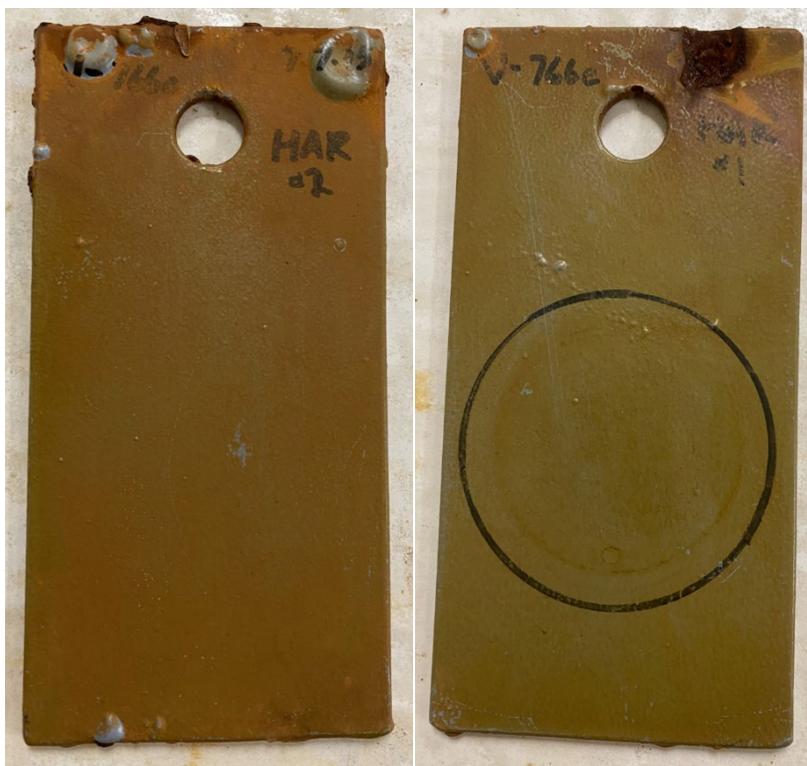
Figure 8. Vinyl System 4 after six years on immersion testing. Large blisters have formed around edges and small blisters formed near EIS test cell.

Close visual inspection of immersion panels for both vinyl System 4 and vinyl System 5-E-Z indicated that defects formed on the surface after six years in immersion testing. Vinyl System 5-E-Z had formed a textured surface, as shown in Figure 7. This could be caused by the formation of zinc oxide which is less dense than the zinc pigments in the coatings. As the galvanic reaction takes place, the zinc is converted into zinc oxide, expanding, causing the textured surface of the coating. At this time, the cause of the textured surface is not determined. A few large diameter blisters had formed on two of the vinyl System 4 panels shown in Figure 8. These panels can be compared to two polysiloxane systems, 2-E1-PS1 and 1-E1-PS1, which have been in immersion testing for five years. Both had mild discoloration from staining and system 2-E1-PS1 had one blister form at the bottom of the panel as shown in Figure 9. System 1-E1-PS1 did not have visible defects.

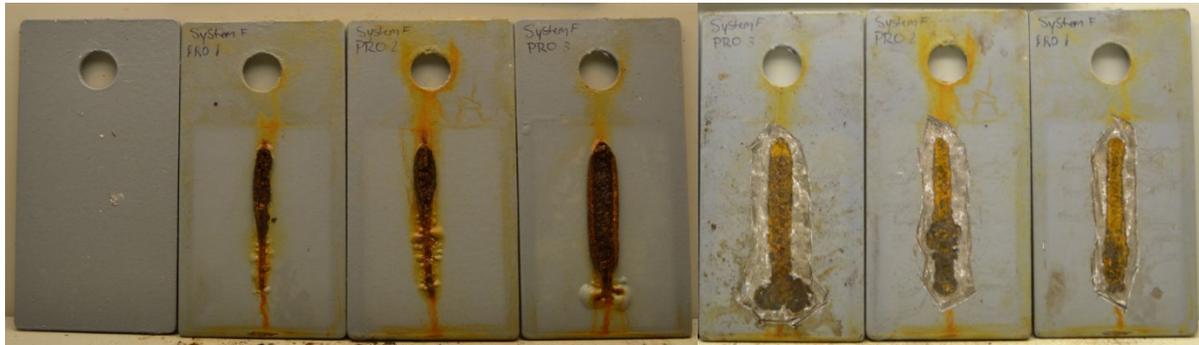
Figure 12. PRO cyclic test of vinyl system 5-E-Z; (left) before scraping (right) after scraping away coating.

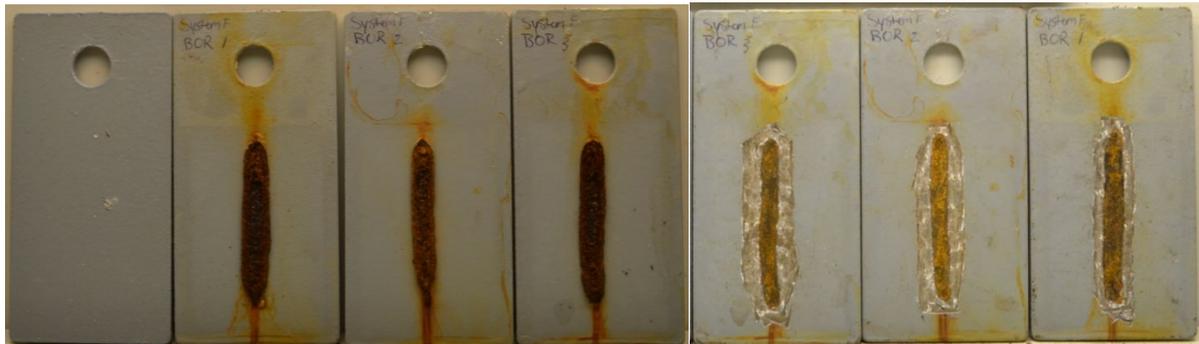
Figure 13. BOR cyclic test of vinyl system 5-E-Z; (left) before scraping (right) after scraping away coating.

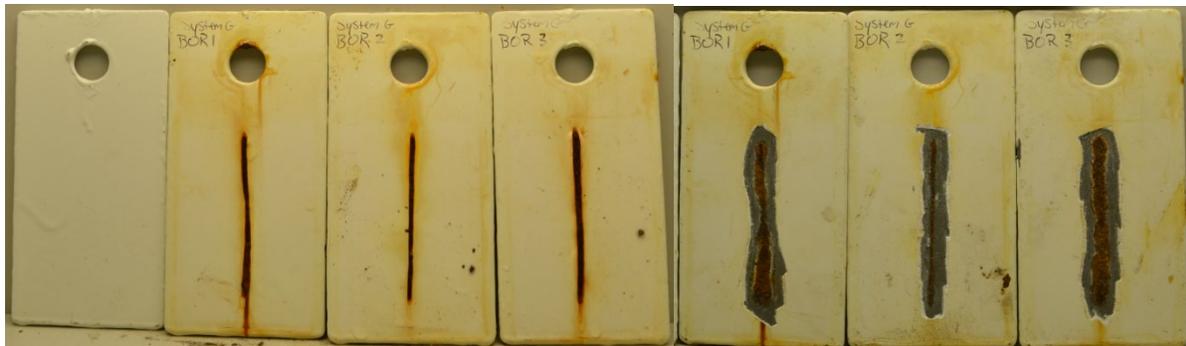
Figure 14. BOR cyclic test of 2-Z1-PS2; (left) before scraping (right) after scraping away coating.

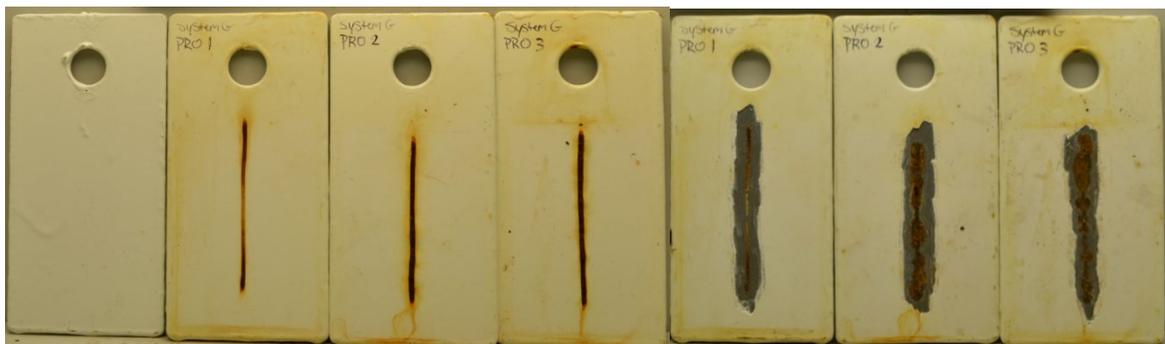
Figure 15. PRO cyclic test of 2-Z1-PS2; (left) before scraping (right) after scraping away coating.

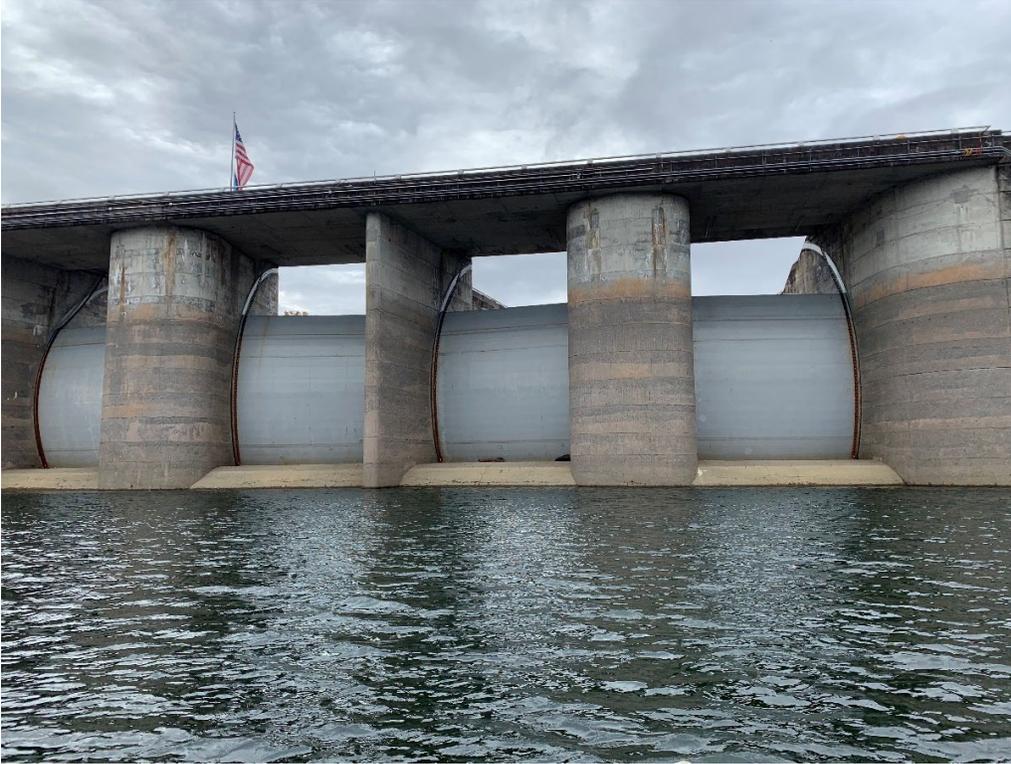
Figure 31: Upstream side of the four radial gates at Fontana Dam.

In November 2019, Reclamation researchers inspected the three-to-four-year-old epoxy polysiloxane coating on TVA's Fontana Dam, NC, spillway radial gates. Between 2015 and 2016, all four radial gates were coated with a three-coat system of an epoxy primer, epoxy with glass flake intermediate coat, and an epoxy polysiloxane topcoat. The coating system utilized by TVA was duplicated for laboratory testing and is system 1-E2-PS1 in this report. During the field inspection, Reclamation staff performed a visual inspection of the gates, shown in Figure 31, and field EIS testing.

The visual inspection of the gates showed that the coating was in overall good condition. All impedance magnitude values recorded were above  $1 \times 10^9$  ohms at 0.1 Hz, indicating that the three-part coating system is providing excellent corrosion protection in the areas tested. However, microcracking was observed in areas where the coatings were applied too thick, and drips, runs, and sags were also visible as shown in Figure 32 through Figure 34. Microcracking was also observed on the seal clamp bars. These flaws were likely from coating application errors such as solvent entrapment from applying the coating too thick. As the solvent evaporates in a cured coating, increased internal stresses can cause microcracking. Additionally, areas of corrosion caused by abrasion from the wire ropes were also noted. Details can be found in Reclamation Technical Memorandum 8540-2020-01. The gates at Fontana Dam show that in the short term polysiloxanes have a successful performance in a field service environment. Routine inspections to monitor the coating's performance should be conducted and will provide useful information on the coating's service life.

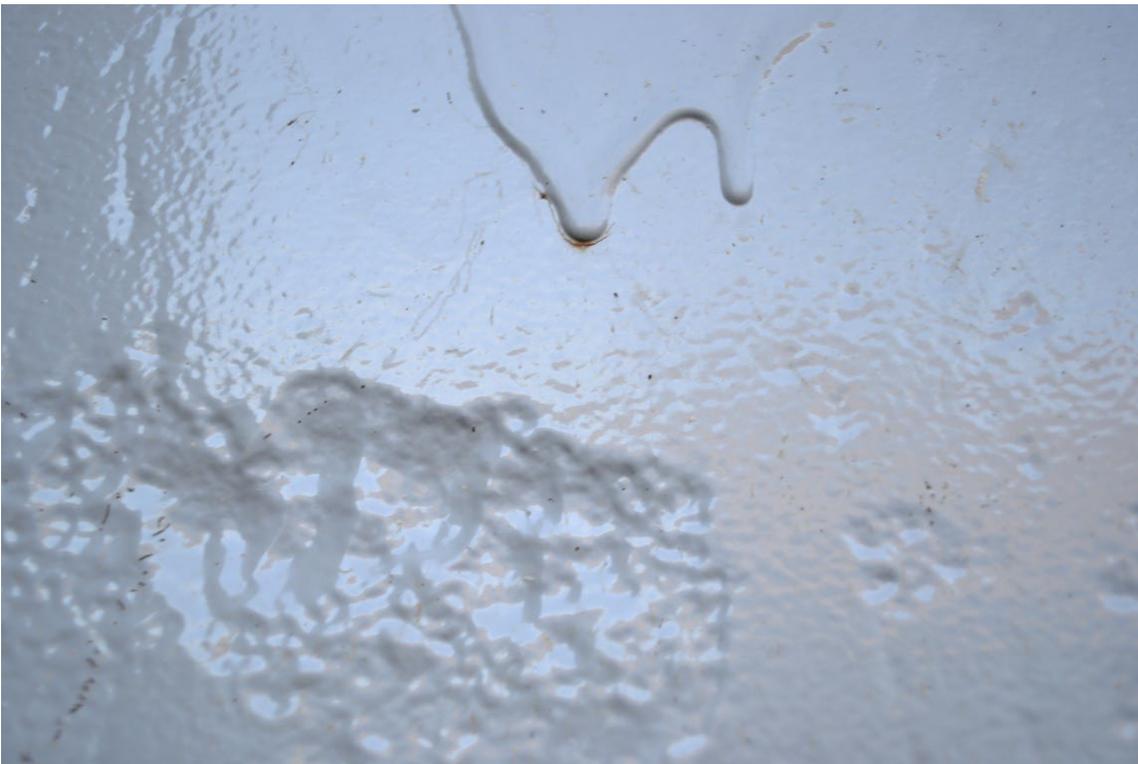
Figure 32: Large drip from application. Pitted area of steel with no defects to the coating or corrosion observed.

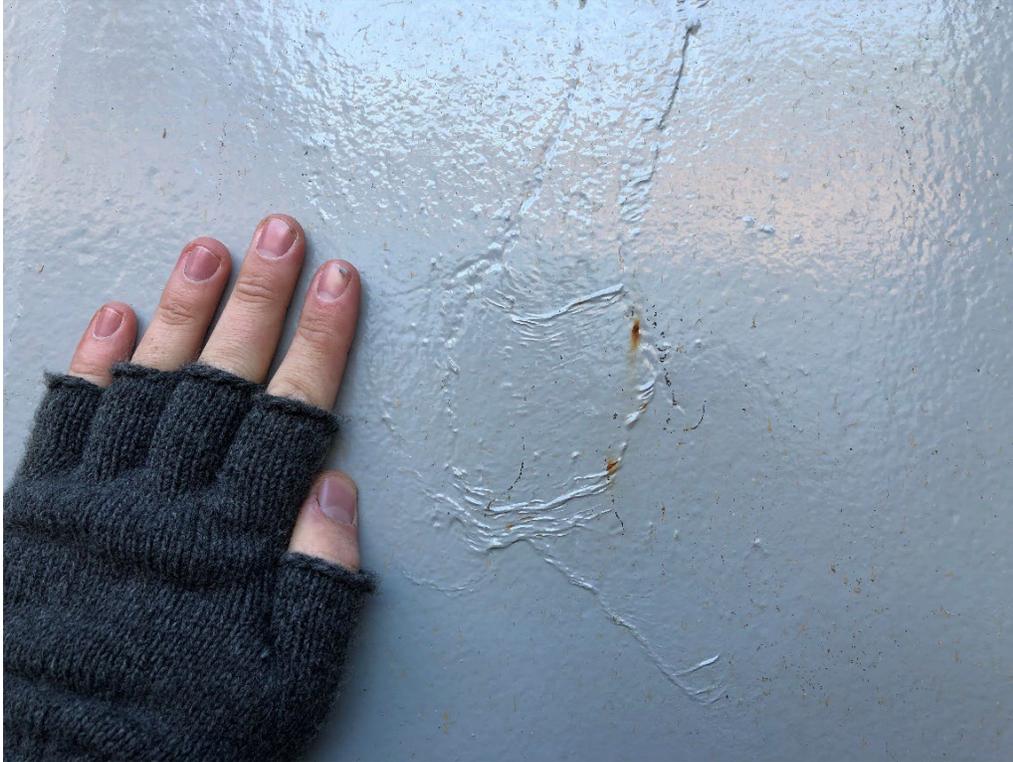
Figure 33: Sag of coating cause by excess buildup of coating during application. Cracking and corrosion have occurred.

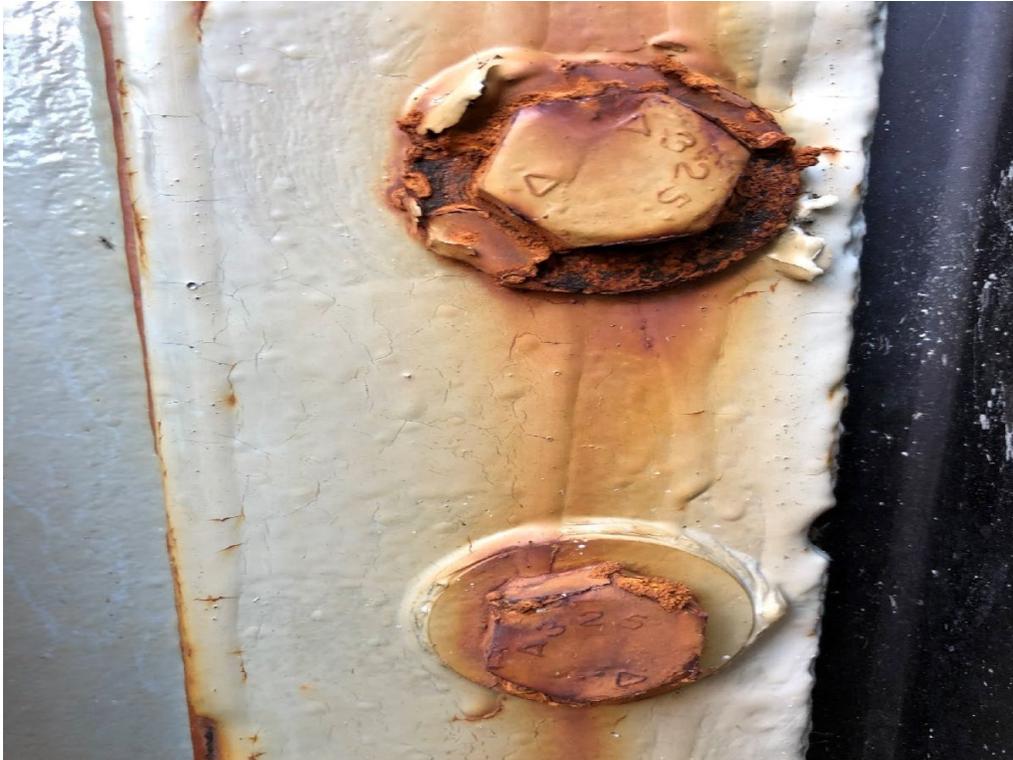
Figure 34: Micro cracking in coating, caused by excess film build up, on seal-clamp bars. Coating on bolts has become damaged and corrosion is present
