Technical Memorandum No. MERL-2011-41

Investigation of Overcoating Coal Tar Enamel with Foul Release Coatings

Materials Engineering and Research Laboratory,
Technical Service Center

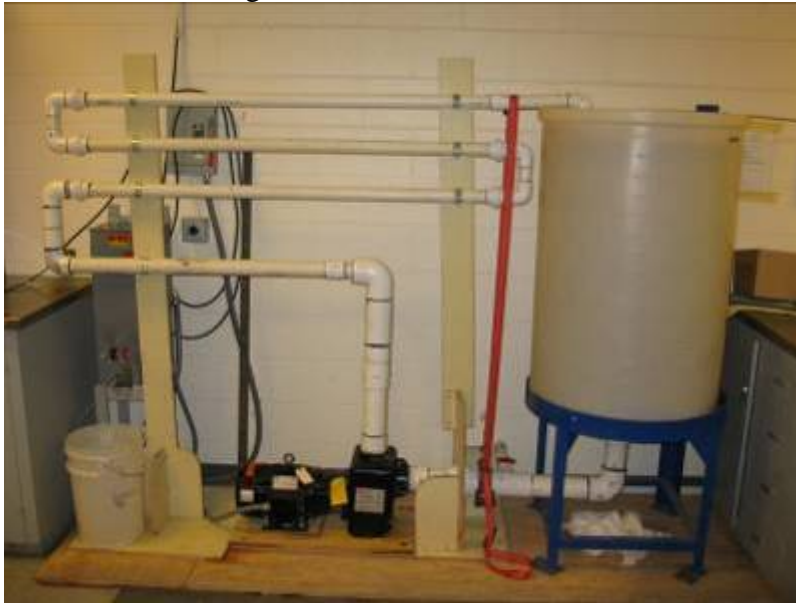
This setup simulates flow rates seen in penstocks and outlet works throughout Reclamation's infrastructure. Due to the limited laboratory space, the set up had a number of bends as seen in Figure 1.

Figure 1: High Flow Water Test set up. Samples are placed inside the PVC pipe.

The test apparatus utilized a 7.5 HP pump operating at 3450 RPM with 3 inch PVC piping on the inlet and discharge sides. The PVC is reduced to 1.5 inch diameter where the samples are placed. Water is discharged into a 100 gallon tank and recirculated from there. The piping is fitted with coupling to allow access to individual sections. Figure 2 and Figure 3 show how the samples are arranged inside the piping. For each system, two coal tar coated panels were overcoated such that some of the underlying coat was exposed to the flowing water. A third sample was coated with the just the foul release system (primer, tie coat, and top coat) direct to steel (no coal tar enamel).

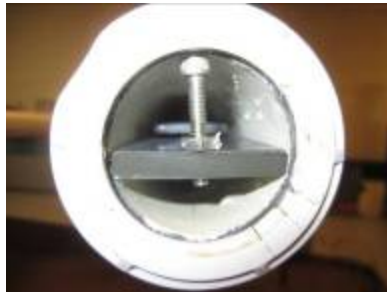
Figure 3: Cross sectional view of sample placement inside PVC piping.

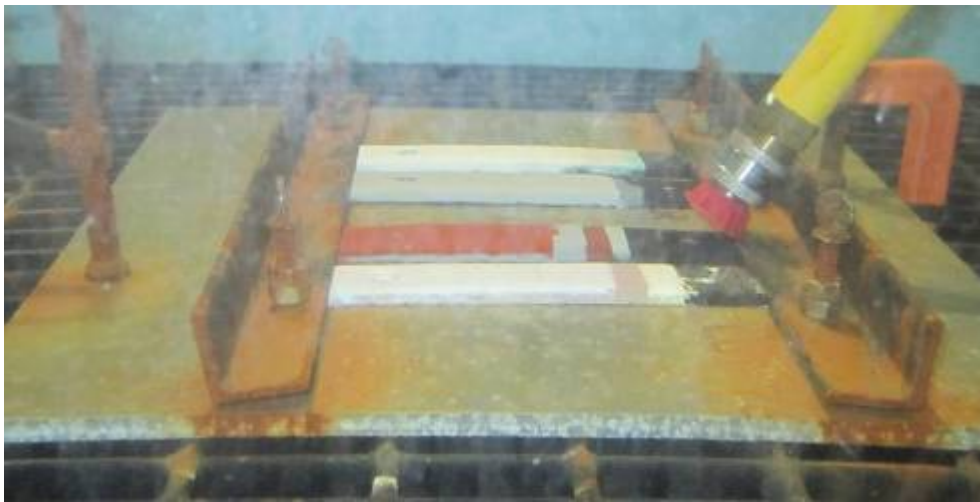
Samples in the waterjetting tank were fastened down using a jig as shown in Figure 6. The nozzle which was mounted on a traveling base was set to a translational velocity of approximately 0.065 inches per second. The idea was to allow enough time for damage to occur in the sample and also to expose each coating interface to the jet for an equal amount of time.

Figure 6: Waterjetting test samples immediately prior to testing.

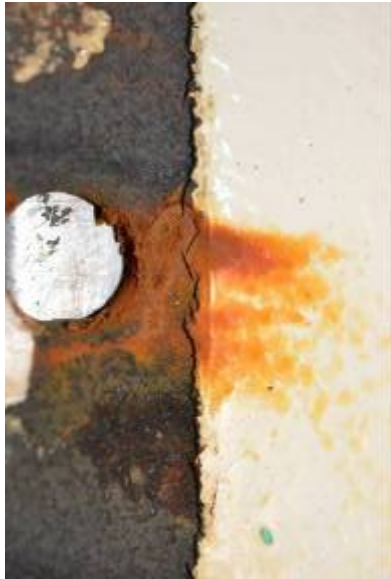
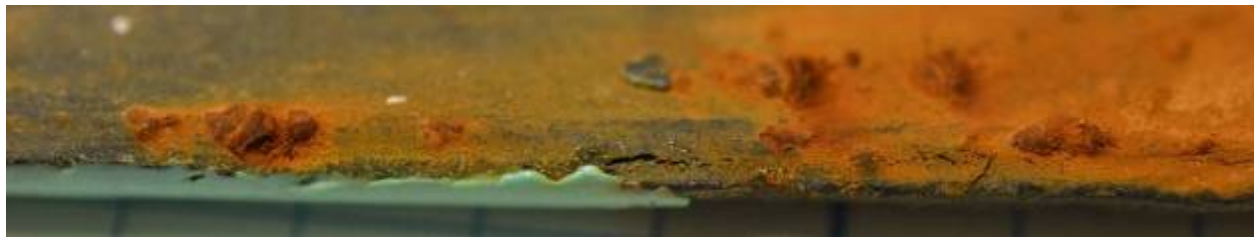
On the striped panels, it was common to observe cracking on the coal tar enamel – primer interface. On panels with only the topcoat exposed, there was sometimes cracking noted on the backside edges along the CTE – primer interface. Figure 8 illustrates the damage that is representative of the immersion samples. Examination of Table 2 shows that for the un-striped samples, the amount of cracking in the DI and HAR samples was similar.

Figure 8: Cracking observed in Harrison immersion test samples after 3048 hrs exposure: (a) At the interface between the coal tar enamel and primer on Fuji smart surface sample (b) Along the plate edge on Fuji smart surface sample (c) Along the plate edge on Intersleek 970 sample.

solution or deionized water. Immersion in either solution resulted in the development of cracks at the border between the coal tar enamel and overcoated portion of the sample. On panels where the coal tar was completely coated, the cracks developed along the panel edge whereas on the striped panels, the cracks were found on the front of the panel at the primer – CTE interface. In contrast, the overcoated refrigerated control samples which were not exposed to an immersion environment experienced no cracking. The cracks are likely a result of residual stresses that are developed within the coating system due to a differential in expansion / contraction following water uptake. CTE is a relatively soft material and is unable to support large tensile stresses which causes cracking to occur.

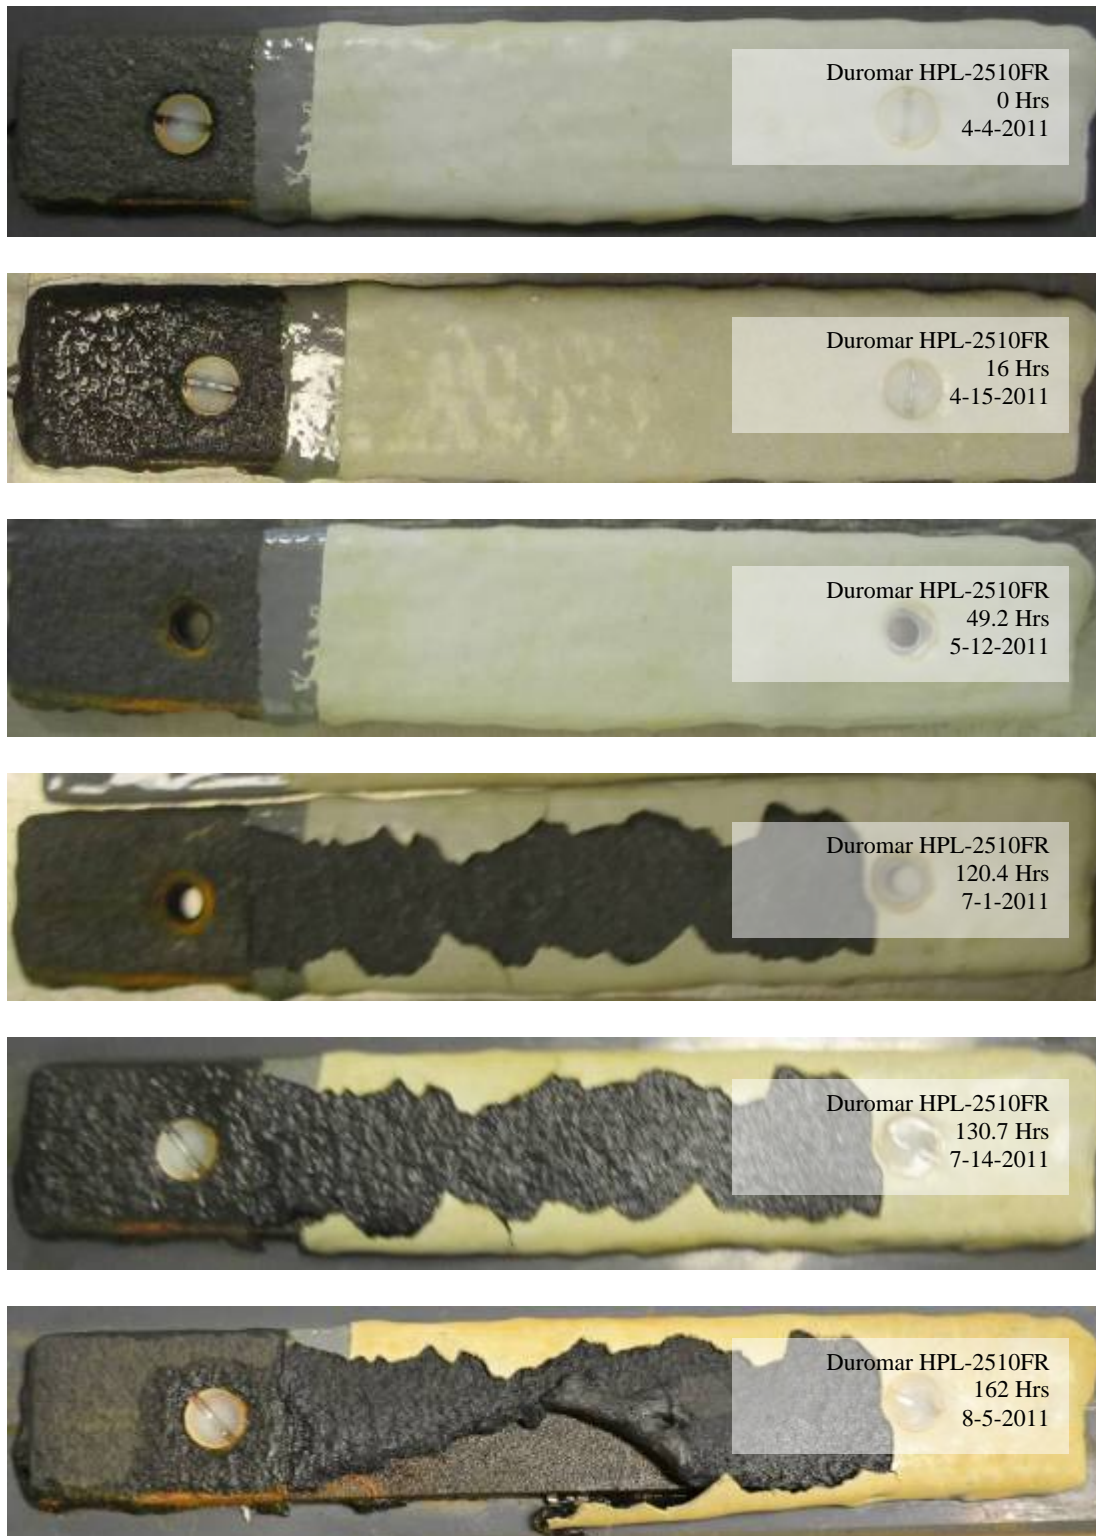
3: Duromar HPL-2510FR	A	Complete removal of coating down to bare metal underneath overcoat ~ 10%. CTE left intact and overcoat removed ~65%. Minor cracking at CTE – primer interface and on edges.
	B	Coating is fully intact. Minor-moderate cracking at CTE – primer interface and on edges
	Control	No Damage

Figure 11: Photo-documentation of High Flow Immersion Test: Duromar HPL-2510FR, sample A.

Detailed photographs show the damage progression from start to finish for each system (Figure 9 - Figure 12). All of the samples had experienced significant damage by 130 hours of testing. Interestingly, the Intersleek 970 and Duromar HPL-2510FR systems which had developed cracking to a lesser extent than the other two systems each had experienced failures by 120 hours (10 hours sooner).

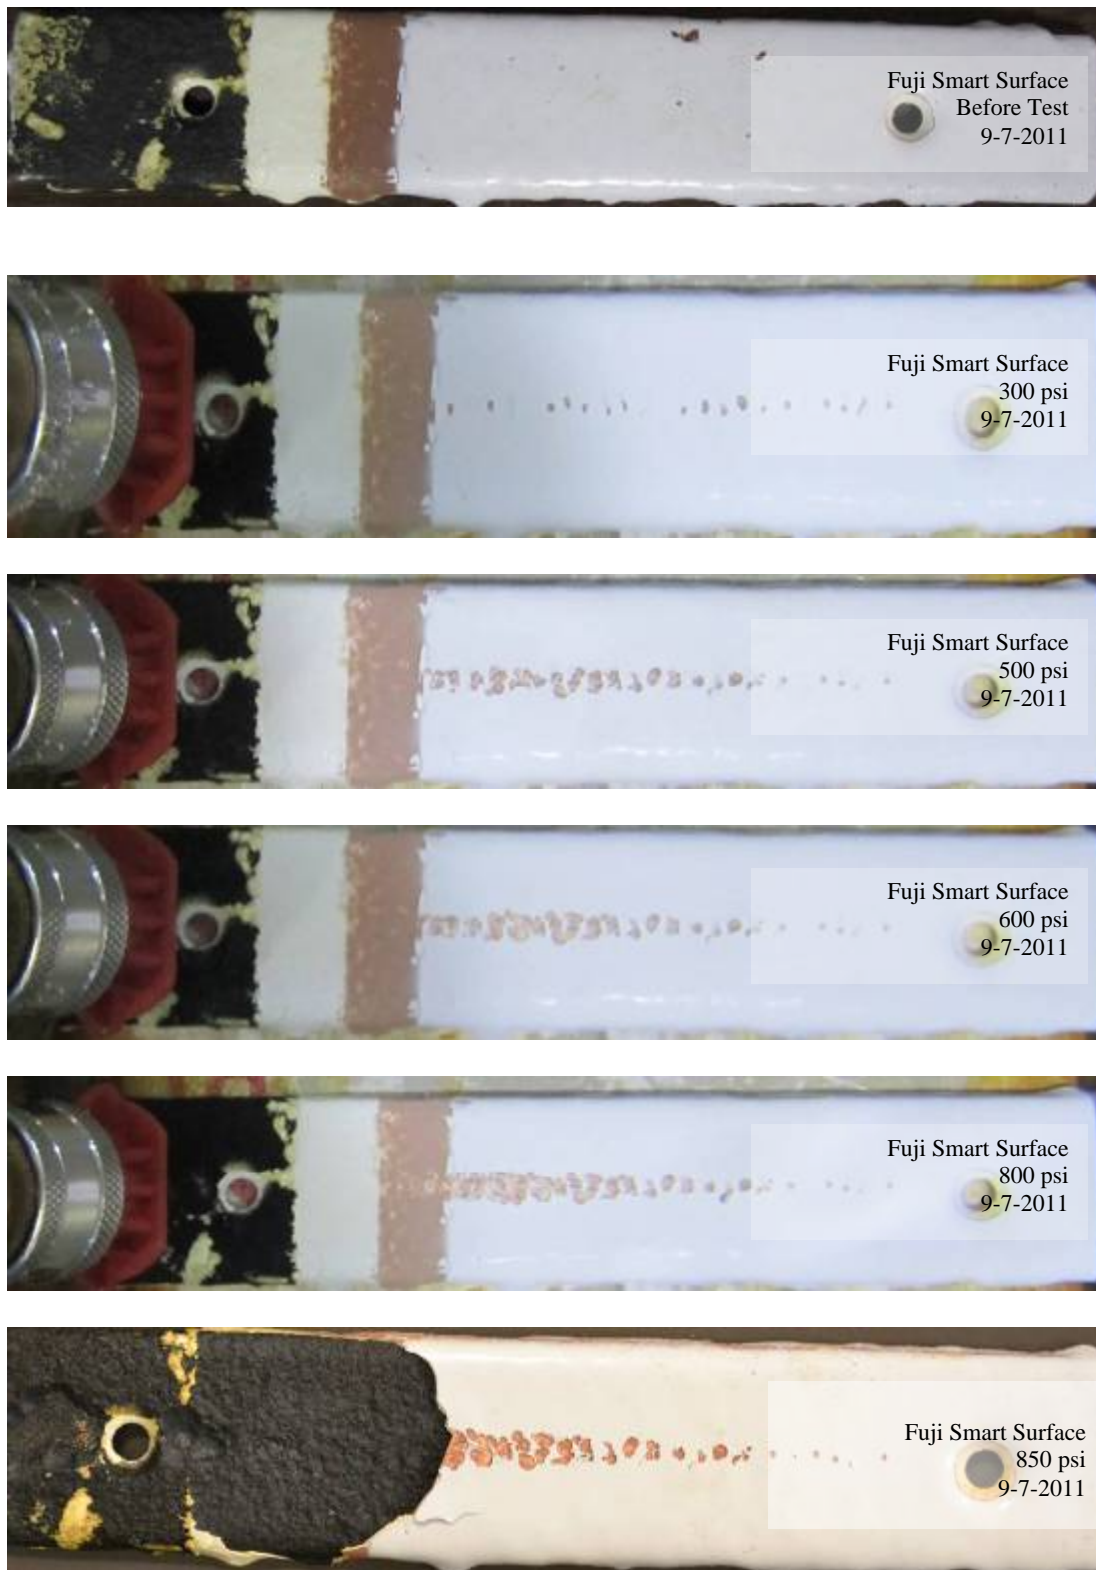
Results for the waterjet test are shown in Table 4. The waterjet test was able to cause failure in all of the coating systems but there was a difference in the amount of pump pressure required to cause damage. The damage at various pressures is shown in Figure 13 through Figure 16. The Fuji topcoat was the most easily damaged system requiring only 300 psi to cause pitting in the topcoat. The two other silicone systems experienced damage at 400 psi. All of the silicone systems failed at much lower pressures than their respective primers. The Euronavy primer in the Fuji system sustained 800 psi with no damage (850 psi caused a complete failure). Enviroline (Intersleek 970 system) sustained 700 psi and Amercoat 240 (Sigmaglide 890) sustained 600 psi. The best system overall was the Duromar HPL-2510FR which sustained 800 psi with no damage to the topcoat or primer. 850 psi cause a complete disbondment between the primer and coal tar enamel but the size of the failure was relatively small compared to the other systems.

Figure 13: Photo-documentation of Waterjet Test: Fuji Smart Surface

While the immersion tests were both long term tests that were conducted over a period of several months, the waterjetting test requires 30-45 minutes. In the waterjet test, the softer silicone products failed at lower impact pressures than their respective primers. The Duromar fared the best in the waterjet test owing to its durable, abrasion resistant topcoat and the strong adhesion of the primer system. The Enviroliner primer also performed well. At 850 psi, the CTE also experienced severe damage which undermined the overcoat primer.

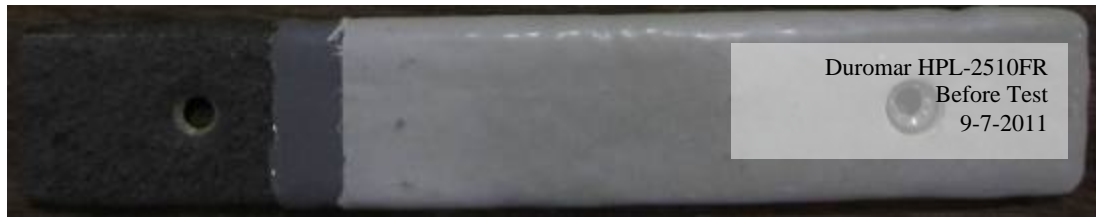
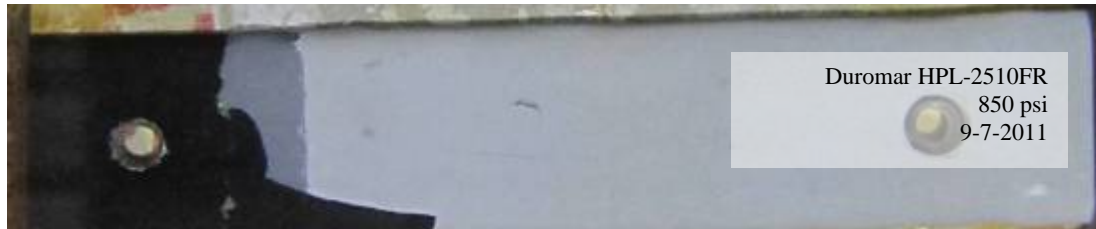
Figure 15: Photo-documentation of Waterjet Test: Duromar HPL-2510FR

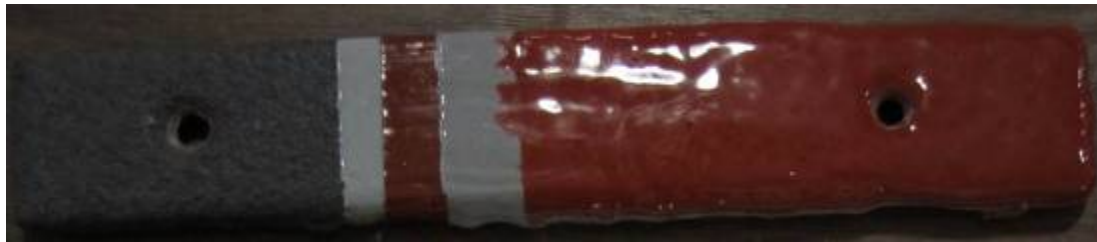
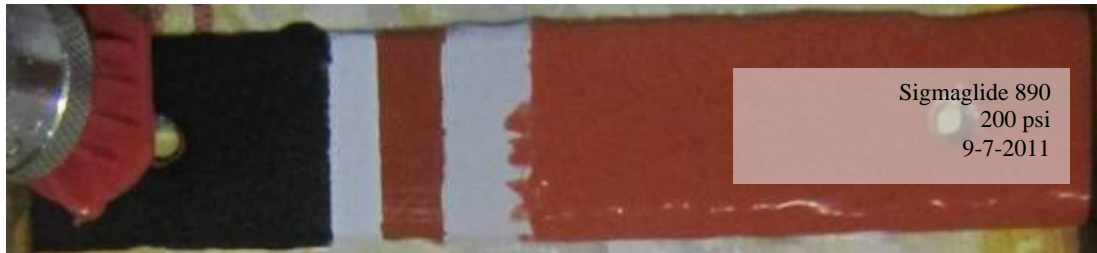
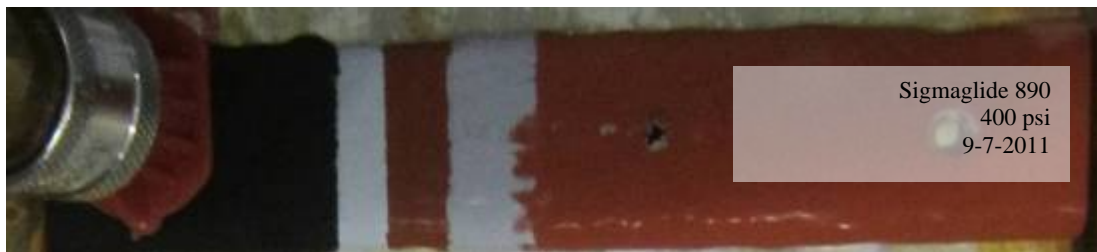
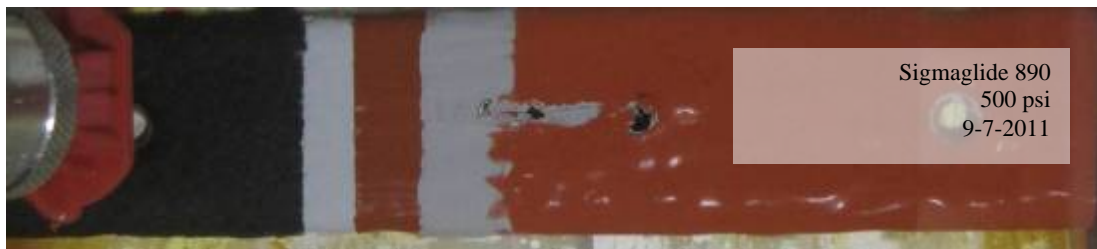
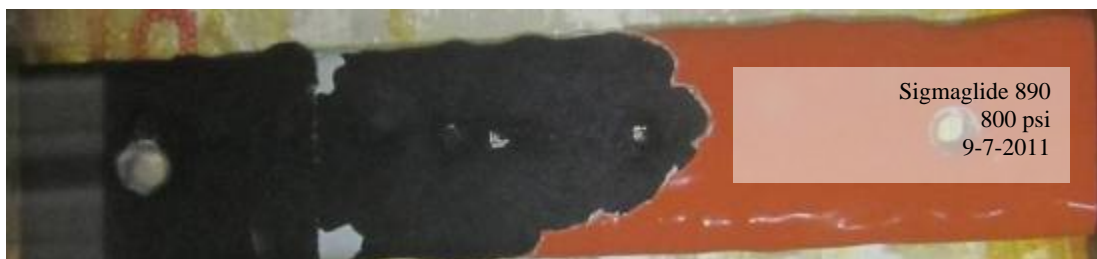
Figure 16: Photo-documentation of Waterjet Test: Sigmaglide 890

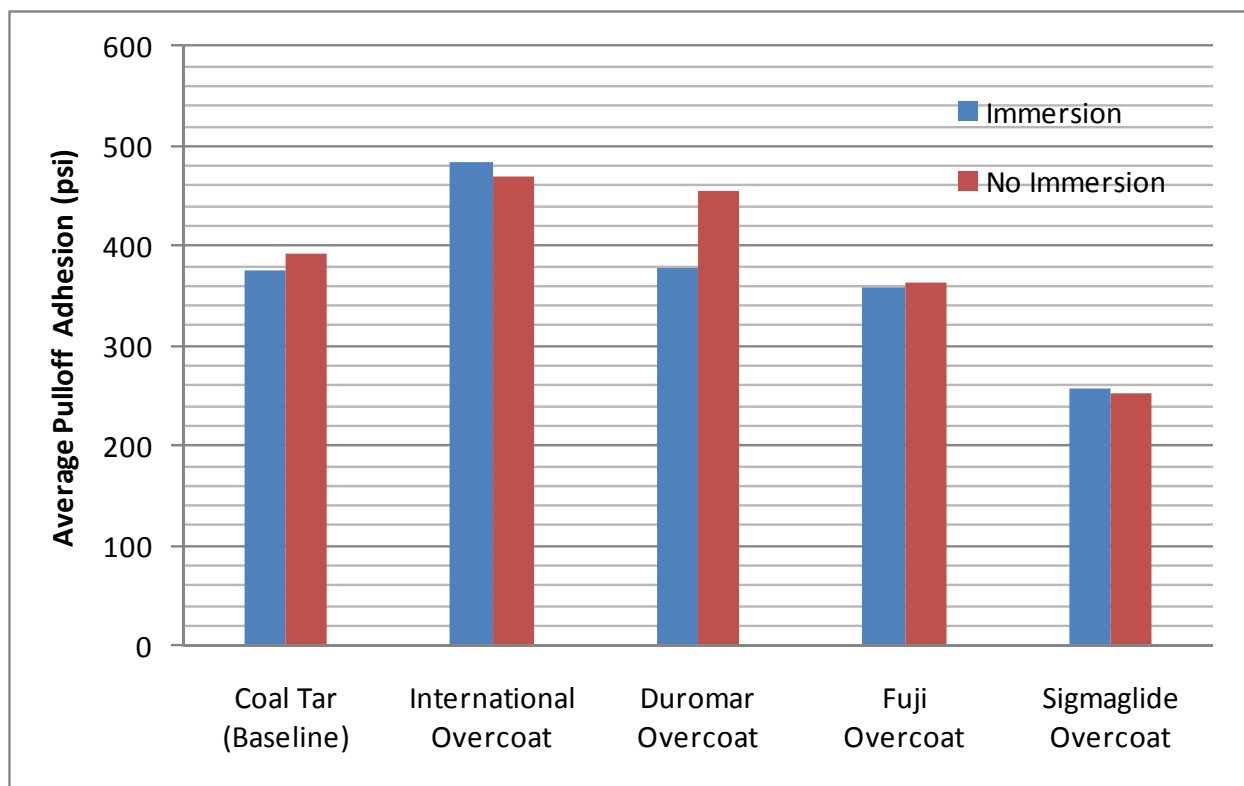
Figure 17: Average pulloff adhesion strength

The adhesion test results are given in Table 5 and summarized in Figure 17. Note that in all of the systems, the test failed within the coal tar enamel. In most systems, immersion did not appear to lower the coal tar strength significantly. The results show no significant decrease in adhesion for the two coating systems that used a 100% solids epoxy primer and actually may be slightly higher. The solvent borne epoxy primers used with Sigmaglride and Fuji caused slight decreases in adhesion due to the solvents dissolving the coal tar enamel. The effect was greater in the Sigmaglride sample which contained a higher amount of solvent (13% vs 3%). There was no significant change between the exposed samples and the controls that were in the refrigerator for the entire testing period.

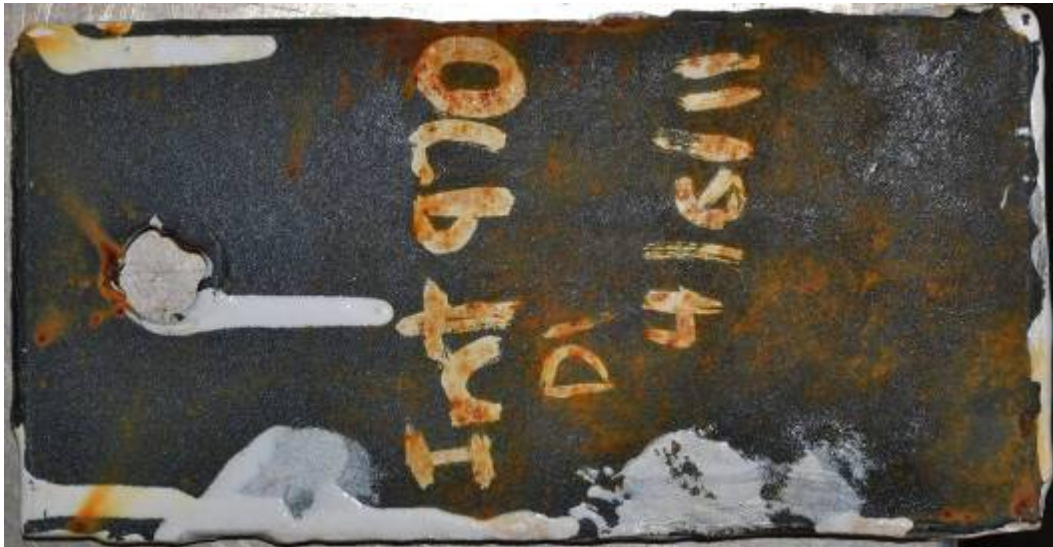
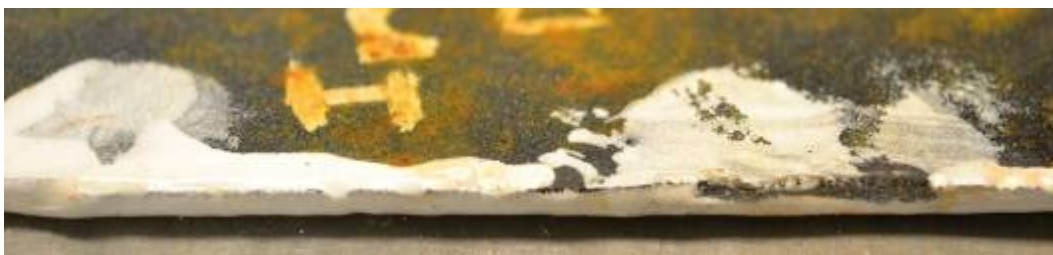
International Intersleek 970 (no cracking)
