Concrete Repair Engineering Experimental Program (CREEP)

Development of Test Methods to Evaluate Cracking Tendency of Repair Materials—Field Study Phase II

MERL Research Report 2009-1

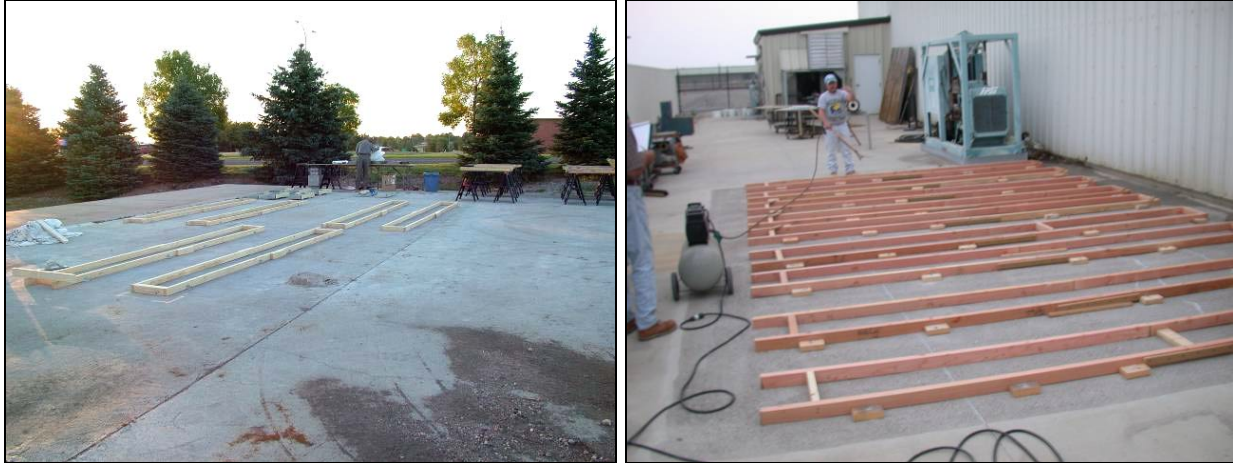
Figure 1.—Reclamation (left) and U.S. Navy (right) experimental sites.

compared to material behavior in the experimental repairs. Figure 1 shows the two sites for the repair slabs and the assembled formwork for repairs.

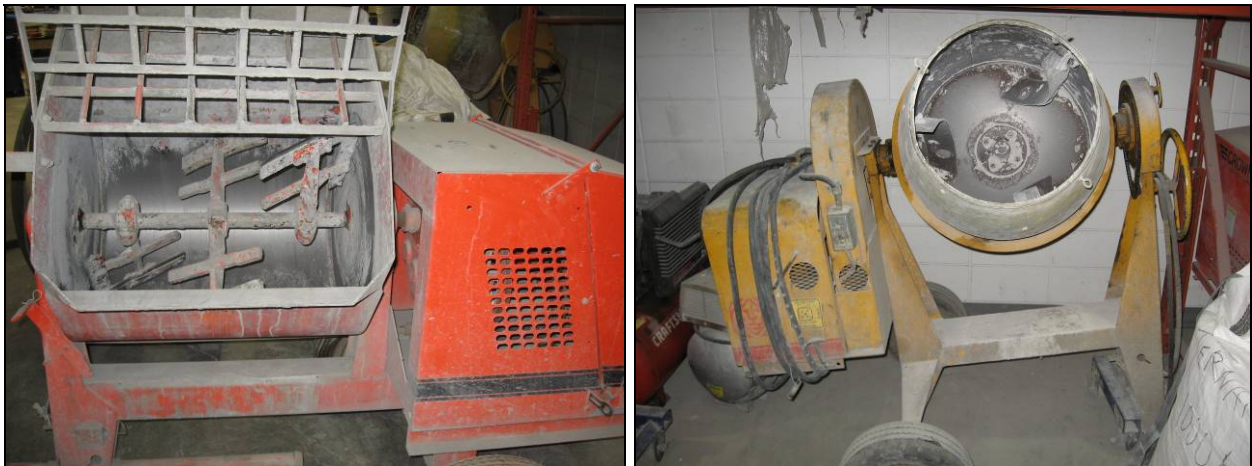
Figure 2.—Paddle type mixer (left) and rotating drum mixer (right).

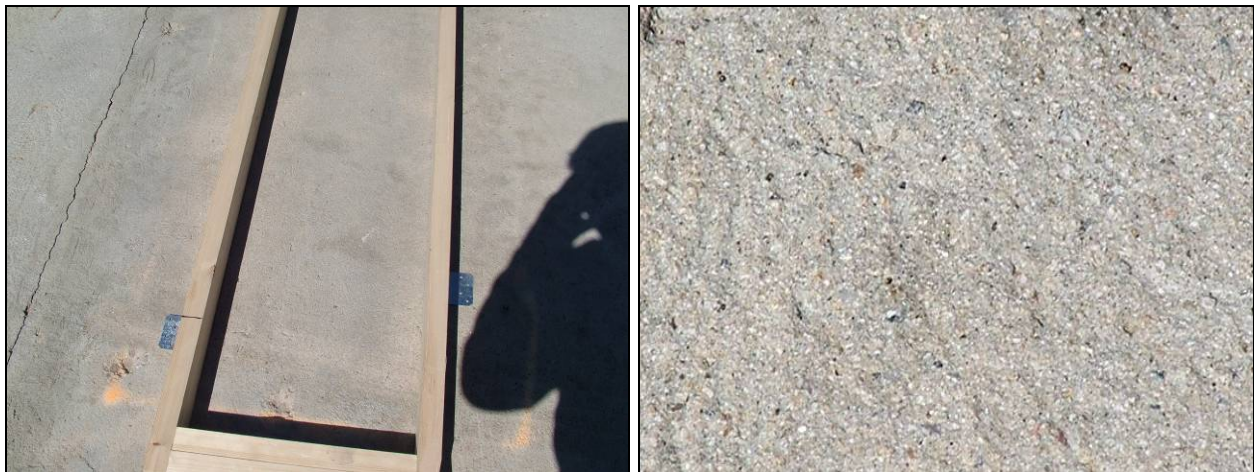
Figure 4.—Surface preparation at Reclamation.

The surface preparation for repairs at Reclamation was accomplished using shotblasting. It allowed removing the thin layer of paste at the existing concrete surface, lightly exposing the coarse aggregate (Figure 4).

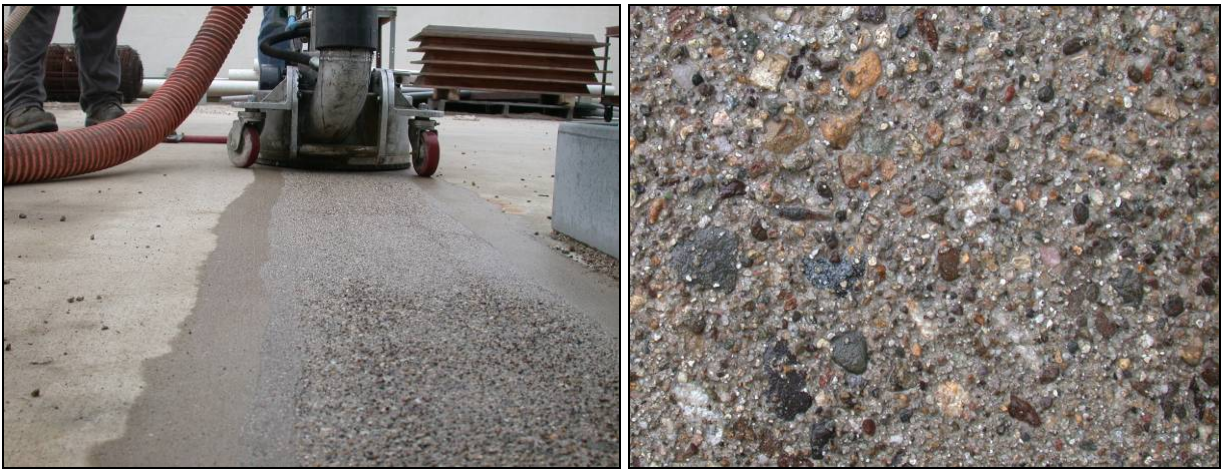
Figure 5.—Surface preparation at the U.S. Navy.

At the U.S. Navy Facilities at Port Hueneme, hydrojetting was used, which exposed the aggregate to a larger extent than at the Reclamation facility (Figure 5).

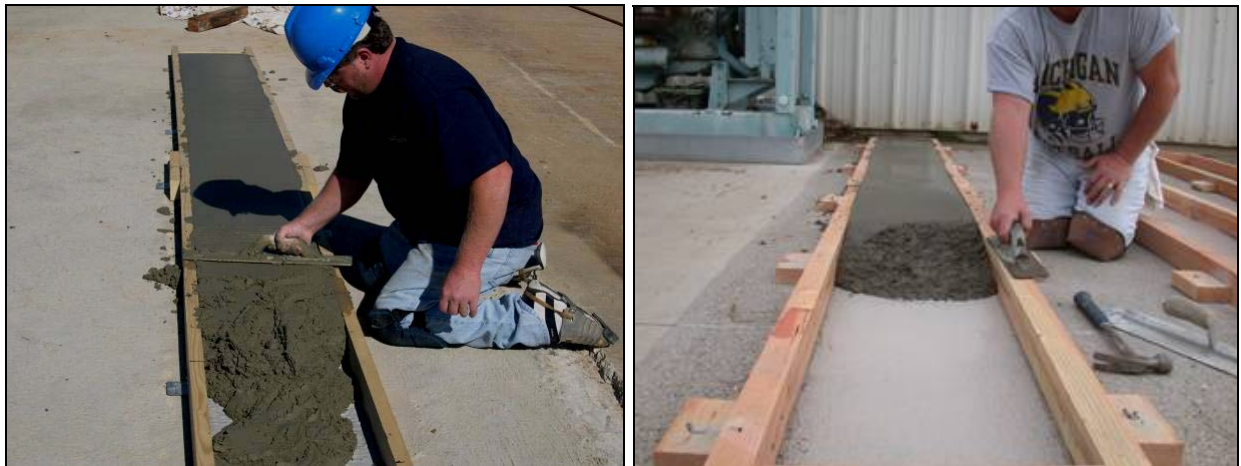
Figure 6.—Placement of the repair material at Reclamation (left) and U.S. Navy (right).

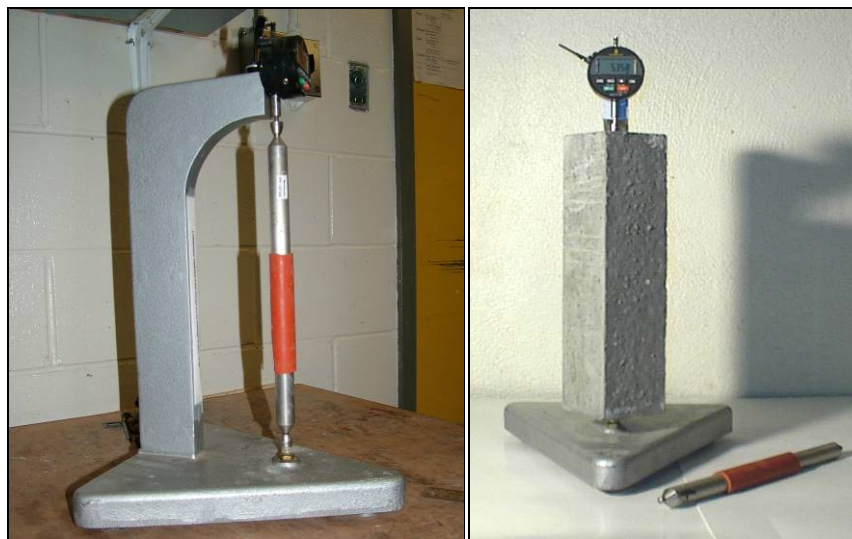
Figure 9.—Standard comparator for measuring free drying shrinkage

strain (Laval University).

The free shrinkage tests were carried out at Reclamation and Laval University in accordance with ASTM C157, *Standard test method for length change of hardened hydraulic-cement mortar or concrete* (modified). The test procedure was modified in accordance with the REMR Report (USACE March 1999). For all repair mixtures, 75- by 75- by 285-mm (3- by 3- by 11¼-in) specimens were used. Two types of comparator were used to obtain the readings. The first is described by ASTM C157 (Figure 9) and was used at Laval University. The

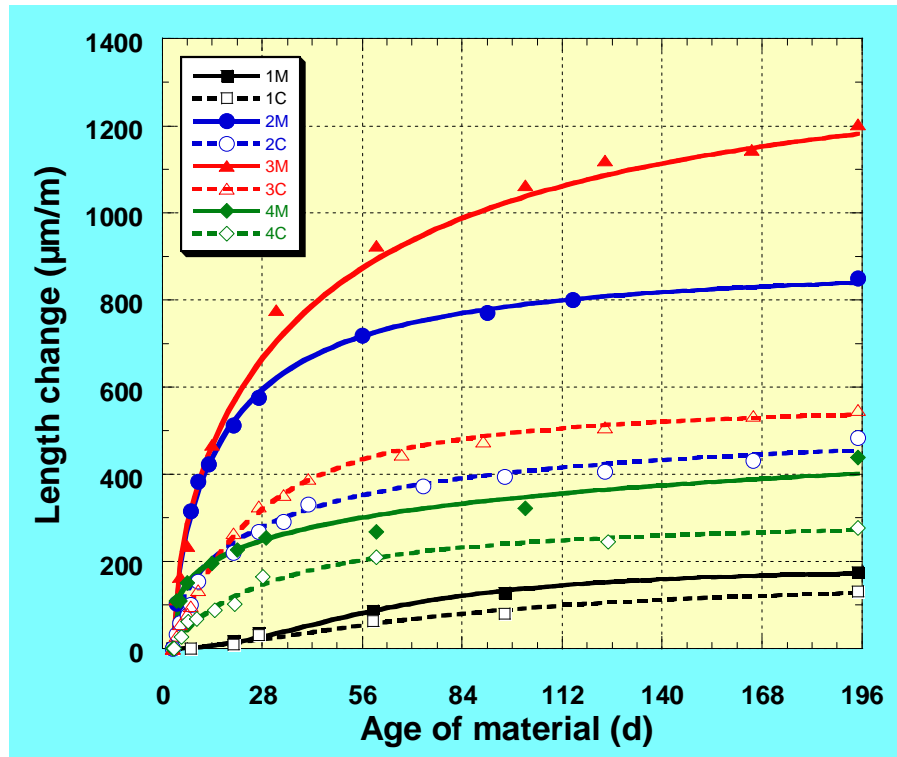
Figure 17.—Drying shrinkage test results (ASTM C157 modified) from Laval University.

The results of the free drying shrinkage test conducted at Reclamation and Laval University are presented in Figure 16 and Figure 17.

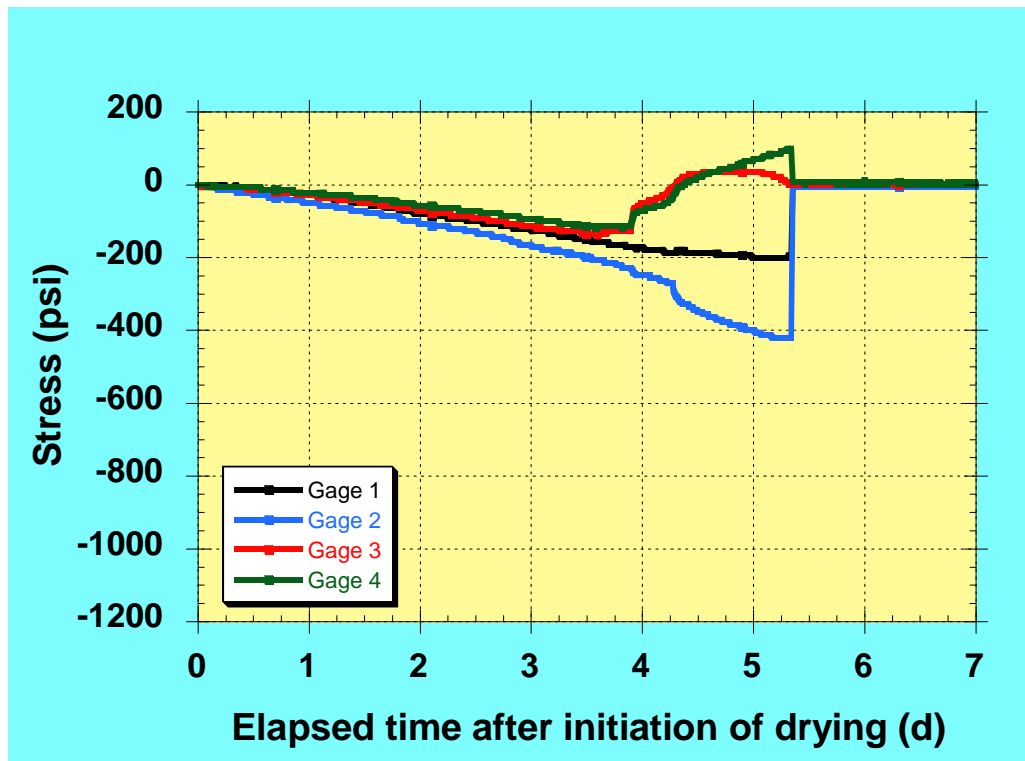
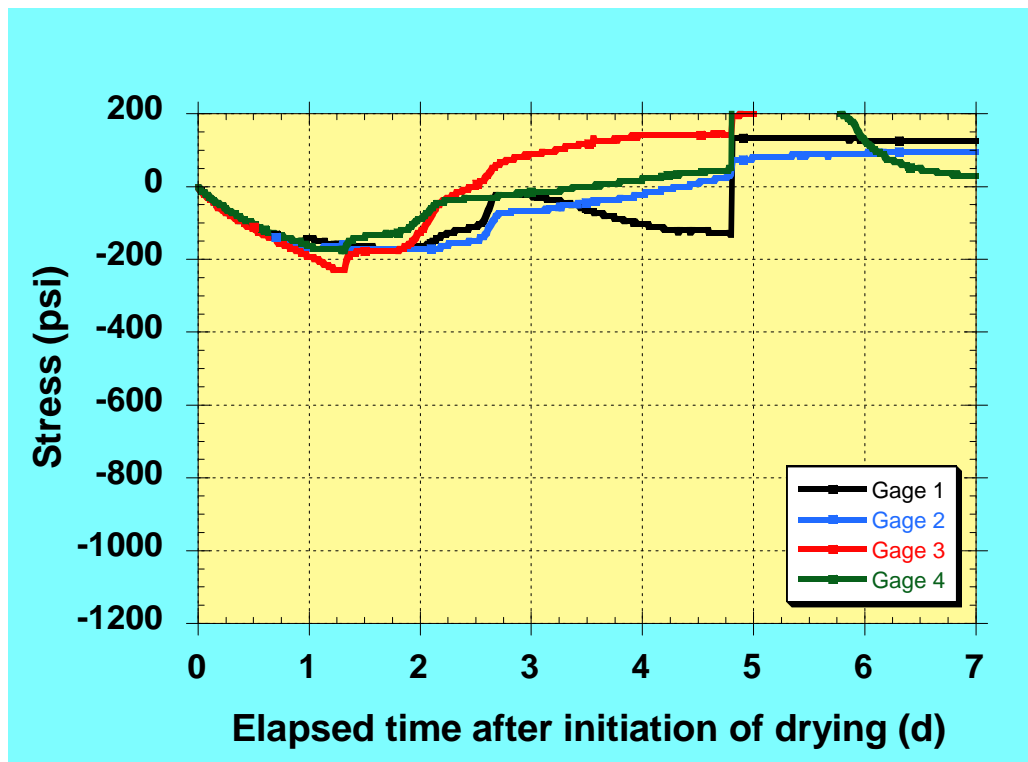
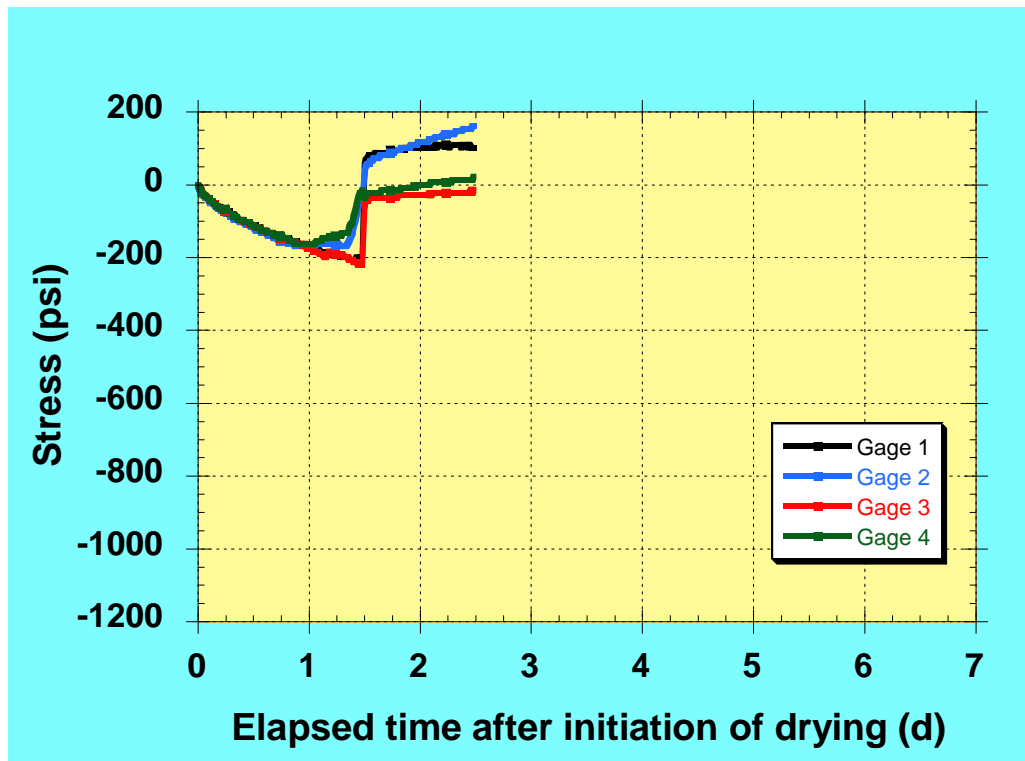
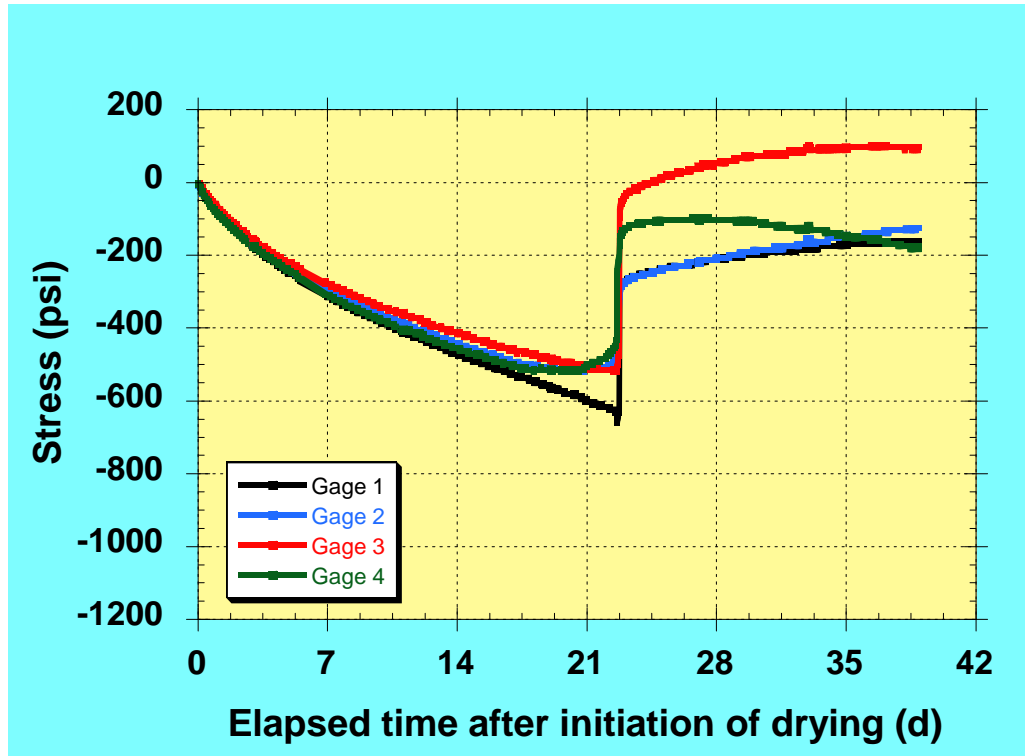
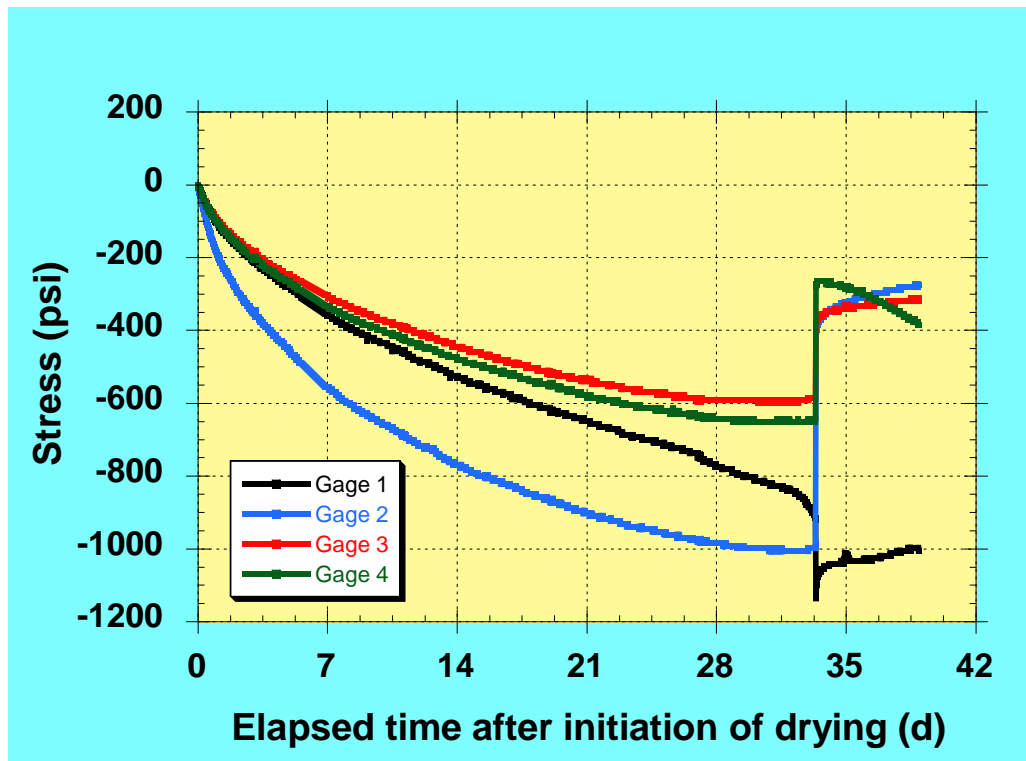
Ring test results are presented in Figure 18 through Figure 29. The sign (-) indicates tensile stress. The summary of the ring test results is presented in Table 11 and Table 12.

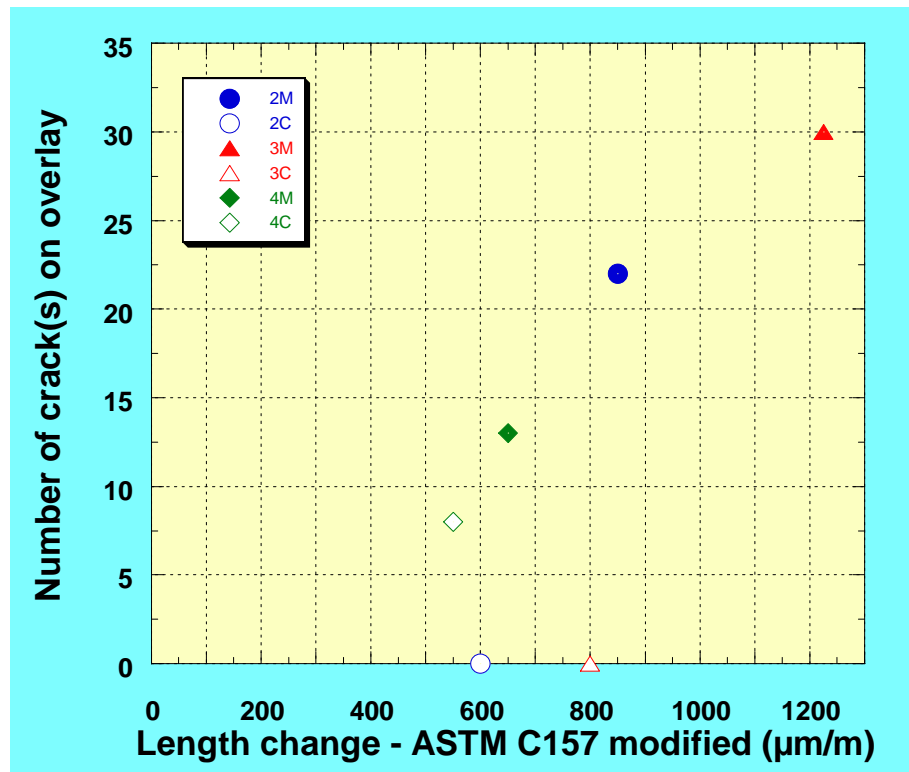
Figure 30.—Relationship between length change and number of cracks in repair—Reclamation.

For materials 2M, 3M, and 4M and 4C, there is a relationship between the length change and number of cracks in the repair (Figure 30). However, this relationship becomes less obvious for rapid set materials 1M and 1C.

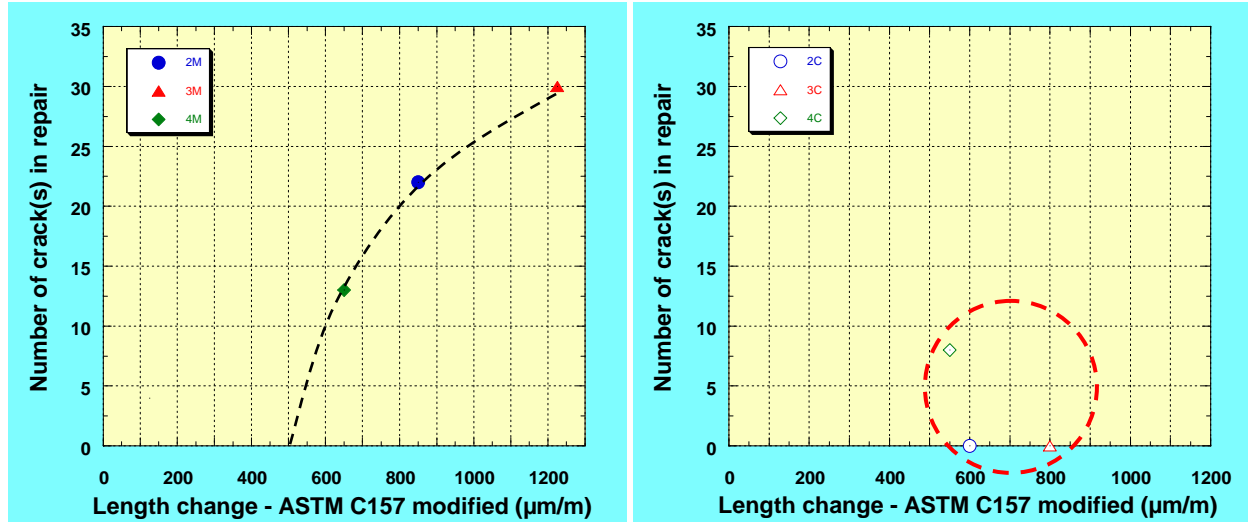
Figure 31.—Relationship between free shrinkage and cracking in experimental repairs (after 9 months).

The correlation between the length change (free-drying shrinkage) test results and the number of cracks in repair is much stronger for mortar materials than for extended mortars (see Figure 31).

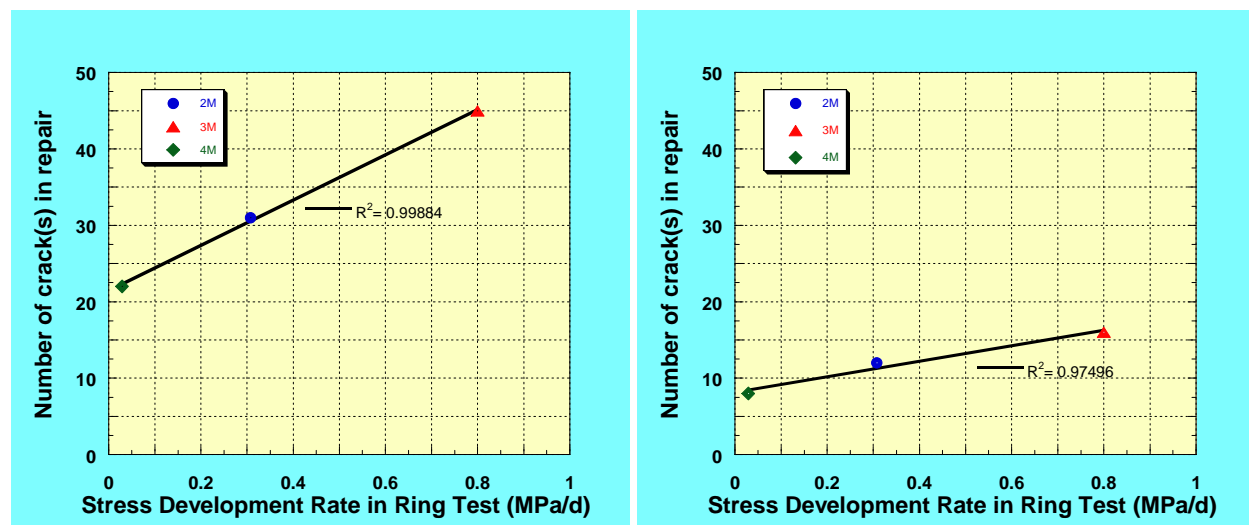
Figure 33.—Relationship between ASTM C1581 ring test and cracking of experimental repairs for mortars.
