**Monitoring the Effectiveness of Gravel Augmentations  
for Salmonid Habitat Improvement Downstream from Dams**

Completion Report  
Project 0295  
January 15, 2013  
David Gaeuman

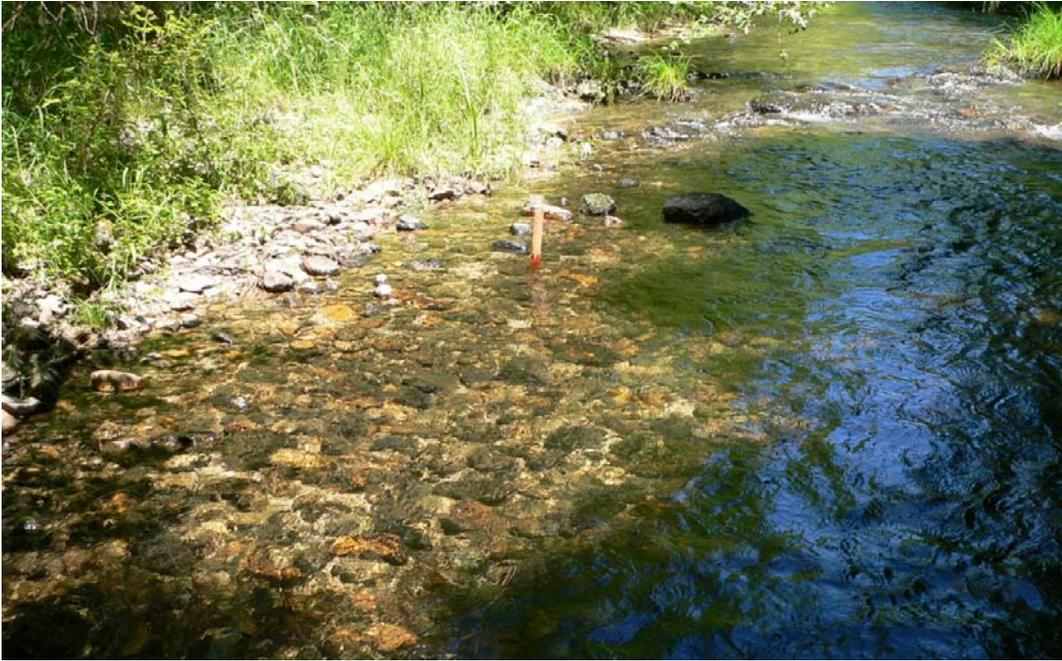
Figure 2: Photograph looking upstream from near station 185 showing native alluvium typical of riffles and runs in the study reach.

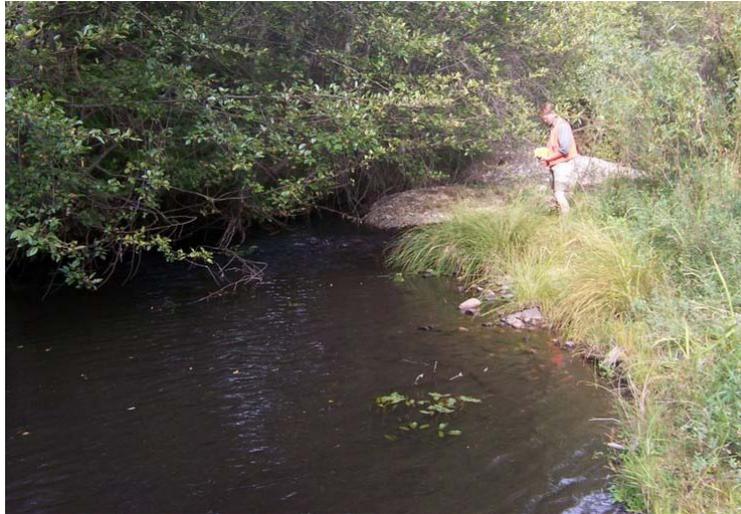
Figure 7: An upstream view of the pool immediately downstream from the gravel recruitment pile in the summer of 2007. A lobe of transported gravel and the remains of the recruitment pile are visible to the left and beyond the man, respectively.

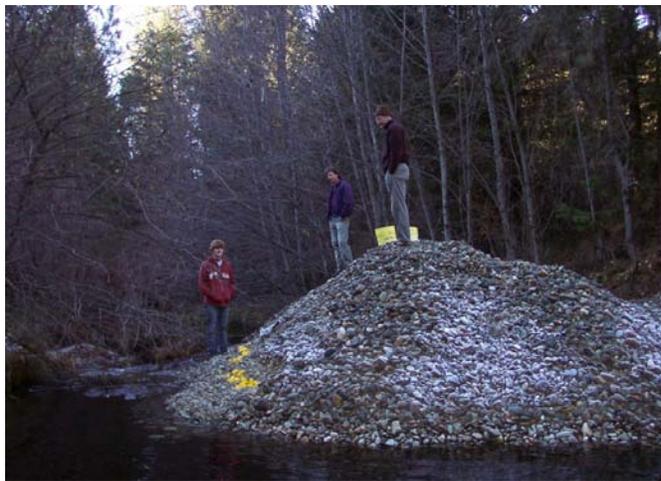
Figure 8: The gravel recruitment pile in the fall of 2008. View is looking downstream.

TCRC D reconstituted and enlarged the gravel recruitment pile in the fall of 2007. The resulting pile was at least 6 ft high and 20 ft wide at its base (Figure 8, Figure 9). Once again, WY2008 proved to be relatively dry with no winter floods capable of entraining the stream bed (Figure 4b). However, flows were capable of spreading the unstable gravel pile downstream, and a new bar formed in the center of the pool between 30 and 70 ft downstream from the recruitment pile. No augmented gravel was observed downstream from the leading edge of the new bar, will be referred to as Bar 1 in the remainder of this report. Based on the baseflow depth observed in the center of the pool area prior to gravel augmentation (~ 2+ ft) and the height the bar above the baseflow water surface (0.7 ft), the fresh gravel deposits in the pool exceeded 3 ft in thickness. These developments were captured in a 2008 sketch map prepared by New Albion Geotechnical (Figure 10).

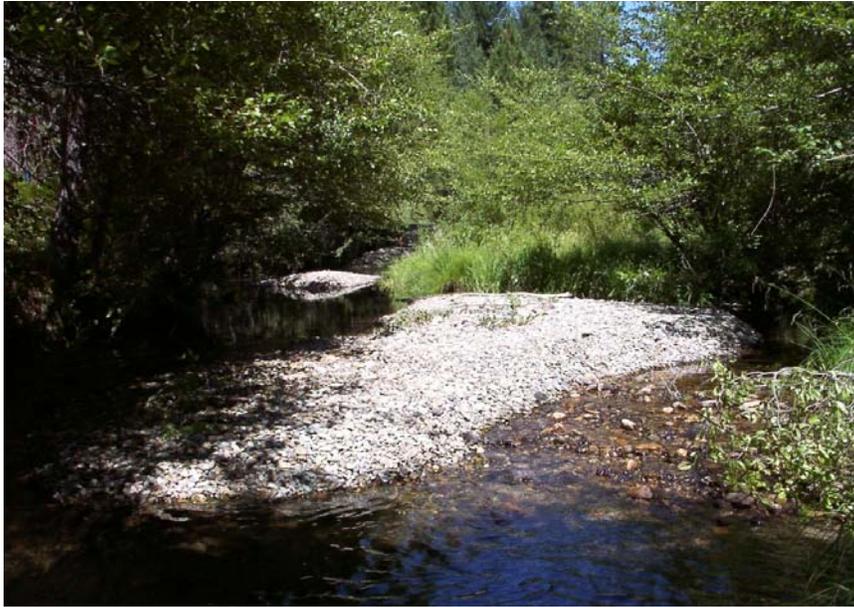
Figure 11: Upstream view from the leading edge of Bar 2 in the spring of 2009. Bar 1 is sunlit in the background and the remains of the recruitment pile is visible in the shadowed area farther upstream.

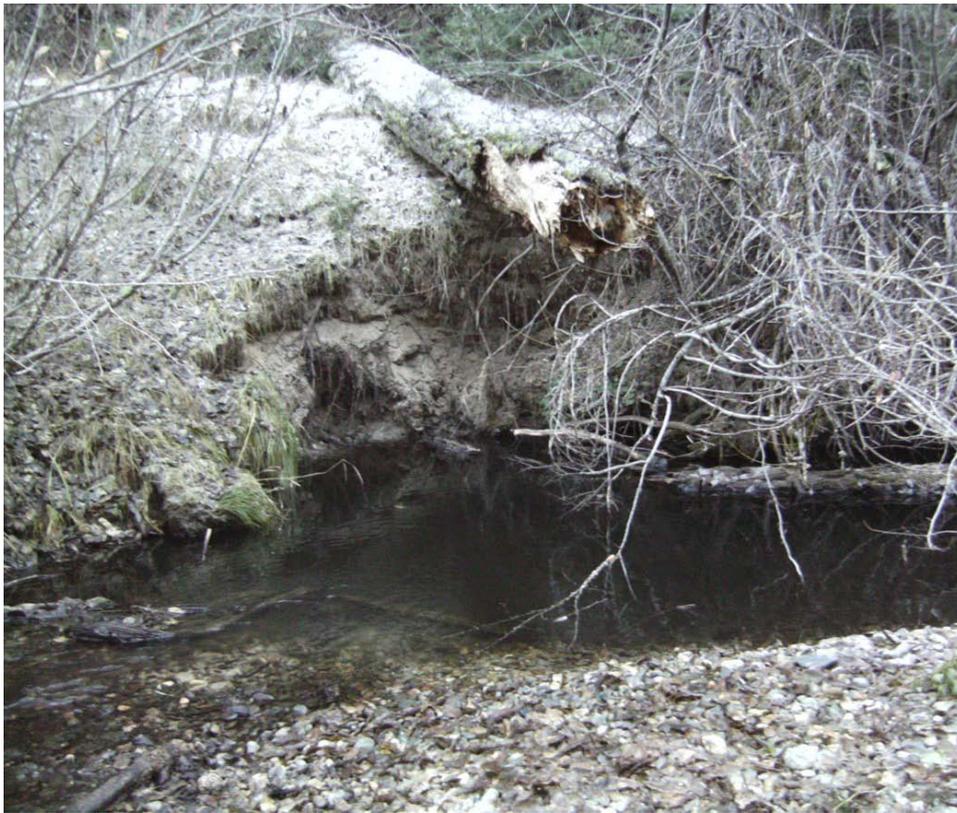
Figure 14: Erosion into the high left bank at the location indicated on Figure 13. Photo taken in December 2009.

In the fall of 2008, TCRCO again reconstituted the gravel recruitment pile. In contrast to the previous 2 water years, however, WY2009 included 2 floods with peak flow that significantly exceeded the threshold of gravel entrainment (Figure 4a). By the spring of 2009, gravel from the recruitment pile was transported downstream as much as 145 ft downstream where a second bar (referred to as Bar 2) formed in the center of the channel (Figure 11). As had been the case with Bar 1 the previous year, Bar 2 ended in an abrupt deposition front with no evidence that any of the augmented gravel moved beyond the bar's leading edge. The summer of 2009 marked the beginning of monitoring activities supported by the S&T Program, and consequently the first year in which topographic changes were captured by Total Station surveys. Figure 12a shows the cross sectional geometry at Bar 1 beginning in 2009 and an example of the geometry of Bar 2 is shown in Figures 12b and 12c. Although Bars 1 and 2 both represent 3 or more feet of deposition, the adjacent thalweg was relatively deep and in several places was scoured to bedrock (Figure 12b). Deposition of the bars also appears to have triggered nearby bank erosion (Figure 13), especially along the left bank adjacent to Bar 2 where a high sandy bank retreated nearly 5 ft between 2008 and 2009 (Figure 14).

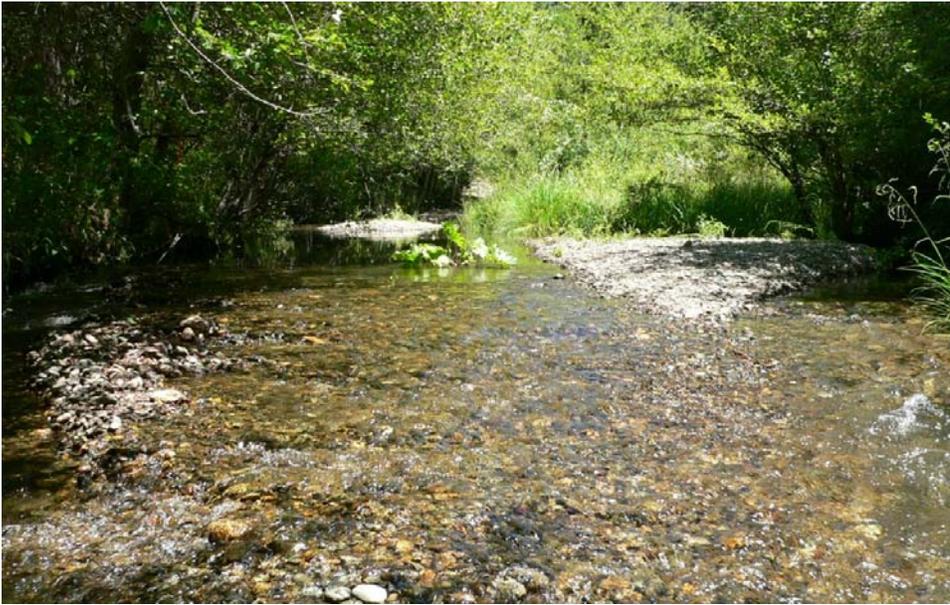
Figure 15: Upstream view from the leading edge of Bar 2 in the spring of 2010. Bar 1 is sunlit in the middle distance and a sunlit portion of the recruitment pile is visible in far background.

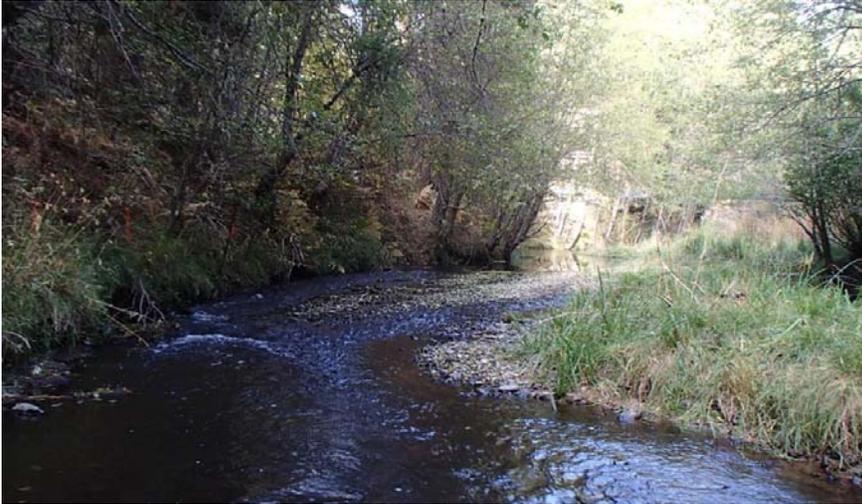
Figure 16: Upstream view from about station 200 in 2012. The leading edge of Bar 2 is visible in the middle distance. A small accumulation of augmentation gravel is visible in the foreground near the left bank (right in the photo). The maximum and average thicknesses of the deposit are about 0.3 and 0.15 ft, respectively, and its area is approximately 200 ft<sup>2</sup>.

small accumulation of augmentation gravel along the left bank 190 ft downstream from the augmentation location (Figure 12d and Figure 16). That accumulation, which has a maximum thickness of about 0.3 ft, is barely discernible on Figure 12d as a slight elevation of the 2012 cross section trace above the 2010 trace near station 45. The most striking change to the site over those 2 years was the establishment of dense herbaceous vegetation on both bar surfaces, and especially on Bar 1 (Figure 17).

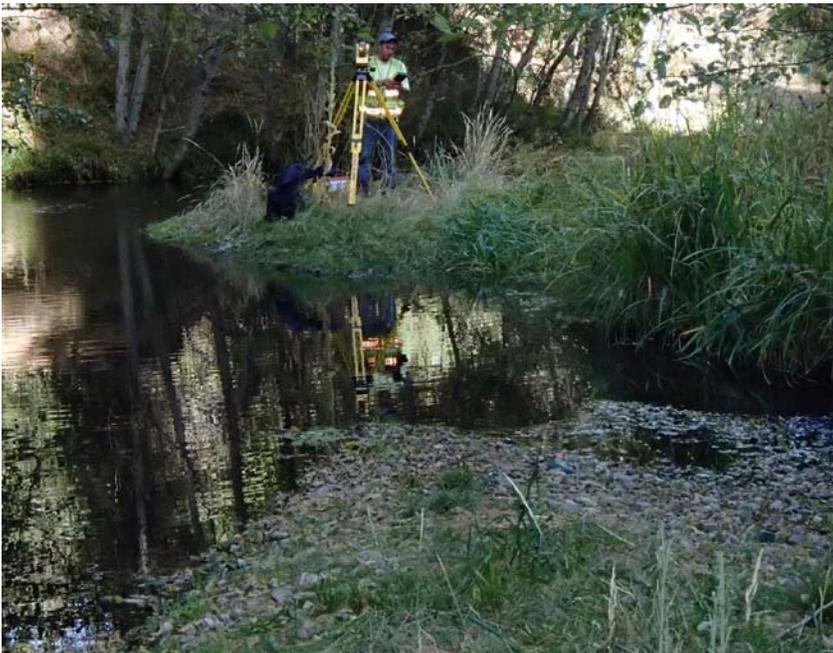
Figure 17: Upstream view from Bar 2 in 2012 showing a dense cover of herbaceous vegetation on Bar 1 (the total station is on Bar 1).
