Progress Report on Testing of Commonly used Fish Screens for their Resistance to Invasive Freshwater Mussel Fouling

September 30, 2013

## Progress Report on Testing of Commonly used Fish Screens and Screen Cleaning Systems for their Resistance to Invasive Freshwater Mussel Fouling

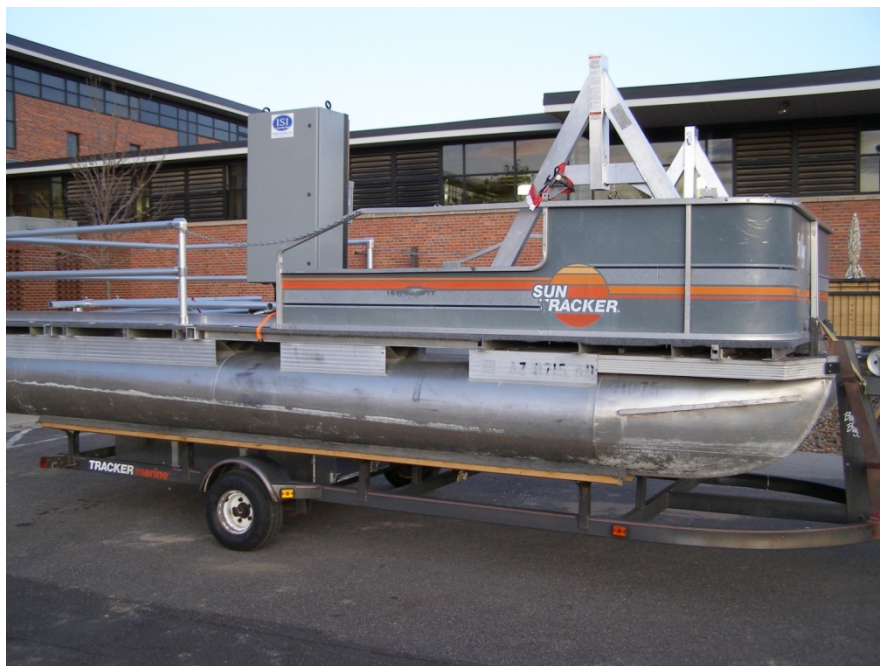
Figure 1. Fish screen testing platform prior to deployment

Our objective was to test the ability of 2 commonly used fish screen systems, a cylindrical, stainless steel wedgewire screen (Intake Screens, Inc.), and a vertically traveling nylon screen (Hydrolox<sup>TM</sup>; Bureau of Reclamation 2006), to resist fouling by quagga mussels. Specifically, we wished to determine fouling rates of these screen systems, and determine if current cleaning methods were adequate to keep screen mesh openings clear. We modified a pontoon boat (15 ft X 8 ft) to serve as a test platform for mounting the screens (Figure 1), added a canvas cover to provide shade for the test area and moored the test platform at the Las Vegas Boat Harbor (Lake Mead, Figure 2).

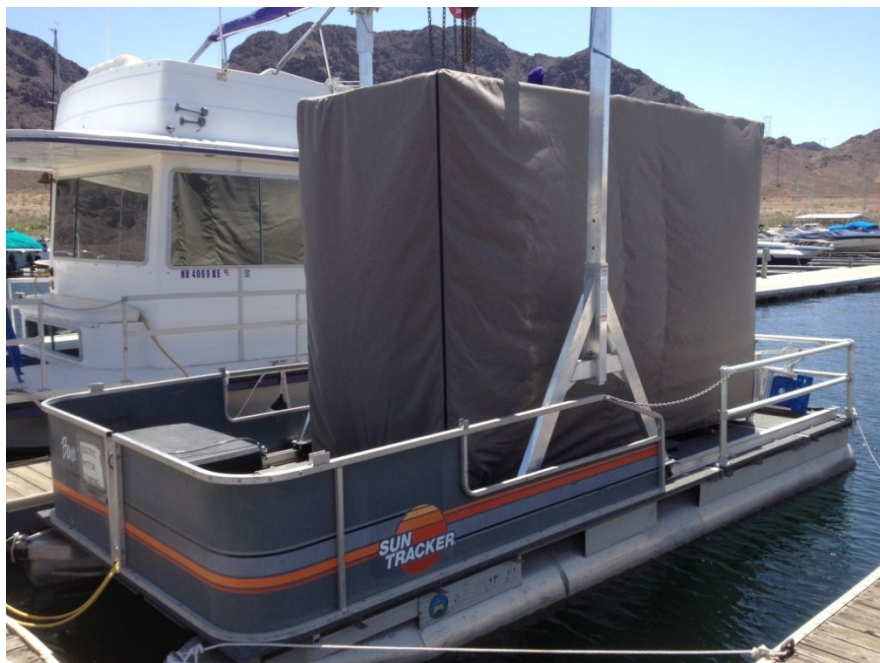
Figure 2. Fish screen testing platform following deployment with canvas covering.

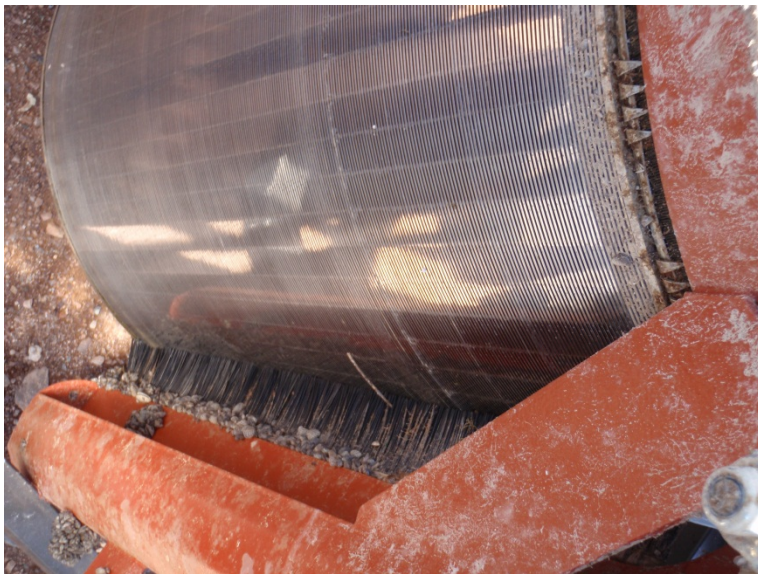
Figure 4. ISI test module with close-up of external brush (note mussel attachment at base of brush and on screen frame)

The ISI is a cylindrical, stainless steel, wedgewire screen (1.75 mm mesh openings) that is used in a totally submerged state for water diversion and fish protection (Figures 3, 4). These screens are kept clean with a system of stationary external and internal brushes with the screen rotating 1 or more times daily. The ISI module we are testing is 5 ft in height by 3 ft diameter, was being cleaned three times daily, and was installed about 13 ft below the surface in spring 2012. Water was drawn through the mesh by a pump that then sent it toward the tank containing the Hydrolox screen.

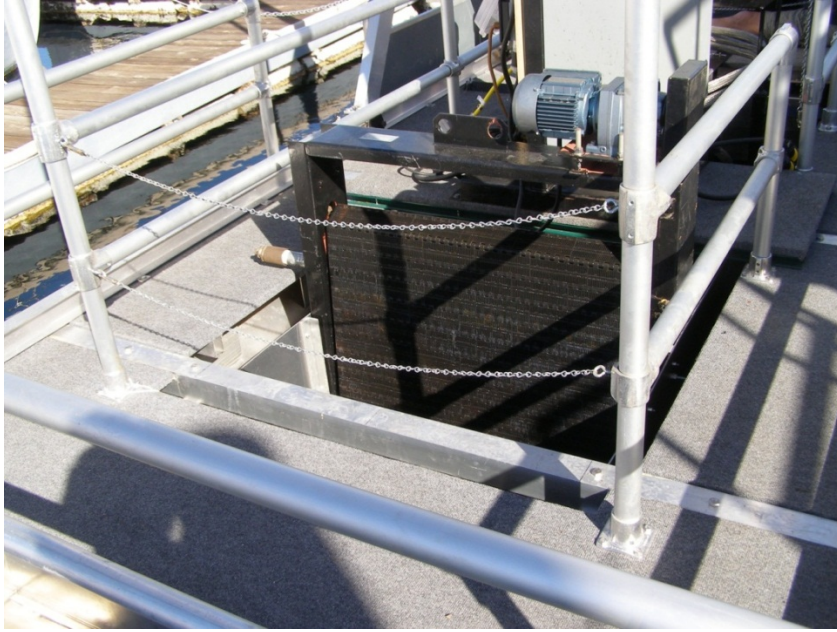
Figure 5. Surface view of Hydrolox test module. Approximately 60% of the screen is out of the water during the rotation).

The Hydrolox screen is a vertically rotating, engineered polymer material that is UV resistant and corrosion free (Figures 5, 6). This screen was developed to prevent impingement and entrainment of small fishes while removing aquatic debris. The external face is smooth which reduces fish injury upon impact. Screen slot openings are small (2 mm) and by incorporating an automatic high pressure spray wash system, maintenance and cleaning are greatly reduced. Diverted water passes through the mesh while floating water born debris can be lifted and removed. The vertically rotating Hydrolox panel we are testing is not yet fitted with a spray wash, but rotates out of the water.

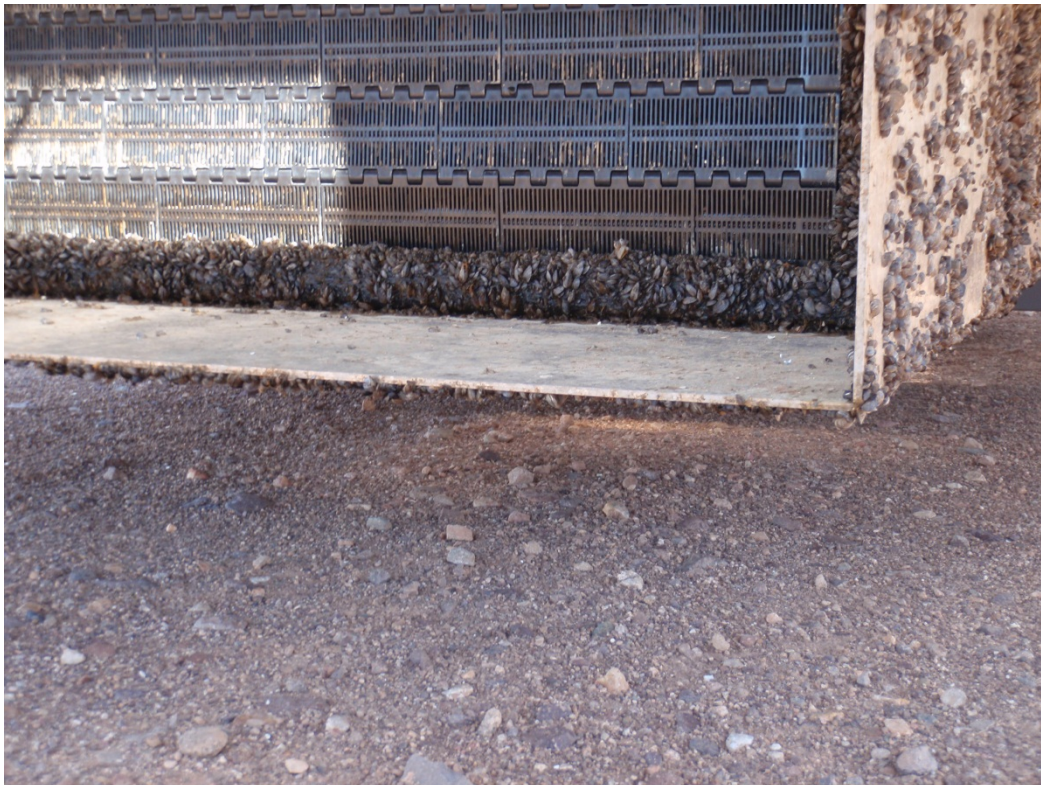
Figure 6. Close up of the Hydrolox screen (note mussel attachment at screen base and exterior box).

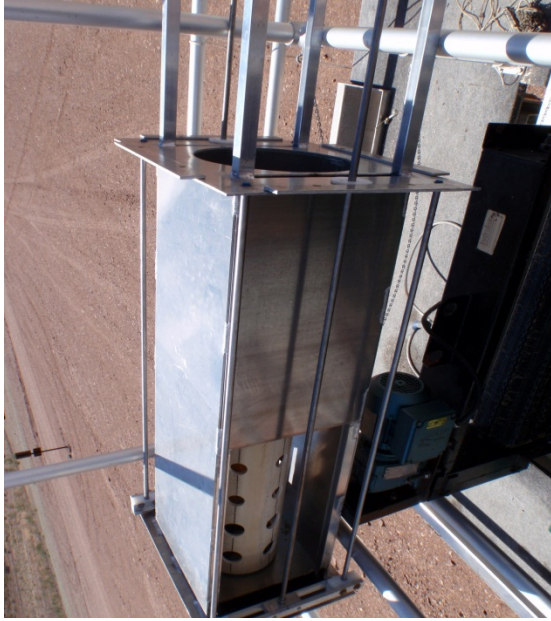
Figure 7. Box for holding flat plate wedgewire panels at depth (note cutout at bottom).

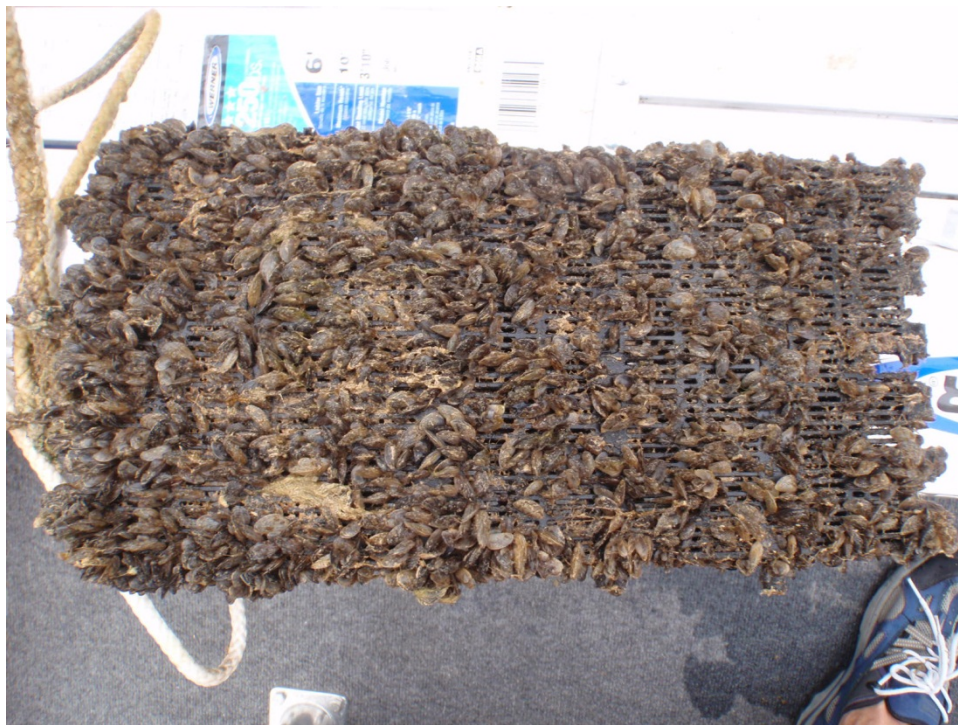
Figure 11. Stationary Hydrolox panel prior to deployment (upper photo) and 12 months following deployment (lower photo).

In spring 2012, we deployed representative screen panels about 13 ft below the surface to confirm presence of mussels, and to determine mussel fouling in the absence of movement and cleaning (Figures 10, 11). These panels were photographed seasonally (winter, spring, summer, and fall) and we will use image analysis software of both moving and stationary screen panels to evaluate and understand the ability of the screens to resist mussel fouling.
