Finding a Green Alternative to Vinyl Resin Coatings

An In-Depth Look into Replacing Legacy Coating Material with Decades of Proven Corrosion Protection, with a Low Solvent “Green” Alternative

Research Bulletin
Science and Technology
Program
8835

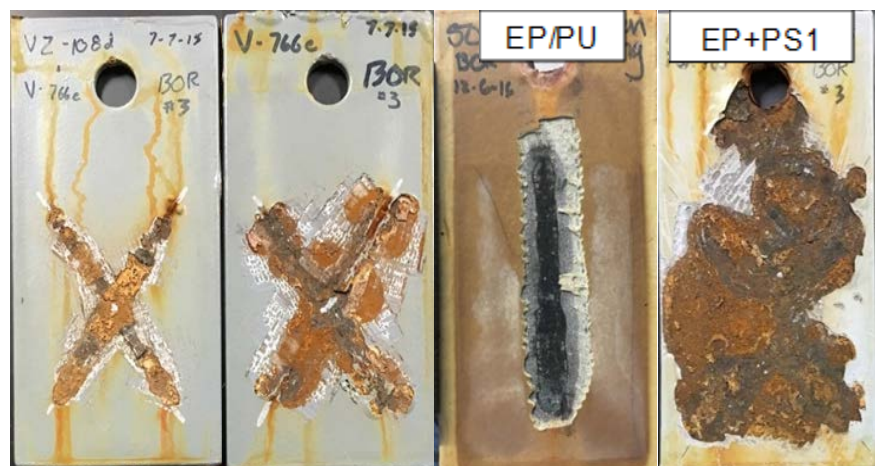
Cyclic test panels shown post-test after coating removal. Rust creep measured following 5040 hrs of cyclic exposure testing. The best (epoxy/polyurethane hybrid) and worst (epoxy primer & polysiloxane topcoat) performing materials and compared with vinyl resins V-766e and VZ-108d+V-766e.

Additional benchmark and comparison testing identified multiple thermoset and thermoplastic materials which retained excellent barrier testing over a shorter 8 month period. This test duration was sufficient to see significant degradation in many of the epoxy materials. A suite of other tests highlighted the strengths and weaknesses of solution vinyl resins and provided a comparison with modern materials. Two products (EP8 and EP/PU) seem to provide performance that is on par with vinyls in most situations however, a UV protective topcoat is required for atmospheric exposure. Additional products may also benefit from the addition of a zinc-rich primer to help curb rust creep when a defect in the coating is created.

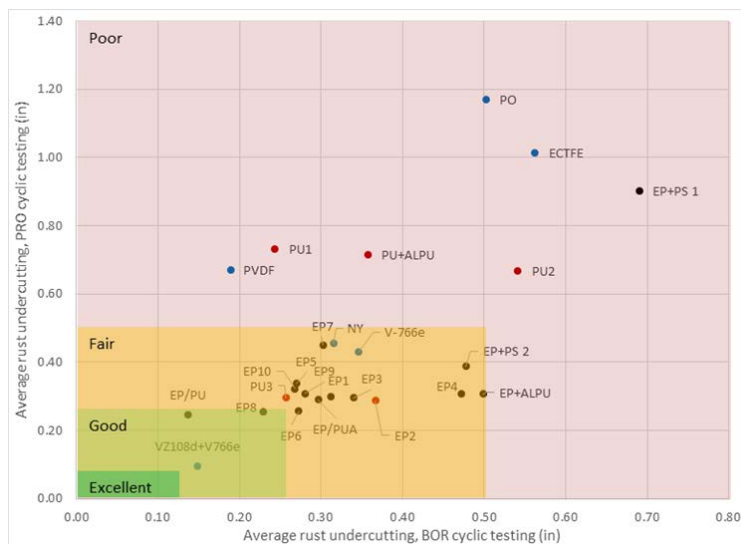
Plot of all products tested in two cyclic exposure test programs compared to vinyl materials V766e (standard) and VZ-108d+V766e (zinc-rich primer).
