— BUREAU OF —
RECLAMATION

Research Updates R&D Office

Water Infrastructure

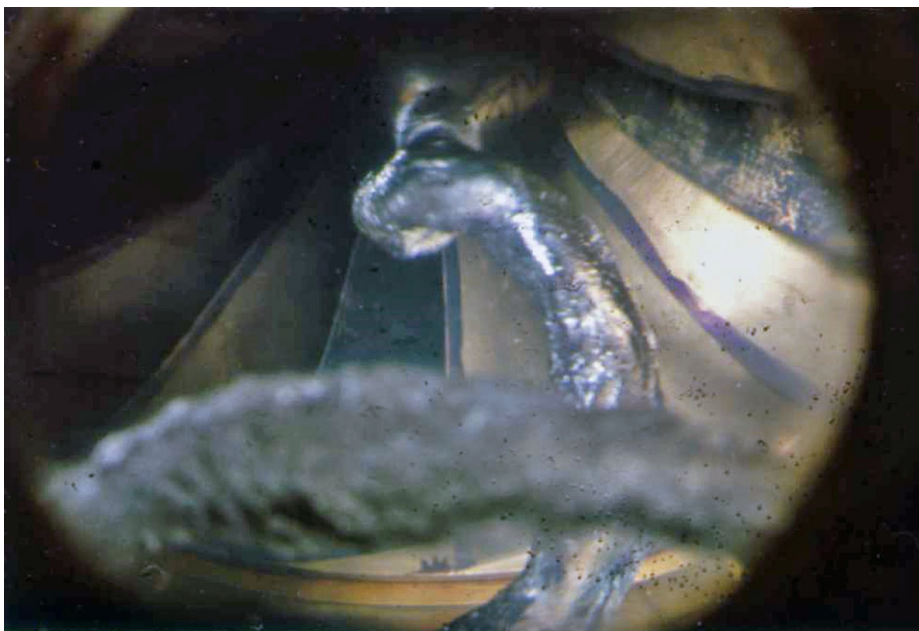
A cavitation vortex in a draft tube.

Currently, Reclamation's primary method for mitigating cavitation is the use of stainless steel weld overlays. This repair method is time consuming, and the overlays typically have a service life of around three years. On hydropower units, repairs may cost \$100–250k every 1–3 years per unit. The objective of this research was to identify a list of candidate repair materials that could help lengthen the time between cavitation repair cycles. Of the epoxy and polyurethane coatings tested, two commercial materials were among the best-performing non-metallic coatings in cavitating water-jet testing. These materials were selected for field trials and performed well on turbine runner blades in mild and moderate cavitation

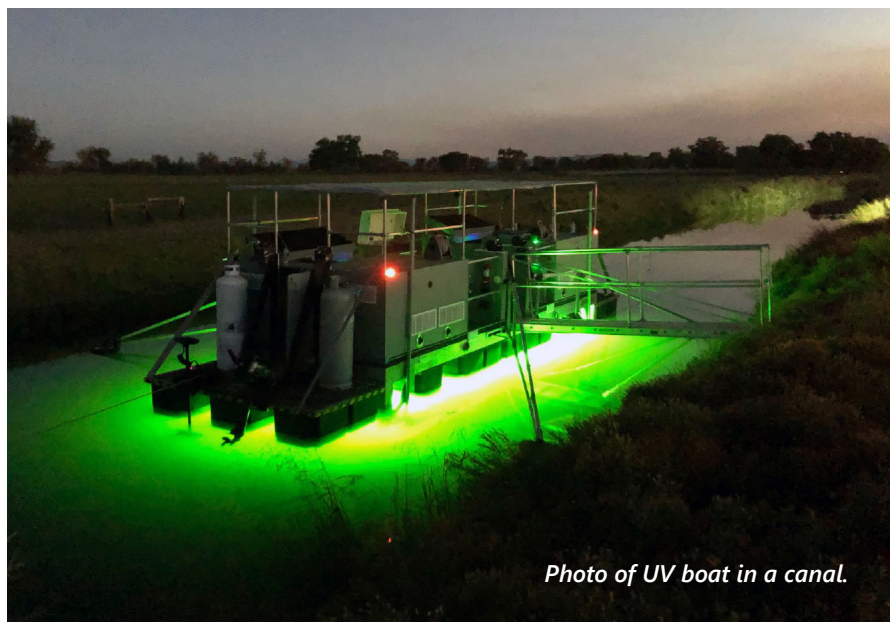
Photo of UV boat in a canal.

Canal conveyance capacities can be decreased by aquatic plants, with losses being dependent upon plant height, density, and location within the channel. Management efforts to extract or eradicate the aquatic plants are costly. A new tool using ultraviolet light (UV) has been developed to control plants, with several successful pilot studies completed. This study implemented UV control tests and set up a monitoring program to quantify plant and chemical water dynamics. There were some complications with

canal test sections being partially dewatered due to drought conditions. However, laboratory and field trials from other ecosystems showed that the UV light treatment can reduce plants by up to 100% with targeted impacts to multiple plant taxa. Monitoring data indicates that plant biomass in these irrigation canals peaks in July, suggesting the best timing for intervention is during initial plant growth in June.

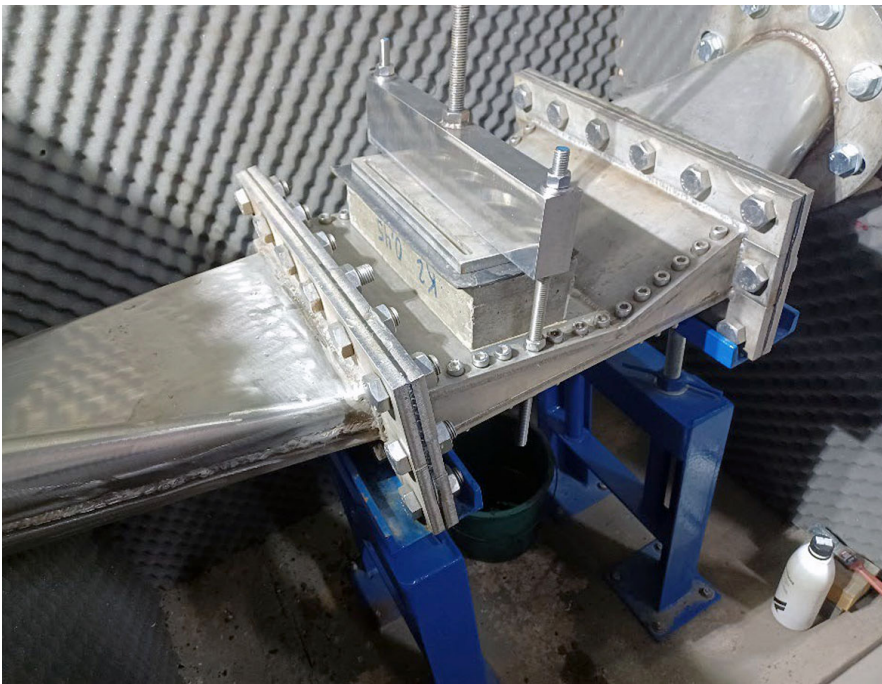
Cavitation machine at Federal University of Rio Grande do Sul (similar to Reclamation's) used to test durability of concrete to cavitation.

Water resource facilities operated by the Brazilian and United States Government are faced with cavitation and erosion of concrete surfaces of spillways and stilling basins, and each have made many costly repairs that impact operations. Since 2018, Reclamation and Brazilian laboratories have been collaborating to study flow-induced damage to concrete surfaces. The main objective is to develop a reliable correlation between concrete properties and local hydraulic conditions to provide updated guidance and advance the state-of-the-art in concrete design. The partnership includes parallel efforts of literature

review, analysis of historical field data and experience, and laboratory testing of cavitation damage to concrete. This report summarizes research efforts made to date and highlights laboratory testing in Brazilian laboratories in 2023 which culminated in a Reclamation site visit to Brazil.

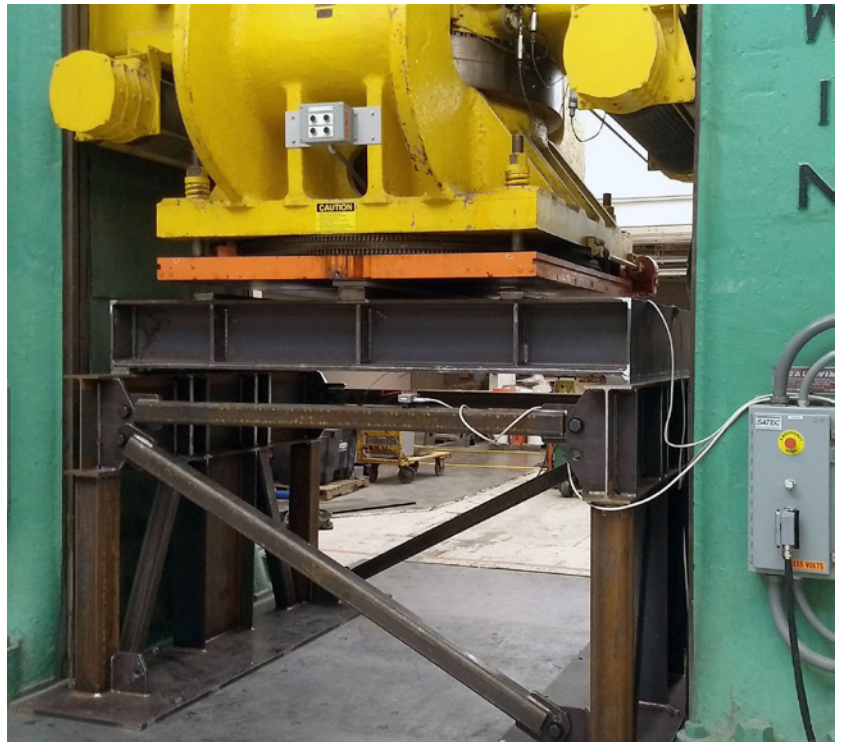
Experimental setup for the steel bulkhead gate.

Reclamation has used simplified analysis techniques and hand calculations for the design of bulkhead and stoplog gates for its entire history. This results in gates that are robust and safe but heavier than needed for the given design requirements. There exist many site-specific requirements where a weight reduction would result in a large cost savings to the government. This research attempted to align the results of traditional hand calculations, finite element analysis (FEA) results, and laboratory results. Scale model steel and composite bulkheads were fabricated and tested to failure. The steel bulkhead gate results were able to be aligned to the FEA simulations, allowing for increased confidence in mechanical design technical capabilities. The next steps in gate optimization would be to run tests in a real-world application, and to apply the lessons learned from laboratory testing to the design of new steel bulkhead gates or stoplogs.

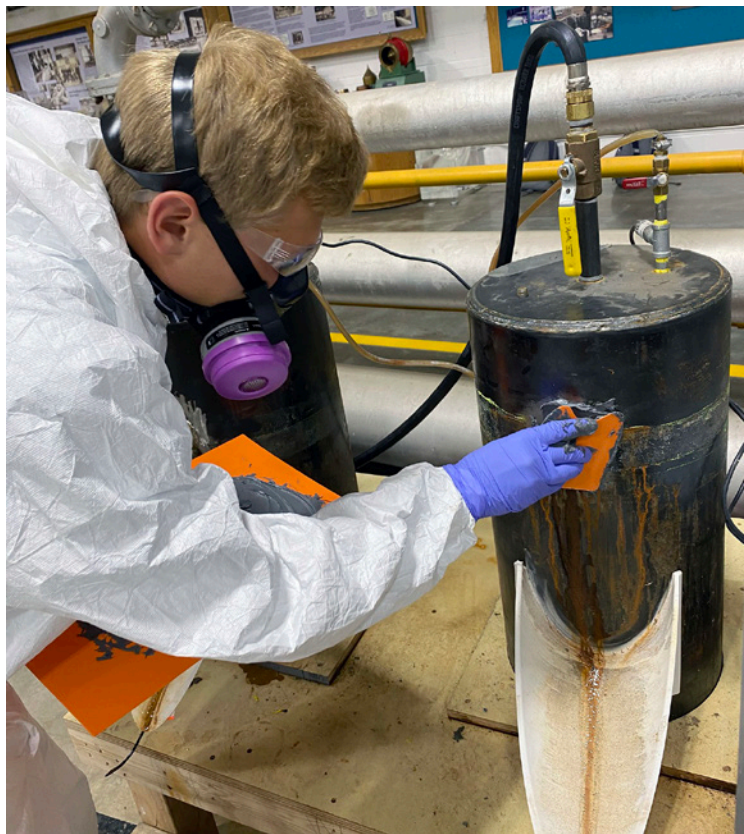
Researcher wearing personal protective equipment applying an epoxy repair to the laboratory pipe set-up.

Leaks in pressurized mechanical systems can be difficult or impossible to repair without first depressurizing and drying, which may be costly or impossible. This work performed laboratory testing on five composite repair systems applied to actively leaking, pressurized pipes. Results found the repairs were only effective on very minor, weeping leaks and only for short periods of time. Information from field partners indicated success with fiberglass wraps and metallic patches and clamps for lower pressure leaks. For higher pressure leaks, field partners have not found repair options that can be applied without first isolating the leak. With much of the infrastructure at the field partner facilities nearing or passing its design life, it becomes increasingly important to find solutions that can address leaks, corrosion, and other degradation, either temporarily until the system can be isolated or permanently, if possible.

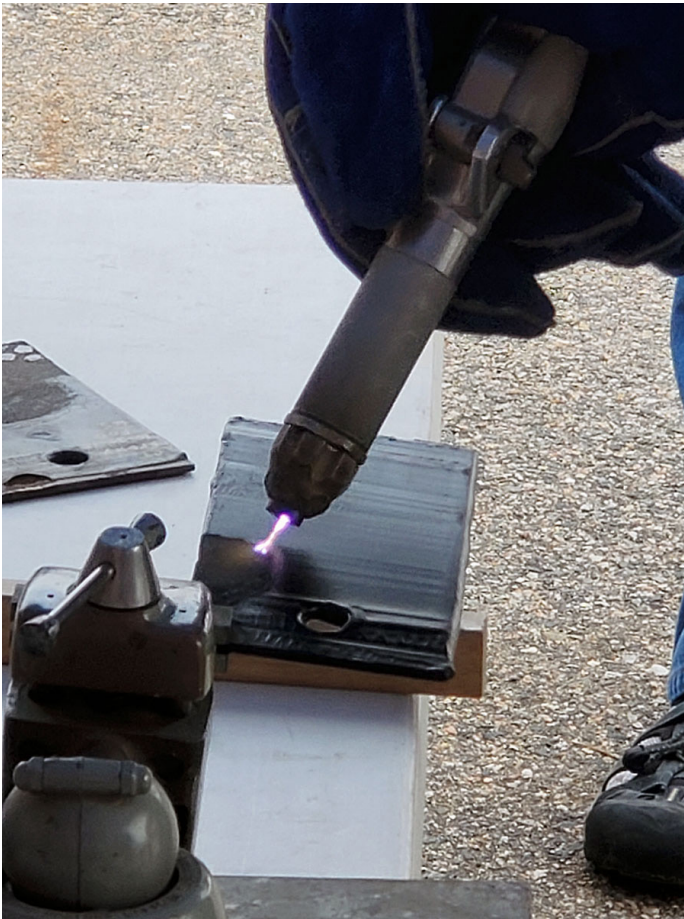
View of atmospheric plasma removing coal tar enamel from a test panel.

The process for removing degraded linings has evolved incrementally throughout the years with advances in technology, health, and safety regulations. However, removing and containing hazardous materials in coatings is still complicated, time consuming, costly, and can be hazardous. This project investigated the use of atmospheric plasma to remove coal tar enamel (CTE). In simple terms, plasma is ionized gas molecules. When used to remove coatings, it reacts with and vaporizes the coating from a surface. Researchers performed two rounds of testing to evaluate and compare atmospheric plasma removal of CTE to traditional blast processes. The research provides results from the testing and recommendations on use of atmospheric plasma for coating removal.

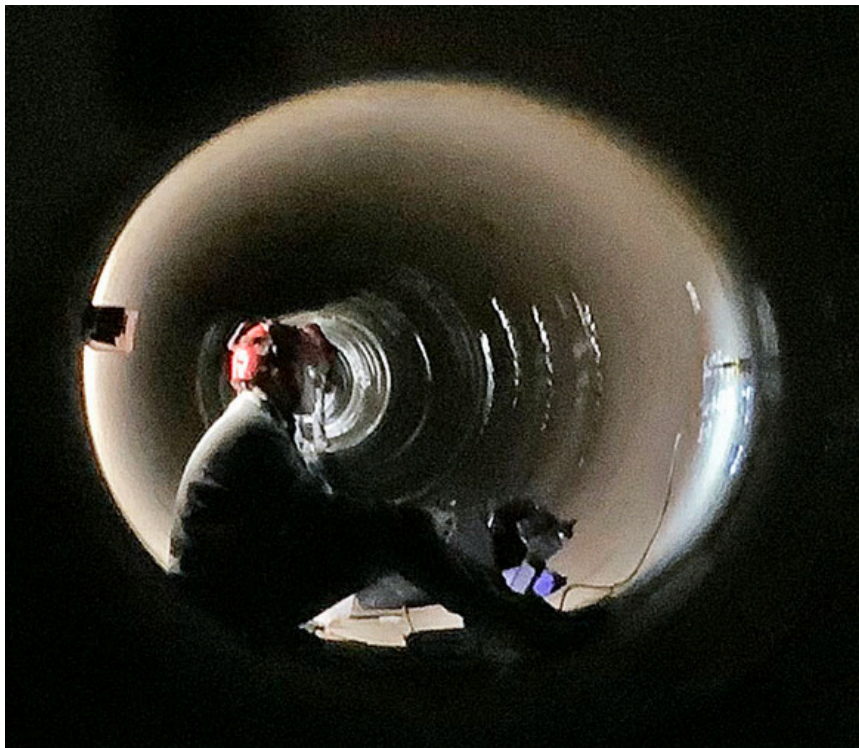
Reclamation inspector collects EIS data from inside of Collbran Salt Creek Siphon.

To evaluate the performance of various lining systems for corrosion protection, Reclamation scientists conducted field trials at the Shasta Dam Unit 5 Penstock (Shasta) in 1949 and at the Collbran Project Salt Creek Siphon (Collbran) in 1959 on 26 and 42 coatings systems, respectively. The current research is the first investigation since 1972 where lining performance at Shasta and Collbran are evaluated together in a single report. The updated data collected on the various test lining materials contributes to understanding why some products provide long-term corrosion protection, with a goal to identify and develop new products with similar characteristics. Furthermore, this work helps researchers and inspectors understand how to effectively evaluate aging coating systems.

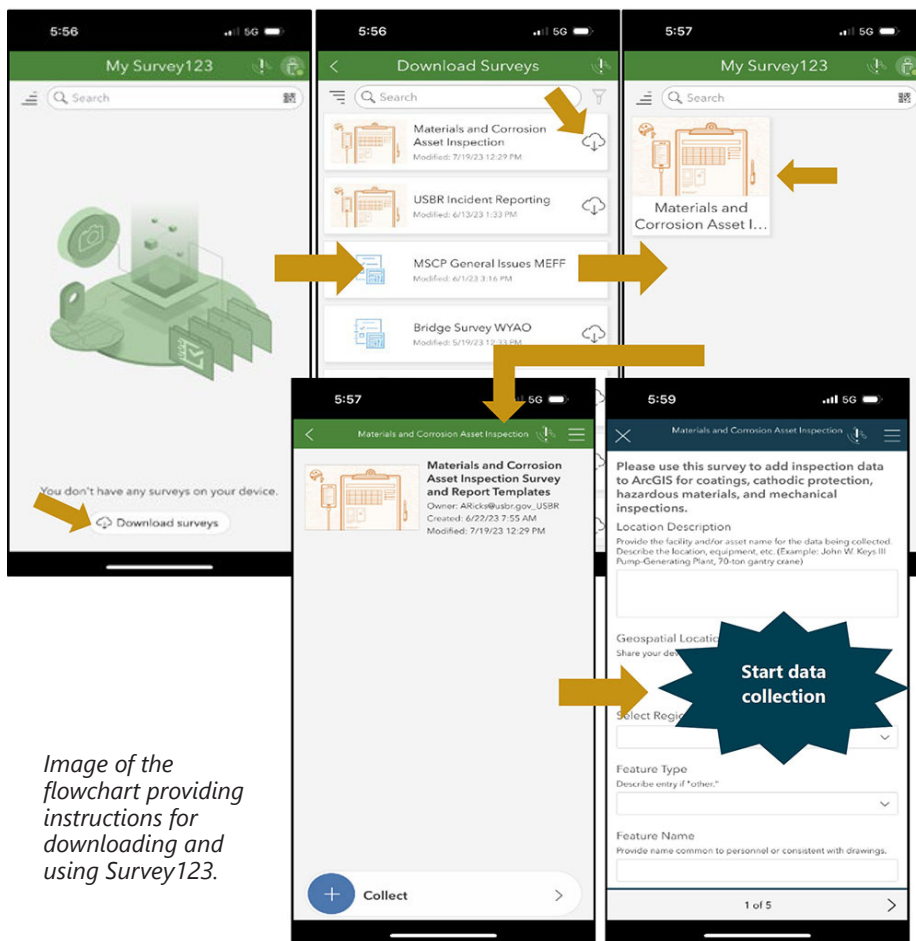
Image of the flowchart providing instructions for downloading and using Survey123.

Reclamation inspects its infrastructure to ensure adequate corrosion protection and to determine presence of hazardous materials. In-field documentation during inspections has historically followed the inspector’s preference. However, with a lack of standardization or online repositories, it can be difficult to review inspection reports across facilities or agencies to obtain and analyze parallel data. This research evaluated the usefulness and appropriateness of centralized data storage for several asset inspections: coatings, cathodic protection, hazardous materials, and mechanical. Researchers developed an ArcGIS Survey123 software application-based tool with geographic information systems (GIS) for centralized storage and access to inspection data. The Survey 123 Materials and Corrosion Asset Inspection mobile app tool is now available to Reclamation ArcGIS Online users on Government phones and tablets.

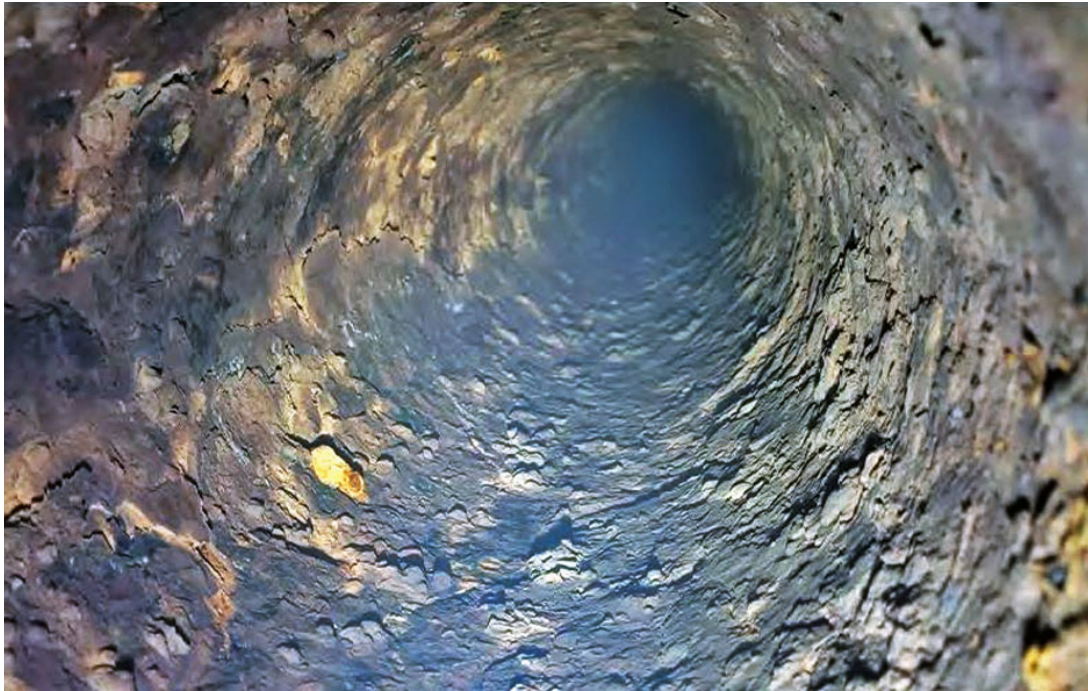
Small diameter pipe interior showing the entire surface corroded with large rust nodules.

This scoping level project conducted market research to identify refurbishment options for small diameter (less than 24 inches) embedded pipes in powerplants and dams that have suffered extensive corrosion. Small diameter pipe is notoriously hard to repair or reline, often difficult to access, and could be embedded several feet into mass concrete, making replacement infeasible. A majority of the Bureau of Reclamation’s infrastructure exceeds 50 years of age,

and corrosion has compromised the integrity of these pipes. This study investigated Cured-in-Place Pipes (CIPP), Spray-in-Place Pipes (SIPP), Fiber Reinforced Polymers (FRP), Cement Mortar Lining (CML), and Polymeric Linings (PL) (epoxy) as refurbishment techniques. A flow chart was developed to help guide engineers and designers to use the best rehabilitation option for the facility situations present.

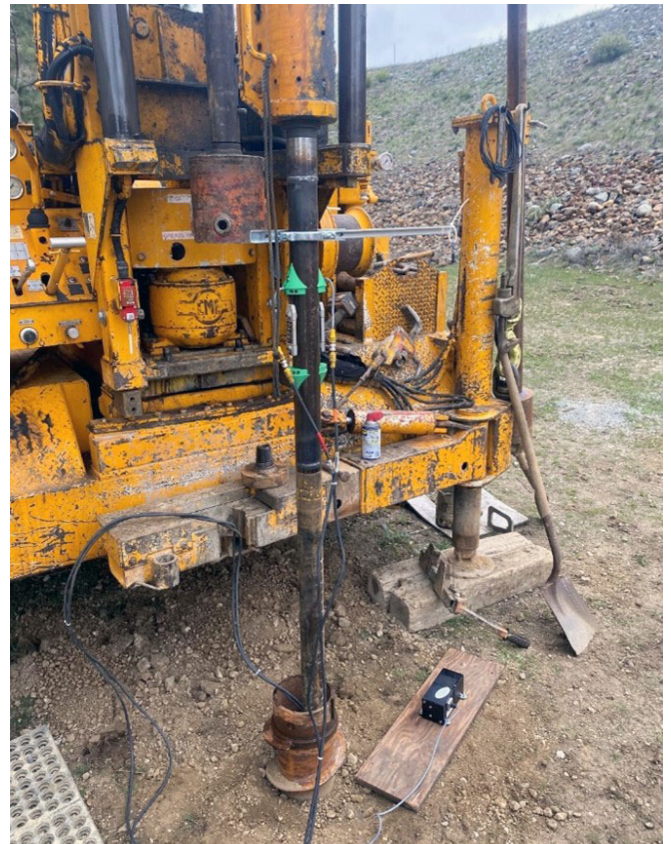
Reclamation instrumented drill rig, a CME 850, at Conconully Dam, Washington.

The Standard Penetration Test (SPT) was created in 1927 as an in-situ geotechnical test for foundation design. The test has many opportunities for error that can alter results, such as overestimation of soil penetration resistance or underestimation of liquefaction susceptibility. This project worked to develop a prototype ISPT tool that can digitally record energy at the sampler, the hammer anvil, and penetration per blow. These digital readings will allow for disparities in the SPT method to be measured and quantified, allowing for more accurate SPT analysis. The report documents the use of the prototype at several field test sites and provides recommendations for continued research.
