## **Colorado Front Range Streamflow, Geomorphological Hazard and Rainfall Relationship. Storm and Flood of September 11-13, 2013.**

Technical Memorandum No. 85-833000-2016-15 (DSO-2017-03)

August 2017

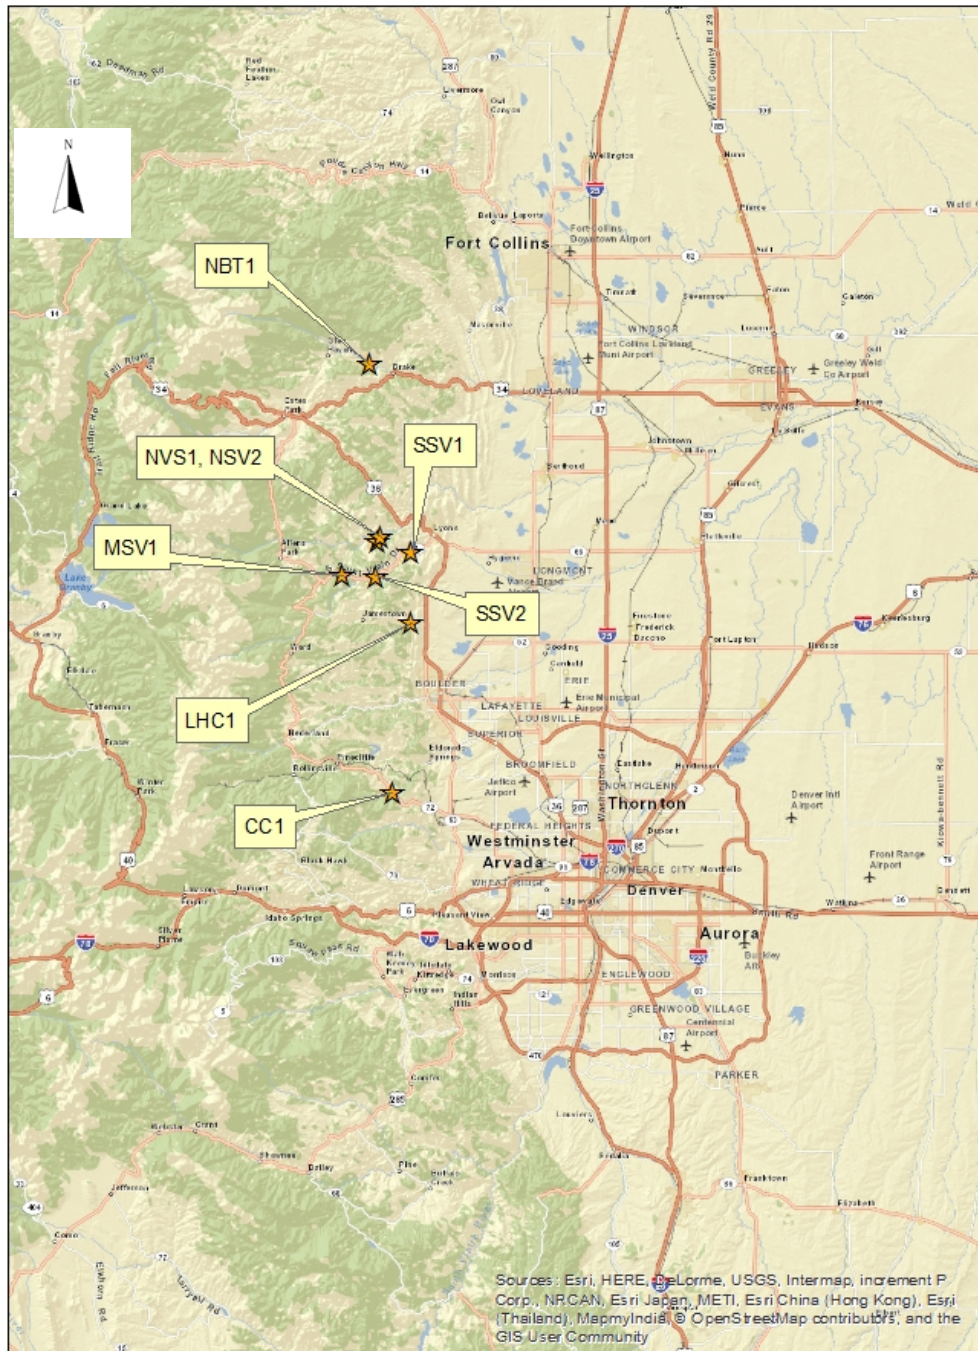
FIGURE2.1: MAP SHOWING THE LOCATIONS OF POINTS OF INTEREST FOR THIS STUDY

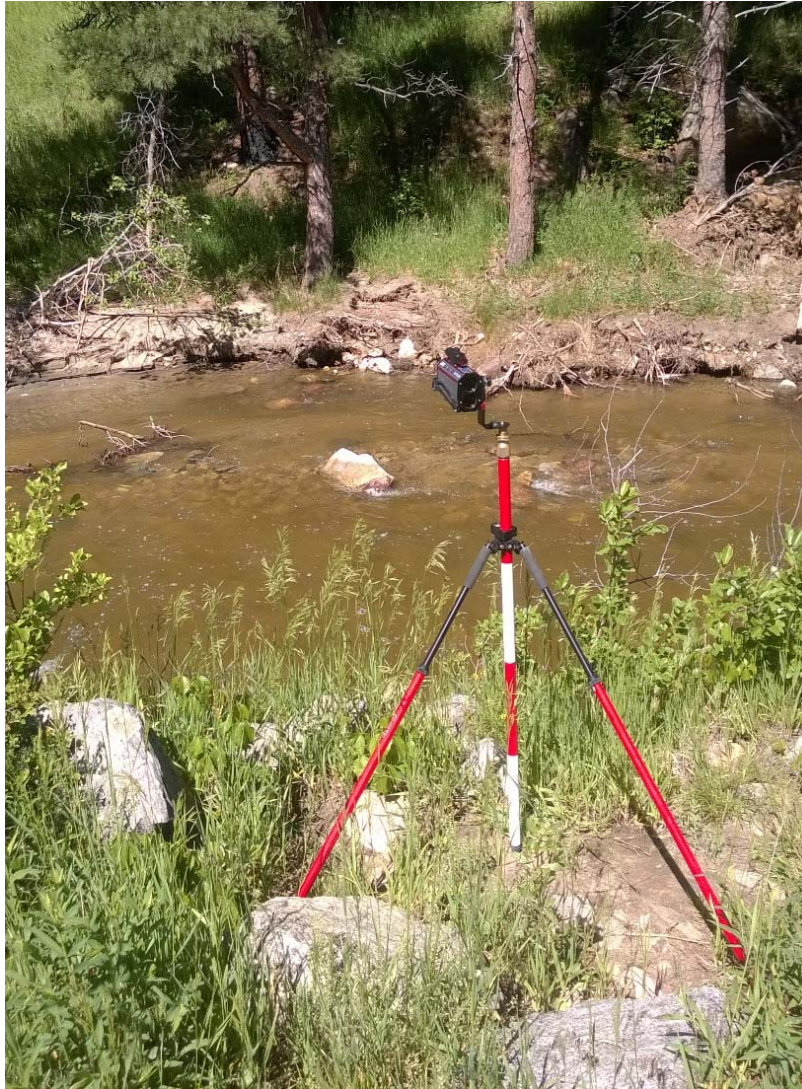
Topographic survey cross sections were conducted during each field work section at all of the nine sites analyzed to facilitate the accurate reconstruction of flood peak discharges. As part of the topographic survey, data were collected on the channel geometry and elevation as well as the elevation of preserved HWMs. The data collected were used to reconstruct a 1D single cross section for each site. The survey field data were collected using a lightweight hand-held laser ranging instrument (Figure 3.1) that allows to measure distances, height and vertical angles. The maximum range of distance of the instrument is 1640 feet while the range resolution on each

FIGURE 3.1: LIGHT WEIGHT HAND-HELD LASER RANGING INSTRUMENT USED TO COLLECT SURVEY DATA FOR THE DETERMINATION OF A CHANNEL SINGLE CROSS SECTION AT EACH SITE.

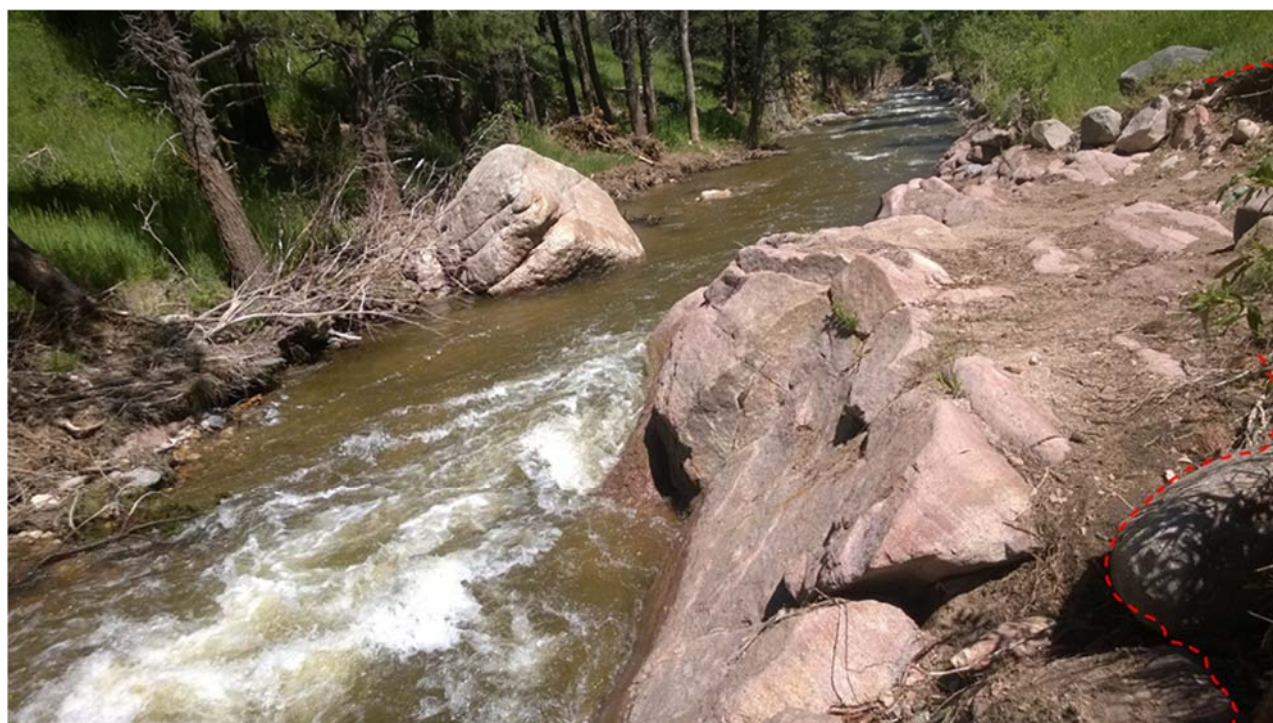
FIGURE 3.3: SITE LCH1 ON LEFT HAND CREEK DOWNSTREAM OF THE CONFLUENCE WITH SIXMILE CREEK LOOKING DOWNSTREAM, EVIDENCE OF HWMS ON THE RIGHT BANK.

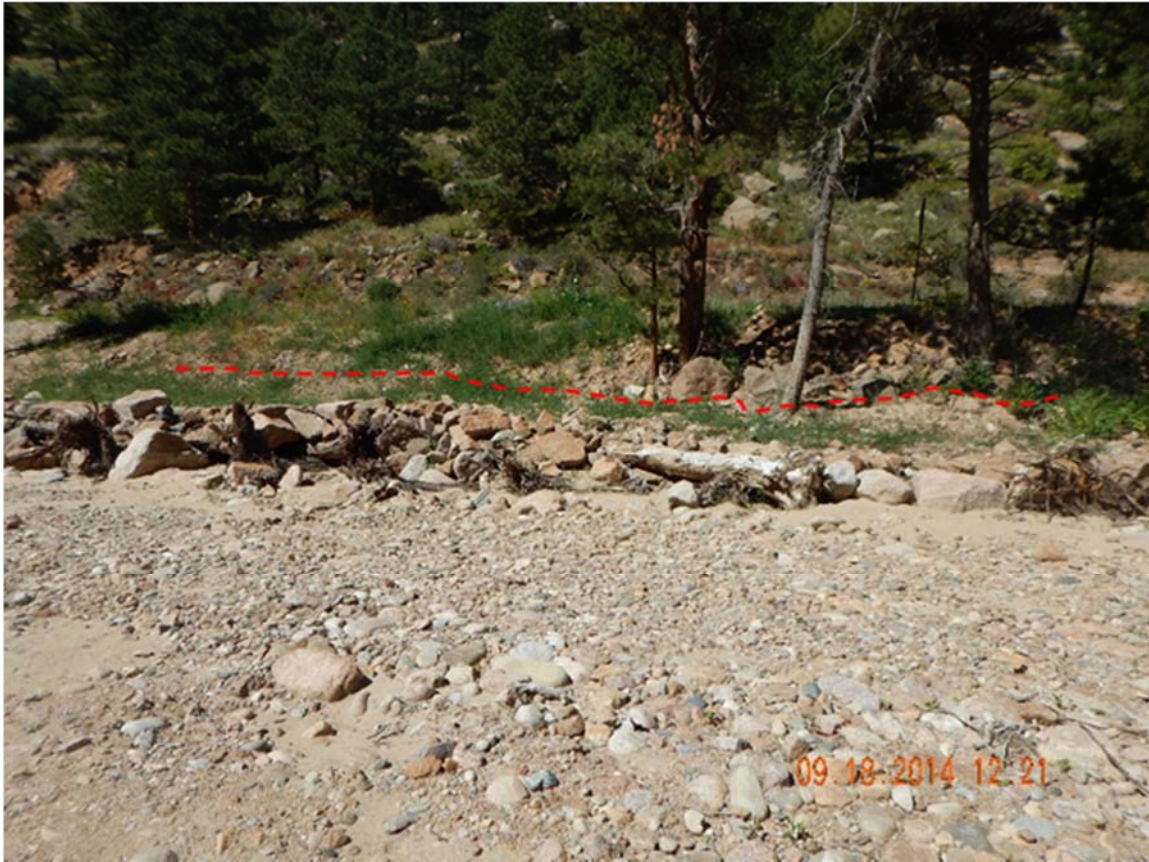
FIGURE 3.4: SITE SSV1 ON THE SOUTH SAINT VRAIN RIVER NEAR LYONS. LOOKING UPSTREAM, EVIDENCE OF HWMS ON THE LEFT BANK

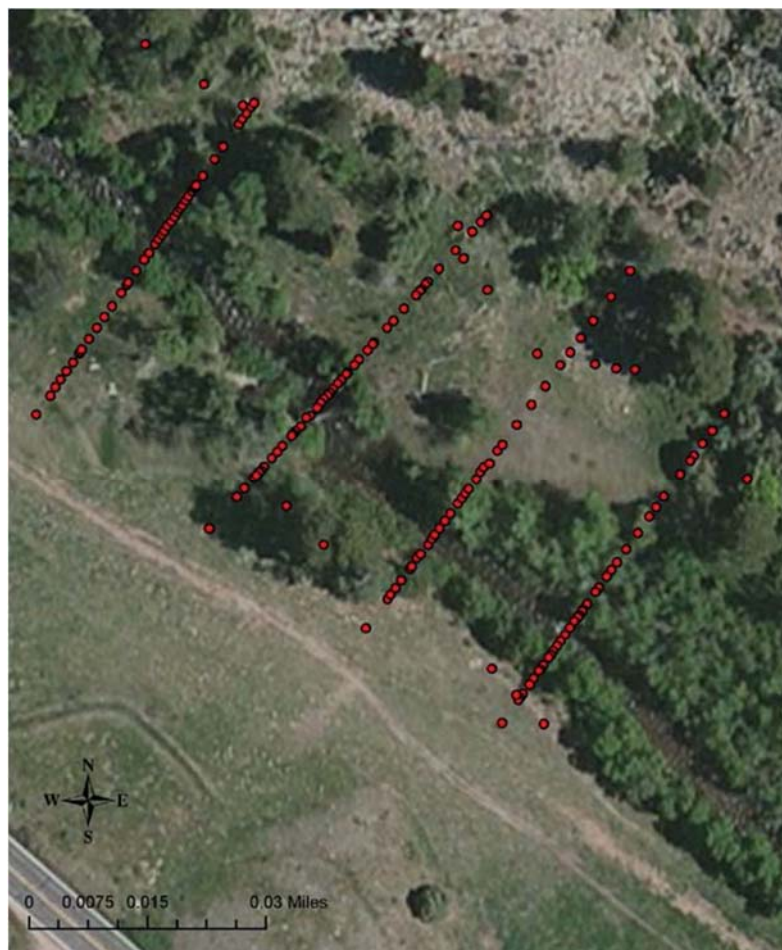
FIGURE 3.6: CROSS SECTIONS SURVEYED AT SITE NBT1 ON THE NORTH FORK OF THE BIG THOMPSON RIVER NEAR DRAKE. THE CROSS-SECTION WHERE USED TO DEVELOP THE 1D HEC-RAS HYDRAULIC MODEL FOR THE SITE (HARDEN, DEWOLFE AND KLINGER, 2014).

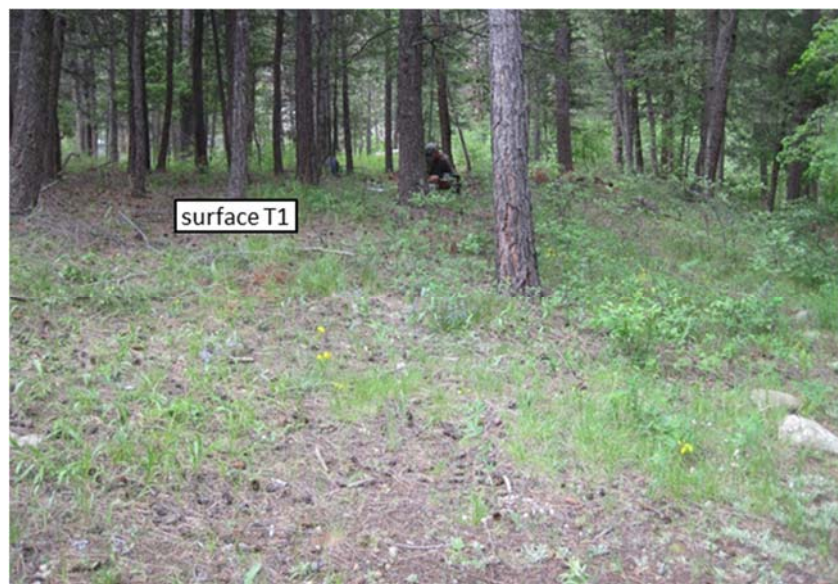
Two sites were investigated on the North Saint Vrain immediately downstream of Button Rock Dam. The first site (NSV1) is located immediately downstream of the dam outlet work and is characterized by a flood plain and two terrace surfaces (a higher T1 surface and a lower T2 surface) preserved on the left bank of the river that appears to be isolated from historical flows. While the North Saint Vrain is historically been impacted by several floods, the terraces morphology at this site is particularly well preserved due to the presence of the dam and outlet work controlled flow releases. The center section of the lower terrace T2 is characterized by a gravel bar with large exposed boulders, while the back of the terrace presents evidence of an old back channel. While the terrace, approximately three feet above the floodplain, appears of a certain age, evidences of old flows are still present on the surface. The highest and older T1 surface (Figure 3.9), approximately two feet above the T2 surface has a smooth appearance with no evidence of flooding. A 55-inch deep test pit was excavated on this surface exposing what appears to be a continuous stratigraphic profile, which will be an indication of prolonged surface stability (Figure 3.10). The upper part of the profile (O/A/Bw1/Bw2 horizons) is characterized by fine sandy alluvium parent material, while the lower part (2Bw horizon) is composed by sandy gravelly alluvium.

FIGURE 3.9: HIGHER T1 TERRACE ON THE LEFT SIDE OF THE CHANNEL AT SITE NSV1 DOWNSTREAM OF BUTTON ROCK DAM.

A piece of charcoal collected in the 2Bw horizon yielded a radiocarbon age of  $5720 \pm 30$  (RCYBP), 6690-6505 CAL years BP, (Appendix G) indicating that this is indeed a very old stable surface. A peak discharge in the range of 7,300 to 9,950  $\text{ft}^3/\text{s}$  was estimated for the non-exceedance bound at this site on the basis of a slope conveyance calculation through a single cross-section using Manning's equation and a critical depth calculation (Appendix C). This discharge range represents a 3-foot flood depth over the surface of the terrace T1.

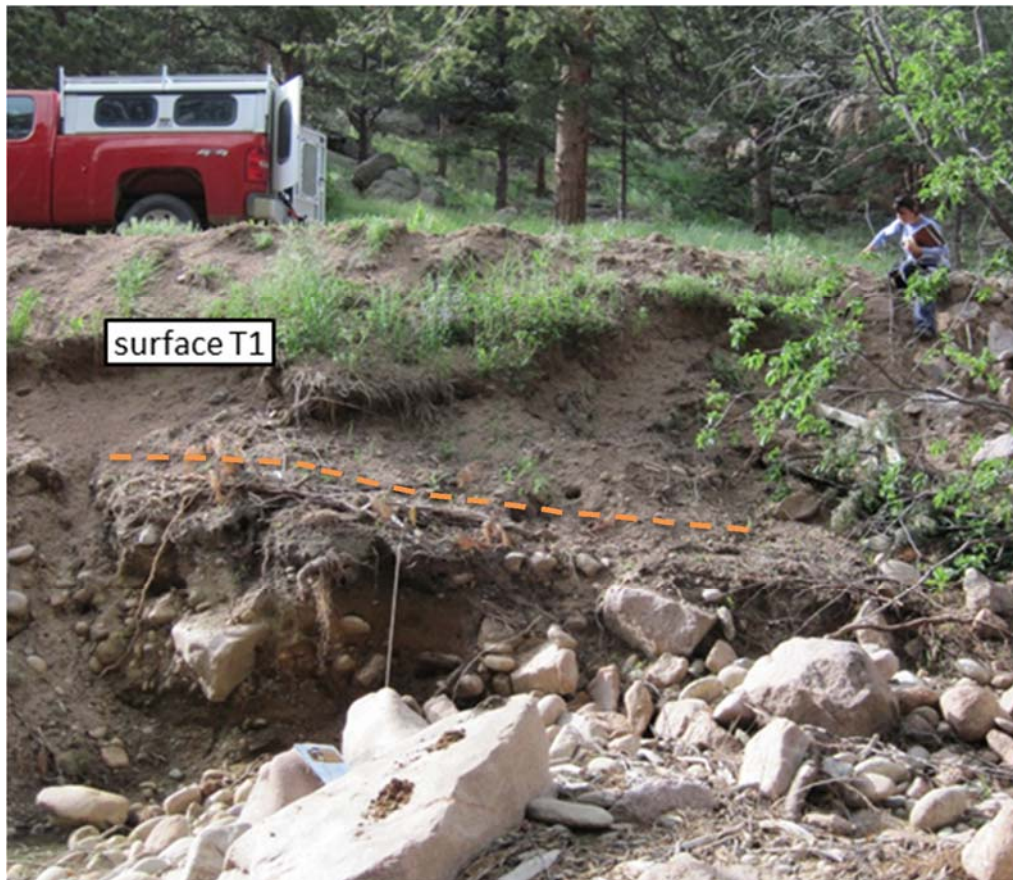
The surface T1 stratigraphy was described in a soil exposure on the left riverbank (Figure 3.11). From the observation of numerous high water marks at the site, it was clear that the T1 surface had been lightly overtopped by flows in 2013 while run off flows along the road were responsible for the scour of the road embankment slope. The soil stratigraphy of surface T1 appears continuous and consistent with what already described at site NSV1 (A/Bw/2Bw). A piece of charcoal collected in the Bw horizon yielded a radiocarbon age of 1290 ±30 (RCYBP), 1355-1245 CAL years BP, (Appendix G). Because the T1 terrace remnant did not appear to be heavily overtopped or modified in its continuous stratigraphy by the 2013 flows, and because the computed flows cannot be considered a natural flow due to the large contribution from the emergency spillway discharge, it can be concluded that discharges in the range of 16,950 to 14,570 ft<sup>3</sup>/s have not been exceeded at this site approximately in the past 1250 to 1350 years.

FIGURE 3.11: T1 SURFACE SCoured BY THE 2013 FLOOD FLOWS ON THE LEFT SIDE OF THE CHANNEL AT SITE NSV2. THE ORANGE LINE IDENTIFIES THE HIGH WATER MARK ELEVATION ON THE SLOPE.

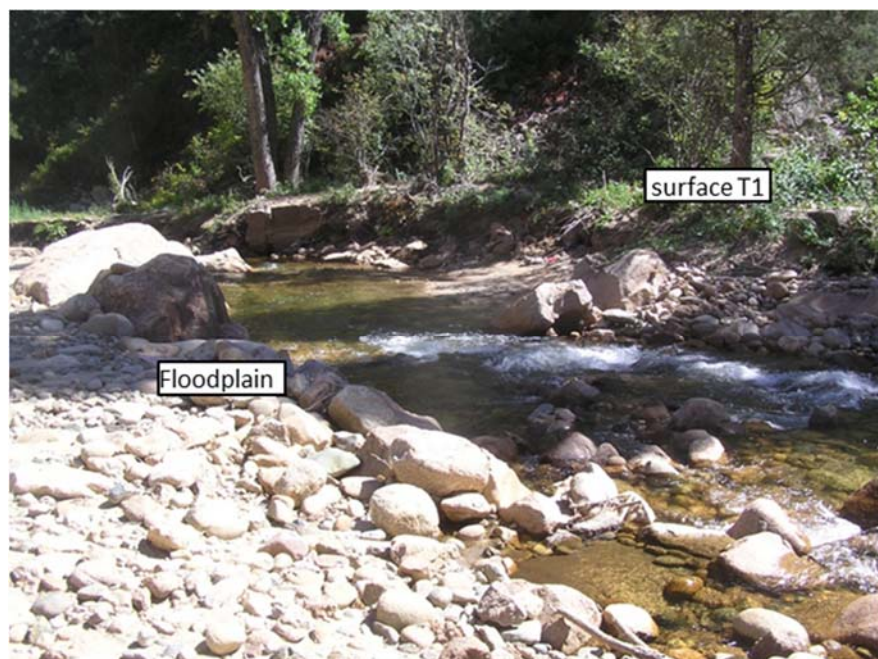
FIGURE 3.13: T1 SURFACE AND FLOOD PLAIN WIDEN BY THE 2013 FLOWS ON THE LEFT RIVERBANK AT SITE SSV1.

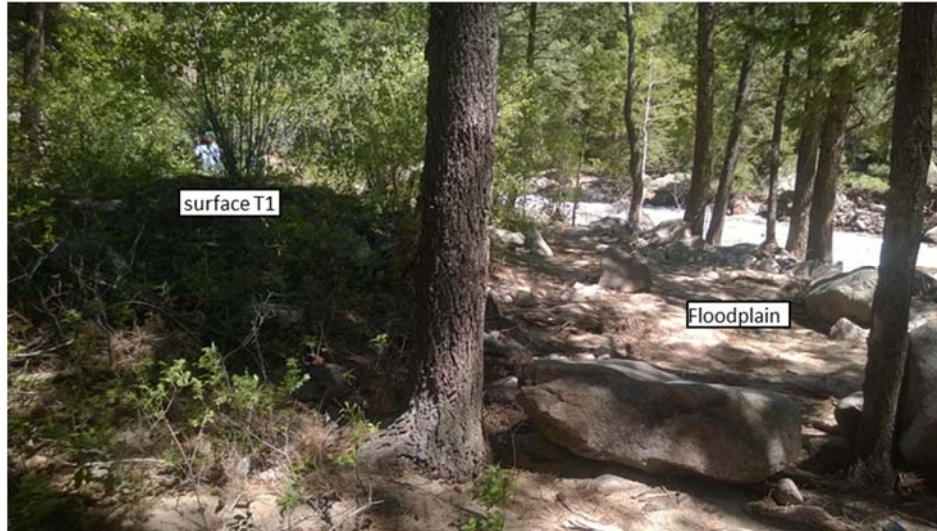
The second site (SSV2) is located along the South St. Vrain downstream and near the confluence with the Middle St Vrain. The site is characterized by a one single terrace, which appears partially overtopped by recent flows only on its margins near to the floodplain (Figure 3.15).

FIGURE 3.15: T1 SURFACE AND FLOOD PLAIN ON THE LEFT RIVERBANK AT SITE SSV2. NUMEROUS LARGE BOULDERS ARE PRESENT ON THE FLOOD PLAIN AND ON THE SURFACE OF THE T1 TERRACE.

The majority of the terrace surface appears in its natural state, irregular as punctuated by several large boulder in place, and highly vegetated. Several large boulders, which represent talus from the near hillslope, are present on the flood plain. Flotsam and flood sand from recent events, most likely the 2013 flood) are visible on the floodplain but not on the terrace surface analyzed. A test pit was excavated on the T1 terrace, which is composed by sandy and gravelly alluvium parent materials (Figure 3.16).

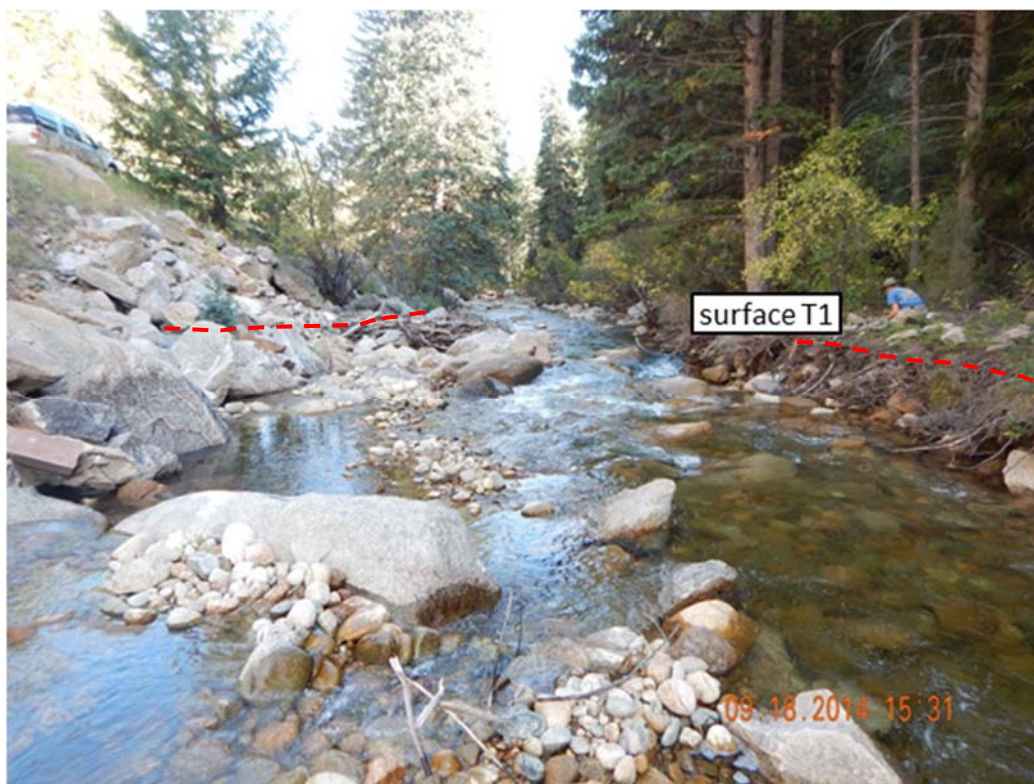
The single site investigated on the Middle Saint Vrain River (MSR1) is located immediately upstream of the confluence with the South St. Vrain River. The site is characterized by one terrace preserved on the right riverbank, of which only the upstream margin appeared to be marginally overtopped with signs of sand deposition during the 2013 flood event. While most the main terrace surface appears to be non-disturbed and smooth, the downstream end of the terrace is covered by slope failures debris. Both riverbanks are developed over unconsolidated materials. The channel relief in the right riverbank is approximately five feet while on the left riverbank is closer to 15 feet. Large non in-place boulders and rocks are present on the riverbed while bedrock is not exposed in the channel or the riverbanks (Figure 3.17). Flotsams were observed on the upstream side of the T1 terrace on the right riverbank, and on the rock slope of the left canyon wall. The T1 terrace stratigraphy, characterized by fine grain alluvium, was described on a soil exposure approximately five feet above the river channel (Figure 3.18). The stratigraphy reveals a medium developed soil formed above a 26- thick flood sand deposit fining downward. This sand deposit, that most likely represent multiple stages of a single event, appears to truncate a buried Ab soil horizon which, had developed over an older buried flood sand (Cb horizon).

FIGURE 3.17: T1 SURFACE ON THE RIGHT RIVERBANK AT SITE MSV1. FLOTSAMS FROM THE 2013 FLOOD EVENT ARE CONTAINED FOR THE MAJOR PART WITHIN THE RIVER CHANNEL. THE HIGH WATER MARKS ELEVATION IS IDENTIFIED WITH A RED LINE.

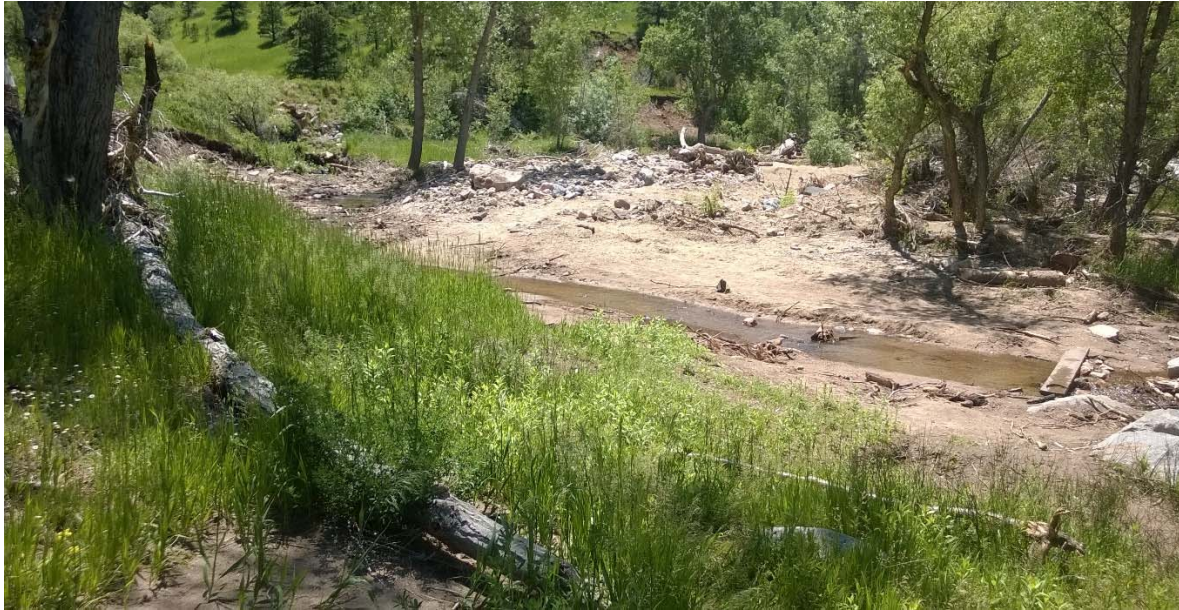
FIGURE 3.19: T1 SURFACE NEAR THE CONFLUENCE WITH SIX MILE CREEK. FLOTSAMS AND LARGE WOODEN DEBRIS FROM THE 2013 FLOOD EVENT ARE DEPOSITED ON THE WIDEN AND ERODED RIVER CHANNEL.

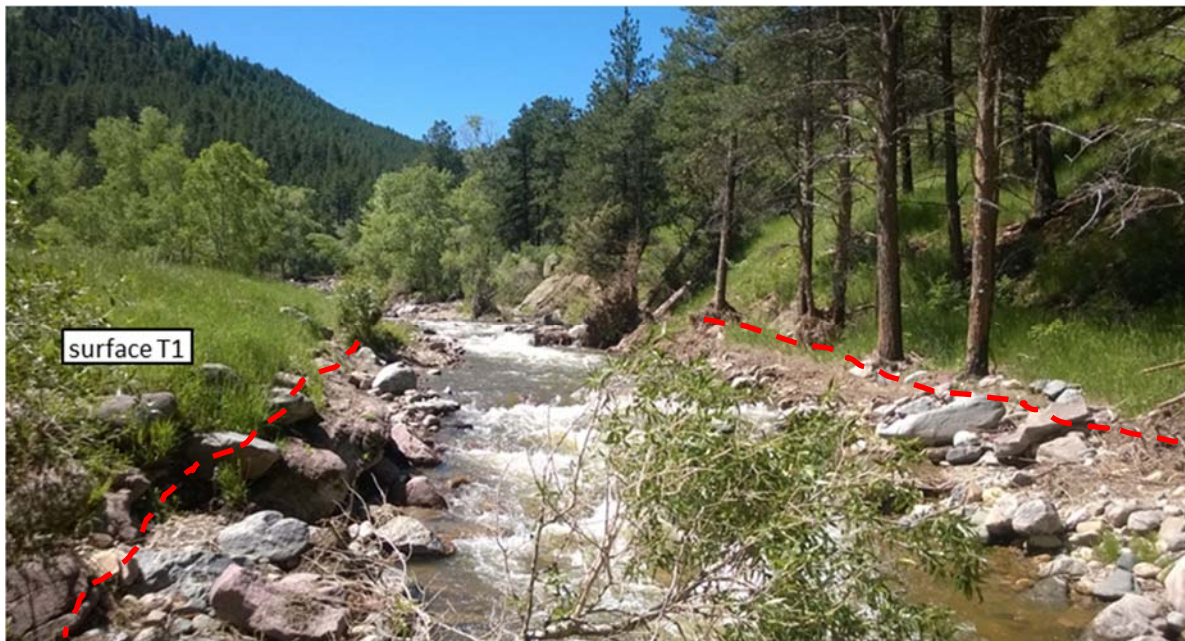
FIGURE 3.20: T1 SURFACE ON THE LEFT RIVERBANK LOOKING UPSTREAM AT SITE LHC1. FLOTSAMS AND ELEVATION OF HIGH WATER MARKS FROM THE 2013 FLOOD EVENT ARE IDENTIFIED BY A RED LINE.

The downstream section of the T1 terrace further from the confluence appears overtopped but less disturbed (Figure 3.20). From his position and from the exposed stratigraphy this inset section of the terrace could be cut on alluvial fan material. The stratigraphy of the T1 terrace was described in this downstream section in a soil exposure characterized by medium to coarse grained, quartz-rich granitic sand parent material. The stratigraphy of the exposure shows a poorly developed soil (A/Ab/2Bw) incorporating medium to large rounded boulders in the lower section of the soil profile (Figure 3.21). Pockets of lighter sand (possibly from Six Mile Creek) are also incorporated in the upper portion of the A horizon, suggesting the potential presence of multiple wetting flows on this surface in recent years. In this section of the T1 terrace, flotsams were observed along the margins near to the right riverbank as well as on the left riverbank slope at similar elevation (Figure 3.20).

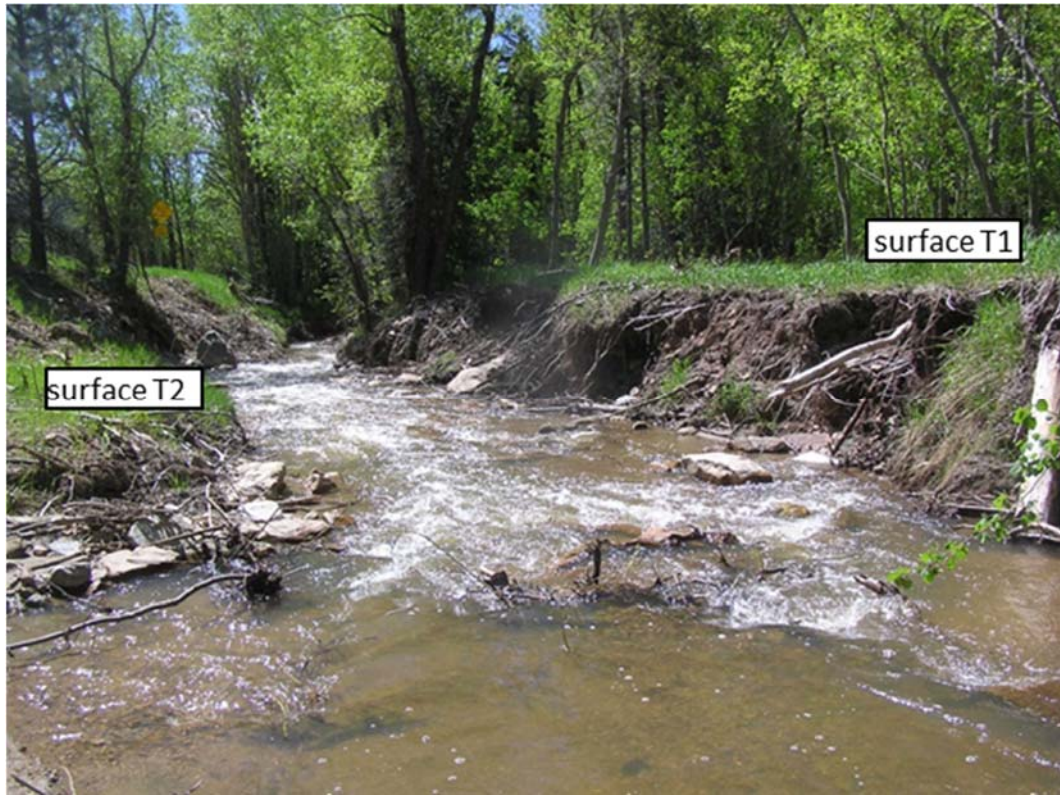
The high water marks and flotsams present on the T1 surface offered an identifiable trail that allowed determining the location where the overbanked flows had re-entered the river. The section of the T1 terrace downstream of this location, where the stratigraphy was described, was therefore considered non-disturbed by flows for the 2013 event.

FIGURE 3.22: LOWER T2 SURFACE ON THE LEFT RIVERBANK AND HIGHER T1 SURFACE ON THE RIGHT RIVERBANK LOOKING DOWNSTREAM AT SITE CC1.

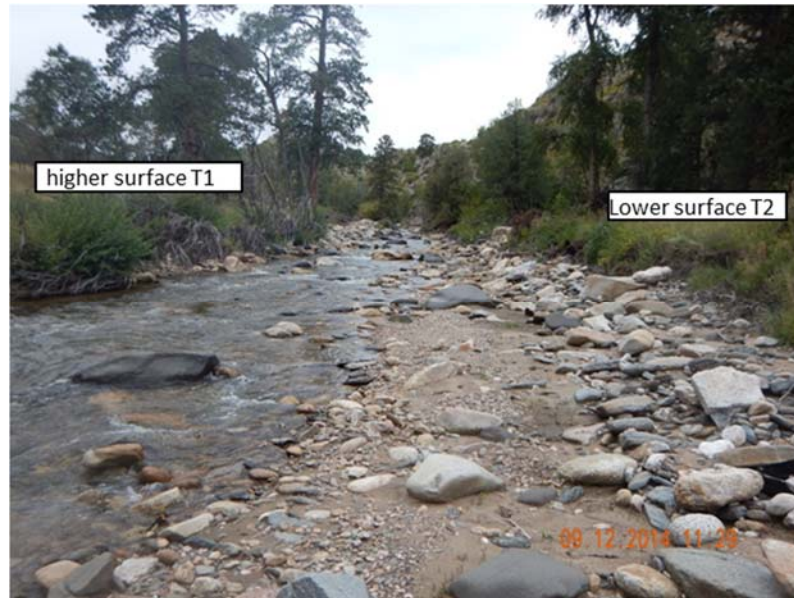
The river channel is composed of large cobbles and boulders with interstitial sand and silt. Bedrock outcrops are visible through the reach, primarily along the right bank and in the hillslope along the left valley wall. The site is characterized by a, fairly broad, lower surface T2 presents on both riverbanks about 5-6 feet above the active river channel and a higher surface T1 observed on the right riverbank approximately 7-8 feet above the river (Figure 3.24). From field observation, the T2 surface appeared extensively overtopped during the 2013 flood, with high water marks visible along the contact between the terrace and the hillslope and flood sand deposition on the margins of the terrace closest to the river channel. As shown on the site

geomorphological map (Appendix B) a small but continuous remnant of the T1 surface is preserved on the right riverbank between the T2 surface and the hillslope. Flood sand and flotsams from the 2013 flood were visible on this surface only along the bend in the upstream section of the reach, while the T1 surface on the center section of the reach did not show any sign of recent flows.

FIGURE 3.24: LOWER T2 SURFACE ON THE LEFT RIVERBANK AND HIGHER T1 SURFACE ON THE RIGHT RIVERBANK LOOKING DOWNSTREAM AT SITE NBT1.

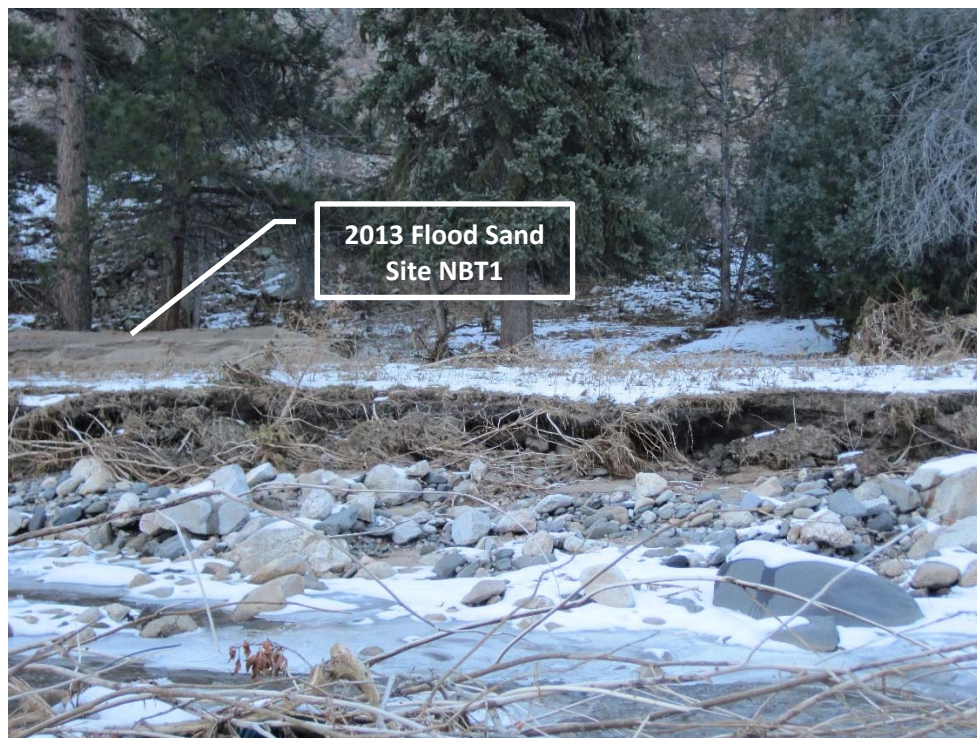
The exposures edge appeared eroded and partially collapsed in near sections of the terrace from the action of recent flows. Although not visible in the exposure, flood sand from the 2013 event is deposited extensively along the surface (Figure 3.26).

FIGURE 3.26: SITE NBT1, EVIDENCE OF 2013 FLOOD SAND OVER THE TERRACE A-HORIZON.

The stratigraphy shows a thin A-horizon forming over a flood sand C-horizon, most likely deposited during the 1976 Big Thompson flood. The 1976 flood sand is deposited over a 26-cm-thick, medium developed, buried Ab1 horizon. Below the Ab1 horizon, another flood sand is deposited over a holder buried Bb2-horizon of which the upper A-horizon may have been removed by flows erosion. The bottom of the exposure is characterized by another Cb2-horizon over which the buried Bb2-horizon had developed. This stratigraphy sequence suggests that at least three paleoflood events are recorded at the site.

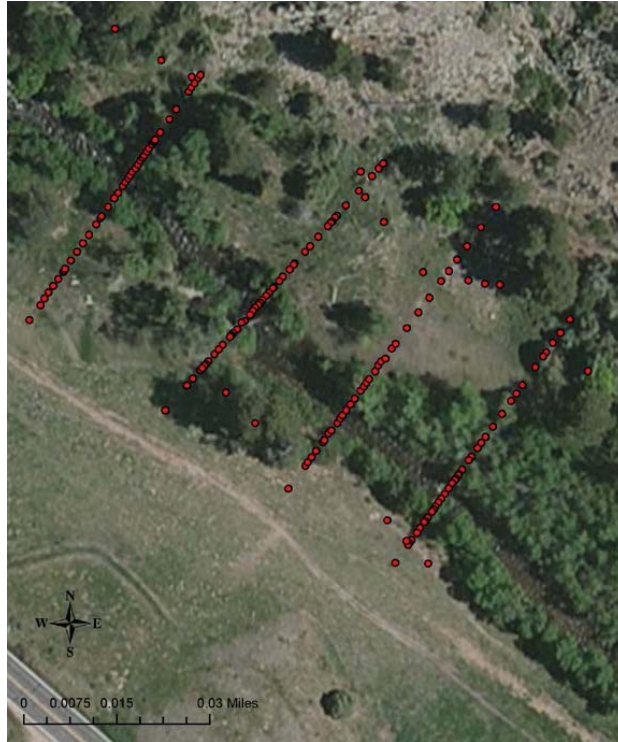
As part of a study conducted by Reclamation in 2014 (Harden, deWolfe and Klinger, 2014) a HEC-RAS model of the same site was developed using four cross sections measured along a channel segment of about 280 feet (Figure 3.27).

FIGURE 3.27: SURVEYED CROSS SECTIONS AND HWMs ALONG THE NORTH FORK BIG THOMPSON RIVER AT SITE NBT1 (FROM HARDEN, DEWOLFE AND KLINGER, 2014)

The results of the hydraulic modeling indicate that the peak discharge through the reach was about 9,750 ft<sup>3</sup>/s. The flood frequency return period estimated for flows of this magnitude in the North Fork Big Thompson River basin is approximately 150 years. A peak discharge estimate of 15,000 ft<sup>3</sup>/s can be obtained from the Envelope curve developed for Northern Colorado (see Figure 2.2), for a drainage area of approximately 77 mi<sup>2</sup>, such as the drainage at site NBT1. Based on the peak discharge of 8,710 ft<sup>3</sup>/s recorded at the town of Drake (USGS 06736000) during the 1976 flood, for a drainage area of 85mi<sup>2</sup>, it can be concluded that the discharge produced by the 2013 event was comparable to the 1976 flood event and most likely slightly larger. Based on the comparable nature of the 2013 and 1976 flood at this site it could be suggested that both flood can be associated to a return period of approximately 150 years.

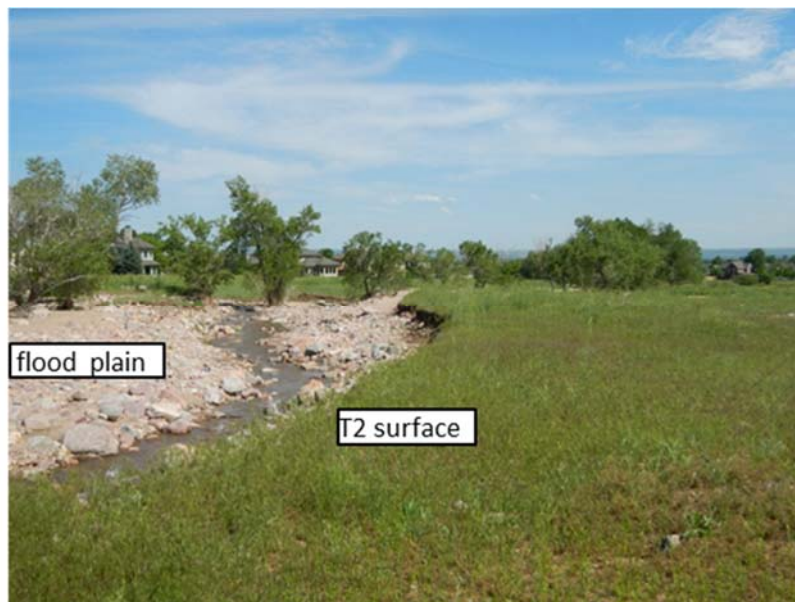
FIGURE 3.29: FLOODPLAIN AND LOWER T2 SURFACE ON THE RIGHT RIVERBANK LOOKING DOWNSTREAM ALONG FOURMILE CANYON CREEK.

Two sites were investigated along Fourmile Canyon Creek (4MC1 and 4MC2), but due to the proximity of their location, these were considered as a one single reach. The reach investigated along the river in the proximity of the city of Boulder, Colorado, encompasses a drainage area of 7.2 mi<sup>2</sup>. The site analyzed is characterized by a well-defined flood plain, greatly widened by the 2013 flood event, and scoured remnants of a lower (T2) and higher (T1) surfaces (Figure 3.28-3.29, geomorphological map on Appendix B).

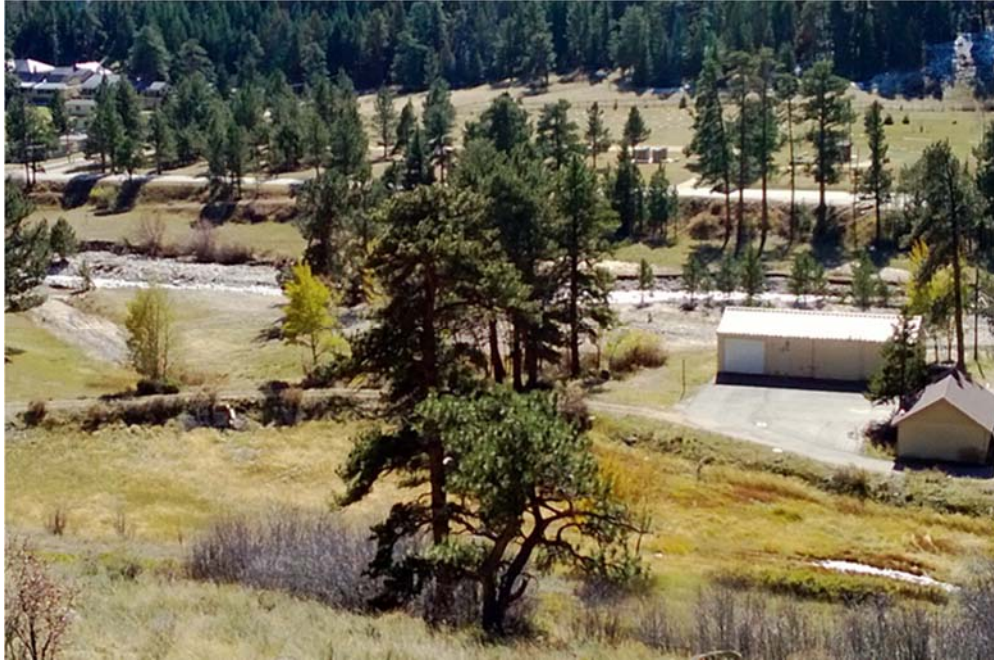
Field observation conducted as part of this research corroborated the observation that flood AEP were found lower than precipitation AEP, perhaps, because evidences of severe flooding were recorded in the lower section of several basins, while the flows caused by the 2013 precipitation event were in most cases contained within the riverbanks in the upstream section of the same watersheds. This is the case for example of the Big Thompson River and the St. Vrain River, where several tributaries located in high elevation mountain environments (upper section of the basin) were less impacted by the flood. Figure 4.1 shows the river channel and banks along Glacier Creek, a tributary of the Big Thompson upstream of Estes Park, just few weeks after the 2013 flood event. The site appears preserved in its natural state with no sign of erosion or sediment deposition from the flood. A similar trend was observed along the South St. Vrain where site SVV1, near to the river mouth upstream of the city of Lyons, experienced severe flooding (AEP > 200 years) while the site upstream in the watershed (SSV2), near to the confluence with the Middle St. Vrain, experienced less impact from the flood (AEP of 25-50 years). During the reconnaissance investigation leading to the selection of the sites examined, the upstream section of the South St. Vrain drainage, from the recreational area of Brainard Lake to the confluence with the Middle St Vrain, showed little to no sign of impact from the 2013 flood event on its channel or riverbanks.

FIGURE 4.1: GLEICER CREEK ALONG BEAR CREEK ROAD, UPSTREAM OF ESTES PARK, CO.

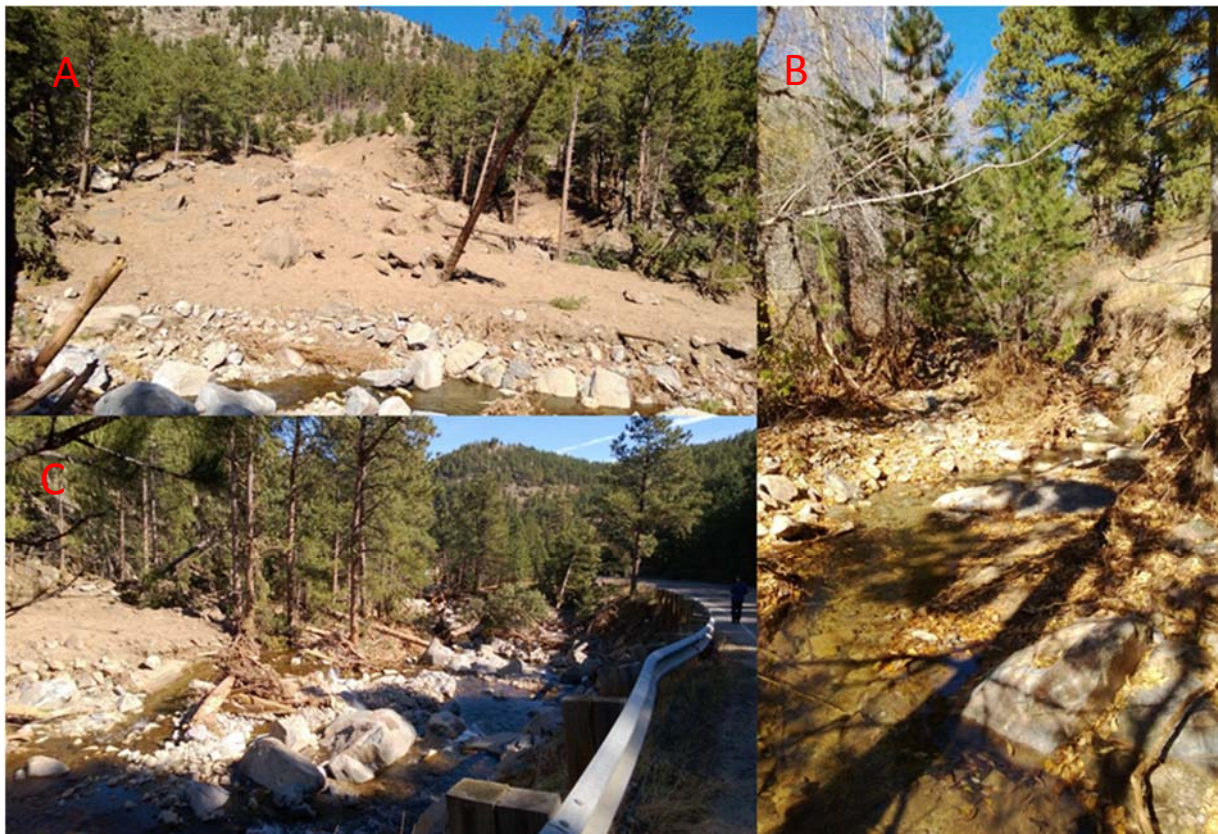
FIGURE 4.2: JAMES CREEK UPSTREAM OF THE TOWN OF SPRINGDALE, CO. (A) DEBRIS FLOW ENTRY POINT, (B) UPSTREAM SECTION OF THE CREEK, (C) DOWNSTREAM SECTION OF THE CREEK.

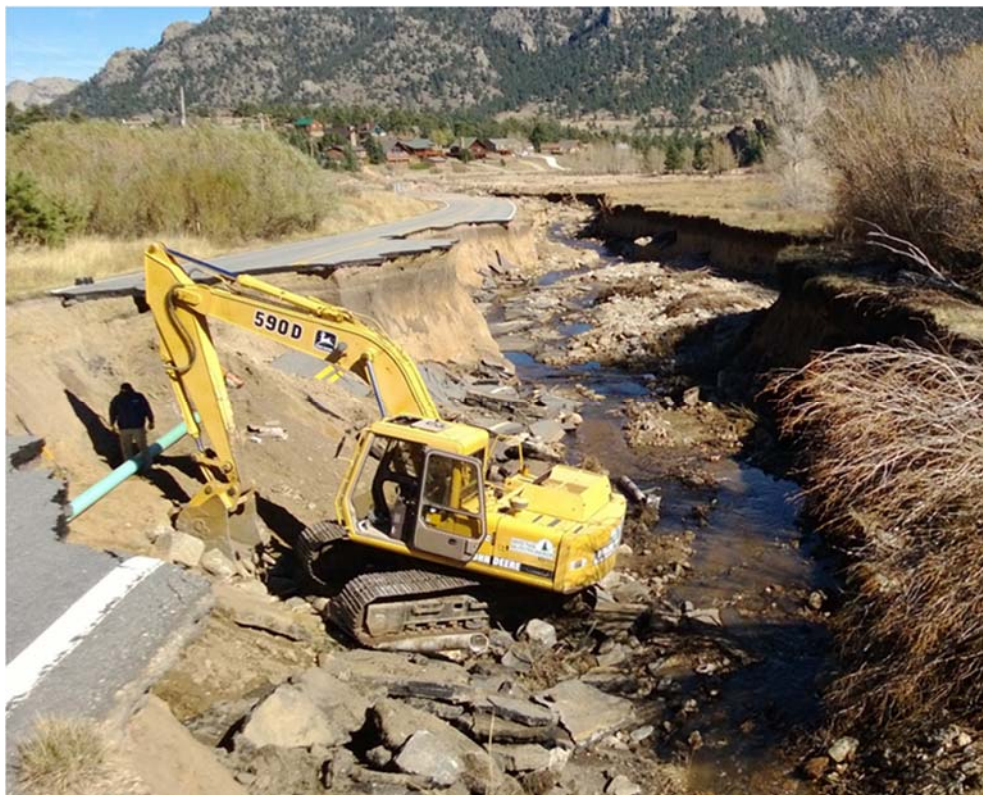
FIGURE 4.3: FISH CREEK ALONG FISH CREEK ROAD, SOUTH OF ESTES PARK, CO.

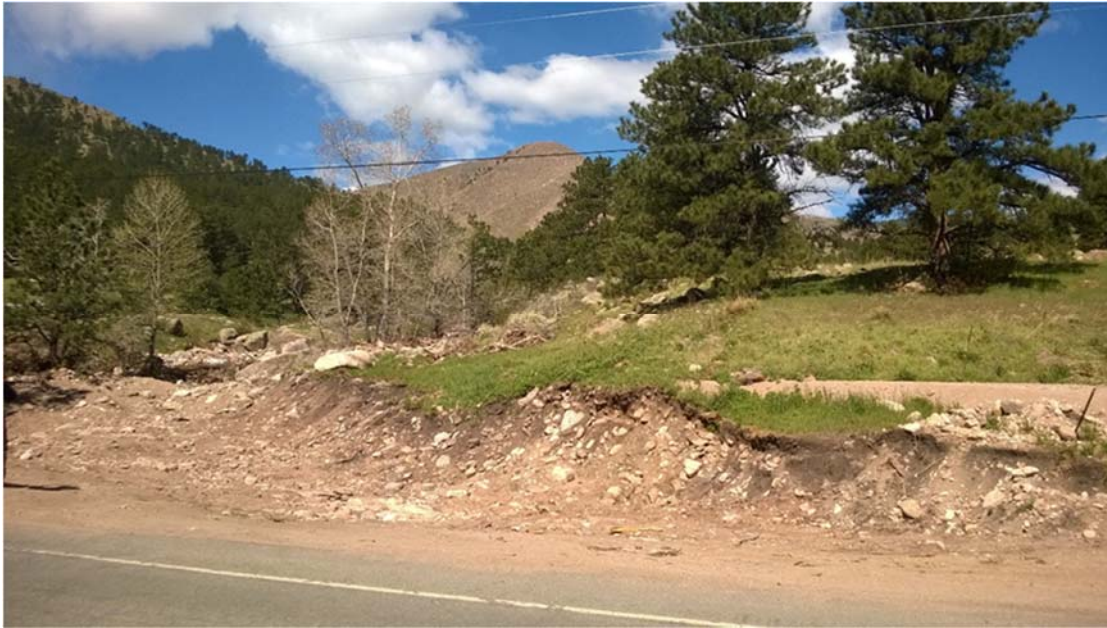
FIGURE 4.4: LEFT HAND CREEK, APPROXIMATELY 1.5 MILES UPSTREAM OF HWY 7. A DEBRIS FLOW GENERATED ON THE LEFT HILLSLOPE CROSSED THE ROAD ENTERING THE RIVER CHANNEL LOCATED ON THE OPPOSITE SIDE OF THE VALLEY.

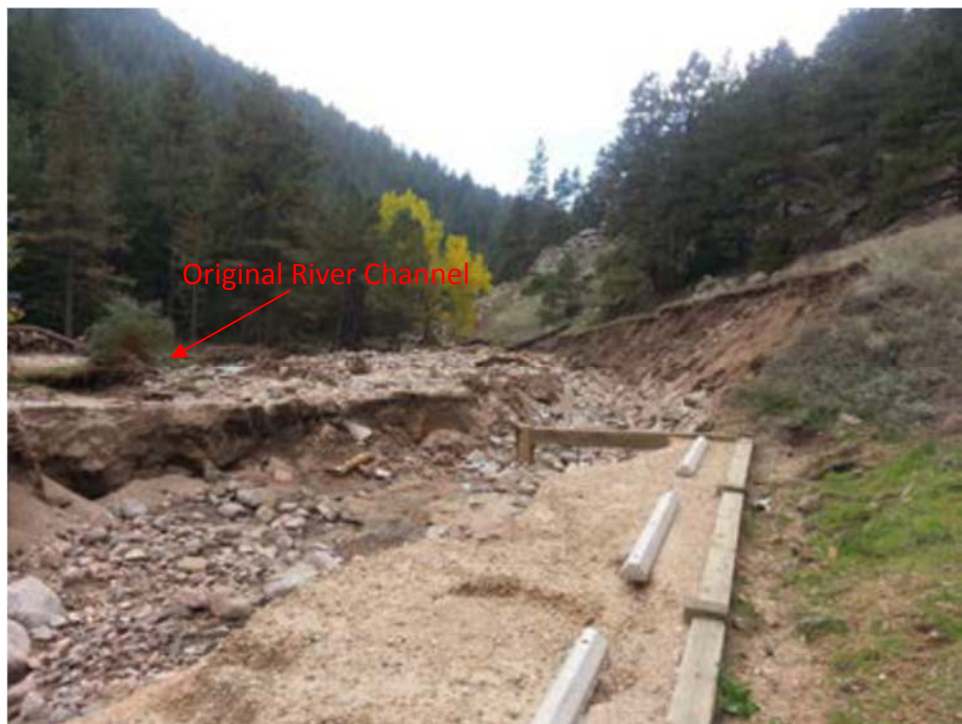
FIGURE 4.5: FOURMILE CANYON CREEK NEAR THE ENTRANCE TO THE ANNE U. WHITE TRAILHEAD NEAR BOULDER, CO. THE RED ARROW INDICATES THE PRE-FLOOD LOCATION OF THE RIVER CHANNEL.
