Buttress Dams

Best Practices in Dam and Levee Safety Risk Analysis

Part E – Concrete Structures

Chapter E-5

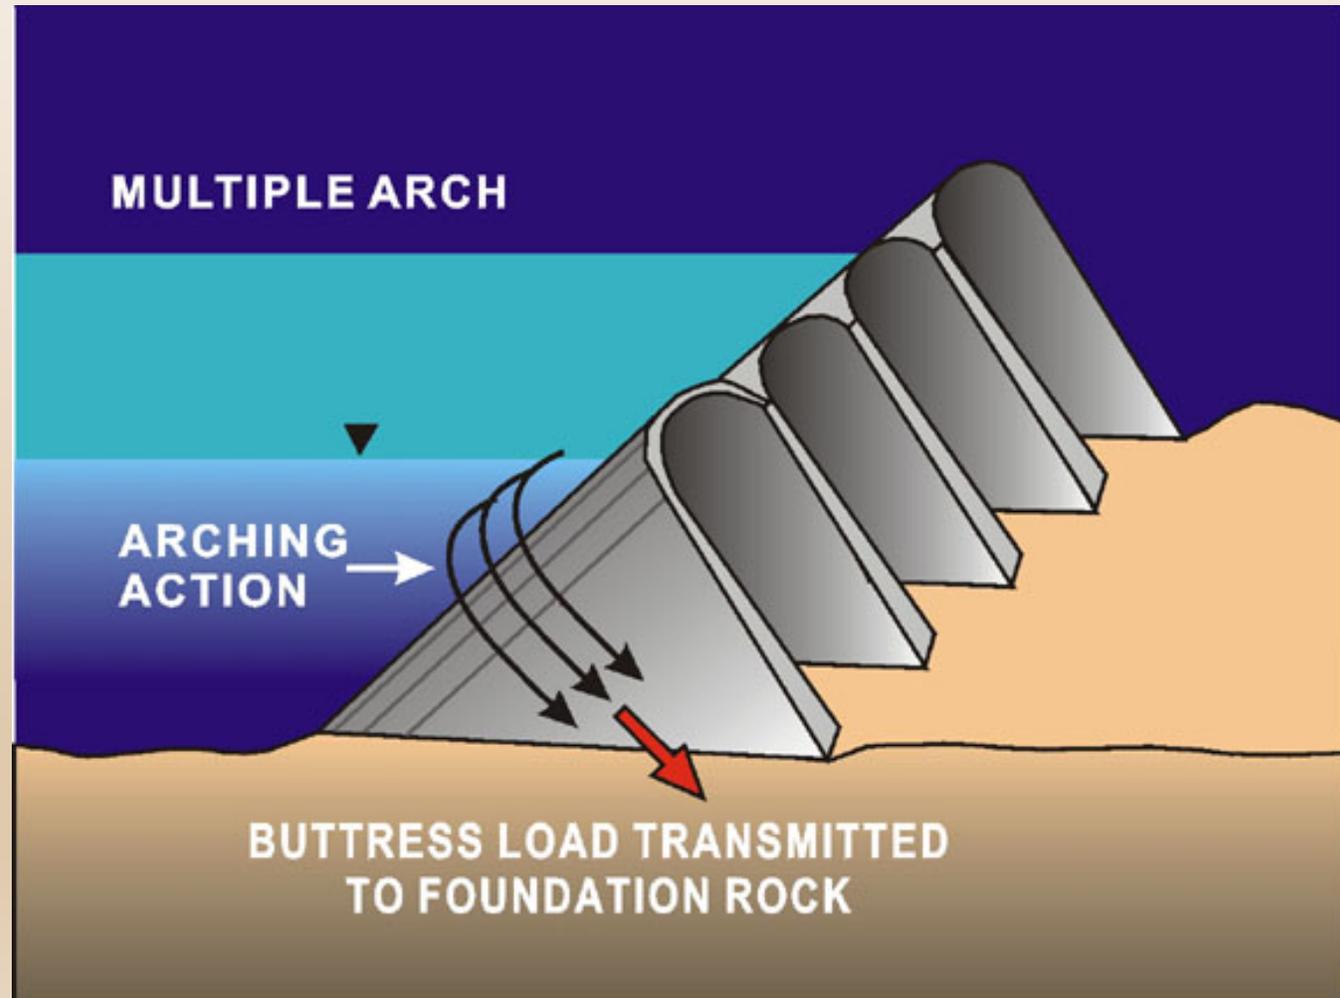
Buttress Dams

- Early 20th century
- Expensive materials
- Cheap labor
- Sloped upstream face needed for stability

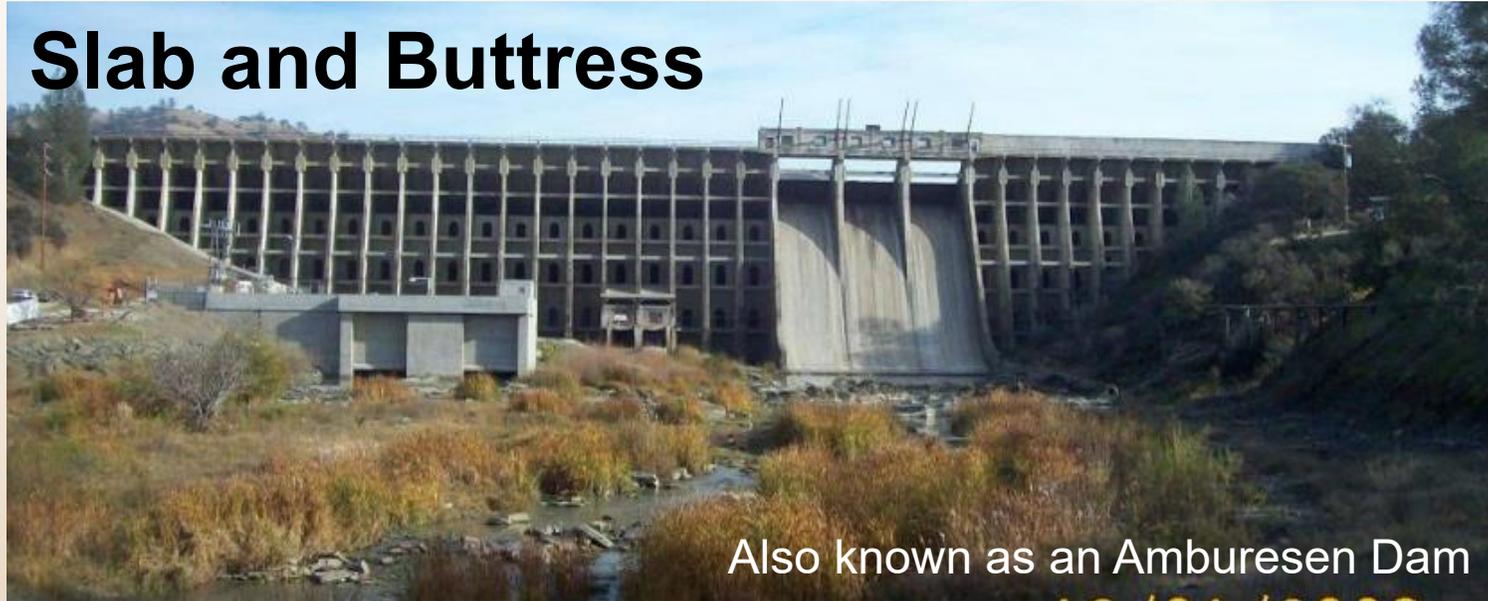
Slab and Buttress

Also known as an Amburesen Dam

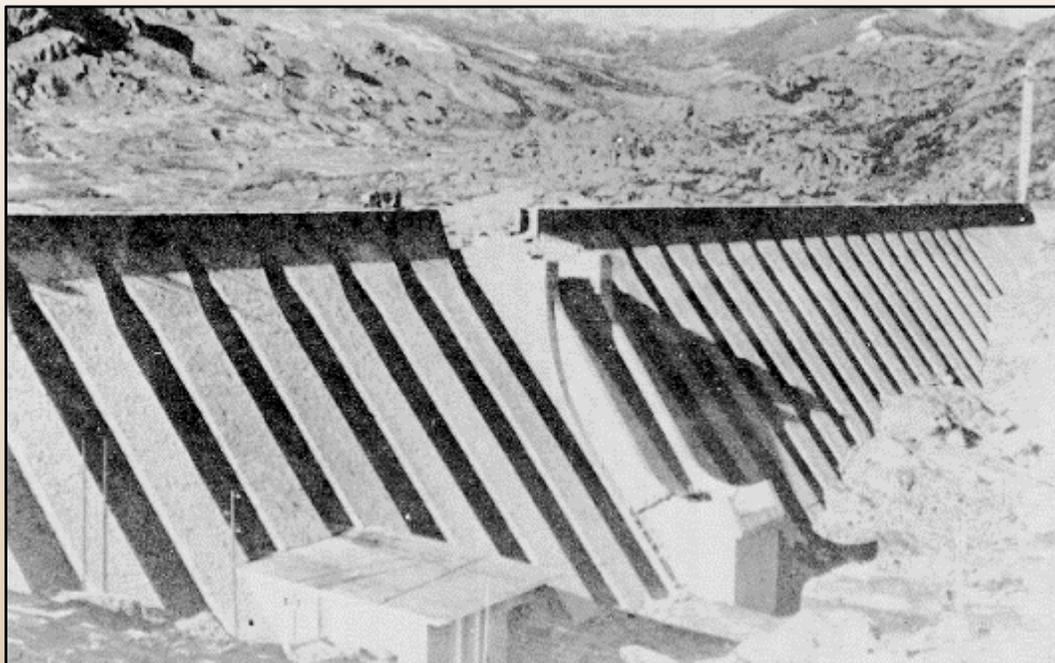
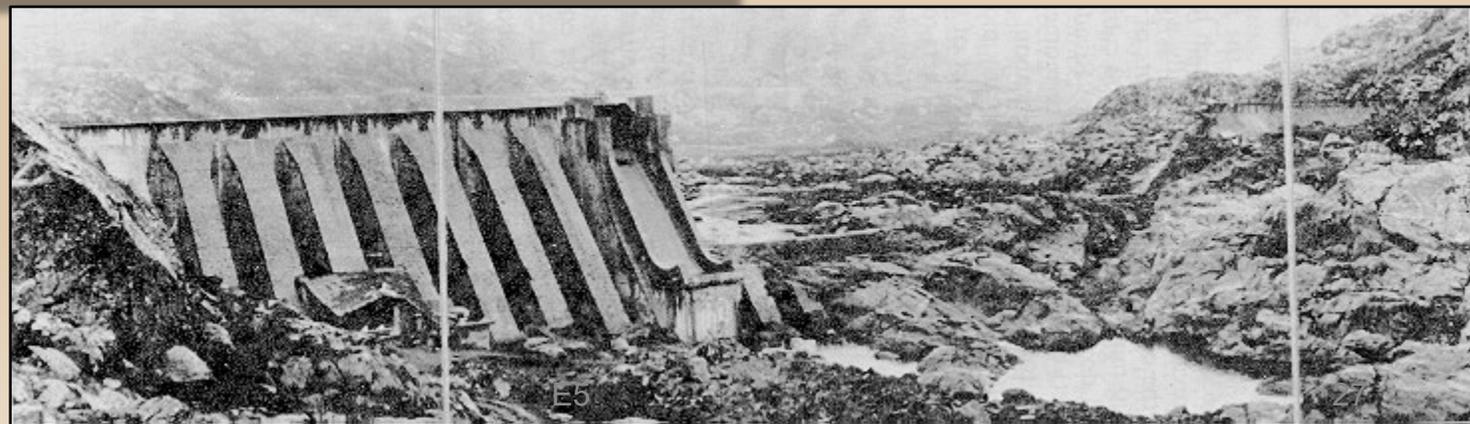
Vega de Tera Dam, Spain

- 112' high buttress dam completed 1957
- Winter shutdown, little attention to lift joints
- Failed January 10, 1959
- 144 fatalities

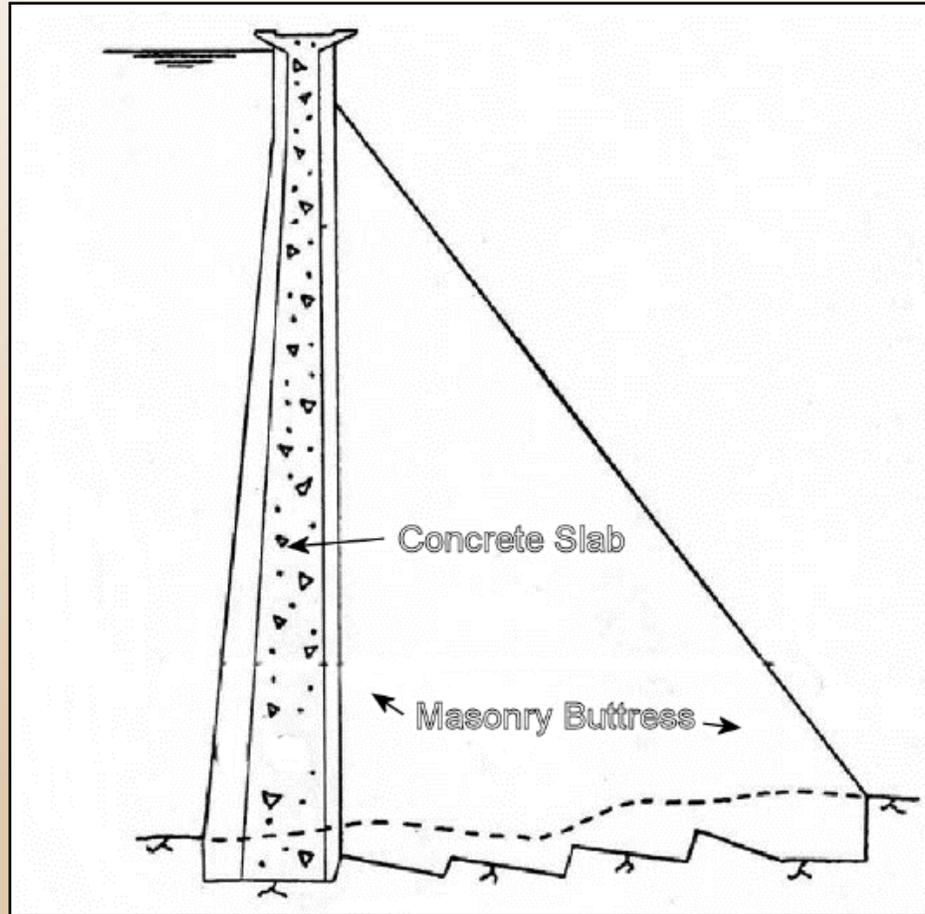
Vega de Tera Dam, Spain

But not much slope on u/s face!

- Buttresses cement mortared masonry.
- Grouting in 1956 to control leakage.
- Reservoir full in 1958. Empty in October 1958.
- In January 1958, heavy rains filled reservoir.
- 17 buttresses failed in rapid succession.
- Failure initiated between masonry and concrete on sloping portion of foundation.
- Modulus of masonry = 140,000 lb/in².
- Official cause of failure attributed to large deformations due to low modulus masonry.

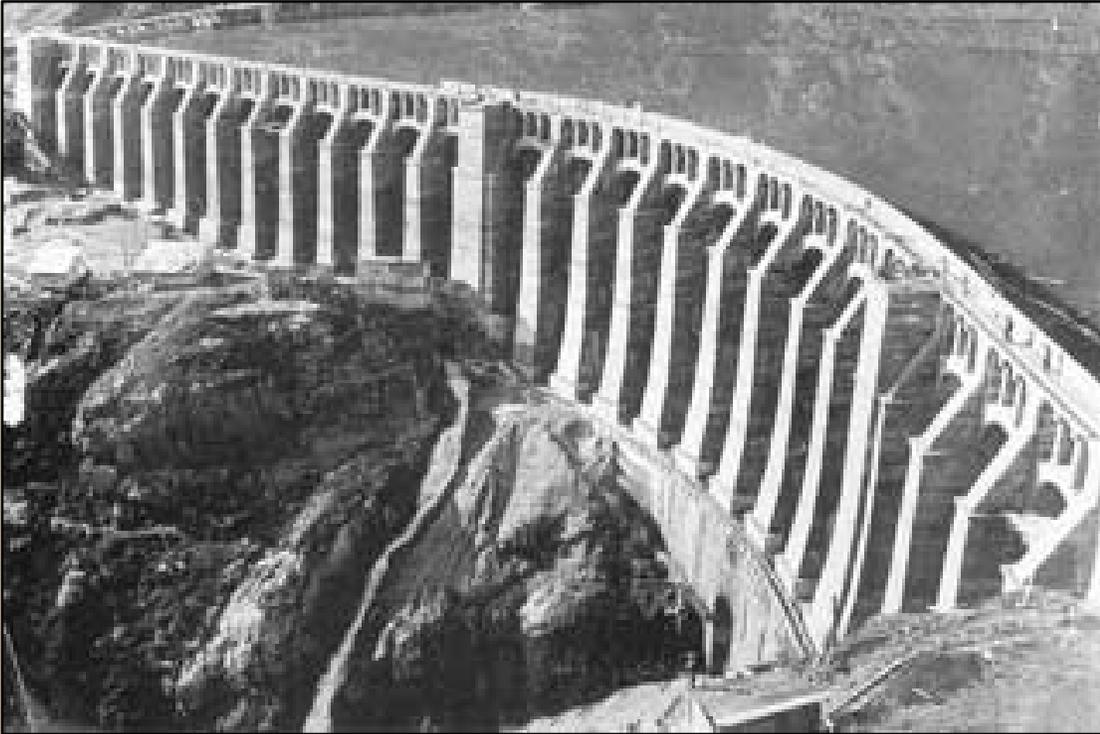
Gleno Dam, Italy

- 164-ft high multiple arch
- 52-foot high masonry plug constructed in deep central gorge (lime mortar instead of specified cement mortar)
- Original design called for gravity dam; design changed and dam built prior to approval
- Poor concrete quality
- Dam survived nearly full for 2 months
- Failed October 22, 1923
- 100-foot high wave, widespread destruction in Dezzo River Valley
- 356 fatalities

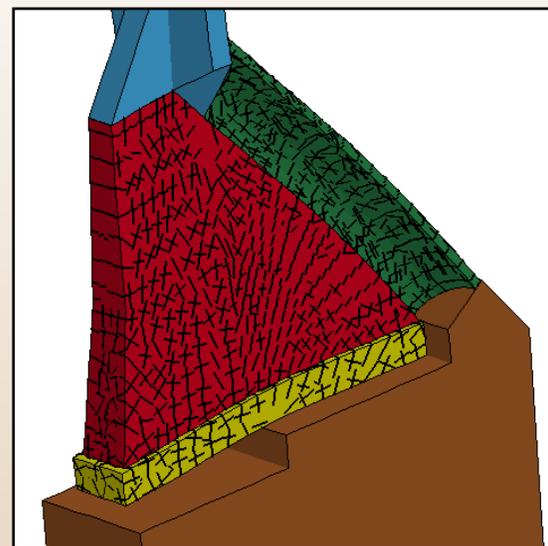
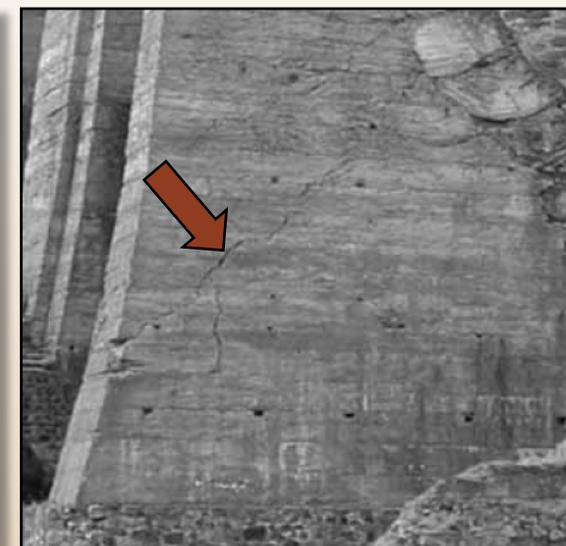
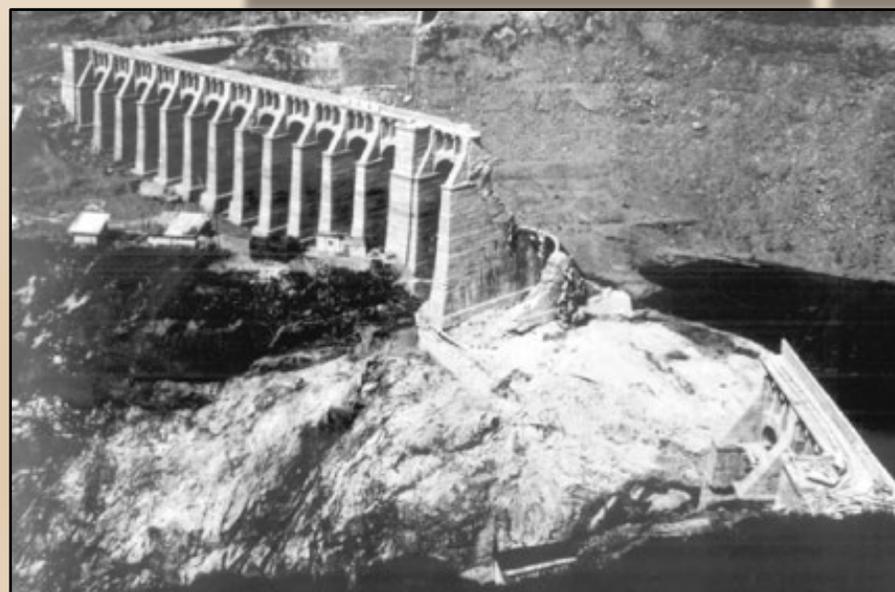
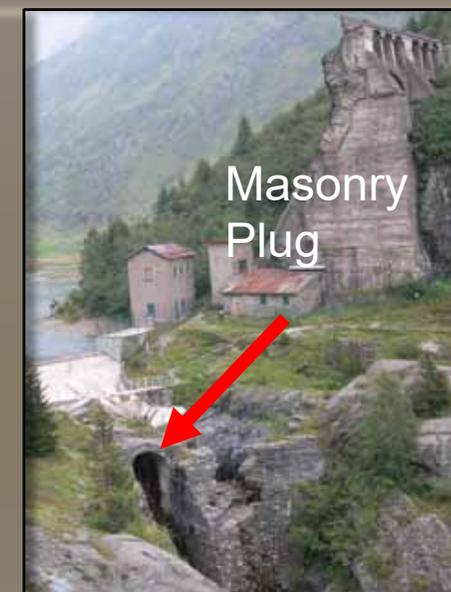
Gleno Dam Failure

- Official inquiry indicated the masonry plug was not stiff enough nor did it extend far enough downstream to carry the buttress loads.
- With complete loss of contact over the front 35 foot of foundation (representing the downstream portion of the masonry plug), the finite model depicted here fails catastrophically!
- FE model predicted cracking matched observed cracking

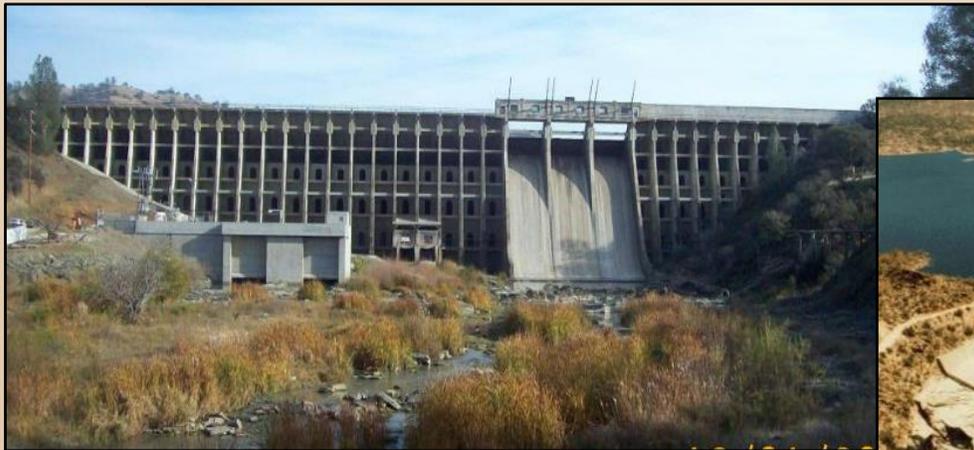
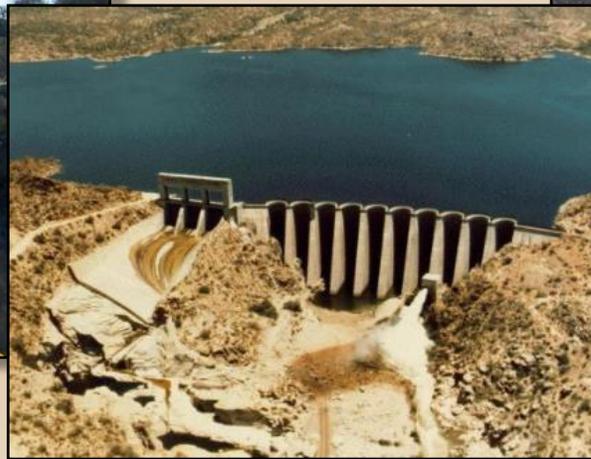
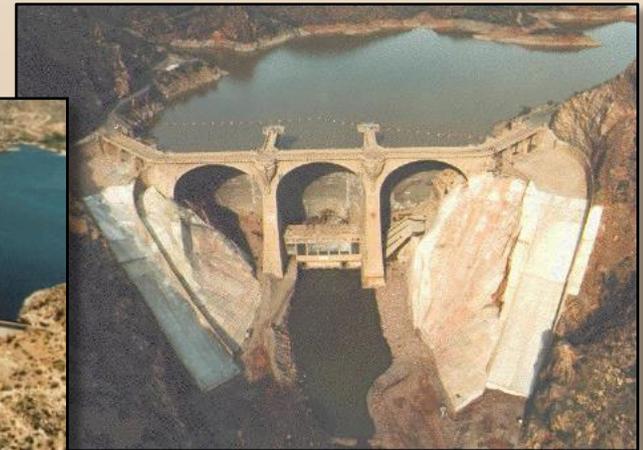
Water Barrier Evaluation

- Note that the previous event tree did not address the upstream slabs/corbels, arches, or domes.
- This would be a separate potential failure mode that should be evaluated using reinforced concrete principles (covered in another chapter).

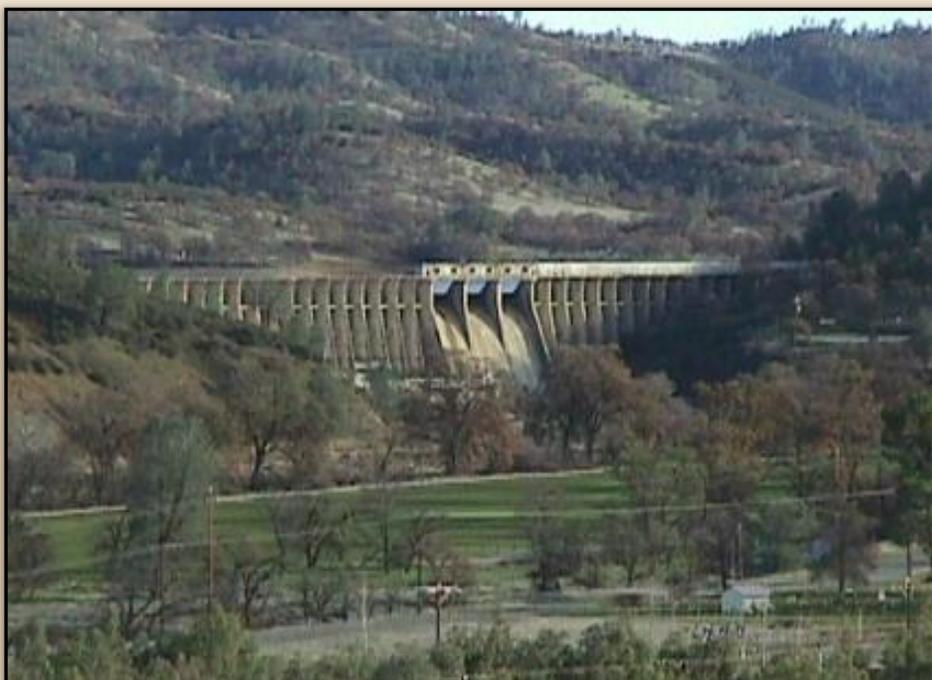
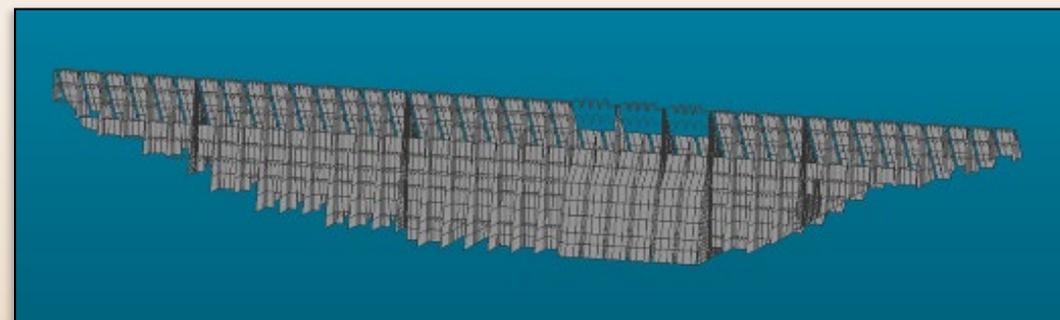
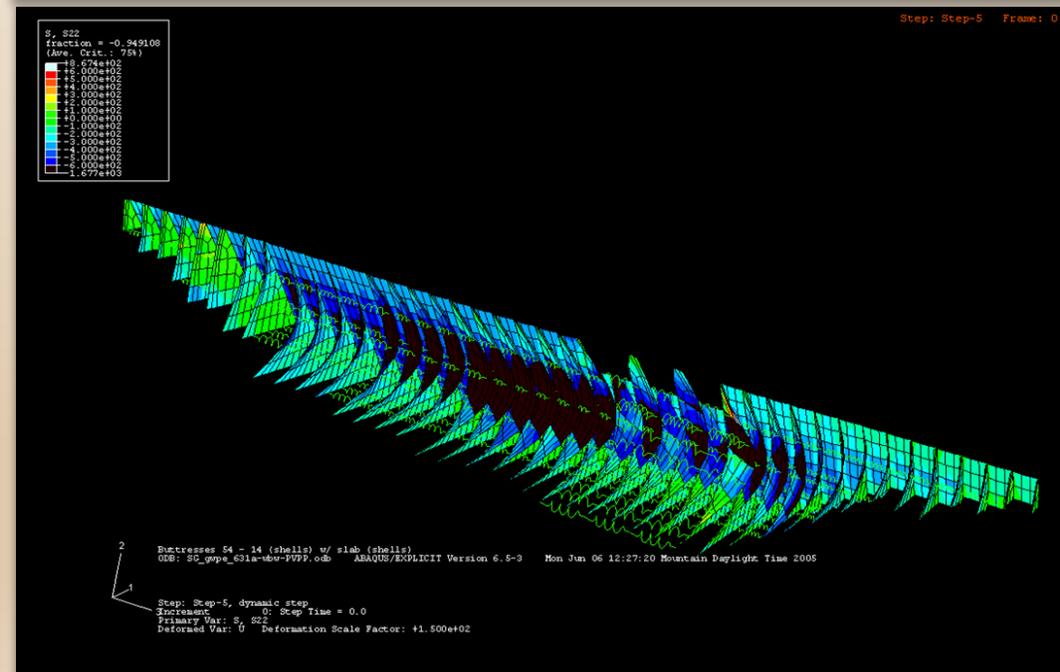
Seismic Analysis

- Buttresses weak in **cross-canyon** direction.
- Entire dam must be modeled to include “**racking**”

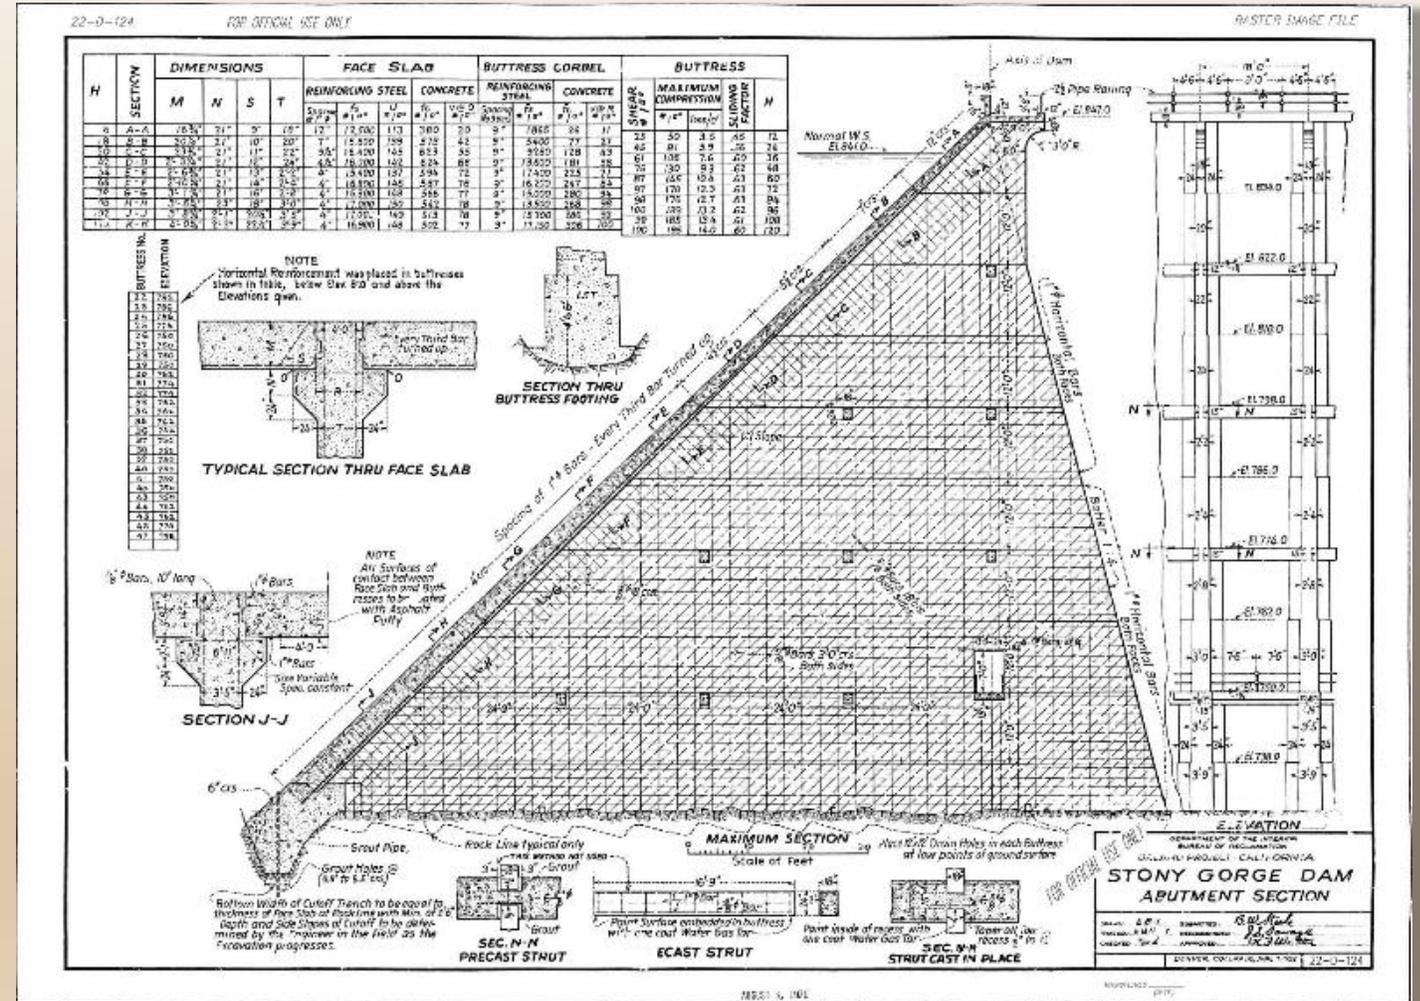
Reinforcing Steel Considerations

- Most buttress dams are getting old, concrete spalls or cracking can lead to corrosion
- Also no air entrainment (freeze-thaw susceptibility) and reinforcement not up to current standards

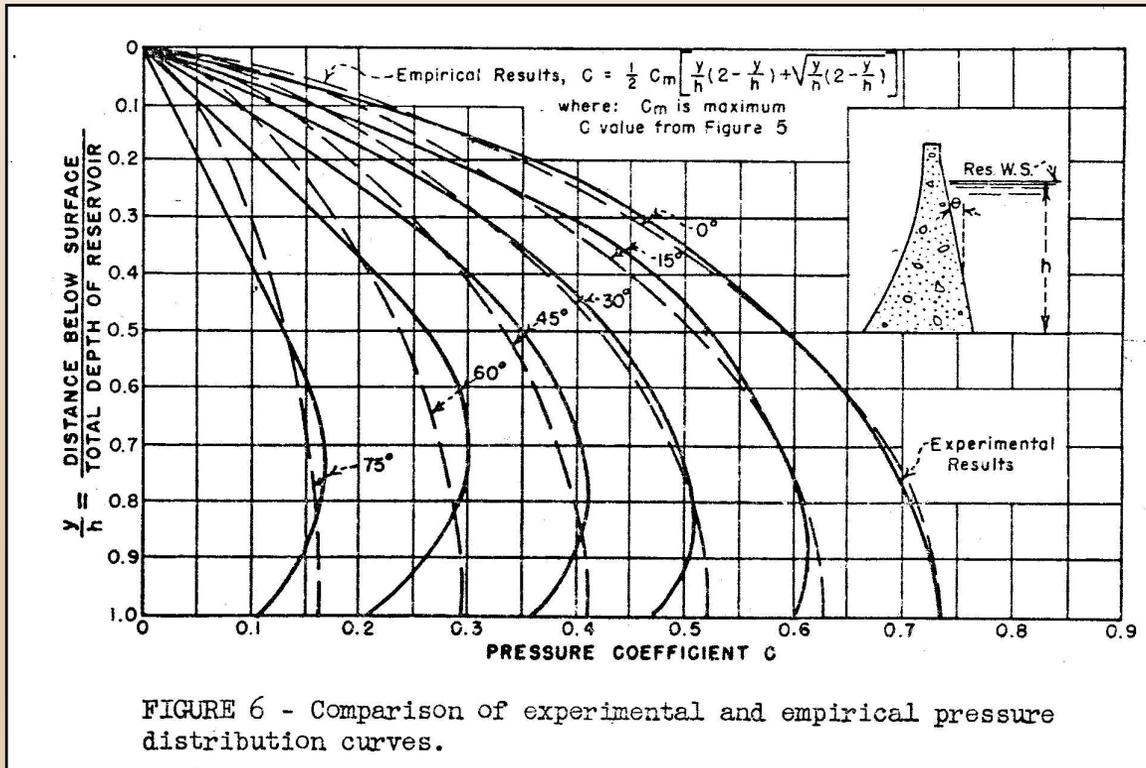
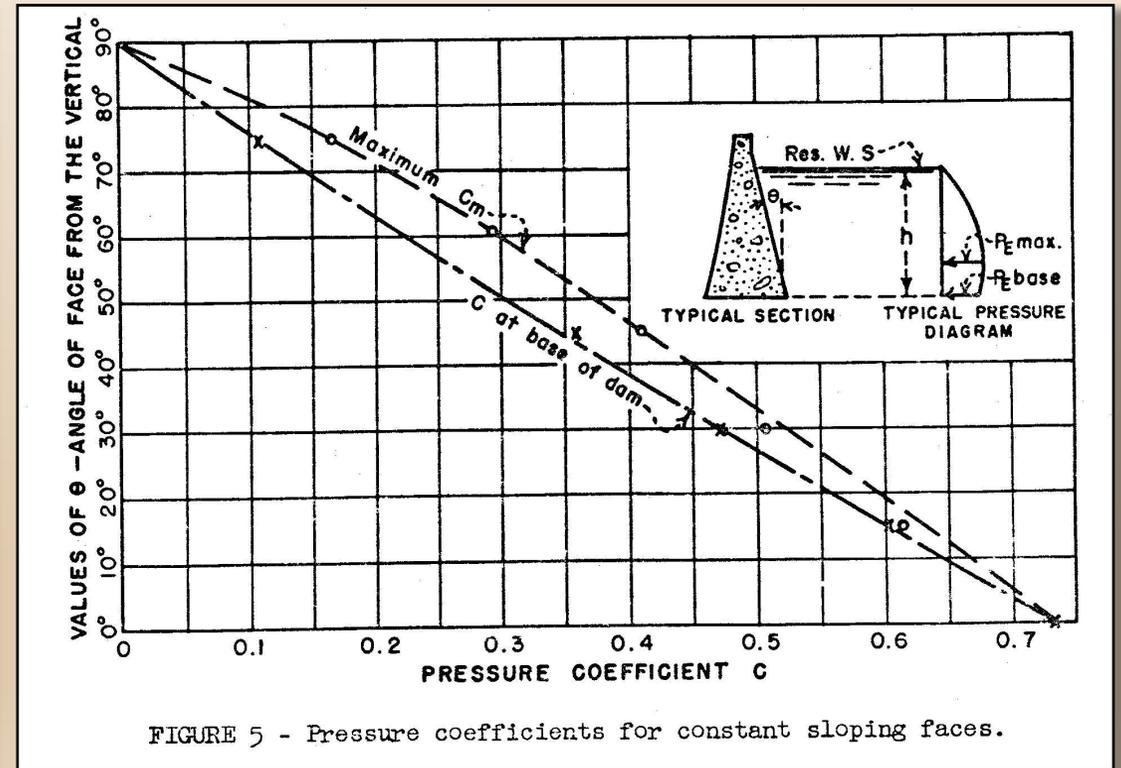
Hydrodynamic Interaction

The hydrodynamic forces in **stream direction** are reduced by the sloping face (the water will tend to ride up along the face). Zanger approach (below) can be used with directional masses, or fluid elements if available.

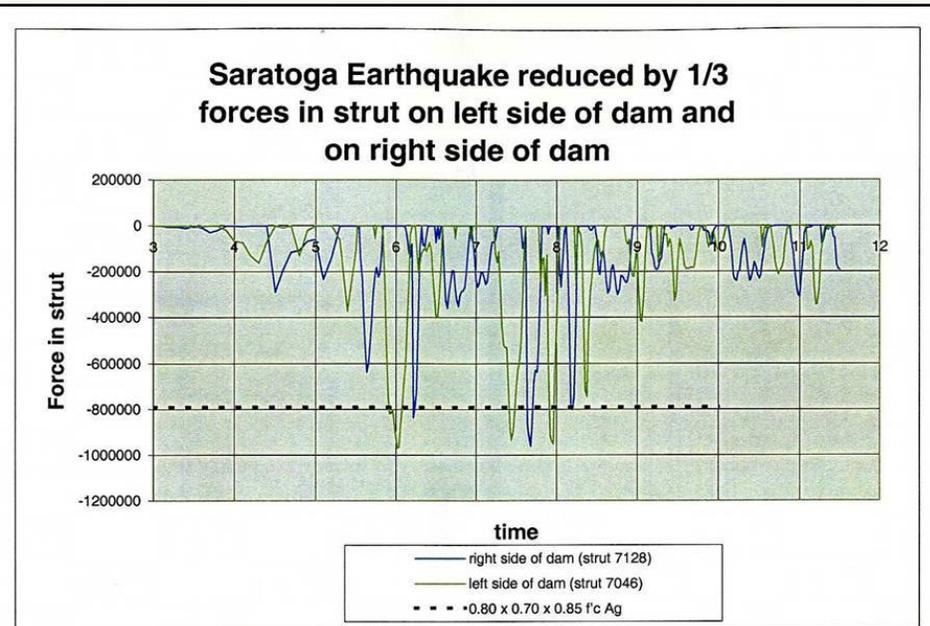
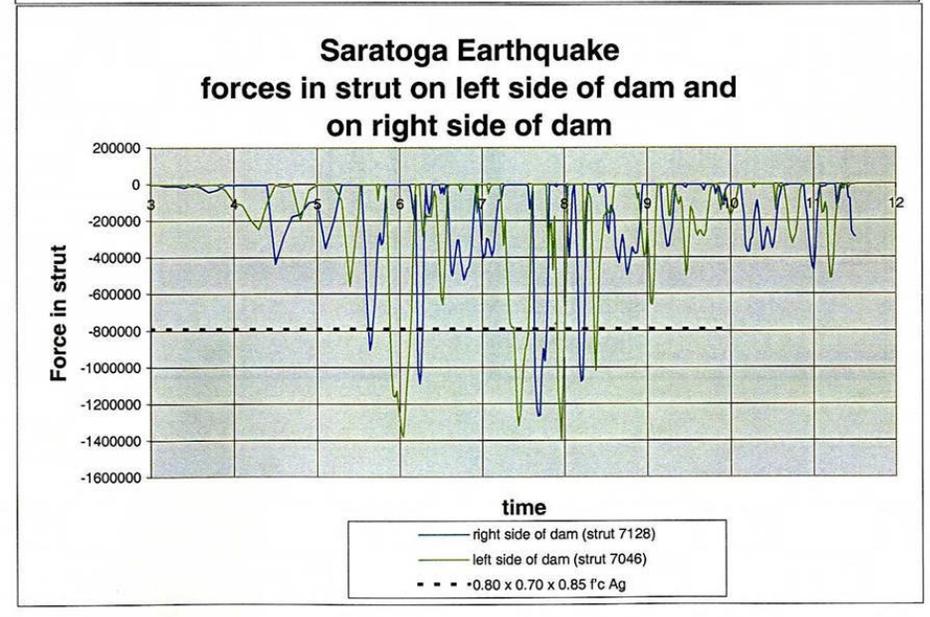
Struts

- Some buttresses have struts between buttresses for lateral support
- As buttresses move in earthquake, load accumulates across dam and can overload end struts (push over analysis)
- Crushing stress in struts normally controls over buckling

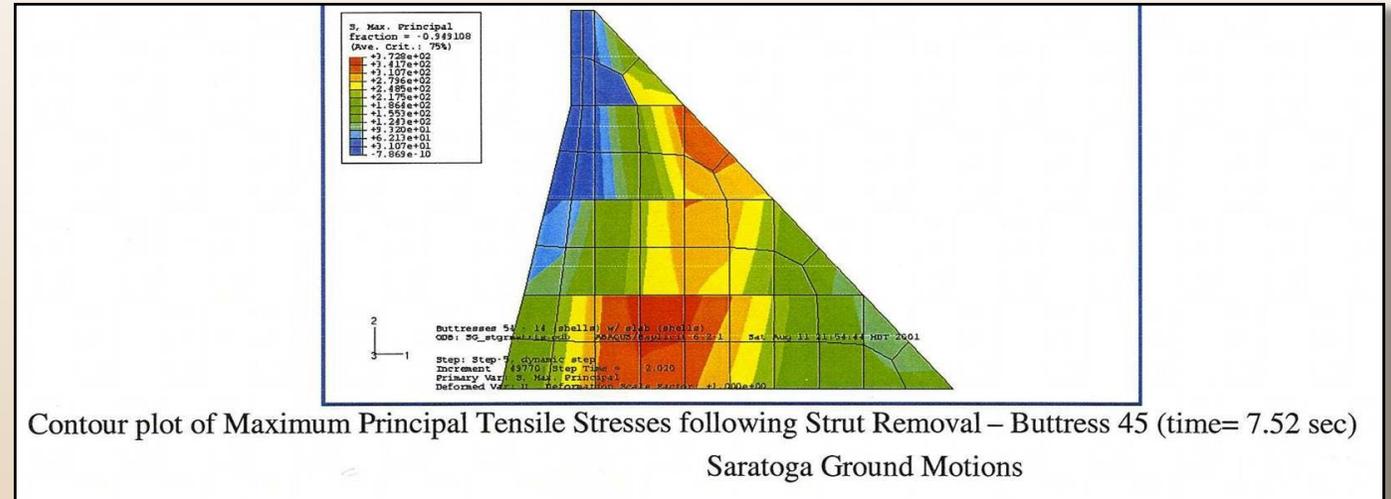
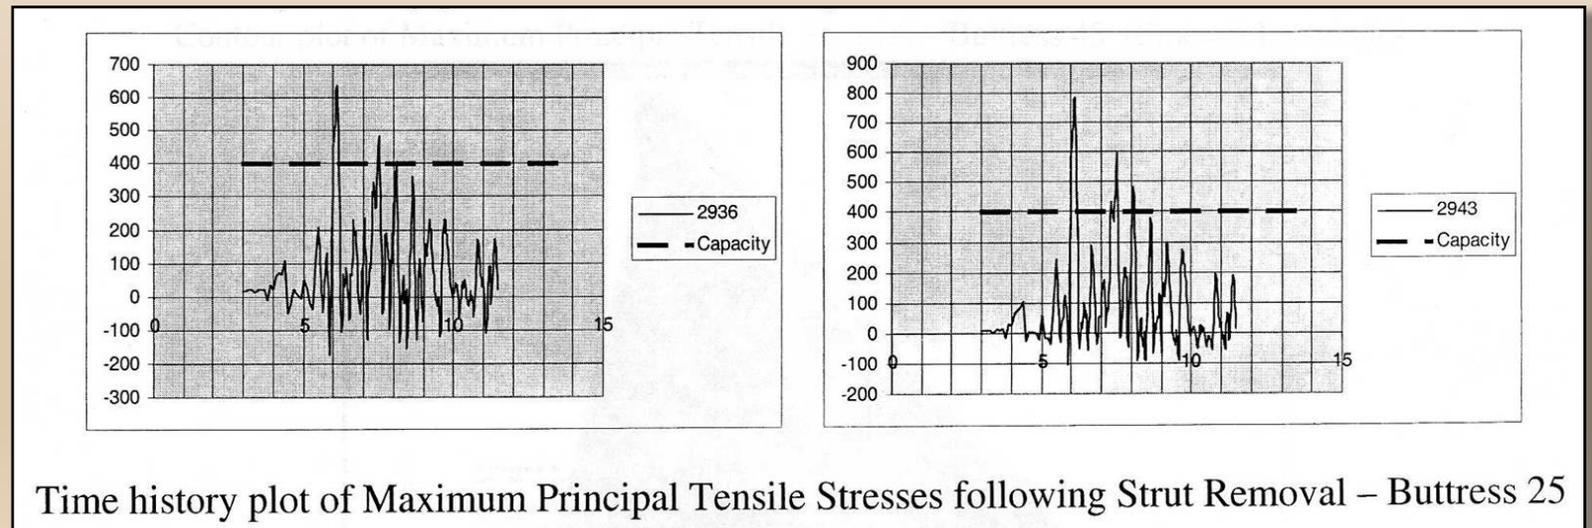
Buttresses

- Some buttresses have struts between buttresses for lateral support.
- As buttresses move in earthquake, load accumulates across dam and can overload end struts (push over analysis).
- Crushing stress in struts normally controls over buckling.

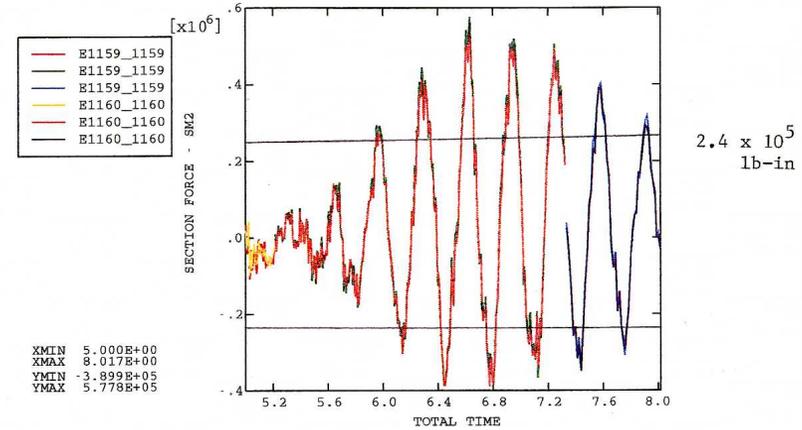
- As a result of buttress dams varying in thickness and reinforcement from base to crest, the response of the dam and seismically induced moments in the buttresses will vary.

Figure 25a-1 Buttress thickness = 32 inches

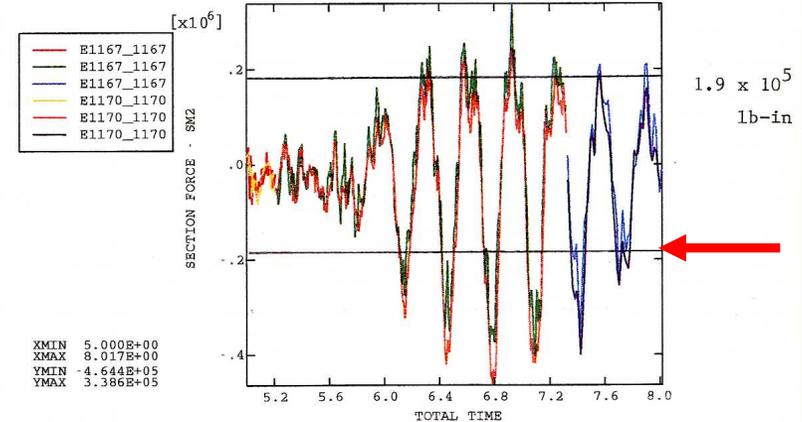
Figure 25a-2 Buttress thickness = 26 inches

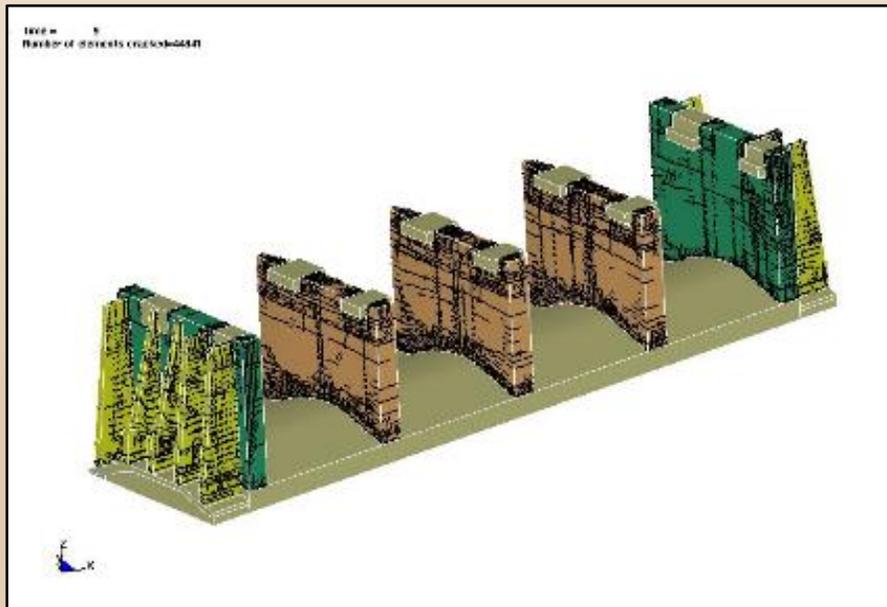
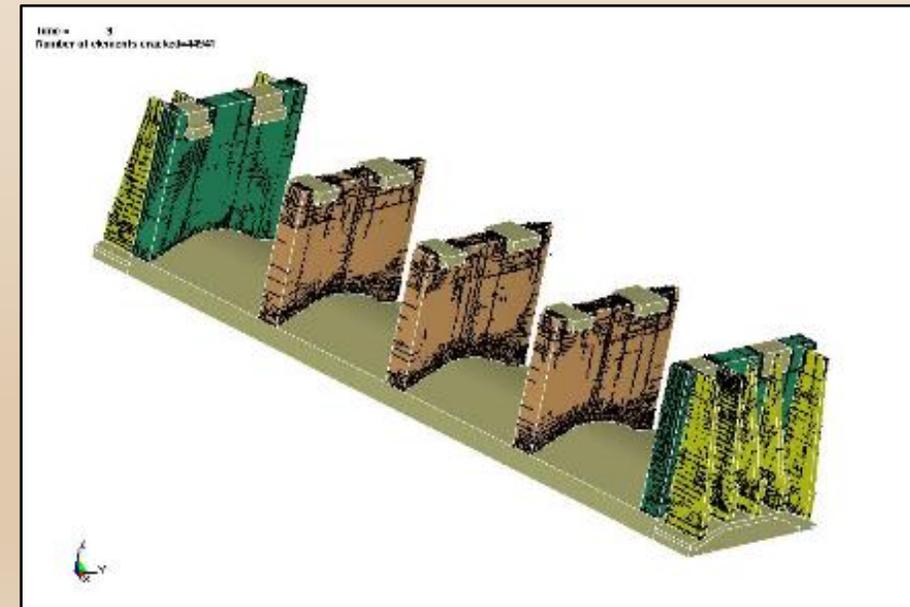
Nonlinear Structural Analysis

- Some nonlinear finite element programs have concrete cracking and steel reinforcement models that can be used to examine the potential for cracking, yielding, excessive deformation and failure directly. However, remember these are just models and careful scrutiny of the input assumptions and output is necessary.
