# Hydraulic Jacking

Best Practices in Dam and Levee Safety Risk Analysis

Part F – Hydraulic Structures

Chapter F-1

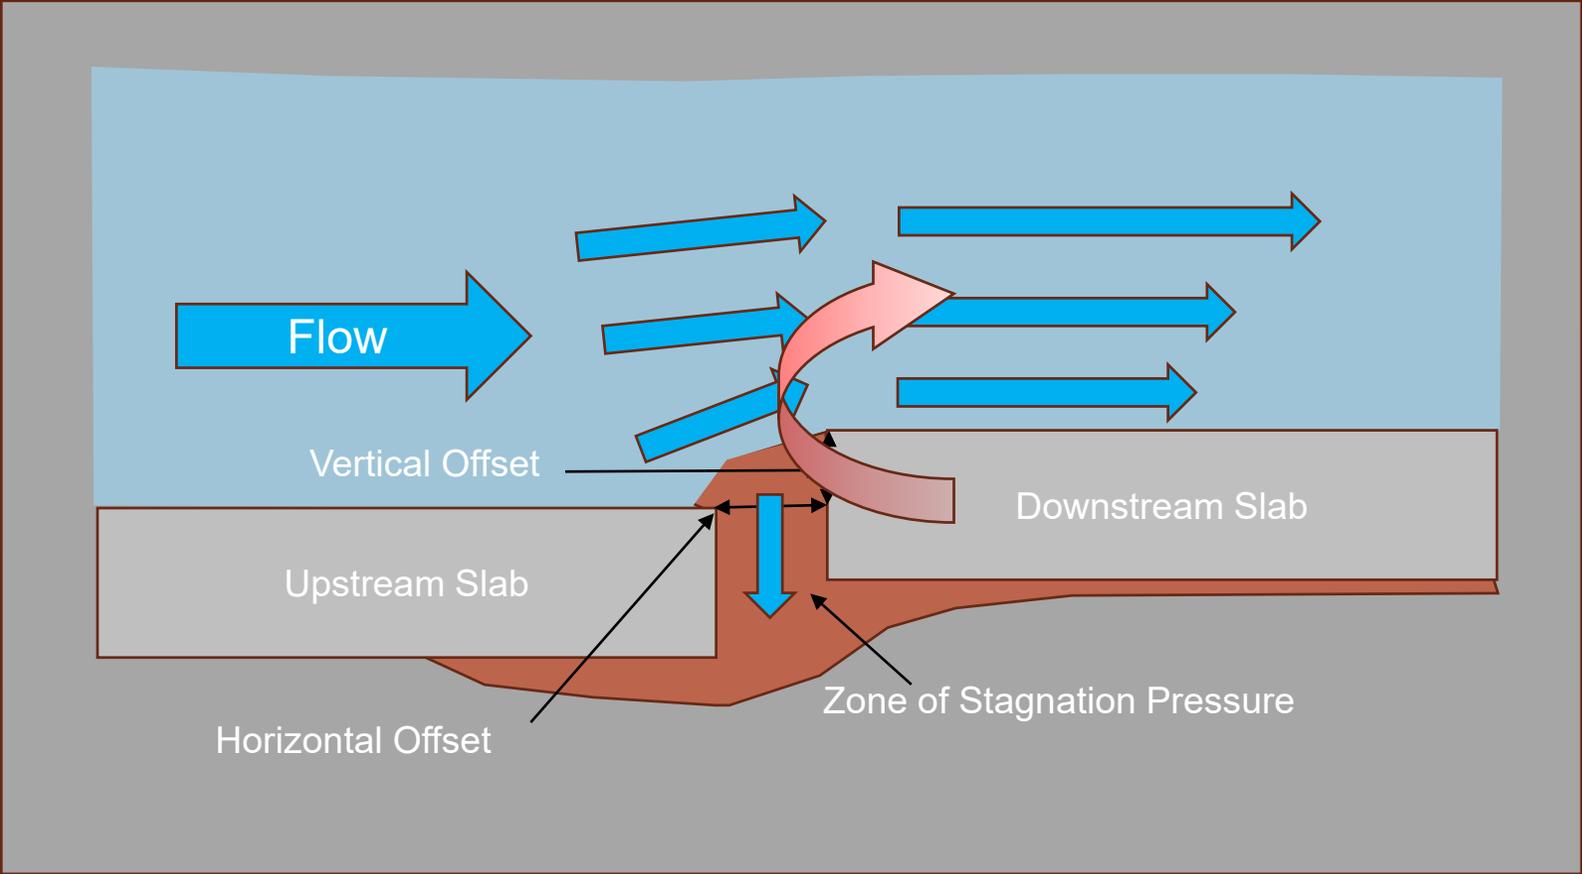
# Stagnation Pressures

- Stagnation pressure enters joint and reaches foundation – High pressures/Significant flows
- Limited/Blocked Drainage Capacity
  - Pressures develop that exceed weight/anchorage
  - Hydraulic jacking removed slab
- Drainage
  - Erosion of foundation materials due to the introduction of spillway flows underneath the spillway chute
  - Collapse of structure

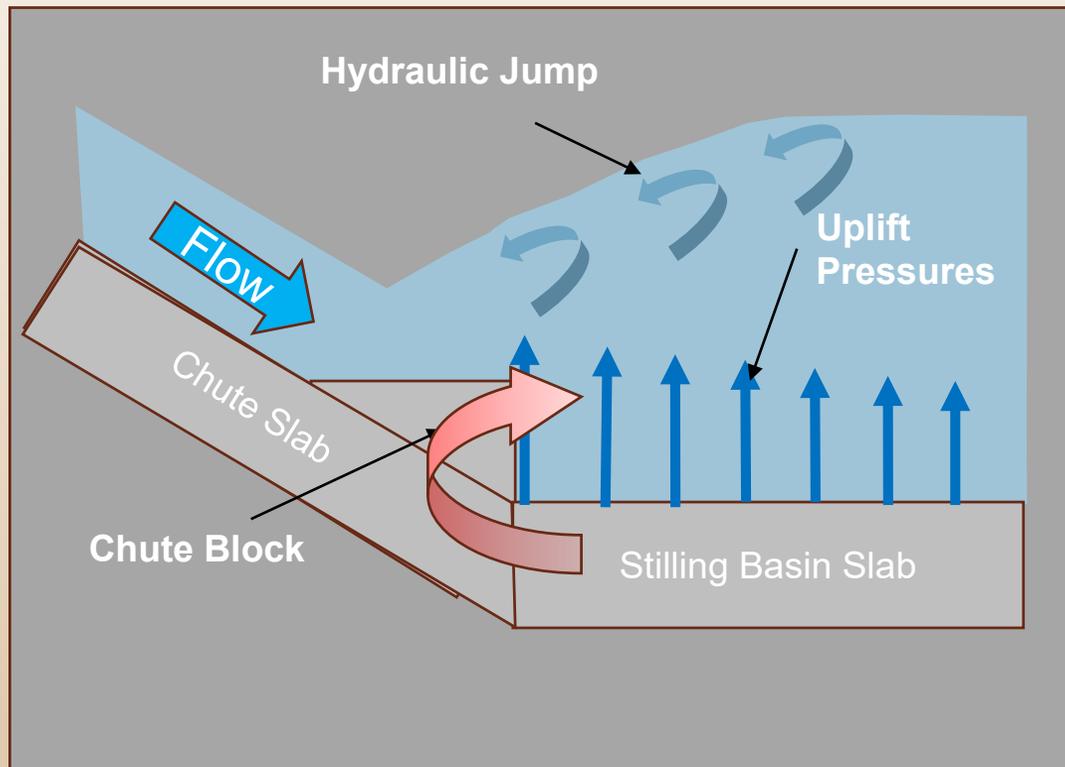
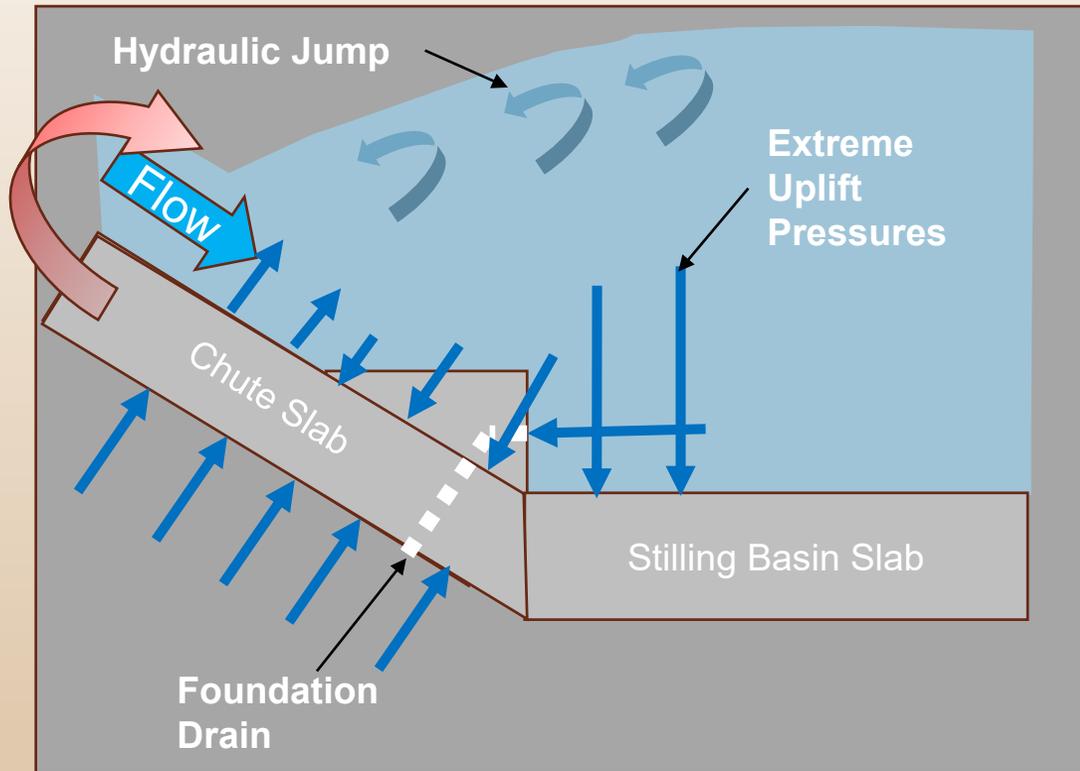
# Extreme Pressure Fluctuations

- Hydraulic jump creates high pressure fluctuations that can act in different directions across the jump
- Negative pressures can occur over the slab at the same time positive pressures can charge under the open slab thru joints and foundation drains
- The location of the hydraulic jump can move with changing flow conditions and tailwater and create unexpected combinations

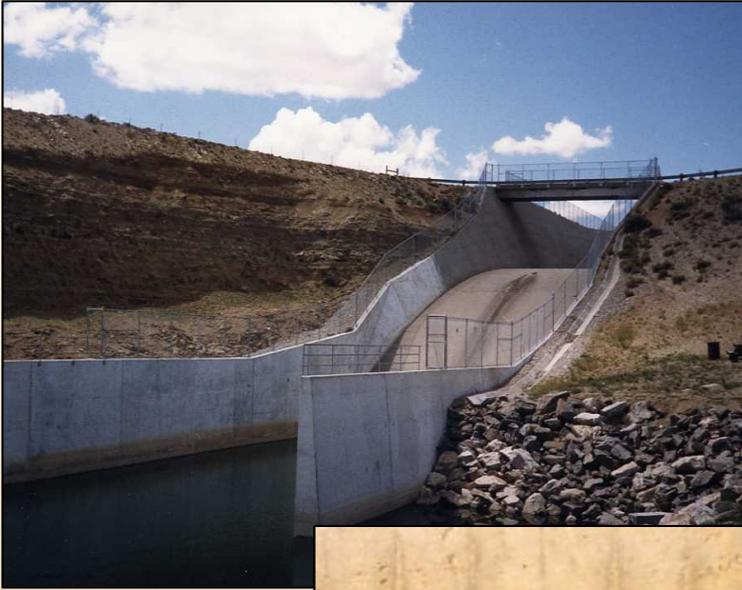
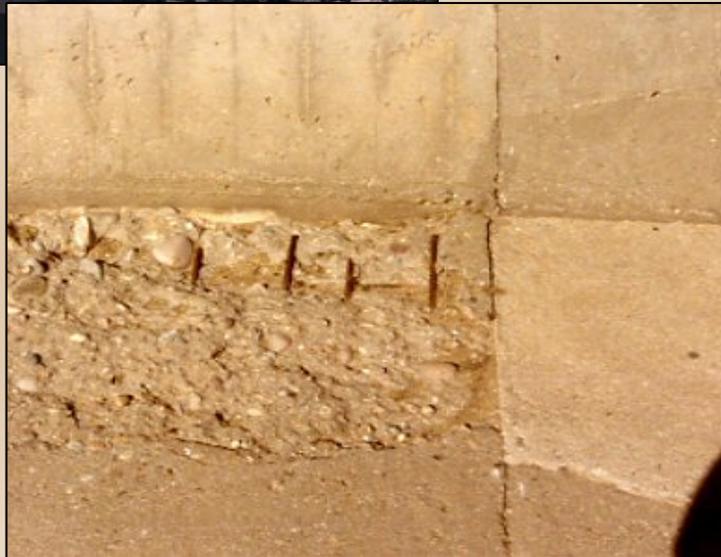
# Big Sandy Dam

- USBR Dam in Wyoming
- Spillway operated without incident from 1957 to 1983
- Chute floor slab failed in June 1983 due to uplift pressures from flows of 400 ft<sup>3</sup>/s
- Chute inspected after releases ended
- 15-inch thick slab was lifted 2 feet off its foundation
- Later determined that slab failed due to static and dynamic water pressures under the slab
- Offsets (vertical and horizontal openings) existed at the upstream edge of the slab allowed water to introduce flow under the slab

- Big Sandy Spillway Slab failed during spillway discharge of 400 ft<sup>3</sup>/s
- Failure was initiated by offset into flow (depth of flow – 0.3 ft; velocity – 31 ft/s)
- Assuming 1/8 inch open joint, vertical offset of 0.50 inches and anchor bars only 50 percent effective, slab would fail
- Analysis demonstrates that with anchor bars fully effective, slab would not have failed by Stagnation Alone
- From observations after failure, anchor bars exposed beneath slab were not coated with grout which suggests they were not bonded

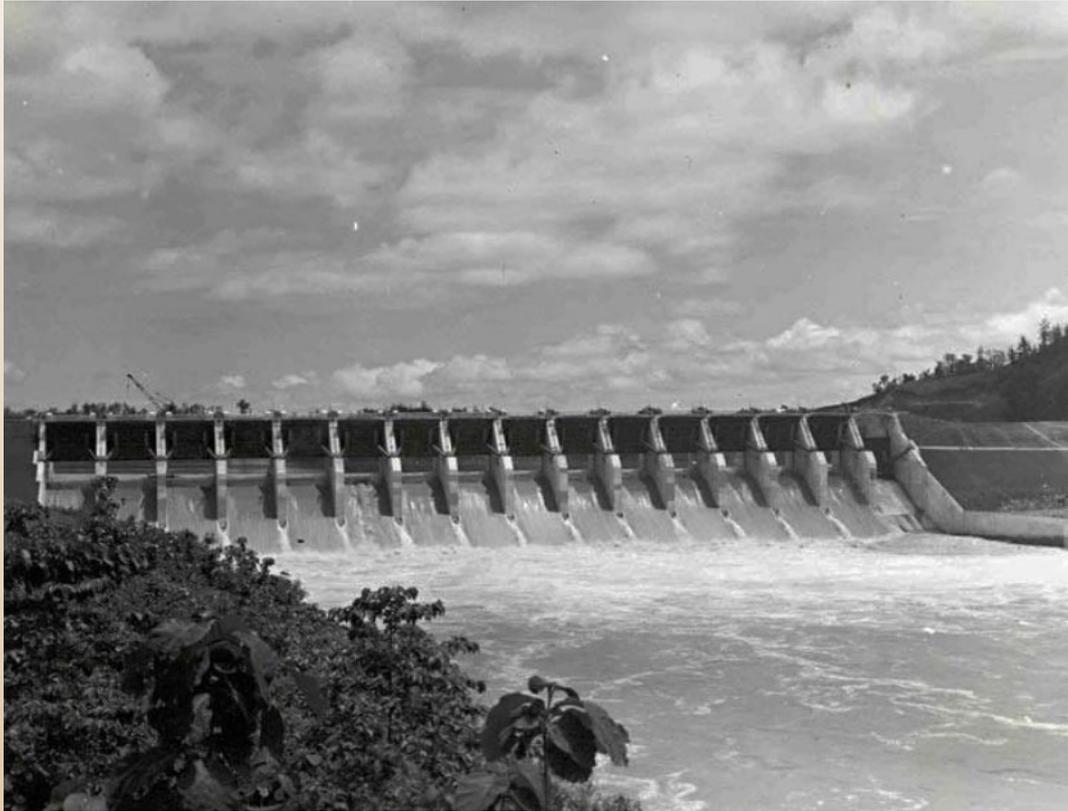
# Karnafuli Case History

- Project is located in Bangladesh
- Spillway operated immediately after completion in 1961 during a Monsoon Flood
- Distressed areas were observed on August 13<sup>th</sup>; but project continued to flow until August 20<sup>th</sup>
- Inspection after the event demonstrated significant damage to the lower spillway chute slabs
- Slabs were 1.5-ft to 4-ft thick, underlain with sand and chute blocks that have foundation drain exits

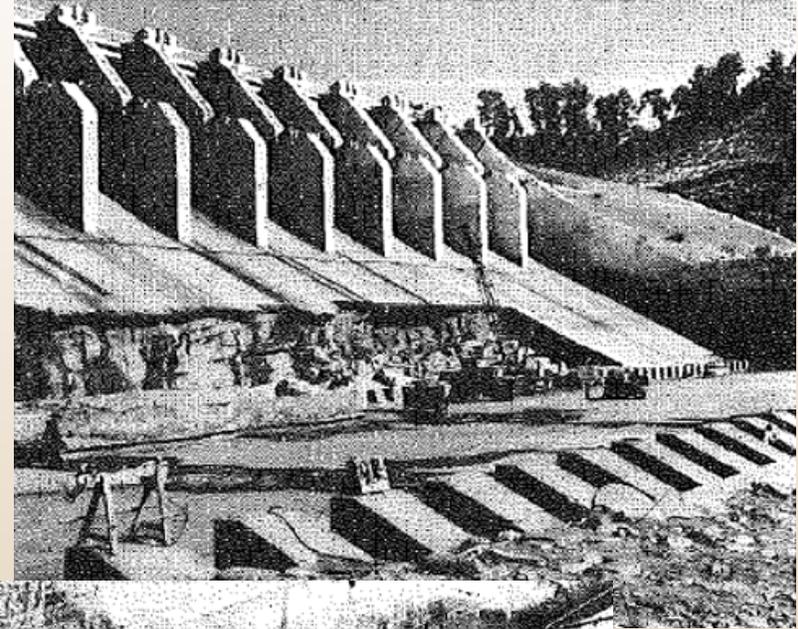
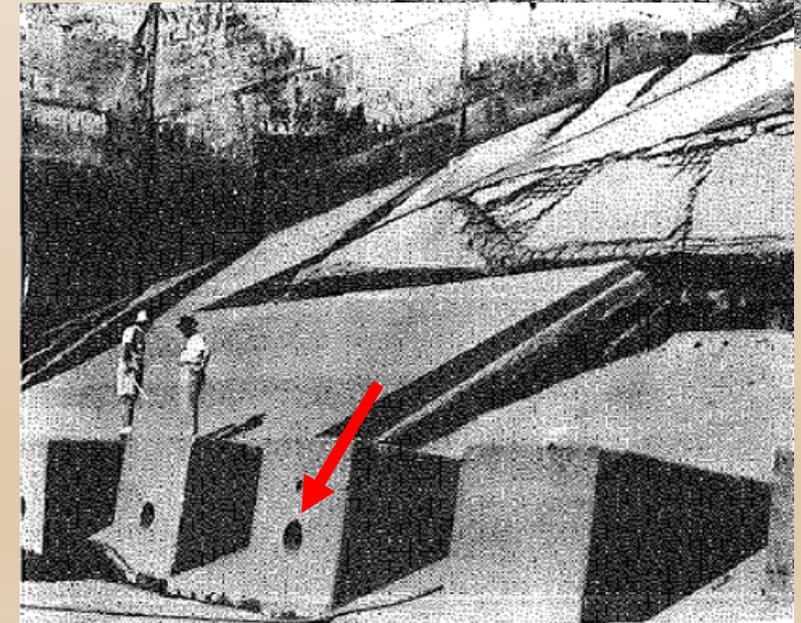
Photos from Bowers et al 1988

- There was damage to approximately 600-ft of the 745-ft wide spillway chute
- Significant erosion of exposed rock
- Board of Consultants concluded that the failure was a result of fluctuating pressure near the toe of the hydraulic jump
- Physical modeling suggests that it was likely that low pressures occurred over the slab while simultaneously positive pressures charged the foundation
- Design philosophy at the time was that the back of the Chute Block would be low pressure zone, the actual tailwater was higher than assumed for design, forcing the jump on the chute

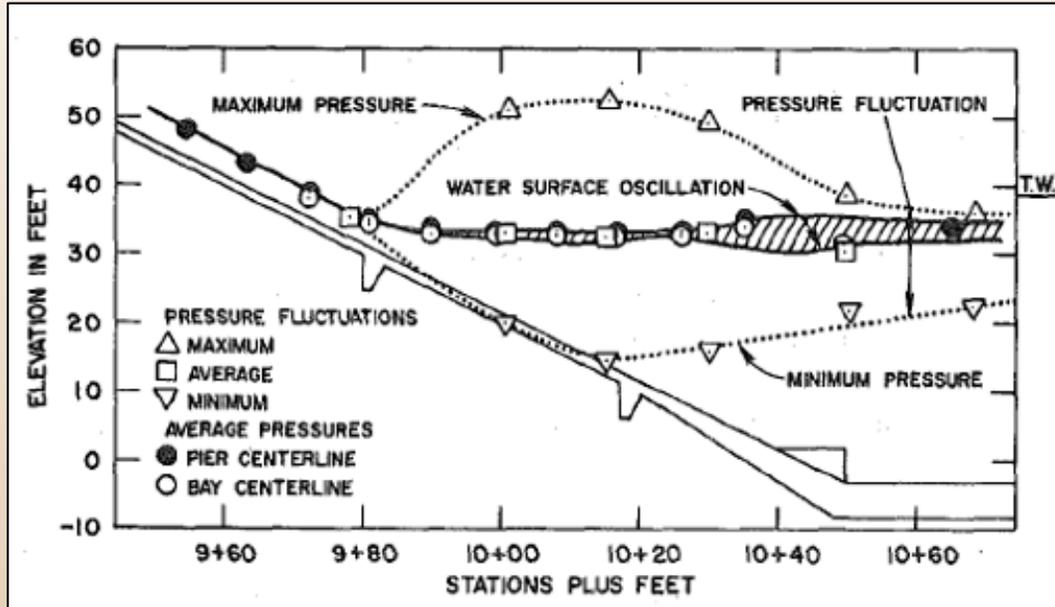
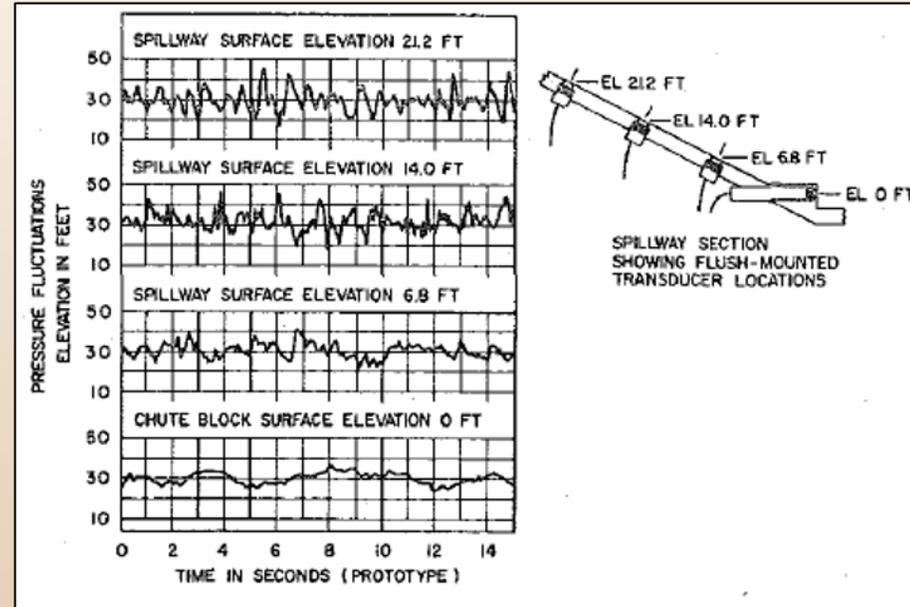
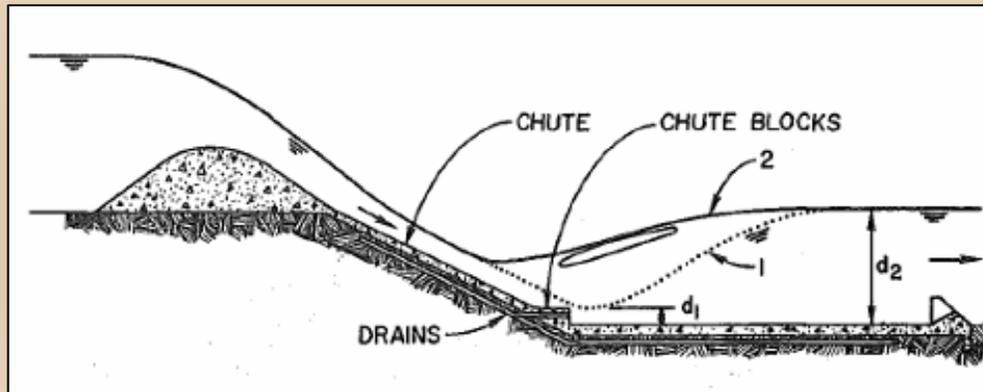
# Karnafuli Case History

*St Anthony Falls Hydraulic Laboratory, Project Report No. 73, Hydraulic Studies of the Spillway of the Karnafuli Hydroelectric Project East Pakistan*

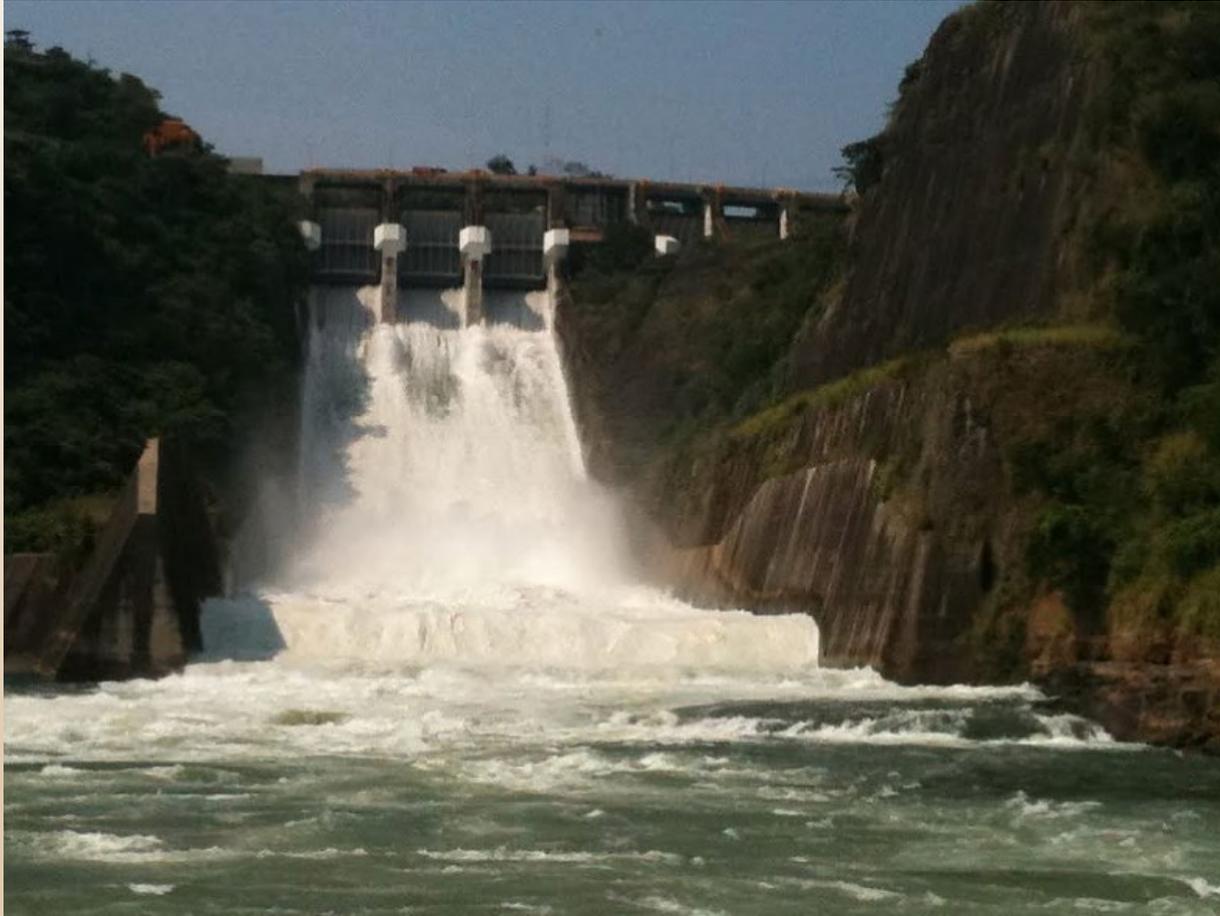
# Malpaso Case History

- 450 foot high Embankment Dam in Mexico
- 8.5 million acre-feet reservoir
- 320-foot Long, 160-foot wide hydraulic jump stilling basin
- Design Discharge of 212 kcfs
- Operated for three years at flows below 88 kcfs
- Had severe stilling basin damage after a 106 kcfs flow event

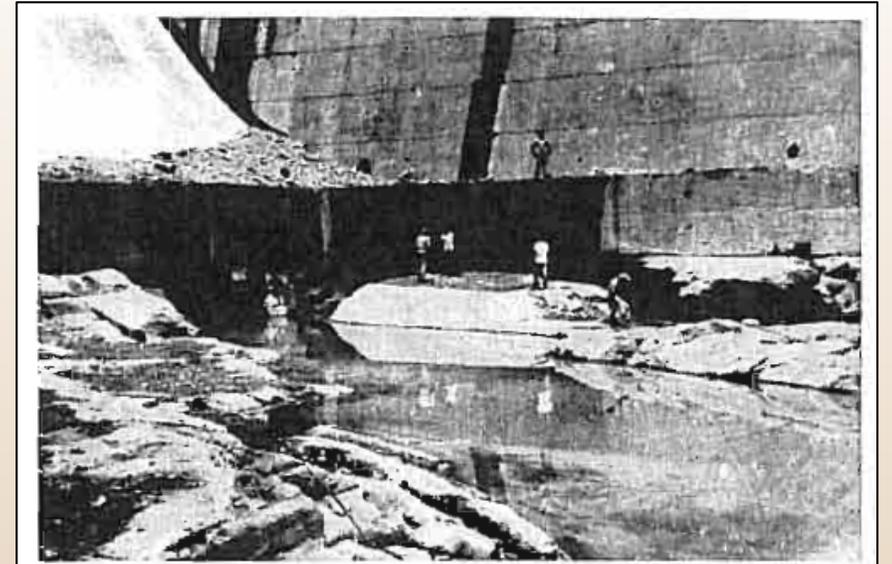
- Multiple Slabs Failed
  - 40ft x 40ft in size
  - 6.5 ft thick
  - (12) 1 ¼ inch bars in each slab
- Slabs flipped upside down and deposited at exit channel
- Significant damage to exposed rock
- Slab failure was attributed to Hydraulic Jacking related to fluctuating Pressures

Plate 1  
View of stilling basin damages.

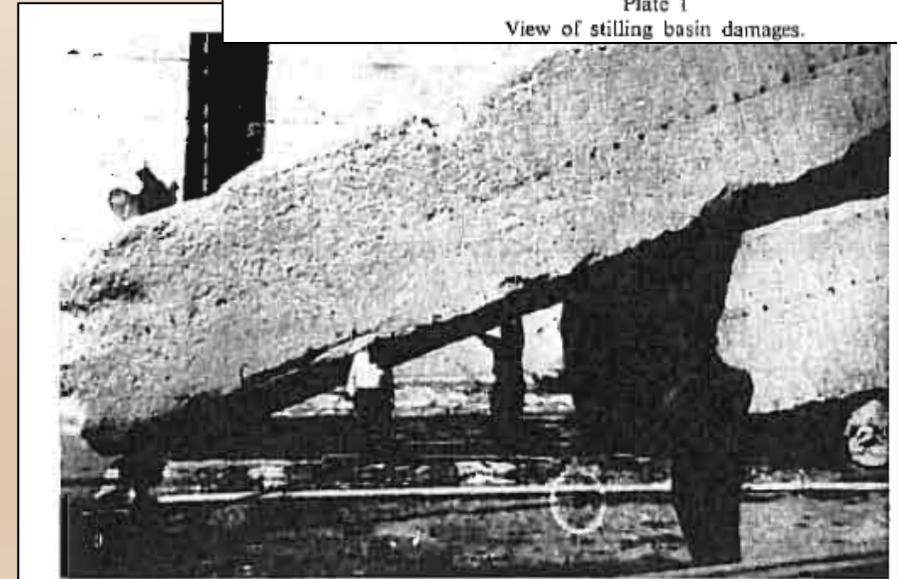
Plate 2  
Another aspect of damages.

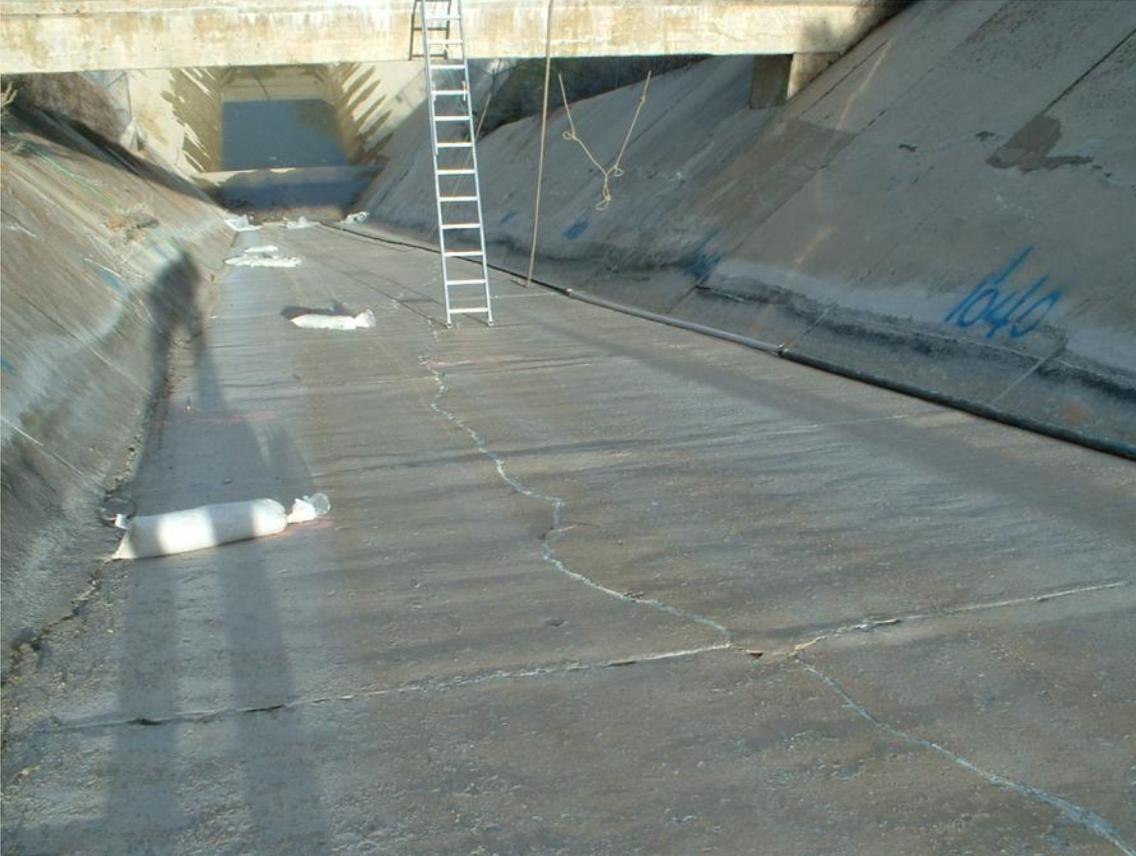
# Hyrum Case History

- USBR Dam located in Utah
- 116 feet high earthfill embankment completed in 1935
- Thin concrete-lined spillway chute
- Erodeable foundation soils

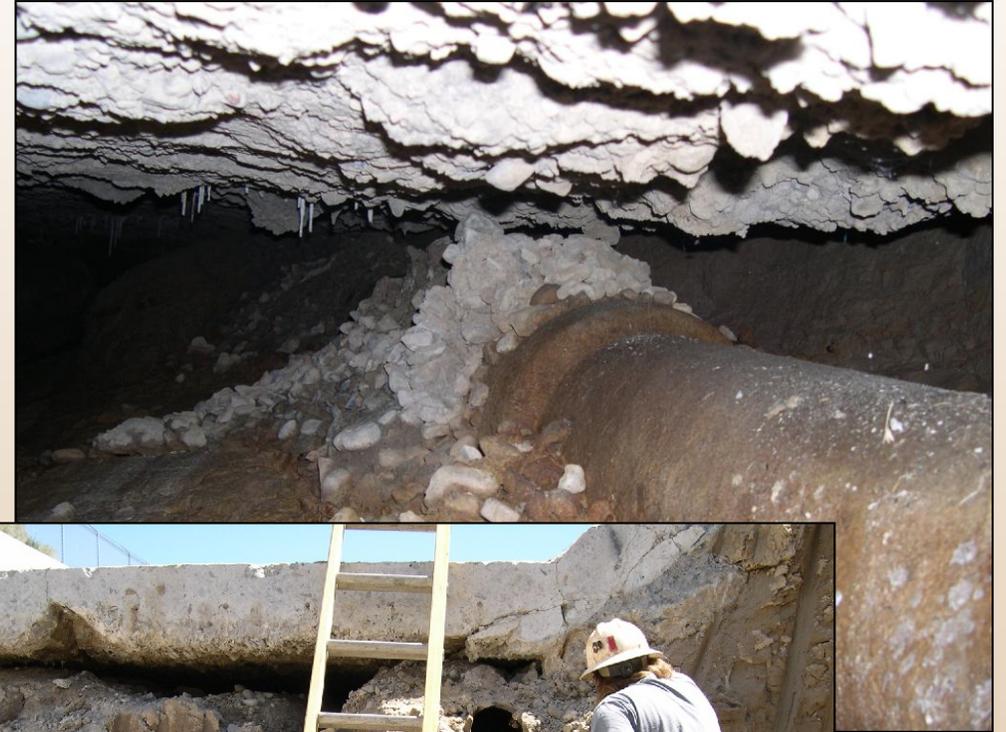
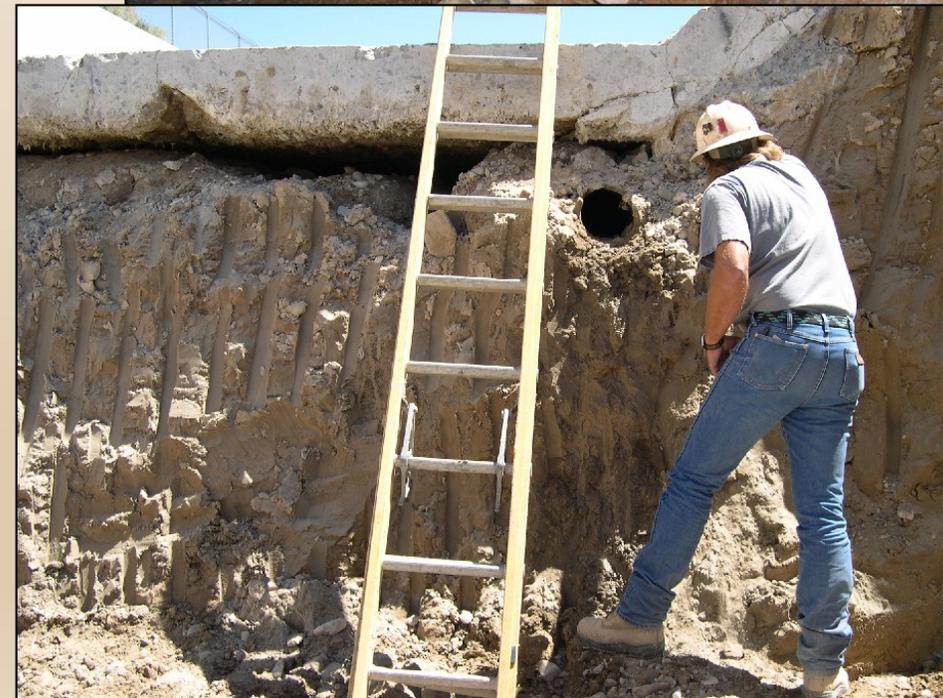
# Hyrum Case History

- A continuous channel over two feet deep in places was observed
- No steel across the slab joints
- Underdrain system; but no filter

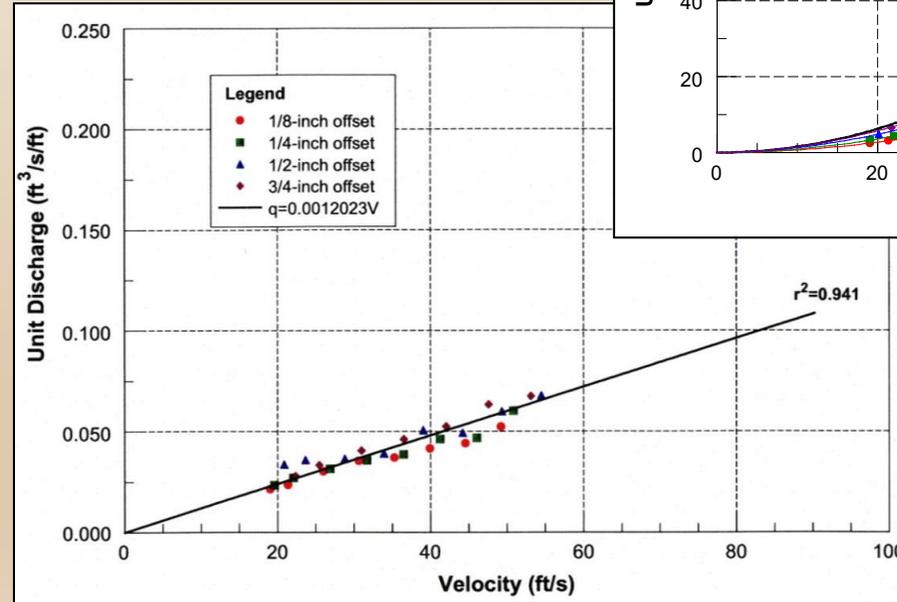
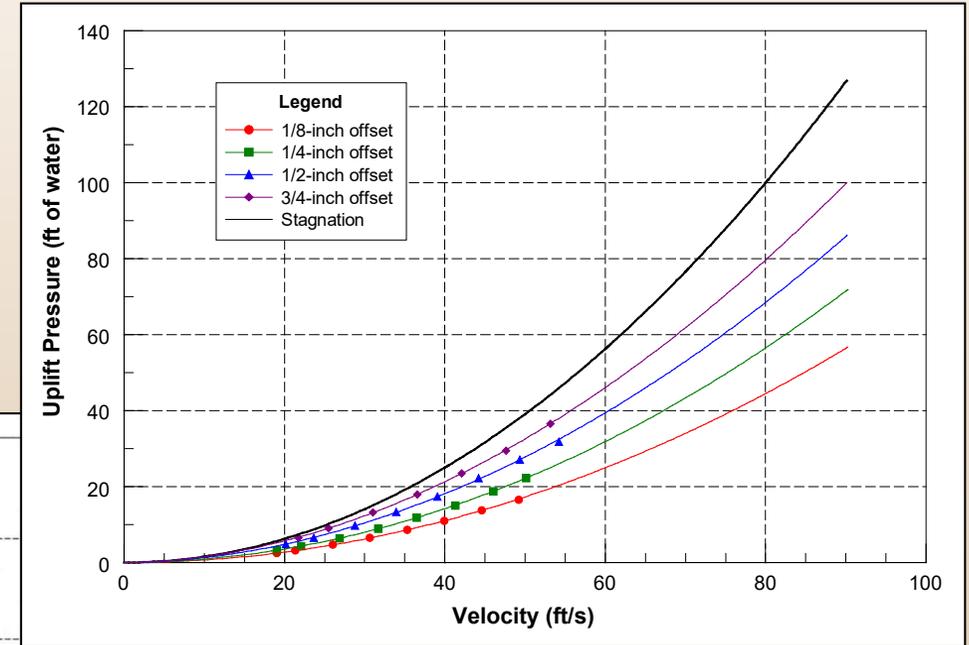
# Analysis Methods (Stagnation Pressures)

**Uplift and Crack Flow Resulting from High Velocity Discharges Over Open Offset Joints**  
Laboratory Studies

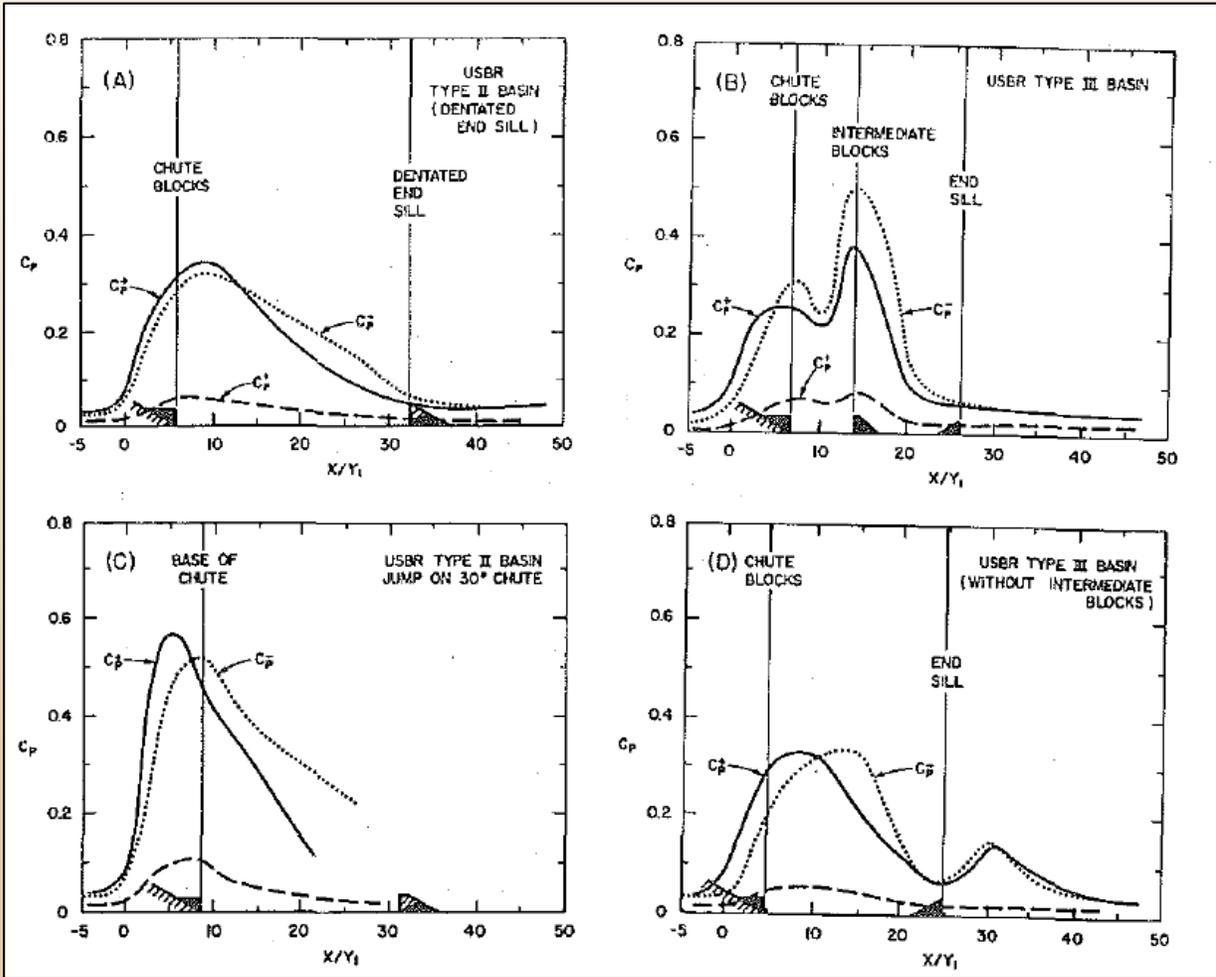
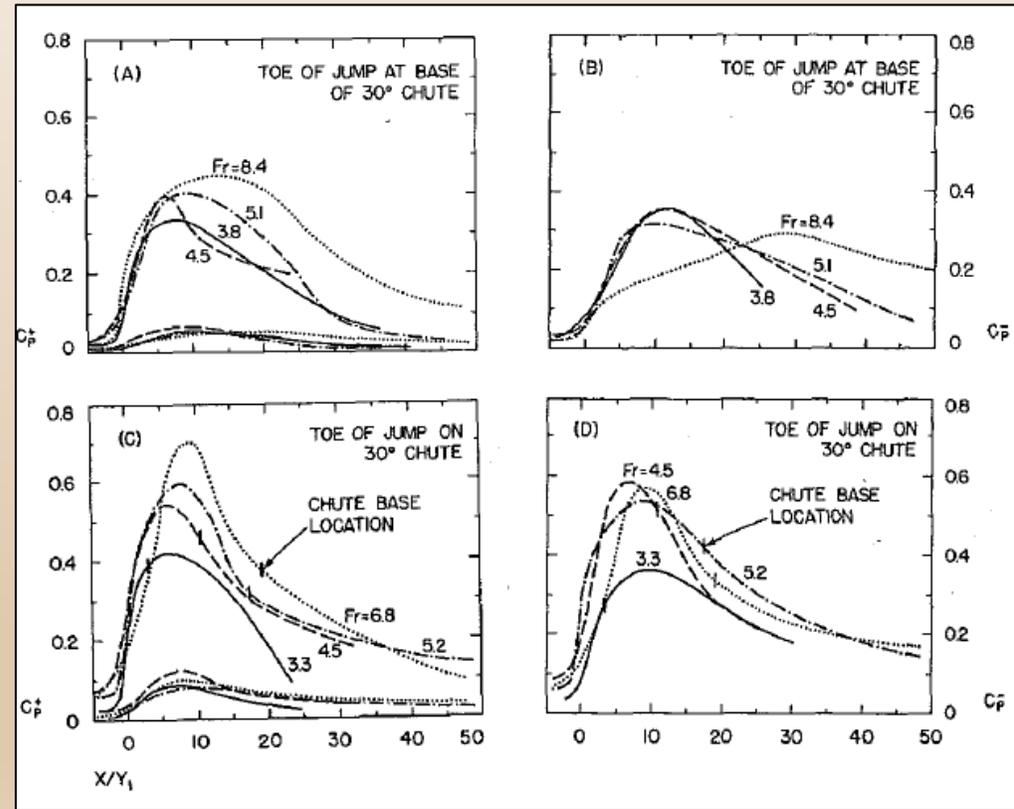
Toso and Bowers (1988)

# Analysis Methods (Pressure Fluctuation)

$$\Delta P = C_p \pm \frac{V^2}{2g}$$
