# Best Practices in Dam and Levee Safety Risk analysis

## V-2. Concrete Gravity Structures

12 June 2015

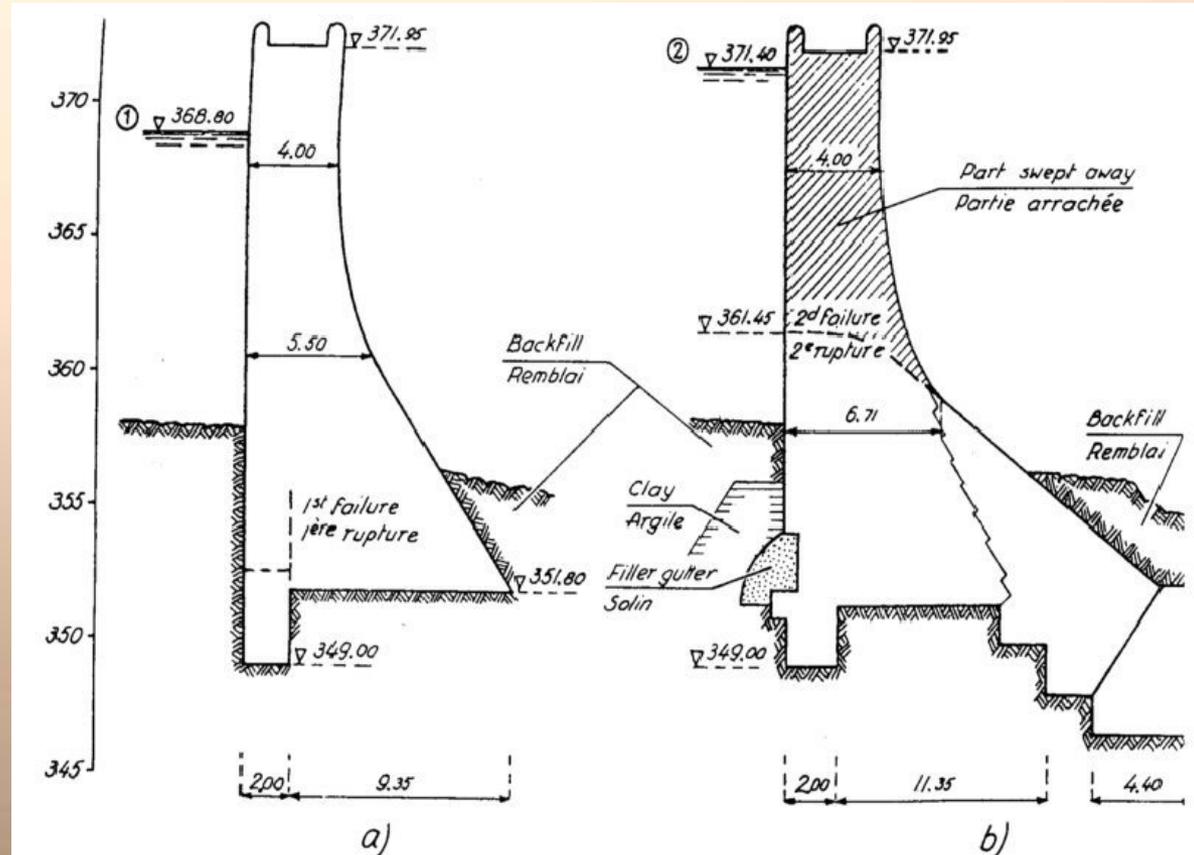
- 72' high masonry gravity dam built in 1884
- Structural damage on initial filling included shearing of key, but no vertical significant vertical displacement when water reached 10-ft from crest
- Other damage during initial filling included cracking along upstream heel of the dam
- D/S lower third of the dam was strengthened by providing a buttress and keying it deeper into the foundation (horizontally-bedded sandstone)
- Subsequent filling in 1895 up to 2-ft from the crest resulted in the upper narrow section of the dam suddenly failing on April 27, 1895
- The failure released a torrent of water on the village of Bouzey causing more than 100 deaths

- Tensile crack likely originated at the upstream face during the first filling due to excessive moment at the base of the narrow upper section
- No structural modifications made to upper section of dam, only buttress section added to base of dam
- Crack propagated through the structure and did not have enough shear strength (friction) to resist the driving forces brought on by the 2<sup>nd</sup> filling (first time to within 2-ft of crest)
- Masonry mortar used dirty sand of poor quality
- Uplift recognized as a contributor for first time
- Horizontal joint opening and subsequent uplift resulted in failure

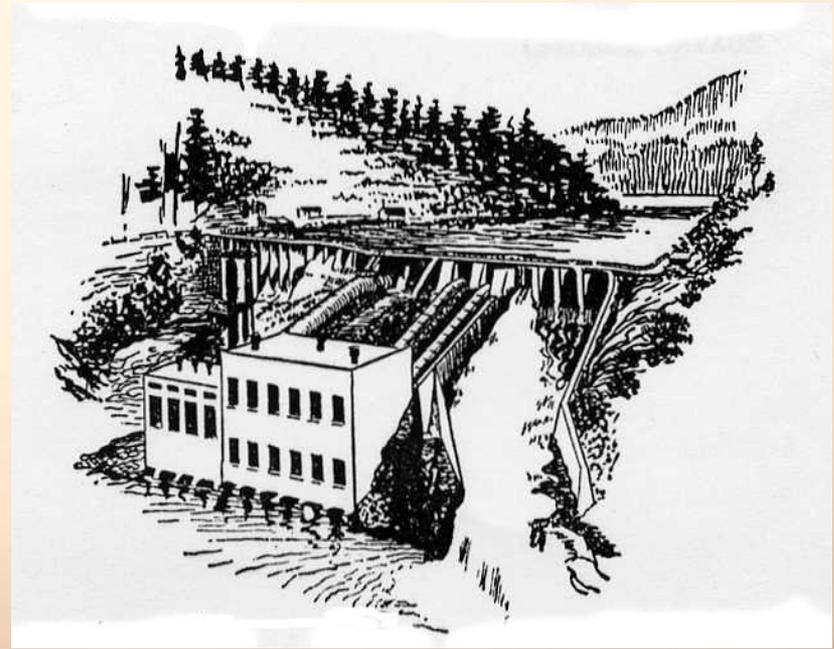
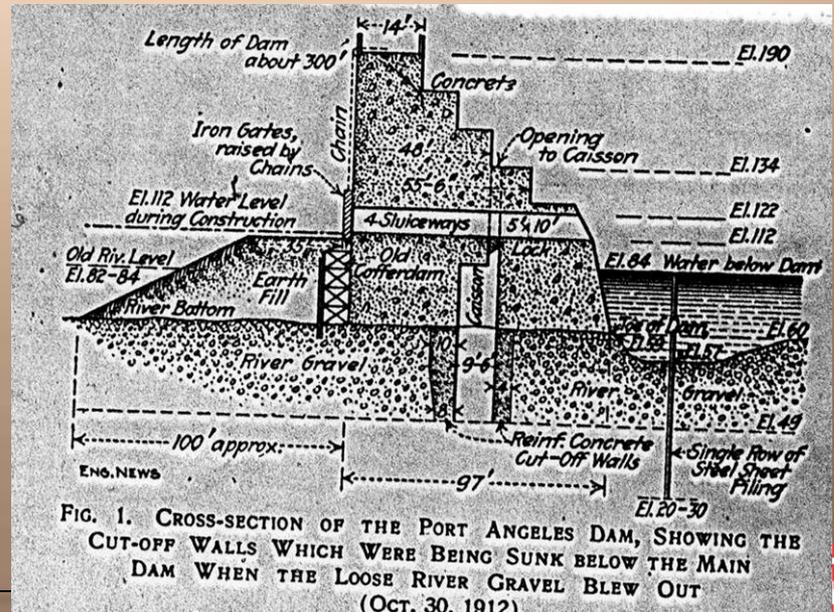
- Constructed in early 20<sup>th</sup> century
- Originally tried to place upstream cutoff, but had trouble during construction
- No cutoff to rock
- Large seepage flows developed D/S during filling
- Attempted to improve seepage by placing single row of sheet piling 30-ft deep about 8-ft d/s of toe of dam
- Unsure why they chose this location
- Very high exit gradients between toe of dam and sheet piles (base of dam served as 'roof' of the piping failure)

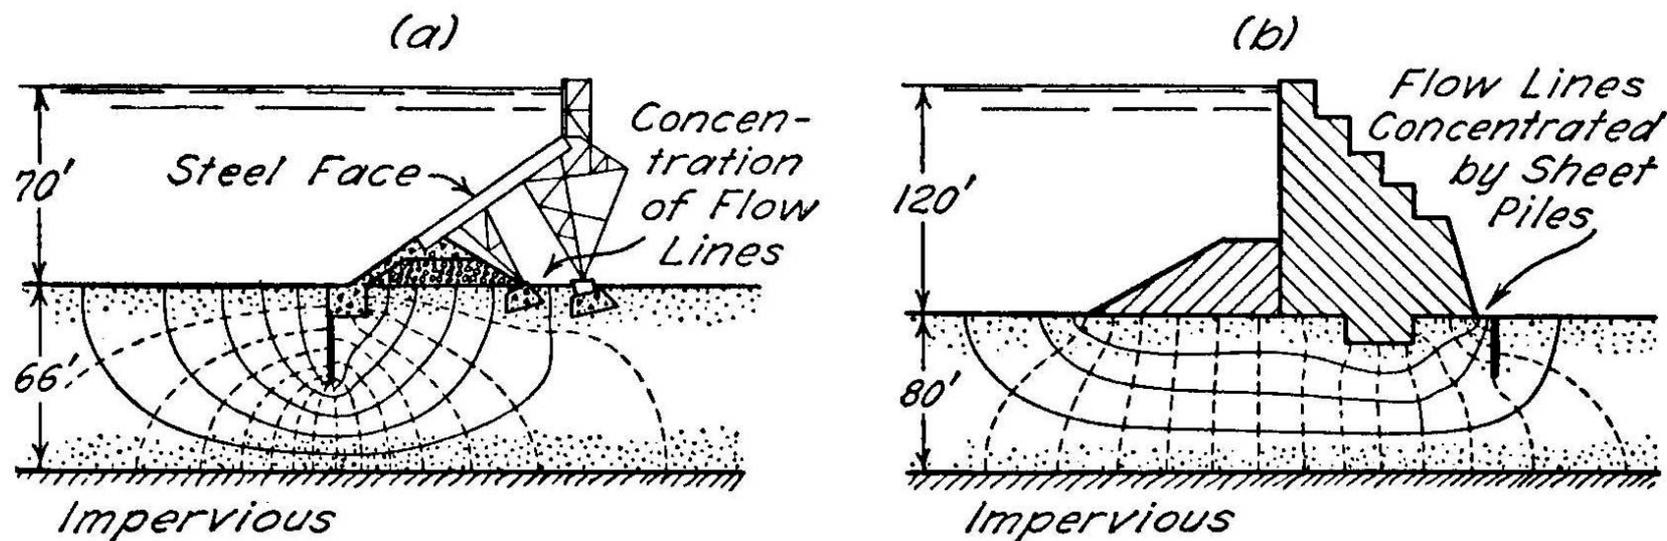
FIG. 208. Flow nets showing concentration of flow lines responsible for failure by piping of two dams; (a) Hauser Lake Dam, Mont. (b) Elwha River Dam, Wash.

- Terzaghi and Peck noted this failure, and attributed it to concentration of flow lines

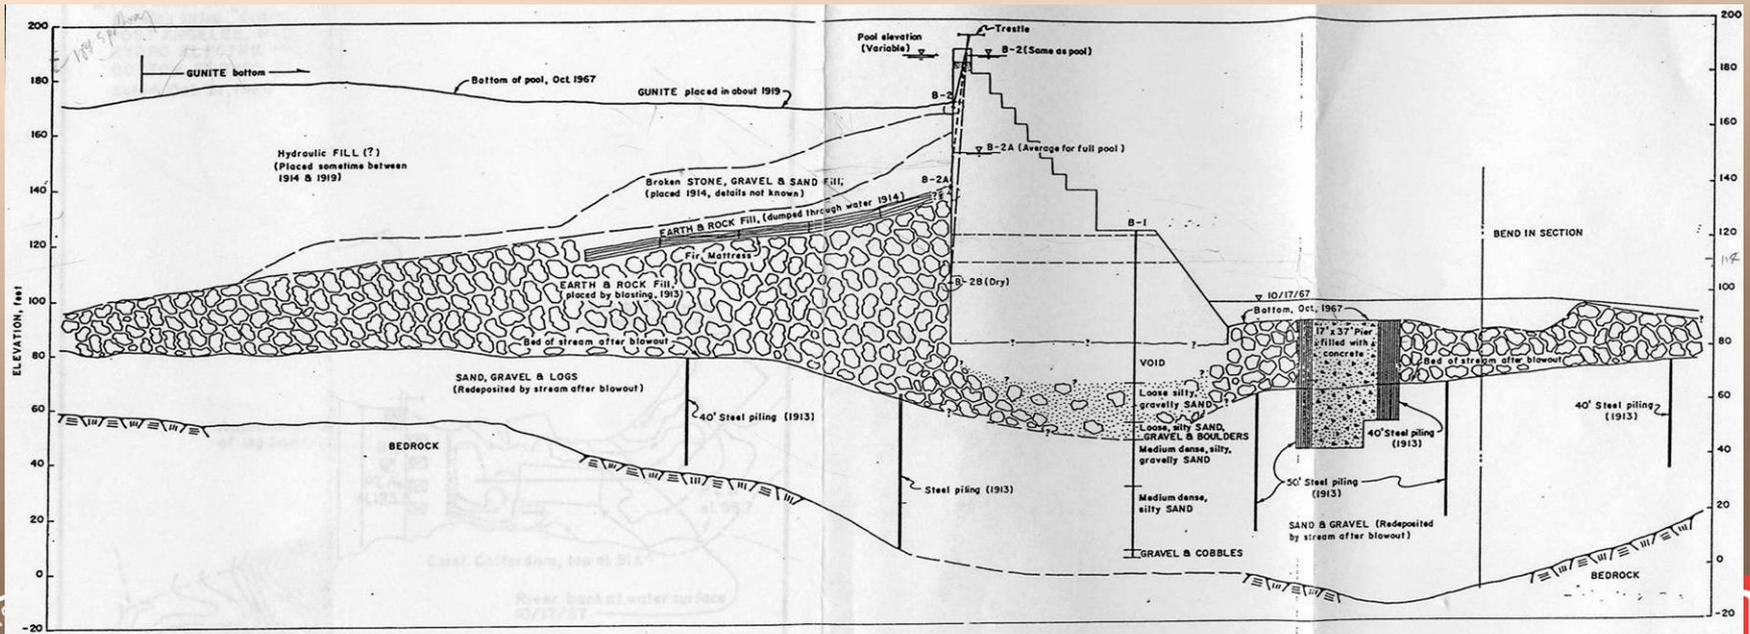
- October 30, 1912 piping failure of alluvium under dam
- 8,000-12,000 acre-ft passed under dam in 1½-3 hrs
- Main portion of dam on rock abutments spanned hole
- Hole was 75' deep at U/S face, 90' deep at D/S face
- Extensive property damage but no life loss
- Extraordinary measures to store reservoir

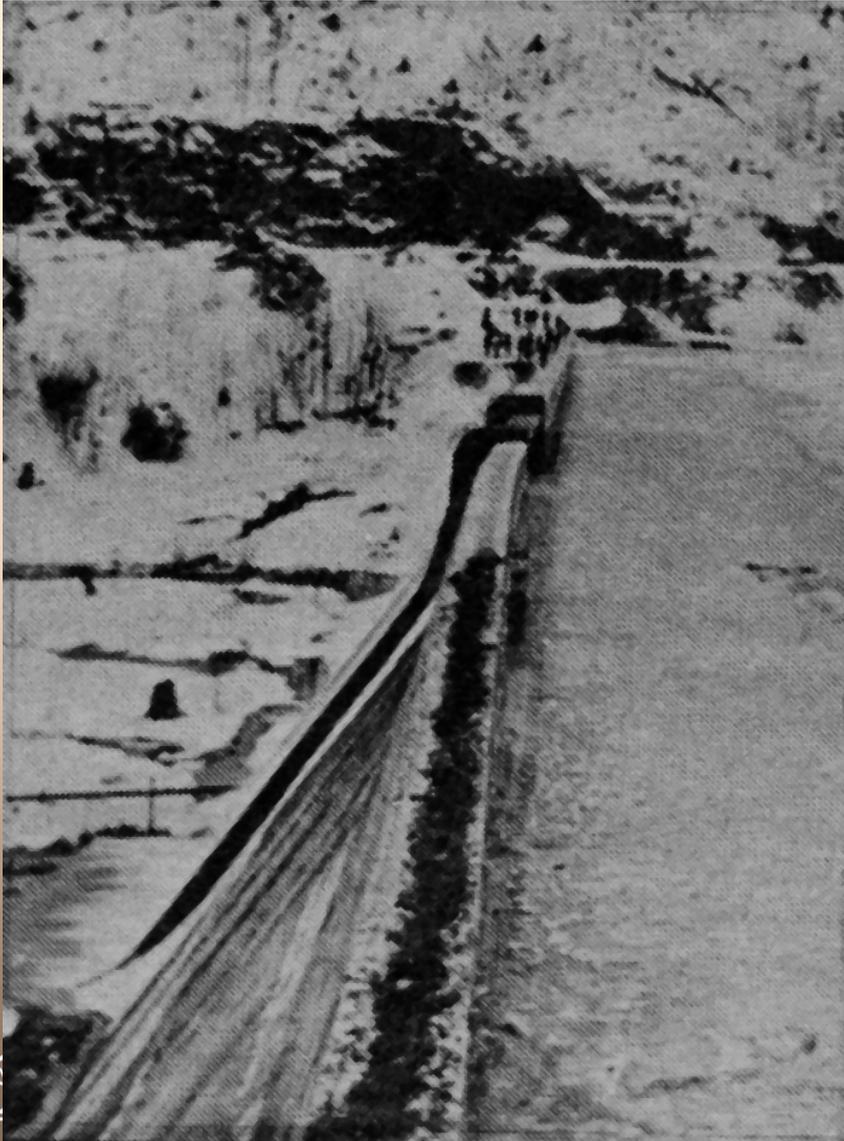
- Dam built by Bayless Pulp & Paper Company
- Capacity between 550-850 acre-ft
- 52' high gravity dam constructed approximately 1-1/2 miles above the town of Austin, PA
- Dam constructed on horizontally bedded sandstone with interbedded layers of shale
- January 17, 1910 - center base slid 18" with crest deflection of 31"
- Reservoir lowered after movement
- Repairs recommended after an engineering assessment was completed

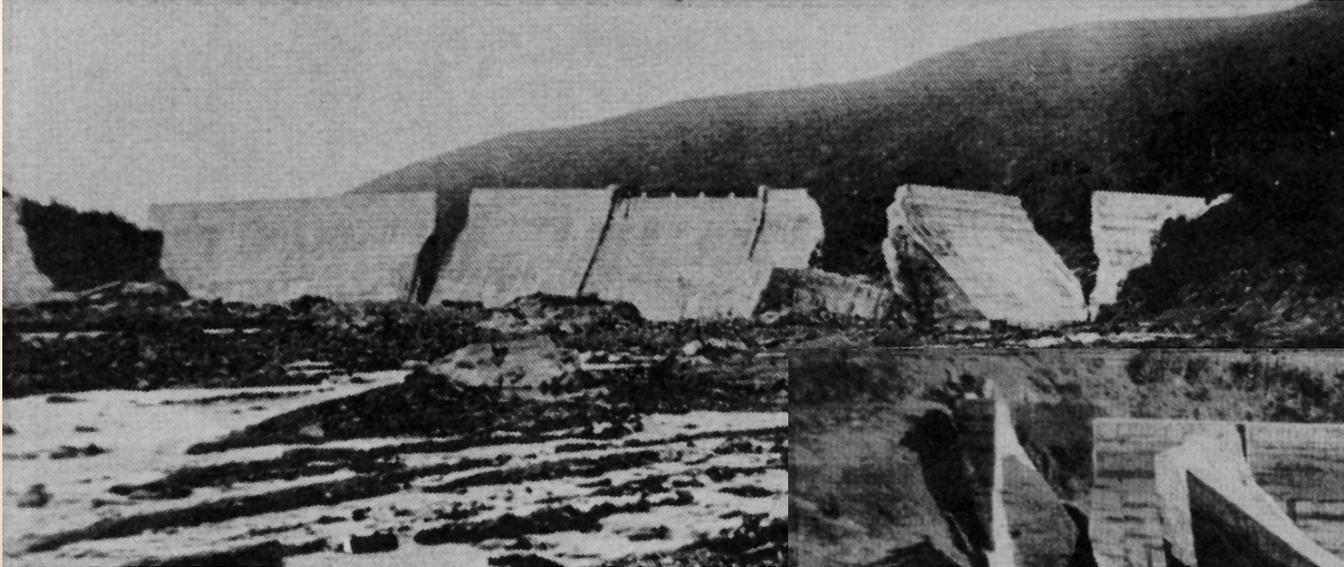
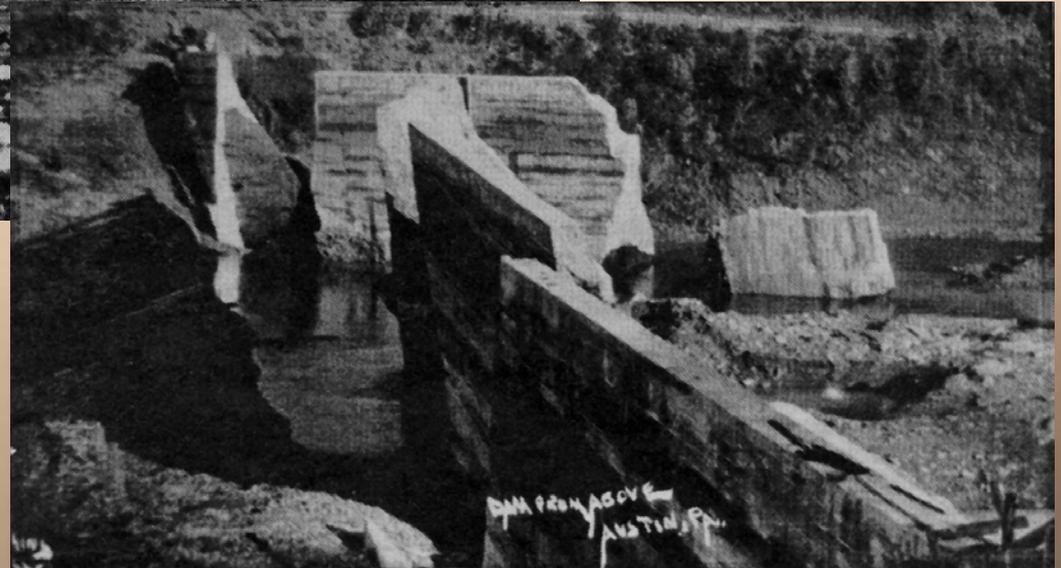
- Repairs were not made
- Dam failed suddenly Sep 30, 1911 after heavy rains with water 7" deep over spillway
- Eyewitness accounts indicate a plug shaped section near the base of the dam 'blew out' and water surged through the opening
- Other sections of the dam opened like a swing gate
- Foundations of some of the failed sections still were attached to the base of the dam indicating sliding along a weak plane deeper in the foundation

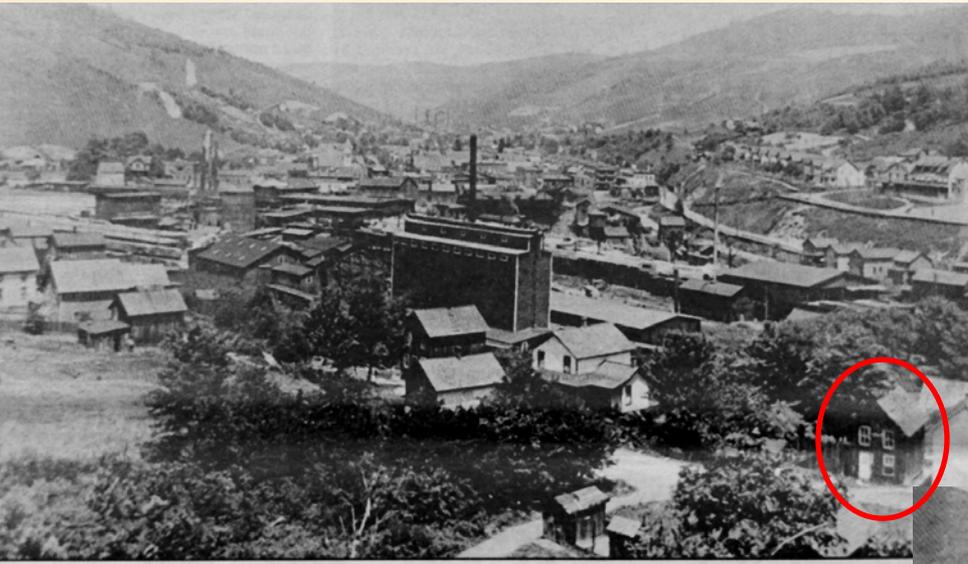
# Austin (Bayless) Dam

- Paper mill whistle blew but warning went unheeded due to previous false alarms
- Flood destroyed the town of Austin leaving only a few brick buildings and houses located above the flood wave

- Flood wave dissipated by time it reached town of Costello located 3 miles below Austin
- Total of 78 fatalities, all in the town of Austin

- Primary cause sliding on weak shale layers within foundation
- Post failure calculations indicated a friction angle  $< 41$  degrees would result in F.S.  $< 1$

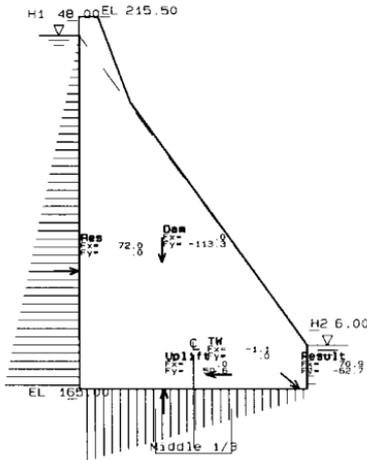
## AUSTIN DAM

DAM DIMENSIONS	
Analysis type	Standard Corps
Criteria at drains	
Top of dam elevation	215.500
Base of dam elevation	185.000
Thickness of crest	2.500
Base width	30.000
Reservoir elevation	213.000
Tailwater elevation	171.000
Silt elevation	.000
Initial crack length	.000
Drain distance from axis	.000
Drain distance from heel	.000
Drain efficiency	1.000
Drainage gallery elevation	
Head at H1, Toe	48.0000
Head at H2, Drain	49.0000
CORPS	H3-H1

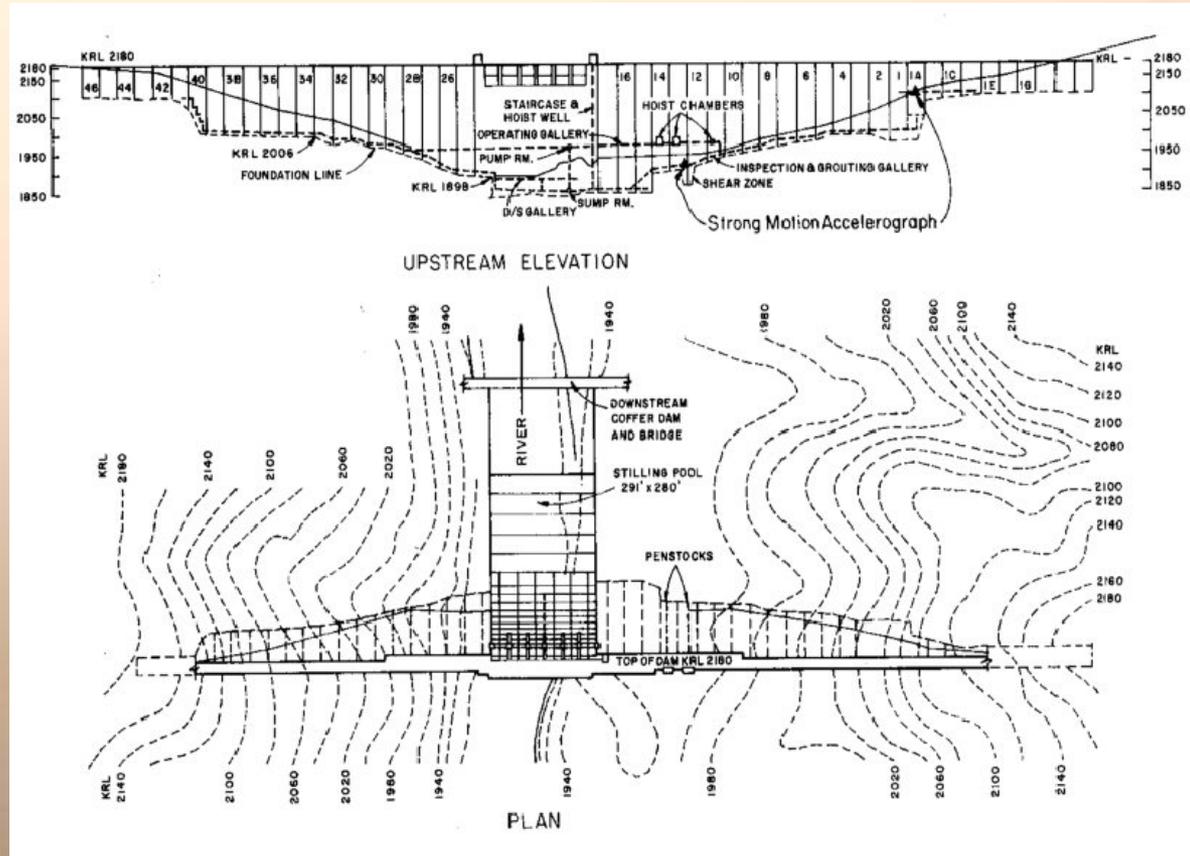
- Straight axis gravity dam located in SW India
- 340-ft high, 2800-ft long
- 50-ft wide monoliths
- Joints not keyed, but contained copper water seals
- Modifications during construction caused a change in geometry of non-overflow monolith cross section
- Steeper d/s slope near top of monolith

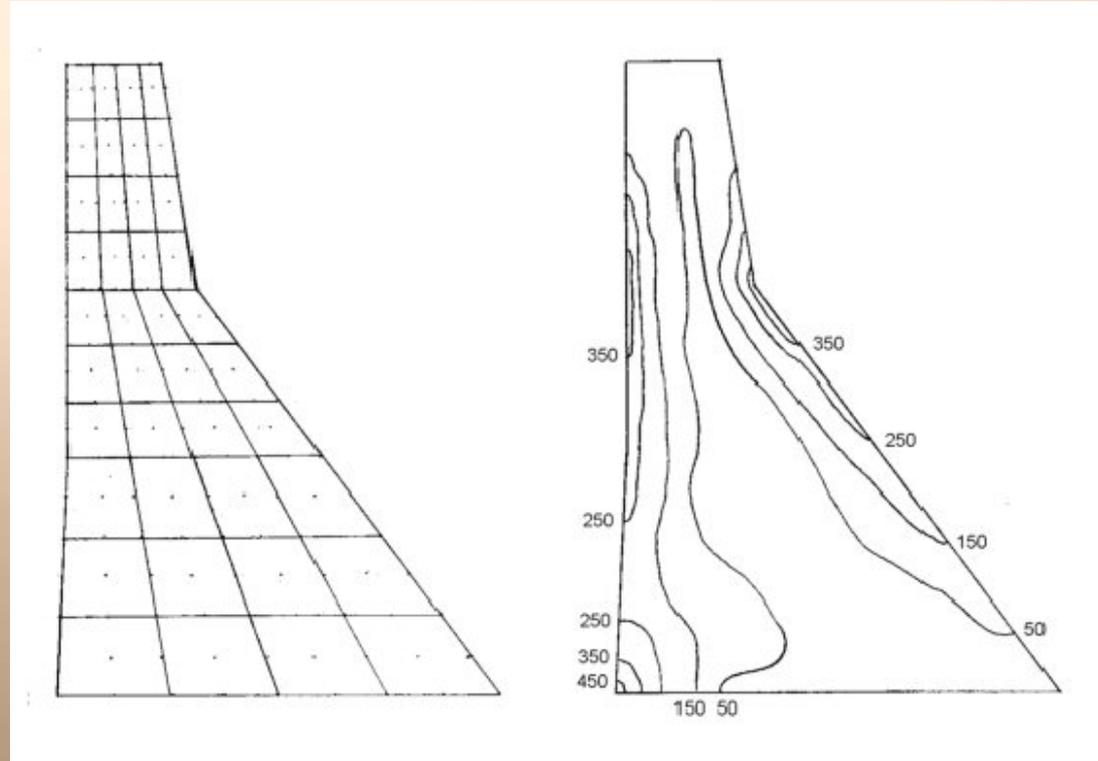
Results of EAGD analysis

- M6.5 EQ on 12/11/76 with epicenter only 13 km from dam
- Reservoir within 40-ft of crest at time of EQ
- Deep horizontal cracks u/s and d/s faces occurred causing significant leakage in most non-overflow monoliths near change in slope
- Modern linear elastic analysis showed tensile stresses  $>$  tensile strength

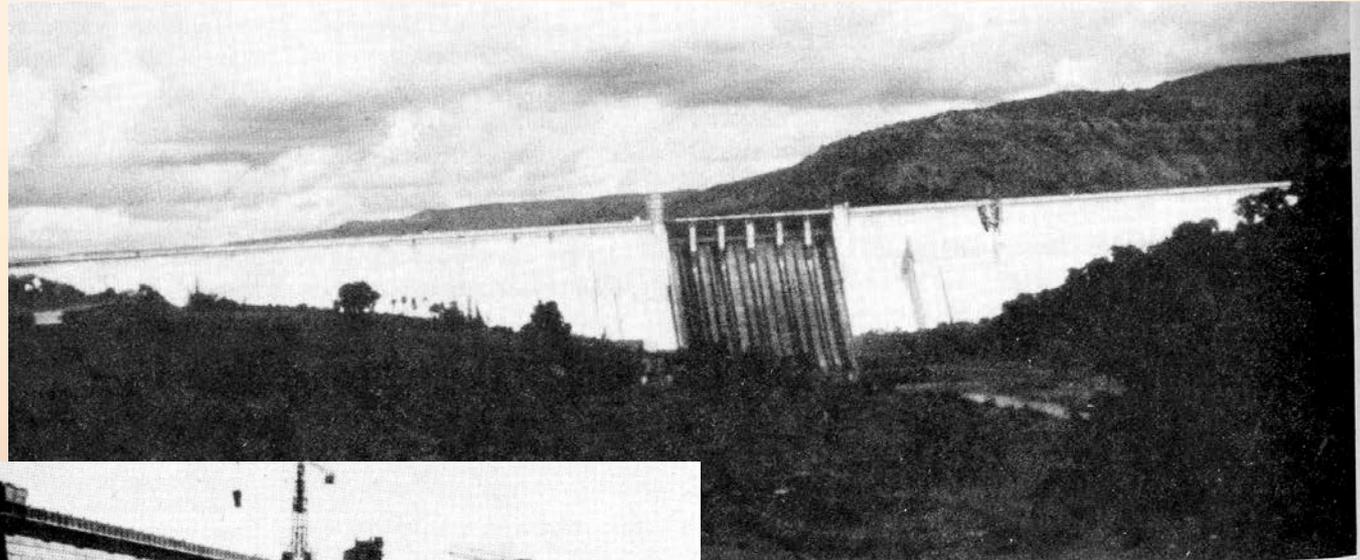
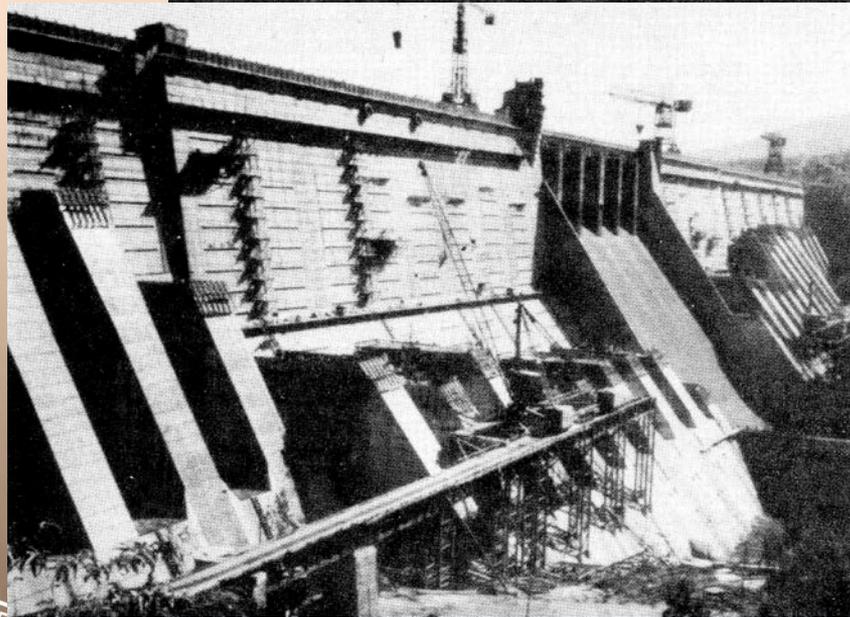
Dam strengthened  
after the EQ

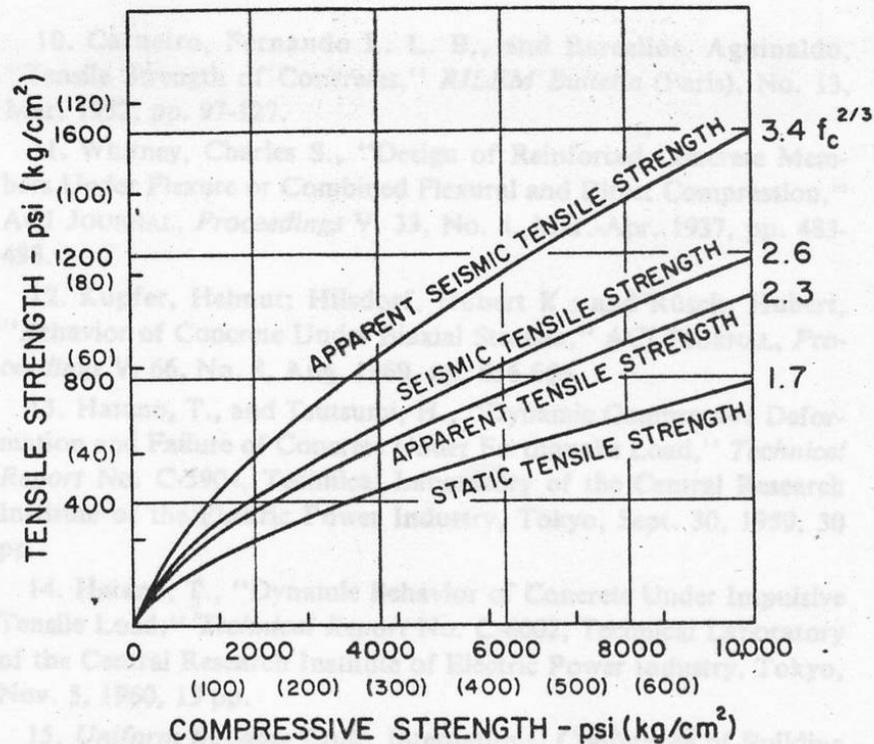
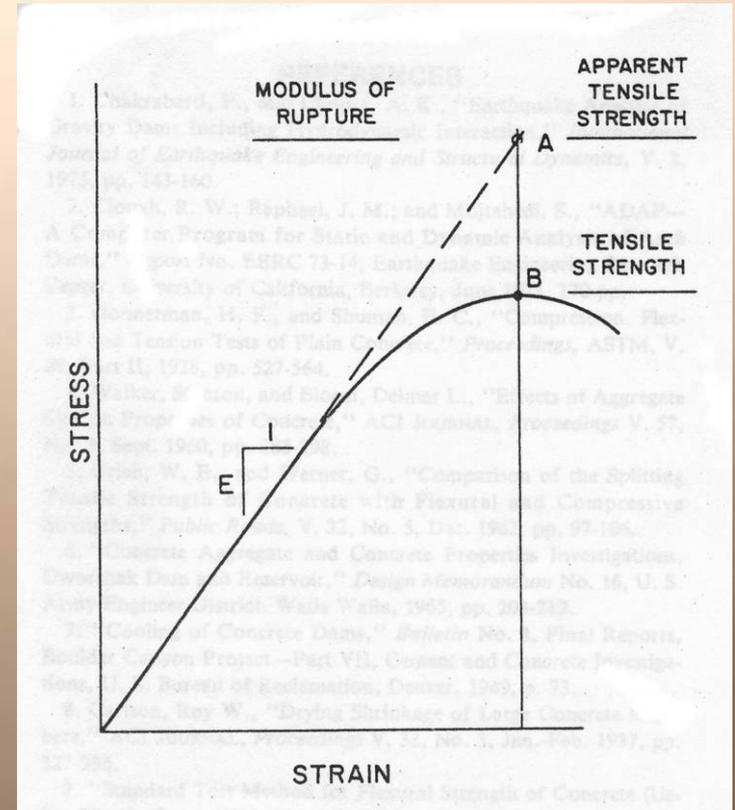
As per Raphael (1984), it is best to use splitting tension tests for best estimate of tensile strength of concrete

Raphael (1984) suggests a 50% increase in tensile strength for dynamic loading

May use apparent strength if a single spike is considered to cause cracking

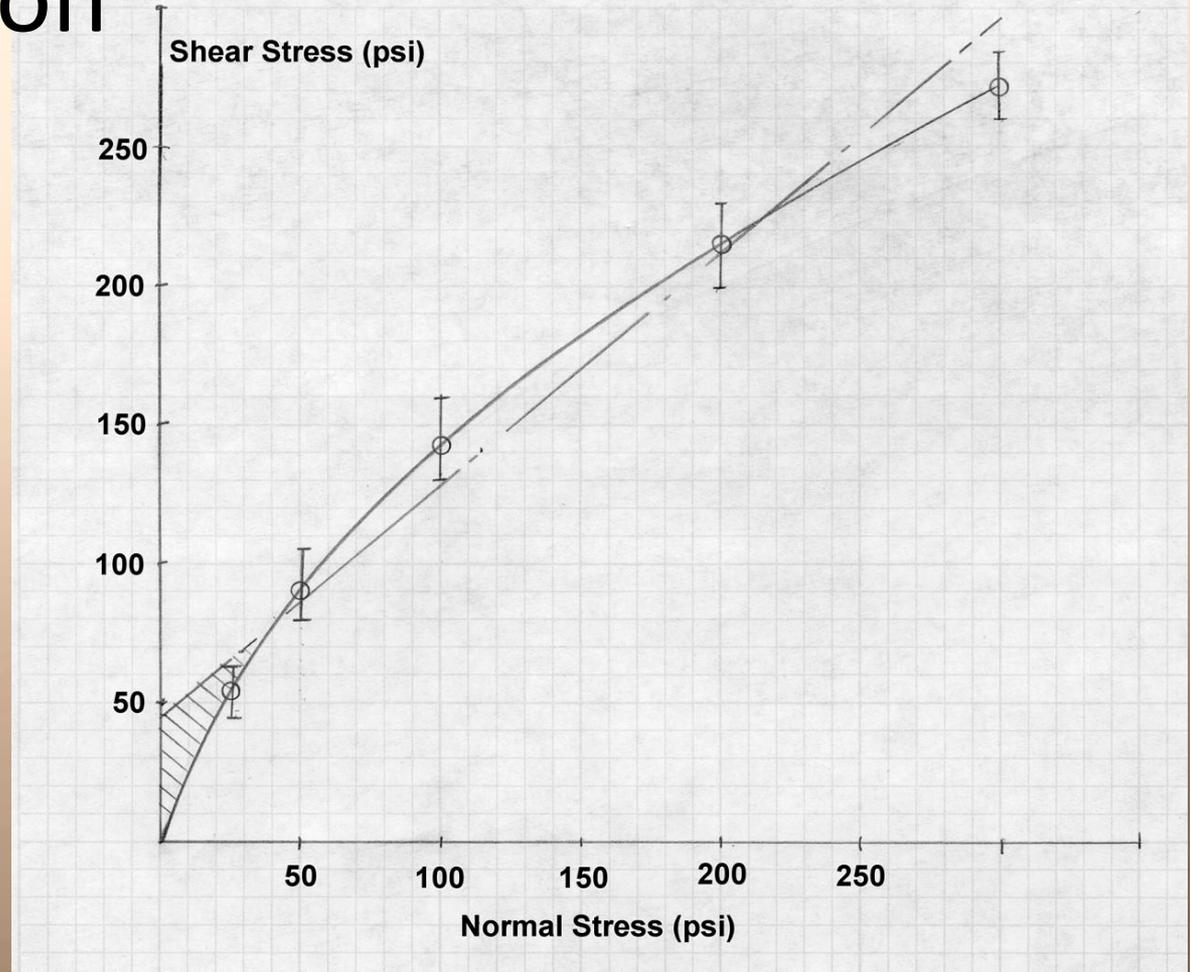
Strength is often over-estimated by straight line fit (at low normal stress typical of gravity dams)

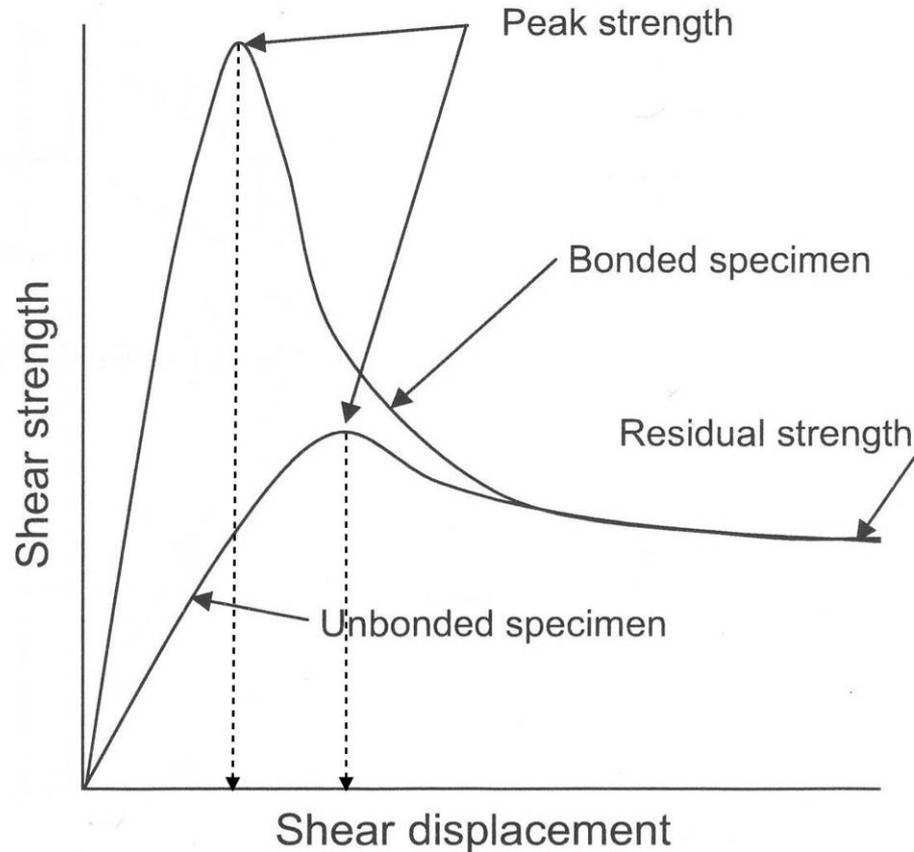
- Make sure added strengths are developed at compatible displacements

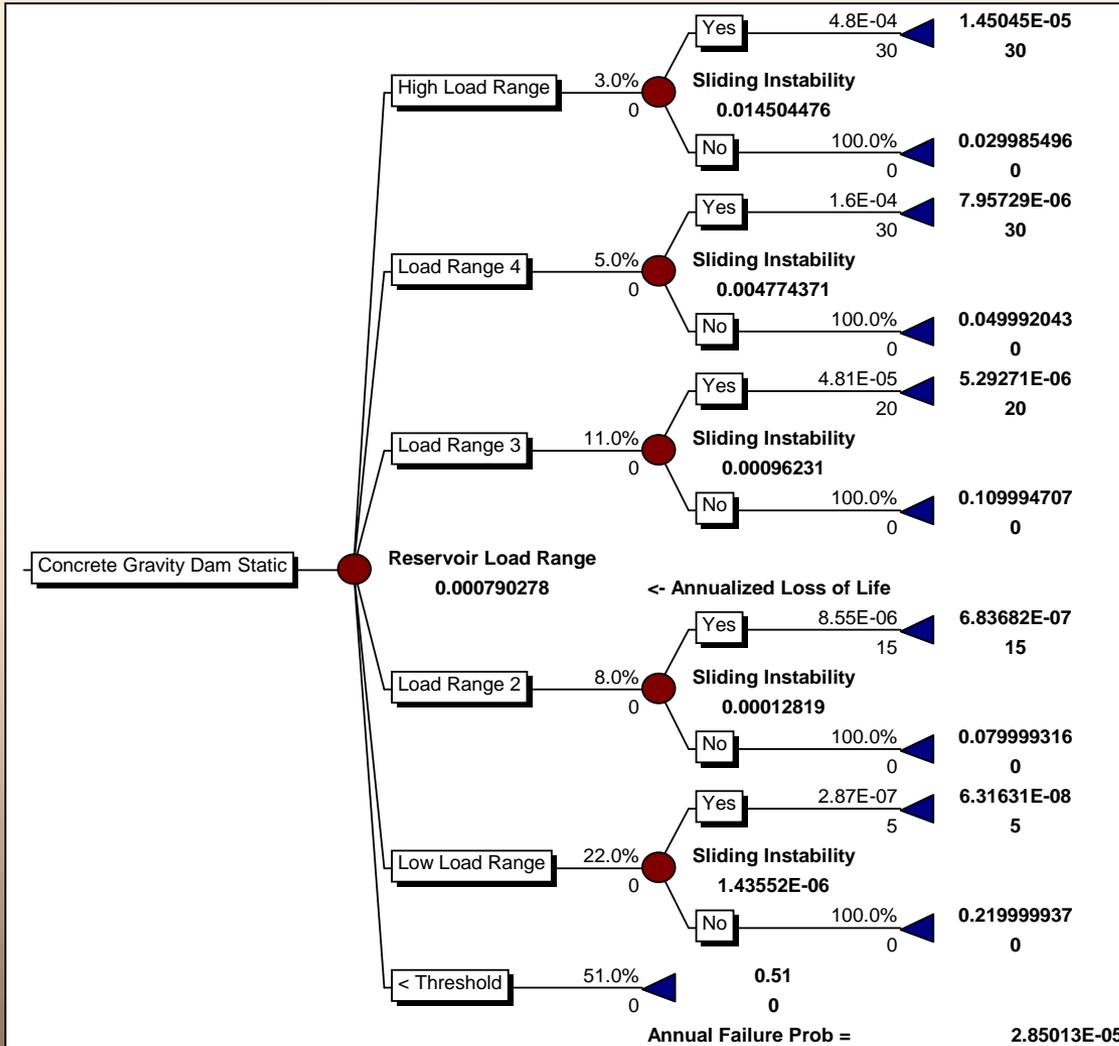
- Use reliability analysis results for 2-D analysis sections and various loads to provide basis for risk estimates
- Account for any 3-D effects judgmentally (as part of elicitation methods)
- Prudent to use tighter ranges around critical load levels (excessive heel stresses, etc)
- Use as input to event trees for risk estimate

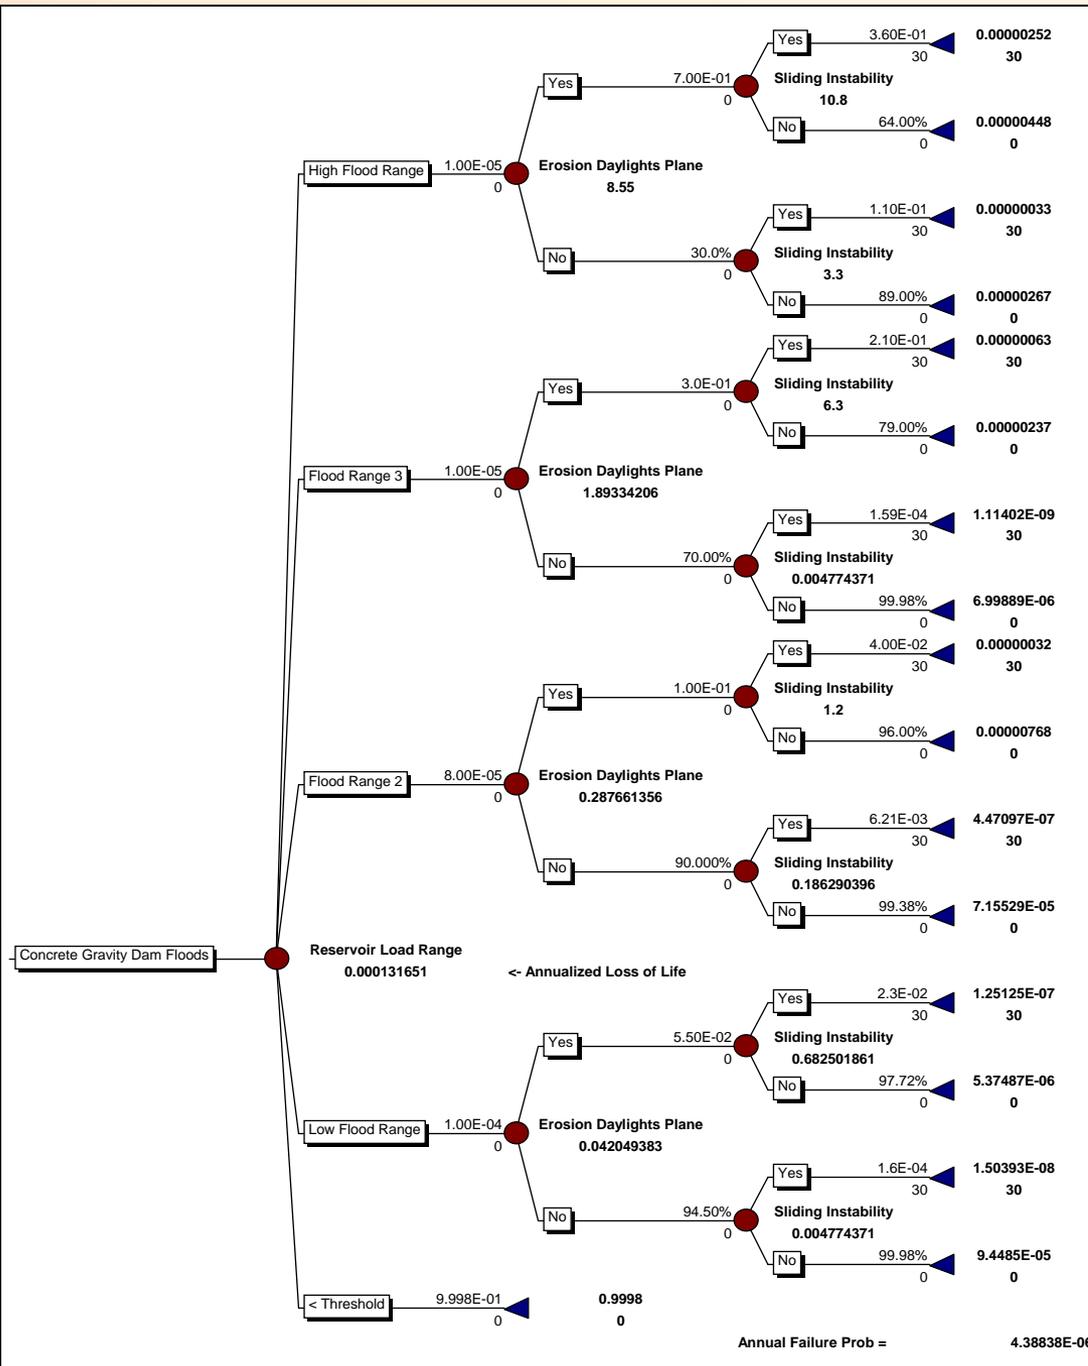
- Careful of nappe and tailwater forces
- Pay attention to potential erosion of rock providing passive resistance (Is there sufficient duration of spillway releases?)
- Will a erosion open (daylight) a weak plane?
- Fully develop event tree and estimate through combination of analytical and elicitation methods

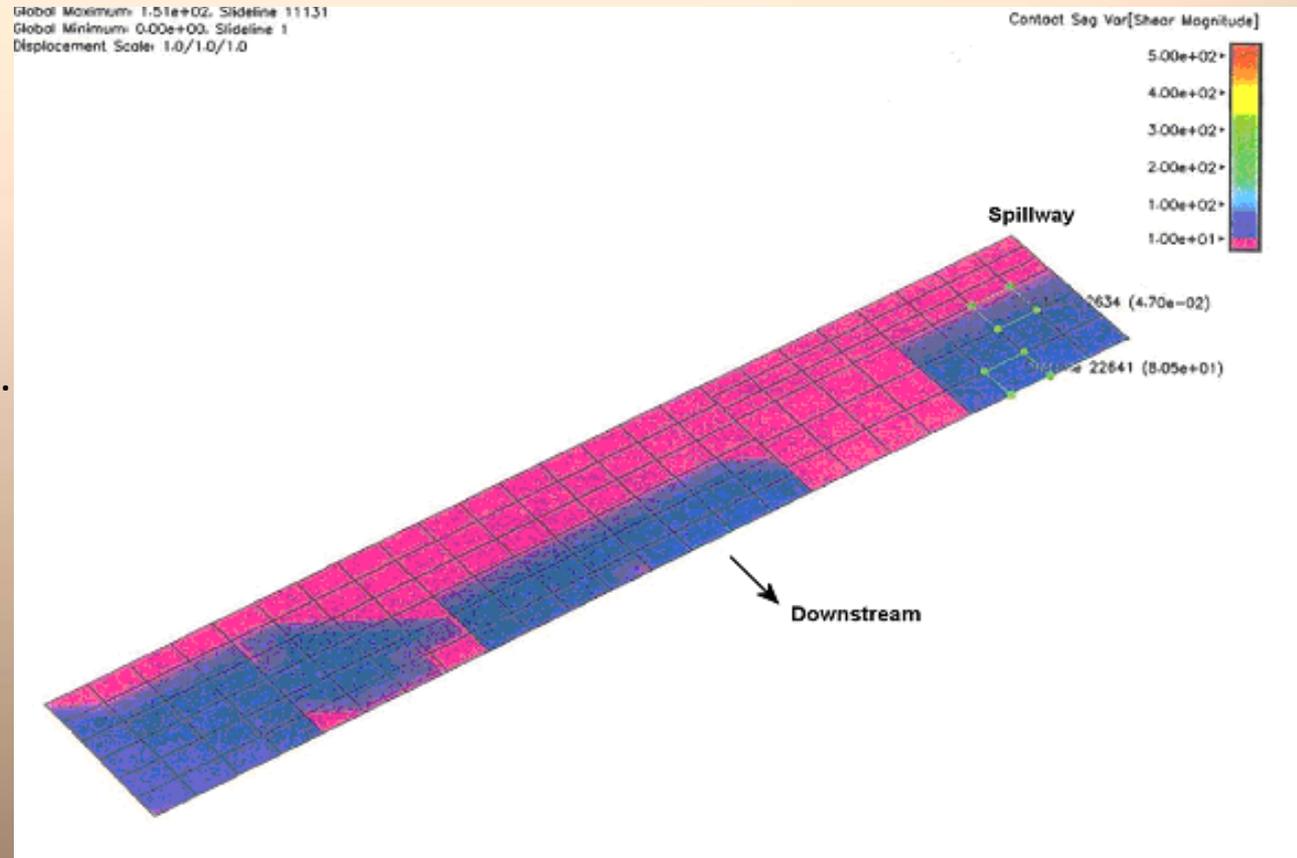
- Nonlinear finite element analysis
- 2-D or 3-D

Important Note: Nonlinear analysis is not for the faint of heart. Make sure you thoroughly test your model. Make sure it can give the correct answer to simple problems, etc. Build the case for why someone should believe the results.

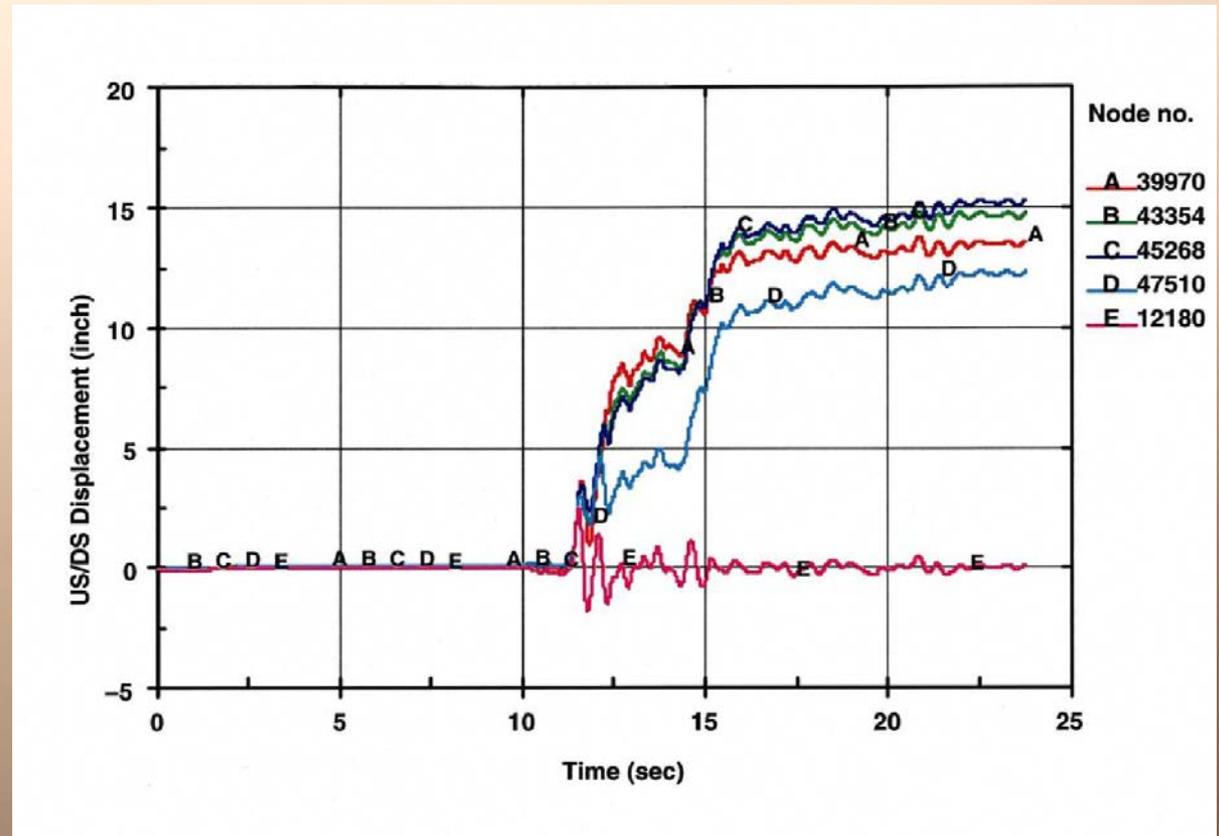
- Nonlinear finite element analysis
- Unbonded surface or shear/tensile cutoff

Some simplified equations included in manual for estimating displacements from yield acceleration – use with caution
