## Percha Tree Farm Vegetation, Soil and Groundwater Assessment: Addendum

Rio Grande Project, New Mexico

U.S. Department of the Interior  
Bureau of Reclamation  
Technical Service Center  
Denver, CO

January 2017

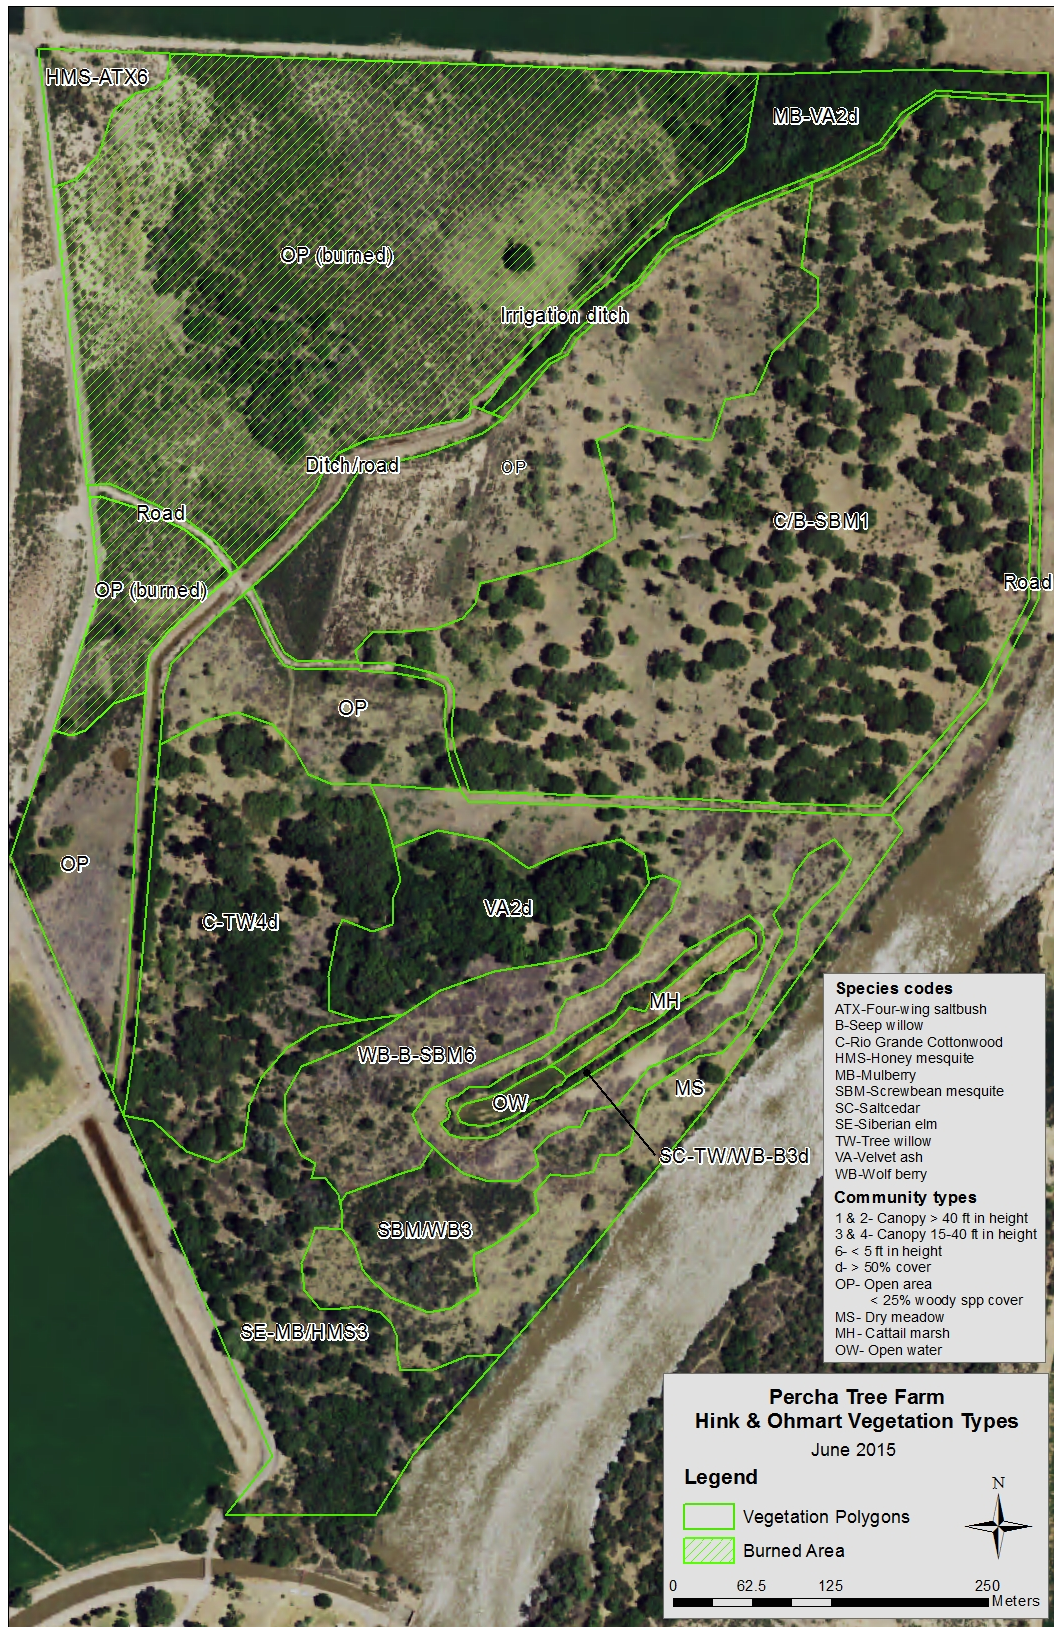
**Figure 3.** Vegetation map of the Percha Tree Farm Project Area using the Hink and Ohmart classification (NAIP 2014 natural color photography).

The vegetation map of Percha Tree Farm is shown in Figure 3. The total acreage within each of the vegetation types is listed in Table 4. A fire in April of 2015 burned approximately 40 acres in the northwest corner of the project area just prior to mapping in June – all vegetation was lost. Vegetation in the remainder of the Percha Tree Farm project area is characterized by occasional tree stands interspersed with open areas (most created by fire), dry meadows, and low shrubs. Tree stands are comprised of various dominant canopy species that include cottonwood (with tree willow understory); cottonwood and tree willow; mulberry and velvet ash; velvet

\* See Figure 3 for species and community type codes

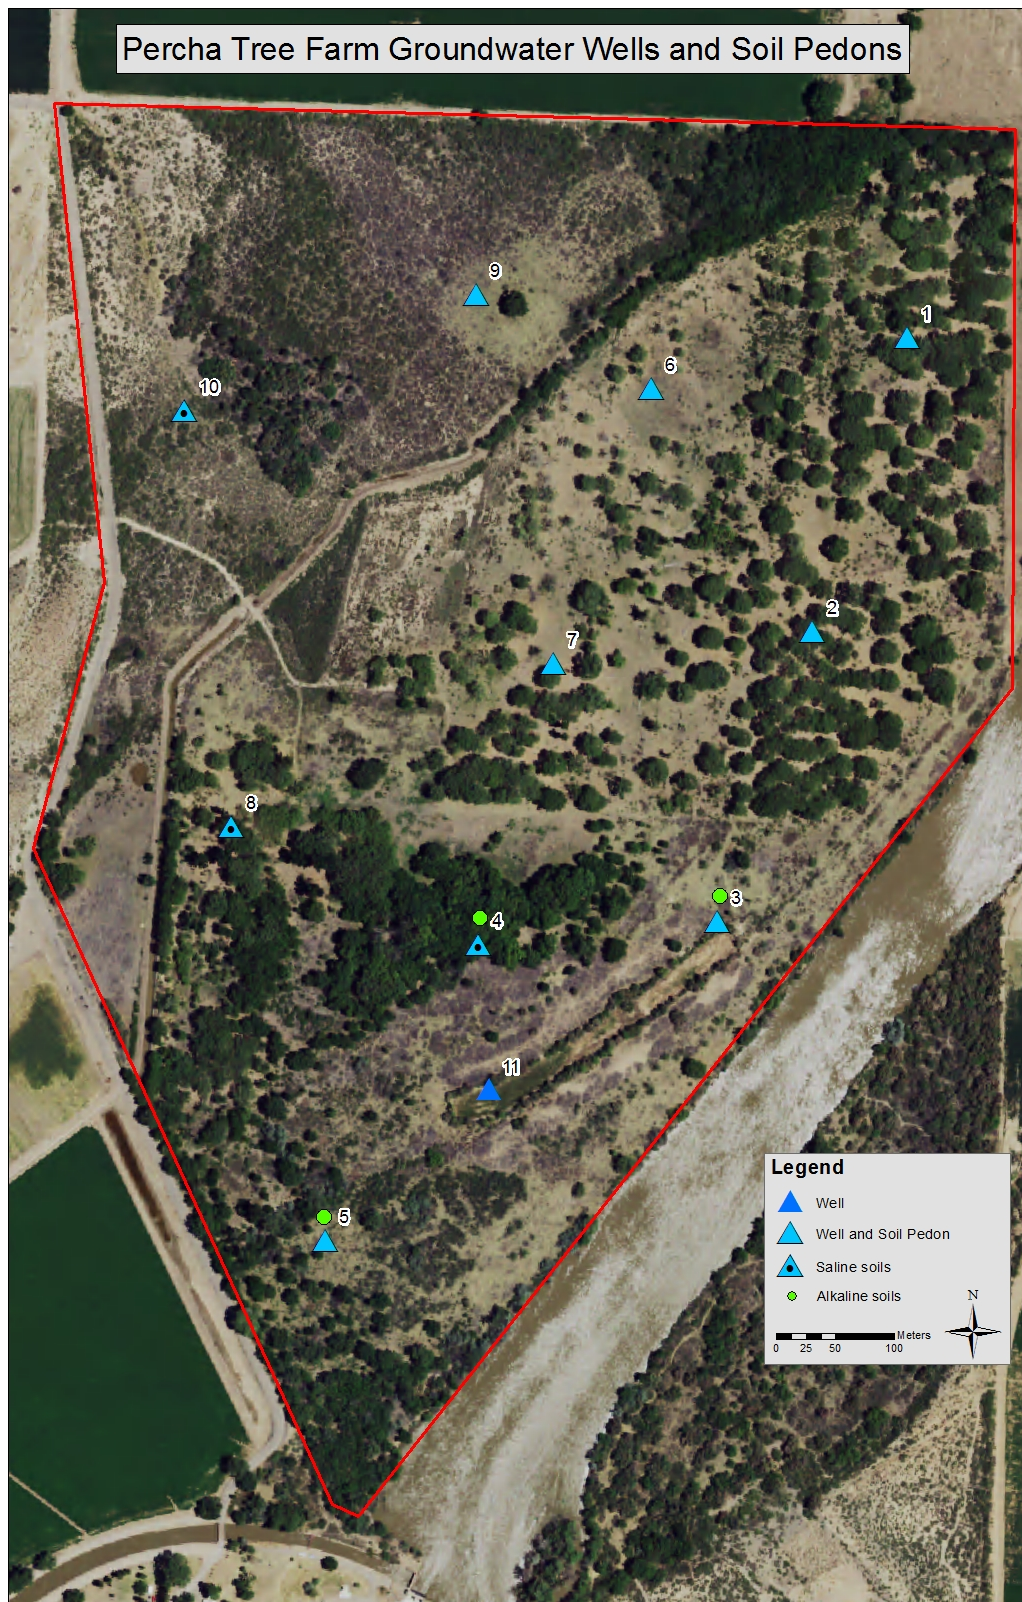
**Figure 4.** Soil pedons in which saline or alkaline conditions were detected.

Saline conditions were detected in four of the 30 samples (Pedons 4, 8, and 10; Table 6 and Figure 4) in the 6 to 36 inch depth range. Saline soils are defined as those having an EC >4 (Flynn and Ulery 2011). High salt in the plant root zone interferes with the uptake of water and depending on the species' tolerance to salt can lead to poor growth or mortality. Saline soil samples were collected along a transect from the south central toward the northwest region of the project area.

Figure 4 shows that the pH levels detected in samples from Pedons 3, 4, and 5 strongly indicated alkaline conditions ( $\text{pH} > 8.5$ ; Herrera 2000). Soil pH affects the availability of nutrients and also the activity of beneficial microorganisms. The majority of plants grow best in slightly acidic soils in the 6 to 7 pH range. Alkaline soil samples were collected from pedons in the southern portion of the project area. Pedons 3 and 5 were located in an alkali sacaton and saltgrass meadow. Pedon 4 was located at the edge of a velvet ash and mulberry stand (adjacent to the grass meadow) and also exhibited saline conditions as included above. Alkaline conditions appeared to be associated with the grass meadow at the southern portion of the project area.

An irrigation ditch currently crosses the site (Figure 4), which could potentially serve as a water source in restoration depending on existing water rights and management. Based on current surface elevation and ground water depths, irrigation would most likely need to be a perpetual management tool for sustaining riparian vegetation. Another consideration with irrigation is the potential to increase soil salinity, particularly at this site where saline soils are already present. Irrigation water often contains salts, either naturally occurring or picked up as water moves across the landscape. When plants absorb water, salts are left behind in the soil and eventually begin to accumulate. In turn, soil salinity alters water uptake, making it more difficult for plants to absorb soil moisture. Surface diversions or irrigation may be more beneficial when paired with bank lowering, as discussed below.
