**United States Department of the Interior
BUREAU OF RECLAMATION**

**THE STRUCTURAL
BEHAVIOR OF
HUNGRY HORSE DAM**

Engineering Monographs

No. 24

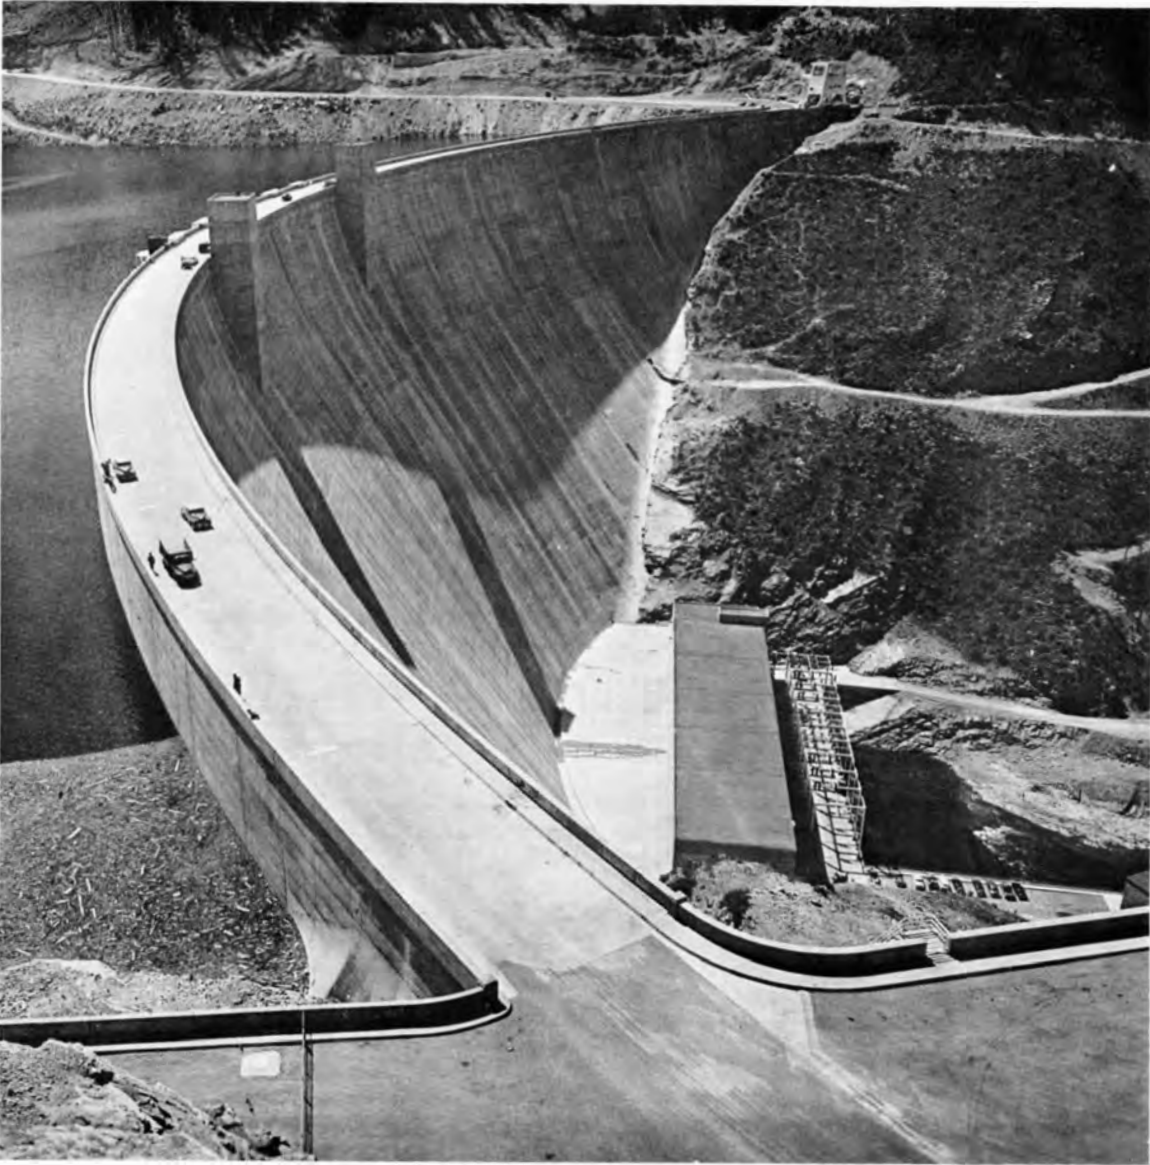
FIGURE 1 - Photograph of Hungry Horse Dam and Powerplant.

Hungry Horse Dam is the principal feature of the Bureau of Reclamation's Hungry Horse Project. The dam, shown in Figure 1, is a variable thickness concrete arch structure on the South Fork of the Flathead River, about 9 miles southeast of Columbia Falls, Montana. Ranking with the highest and largest dams in the United States, the dam has a height of 564 feet above foundation, is 2,115 feet long at the crest, has a base thickness of 330 feet on the plane of centers, and contains 2,935,000 cubic yards of concrete.

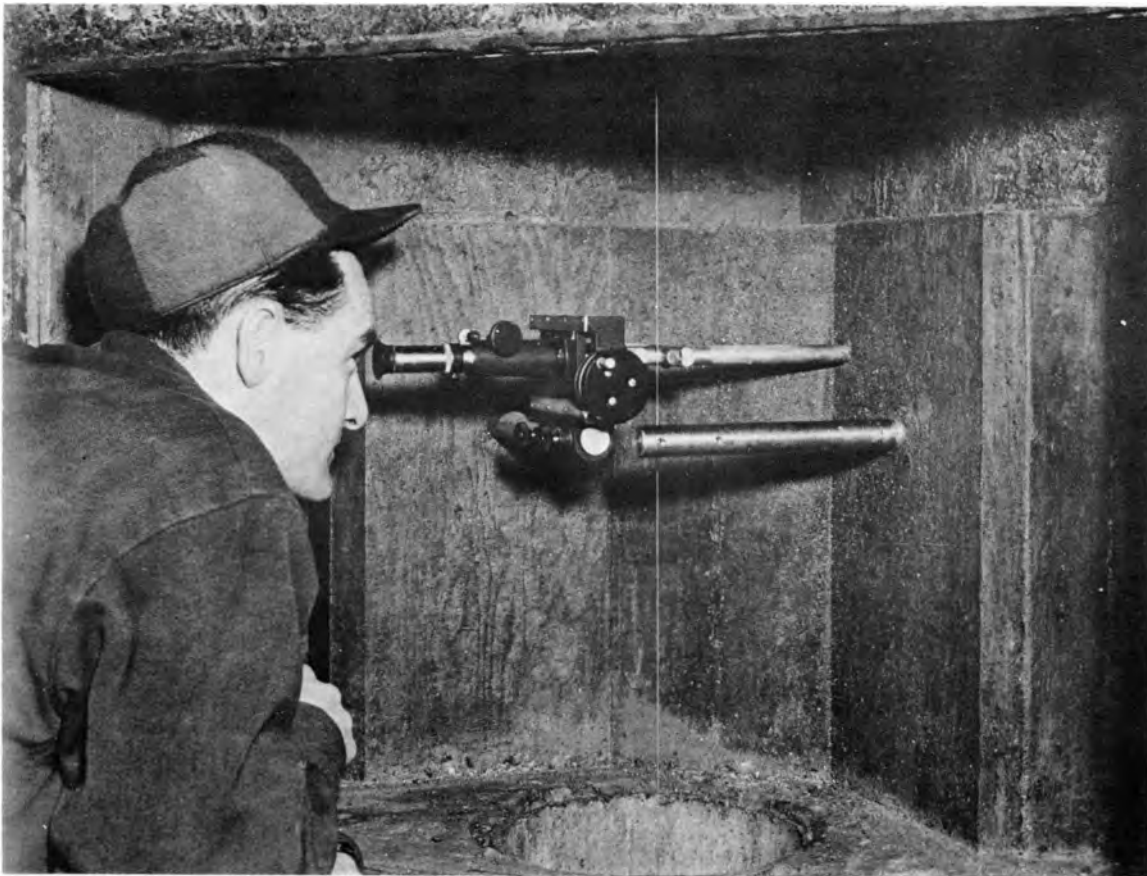
FIGURE 4 - Plumb line observation station showing micrometer carriage and microscope.

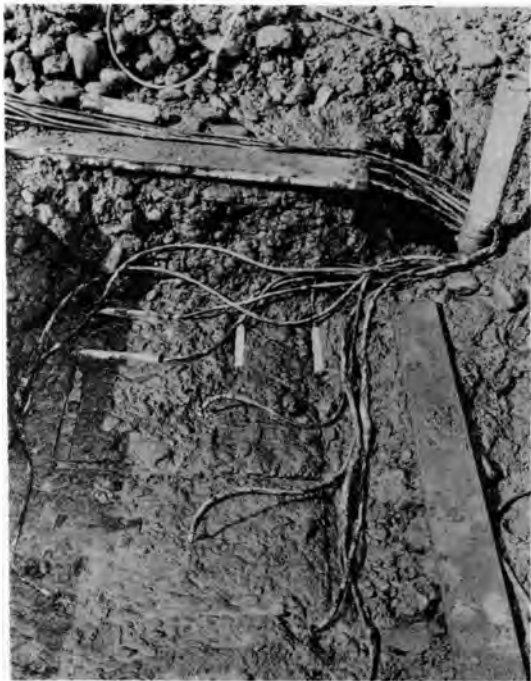
FIGURE 5 - Strain meter group at base of maximum section.

The groups of strain meters were embedded in the dam in two types of arrays. Near the base of the maximum cantilever section, the gage line of strain meter groups is about 50 feet above the foundation rock. The installation consists of 6 groups of 10 meters each. The strain meters in each group are oriented in five directions. Each direction is provided with duplicate meters. In addition, each group includes two stress meters placed to measure stress in the vertical direction. At the base of the dam, the maximum cantilever is divided by the longitudinal joint into two parts about equal in length. Three strain meter groups were placed in each part. These groups are at the center of the blocks and 5 feet from the upstream and downstream edges of the blocks. In each of these groups the strain meters were placed individually in fresh concrete as shown in Figure 5. The strain meters were aligned using a template, level, and protractor, the groups being located from surveyed reference points. A companion pair of stress meters is shown in Figure 6.

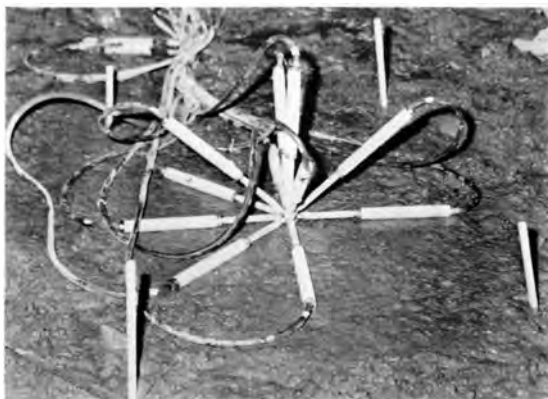
FIGURE 7 - Strain meter group showing instruments assembled to holding spider.

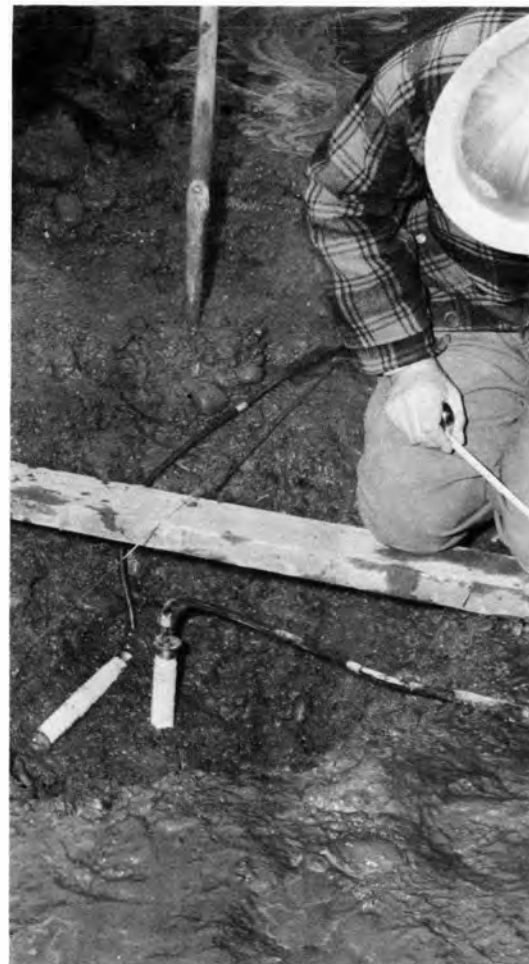
FIGURE 8 - Pair of strain meters for determining volume change in mass concrete.

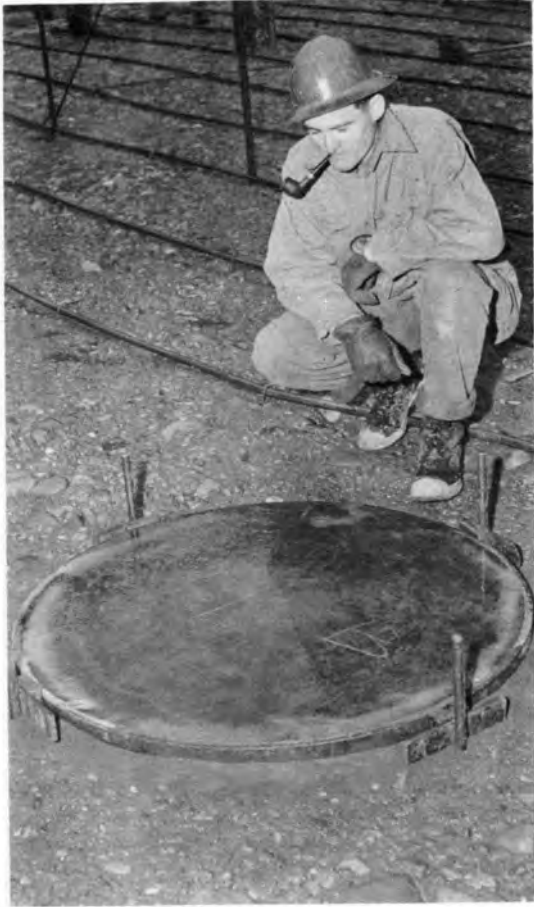
FIGURE 9 - Steel cover plate placed over pair of embedded strain meters.

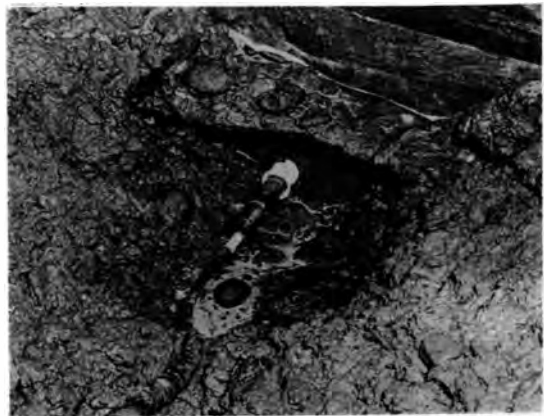
FIGURE 10 - Typical joint meter installation.
