Hydraulic Laboratory Report HL-2007-10

## Intake Diversion Dam Fish Screens

Evaluation of Fish Screens for Protecting Early Life Stages of  
Pallid Sturgeon (*Scaphirhynchus albus*)

November 2007

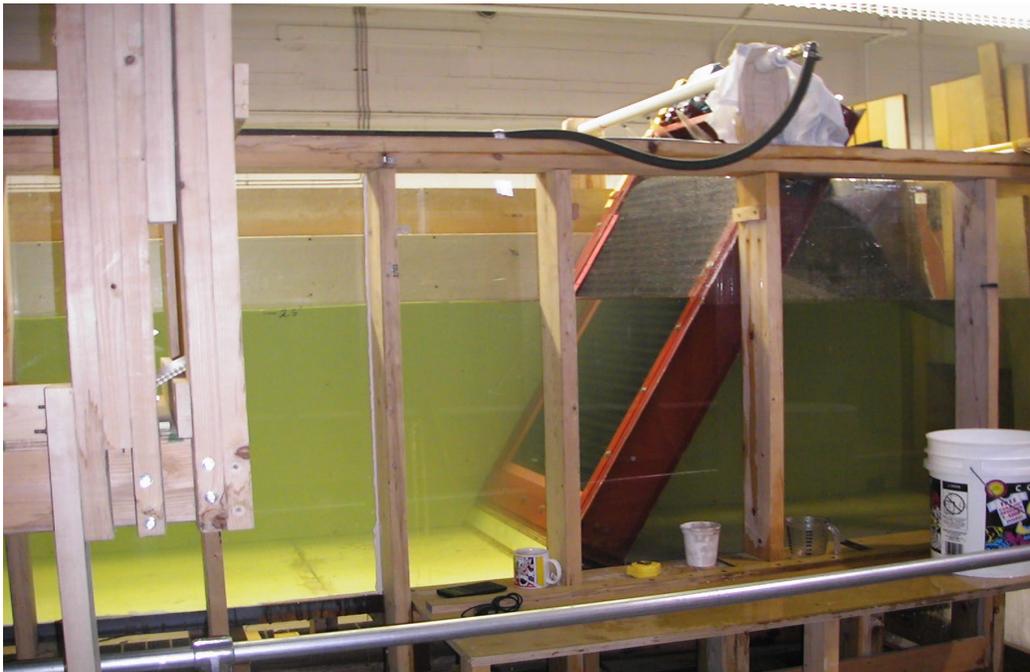
Figure 4b. Pallid sturgeon screen impingement recovery test apparatus.

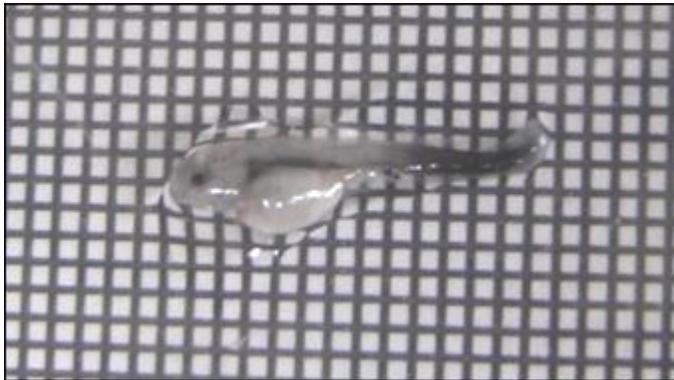
Figure 6a. Photograph of a 15 mm Pallid Sturgeon.

Results of the screen impingement survival experiment indicate all 10-day old Pallid Sturgeon (14 mm mean TL,  $n = 5$ ) drifted through the screen, passing through without any apparent impingement or delay, and ultimately incurred no acute mortality (Figure 6). Given that no impingement occurred with 10-day old fish, test fish were not retained to evaluate 48-hour survival.
