Hydraulic Laboratory Report HL-2010-02

Blue River Fish Barrier Hydraulic Model Study

U.S. Department of the Interior
Bureau of Reclamation
Technical Service Center
Hydraulic Investigations and Laboratory Services Group
Denver, Colorado

March 2012

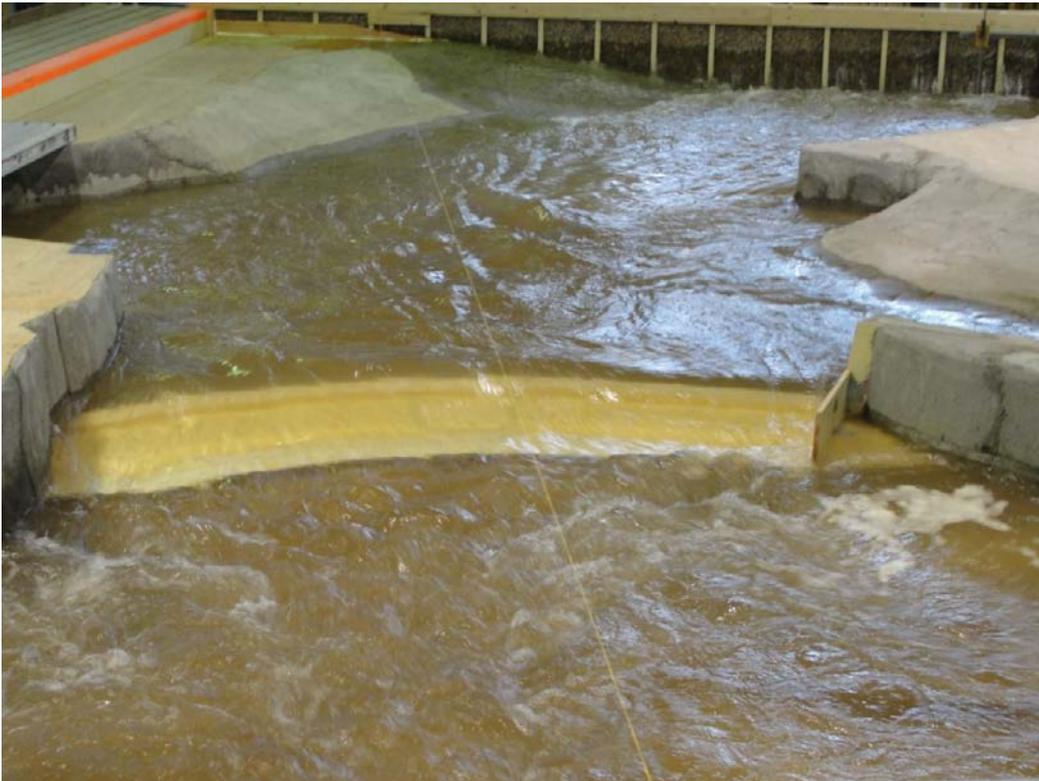
Figure 3. Blue River Fish Barrier- Configuration 3.1 operating at 100-yr discharge, $Q=35,661$ ft³/s.

A physical hydraulic model was constructed at Reclamation's Hydraulics Laboratory in Denver, Colorado (Figure 3).

A geometric scale of 1:28 was used to construct the model, which included the fish barrier, about 650 ft of upstream river channel and about 550 ft of downstream river channel. Since hydraulic performance for open channel flow depends primarily on gravitational and inertial forces, Froude law scaling was used to establish a kinematic relationship between the model and the prototype. Froude law similitude produces the following relationships between model and prototype:

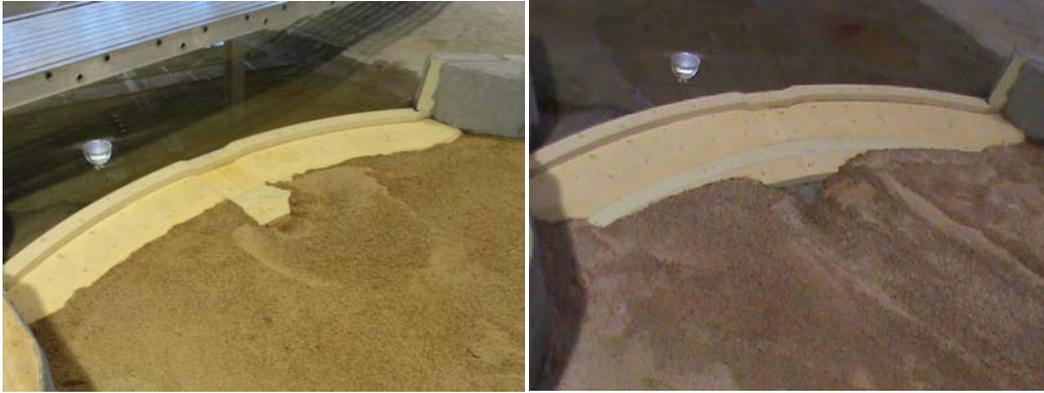
The initial design incorporated a 2-foot deep low-flow notch in the center of the weir and apron. Ideally this will force the river channel at low flows to the center of the barrier and away from the sides where it might have more potential for erosion at the interface between the abutments and the barrier. The weir and apron also have a 1% slope toward the center of the barrier. Testing showed that at low flows the notch concentrated the flow and caused significant scour directly below the low-flow notch. The mean daily flow and the 2-yr flow showed scour holes 8 ft and 16 ft deep, respectively (prototype depths), as shown in Figure 8.

Figure 8. Scour below the low-flow notch for the mean daily flow (left), and 2-yr flow.

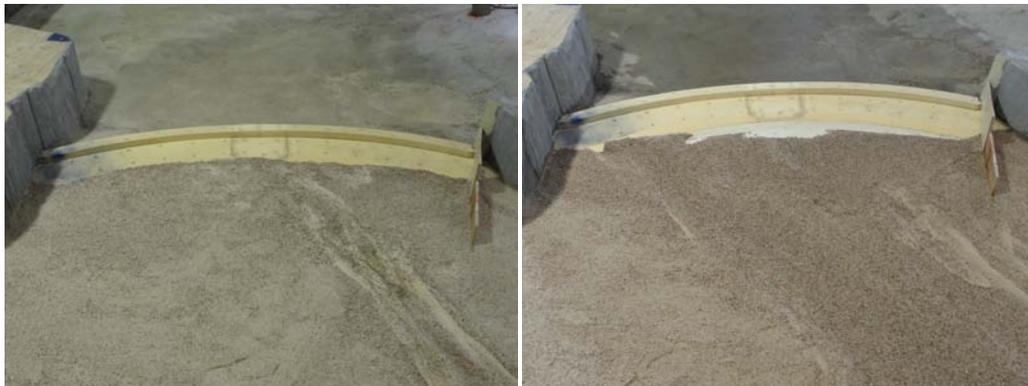
A second series of tests was carried out with the low-flow notch eliminated by filling it in (Figure 9). Without the notch, the flow spread out more and produced very little scour at low discharges. At higher discharges the notch had a minimal impact on scour downstream from the barrier. The 2-ft deep notch in the apron is 0.5 ft above the existing downstream ground surface. It is recommended that the notch be filled in and the entire structure lowered by 2 ft. This would produce similar hydraulic conditions to inhibit upstream fish passage. The vertical drop from the weir crest to the apron would still be 4 ft, but the total drop across the structure would be reduced by 2 ft, leaving less energy available to cause scour downstream from the structure. Tests in which the tailwater level in the model was artificially raised about 2 ft higher than the realistic tailwater level verified that flow across the apron would remain supercritical, so there would be no submergence of the apron.

Figure 9. With the low-flow notch filled in, there was very little scour at the mean daily flow (left) and the 2-yr flow.

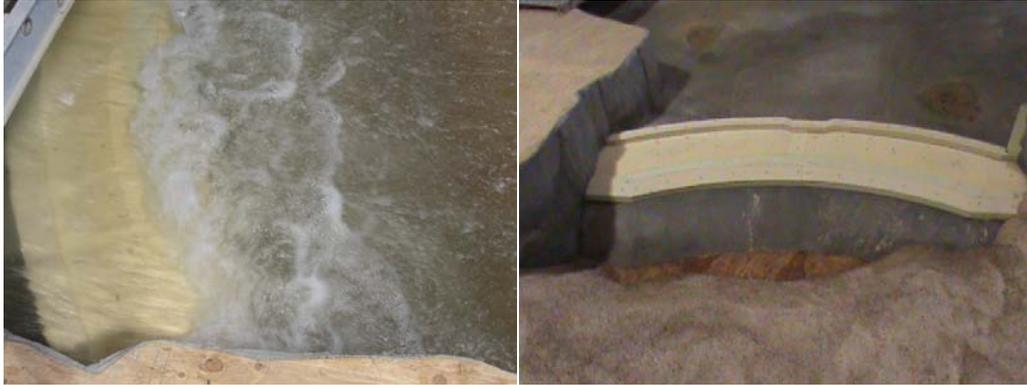
Figure 11. Plunging flow at the 100-yr discharge (left) for the initial deflection block design. Scour caused by plunging flow (right). Note the exposed false floor of the model at the toe of the sloped scour wall. The deflection block is 8-9 ft long.

The design purpose for the deflection block (see Figures. 5 and 6) was to prevent the high velocity flow downstream from the barrier from plunging deep into the tailwater pool and causing scour that might threaten the stability of the structure. The initial deflection block's length in the flow direction ranged from 7.8 ft at the abutments to 10.0 ft at the center. At the 100-yr discharge there were 2 different flow conditions observed over the barrier. In the first condition there was a hydraulic jump immediately downstream from the deflection block against the sloped scour wall (Figure 11). This allowed the flow to remain attached to the scour wall and plunge downward toward the riverbed, producing deep scour. A large scour hole across the full width of the structure was formed at the 100-yr discharge. The depth of scour was artificially limited by the floor of the model sand bed (elevation= 3848 ft). Approximately 80% of the structure's scour wall was visible due the lack of sand (Figure 11).

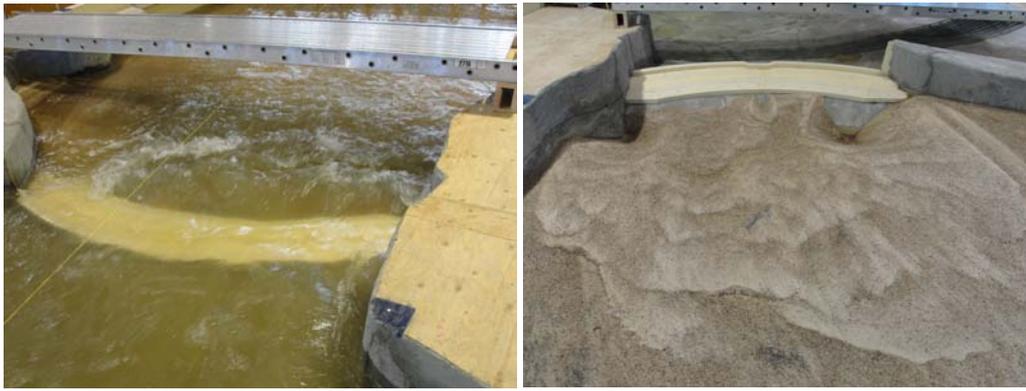
Figure 13. Undular flow at the 100-yr discharge (left) with the initial deflection block design. Scour resulting from undular flow (right). Note the material still in place against most of the scour wall. The deflection block is 8-9 ft long.

In the second flow condition an undular jet was formed downstream from the barrier. The flow detached from the deflection block and the main jet remained near the water surface instead of plunging down. This condition created a small localized upstream current along the river bottom that moved sand back upstream toward the barrier. This flow condition produced much less scour than the plunging condition (Figure 13).

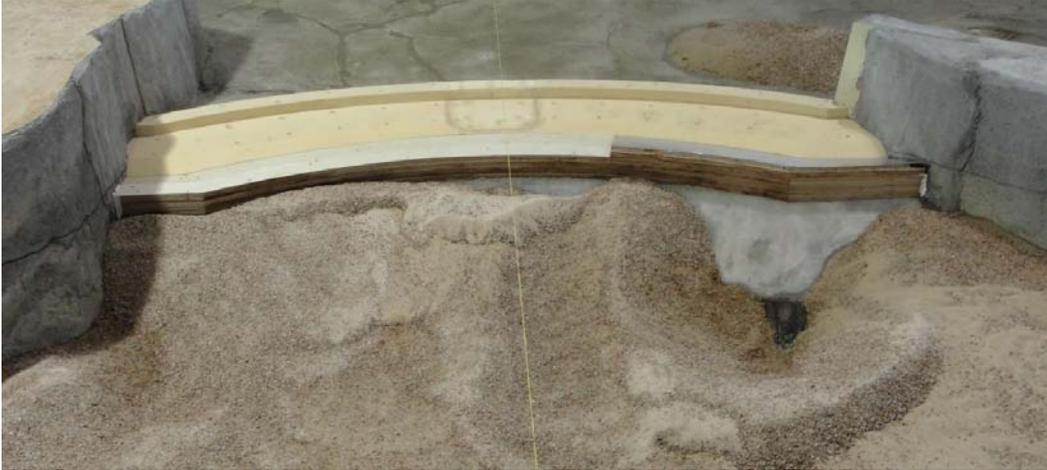
The longer deflection block worked well across most of the width of the barrier, but there was still a significant amount of scour downstream from the left end of the structure (see Figure 16). This localized scour is primarily caused by upstream approach flow conditions that concentrate flow to the left side and an expanding flow downstream that creates a large horizontal recirculating eddy on the river left side.

Figure 16. Looking upstream at localized scour on river left side of barrier.

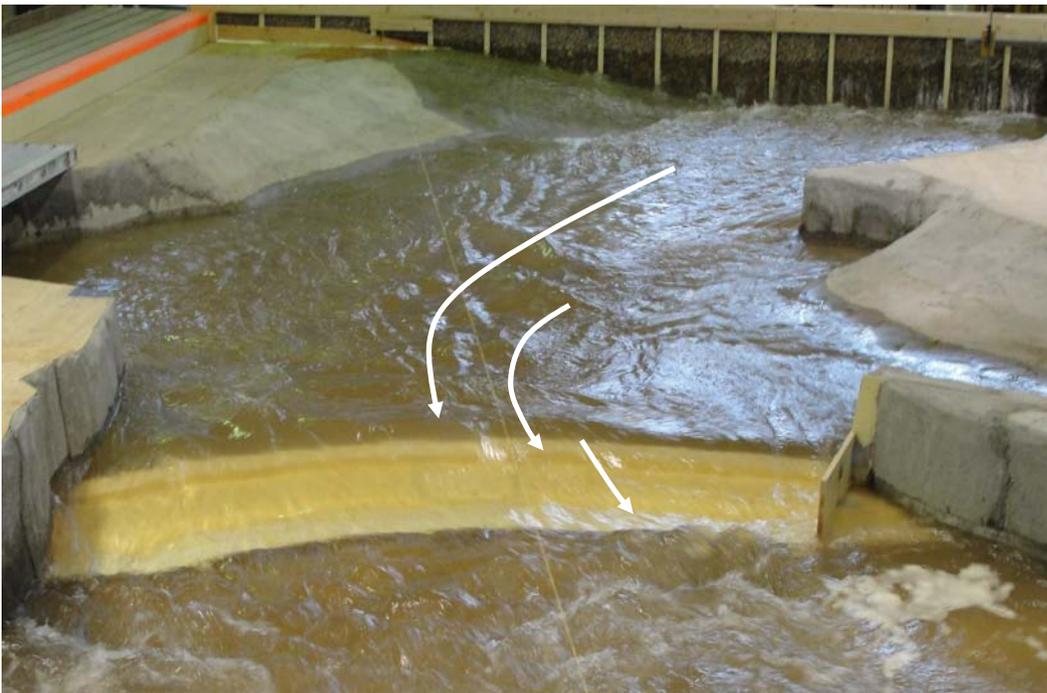
Figure 17. Upstream approach conditions cause flow to pass over the barrier at an angle, concentrating downstream on the river left side.

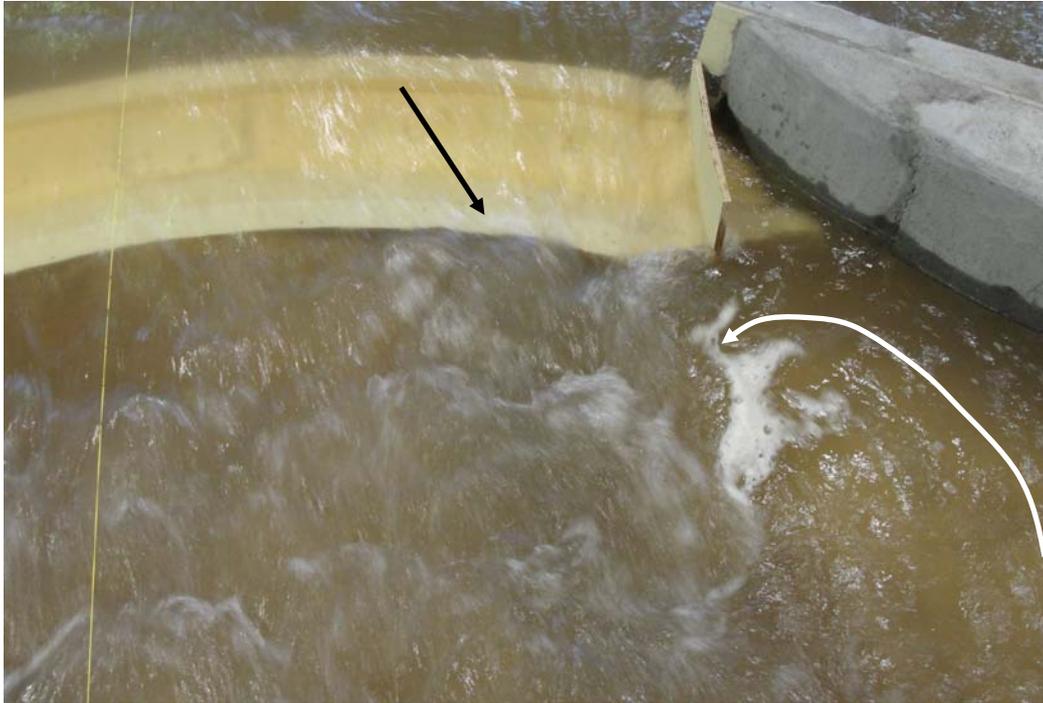
Figure 18. Downstream from the barrier, a large horizontal recirculating eddy forms on the river left side.

The flow coming over the barrier moves downstream in an undular wave as discussed earlier. The downstream recirculating current flows underneath the surface wave creating a vortex along the face of the scour wall. This vortex is very efficient at scouring the scour wall and the streambed in this location.

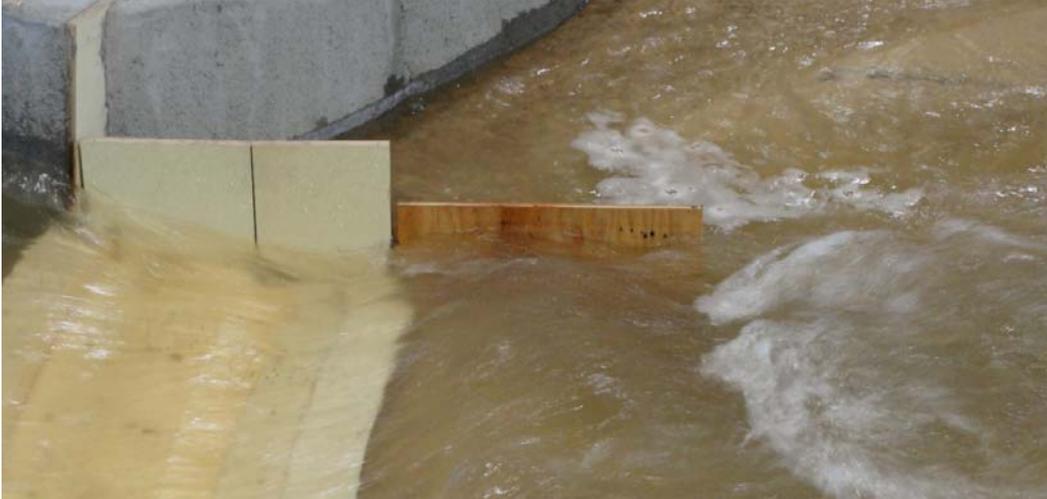
Figure 21. The training wall at the 100-yr discharge.

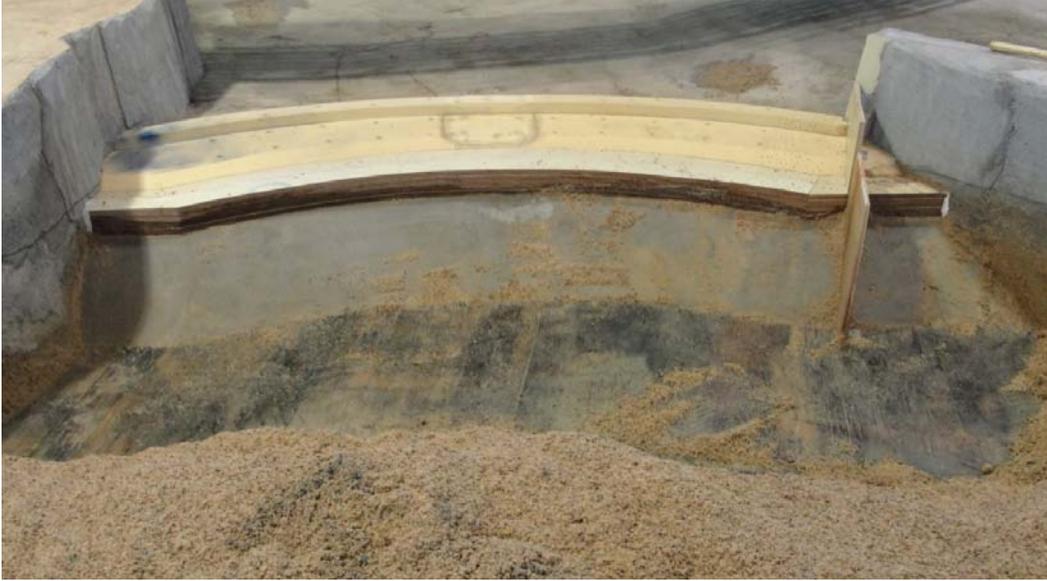
Figure 22. Recommended design with downstream material manually removed to make the scour wall visible for photographs.

Figures 22-31 show the recommended design, the 25-yr and 100-yr flow conditions, and the resulting downstream river channel contour maps obtained by photogrammetry. Areas of scour and deposition are highlighted in figures 27 and 31.

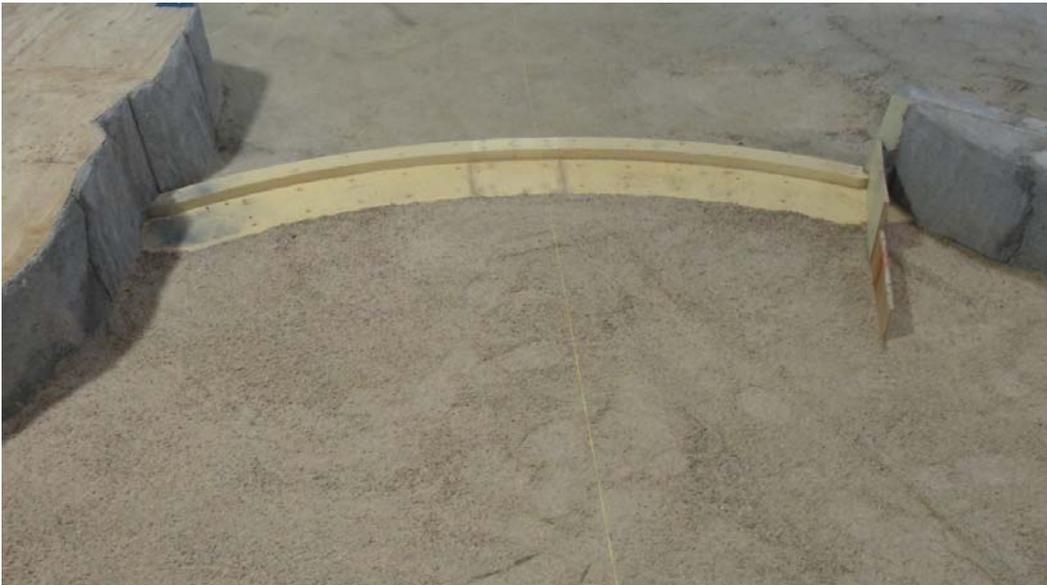
Figure 23. Recommended design with the existing downstream topography in place.

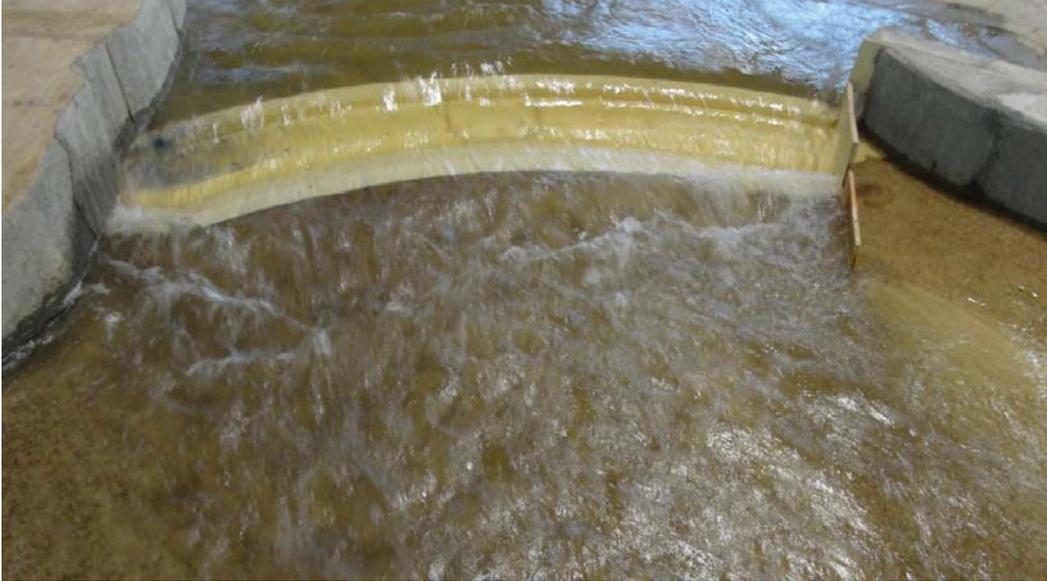
Figure 24. Recommended design at the 25-yr discharge.

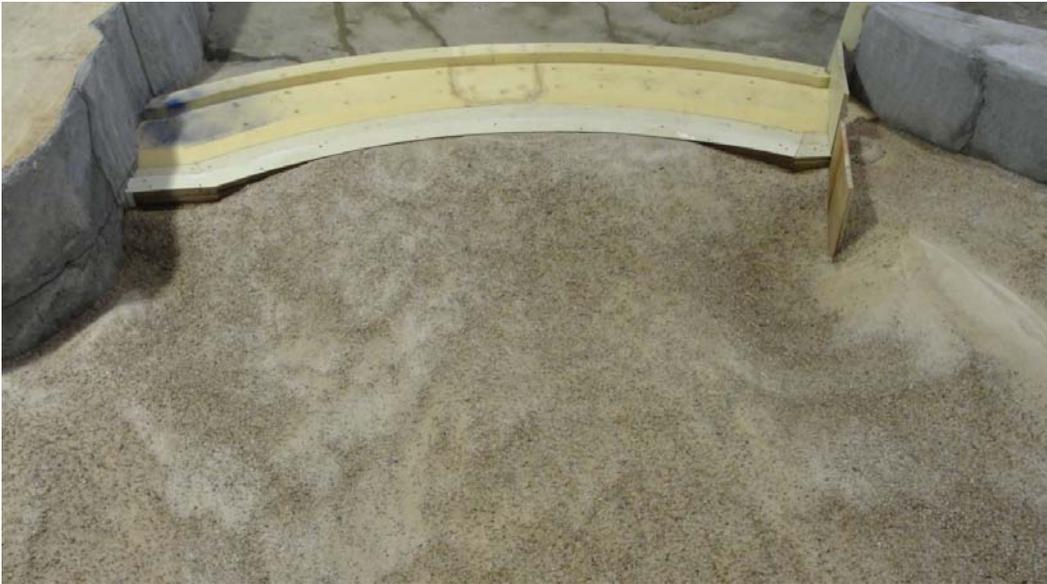
Figure 25. Recommended design showing scour after the 25-yr discharge.

- Average depth of scour for clear water tests at the 25-yr discharge is about 10 ft with localized holes reaching 18 ft.
- The scoured ground surface above the toe of the structure after the 25-yr discharge ranged in elevation from 3862 to 3872 with an average of 3868 ft (7 to 17 ft above the toe).

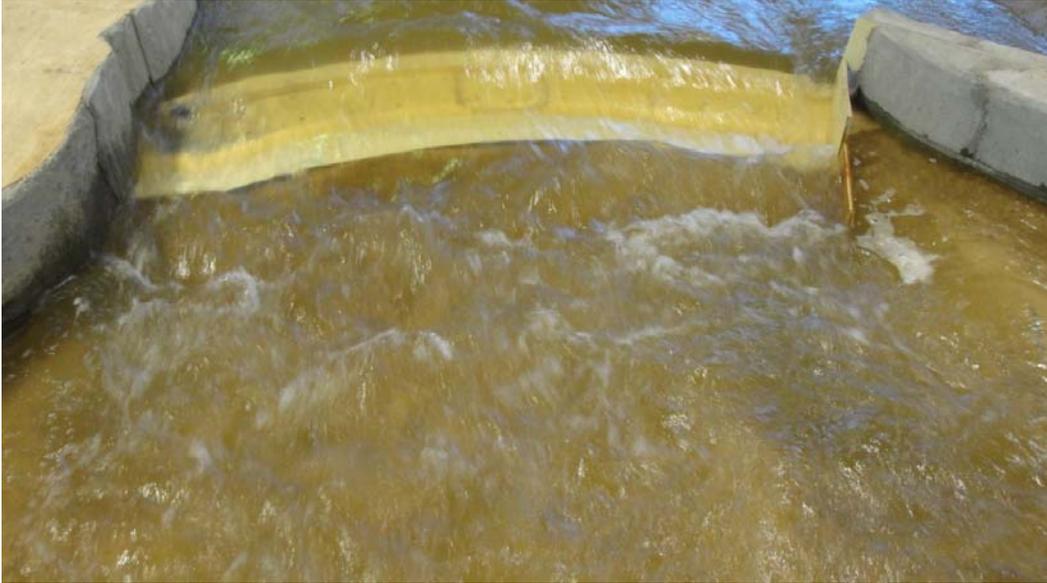
Figure 28. The recommended design at the 100-yr discharge.

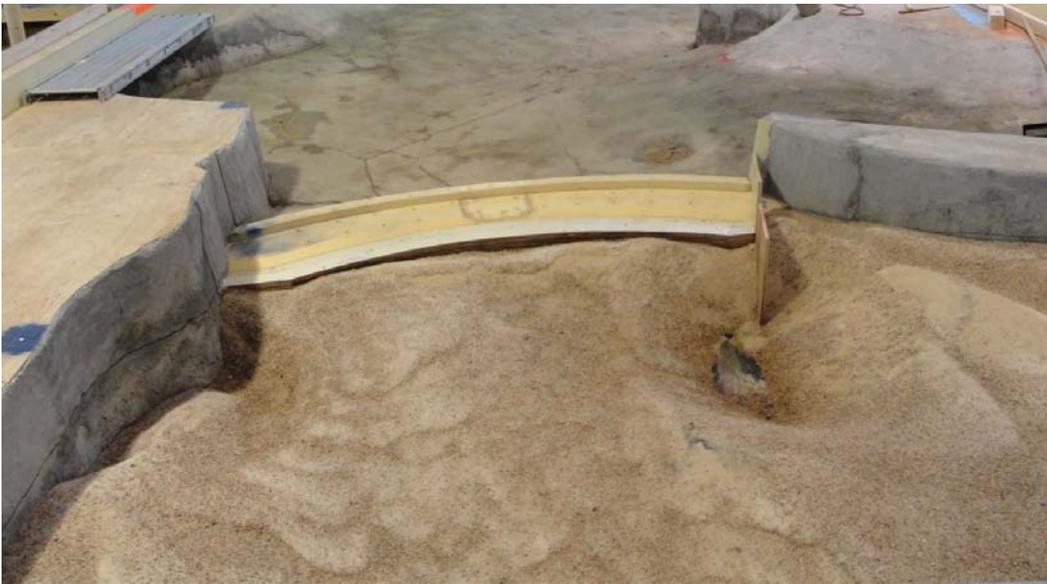
Figure 29. Scour observed with the recommended design after the 100-yr discharge.

- Average depth of scour for clear water tests at the 100-yr discharge is about 16 ft with localized holes reaching 26 ft.
- The scoured ground surface above the toe of the structure after the 100-yr discharge ranged in elevation from 3858 to 3870 with an average of 3868 ft (3 to 15 ft above the toe).
