Hydraulic Laboratory Report HL-2011-01

COE Feasibility Level Fish Bypass Design at Marble Bluff Dam

**U.S. Department of the Interior
Bureau of Reclamation
Technical Service Center
Hydraulic Investigations and Laboratory Services Group
Denver, Colorado**

April 2011

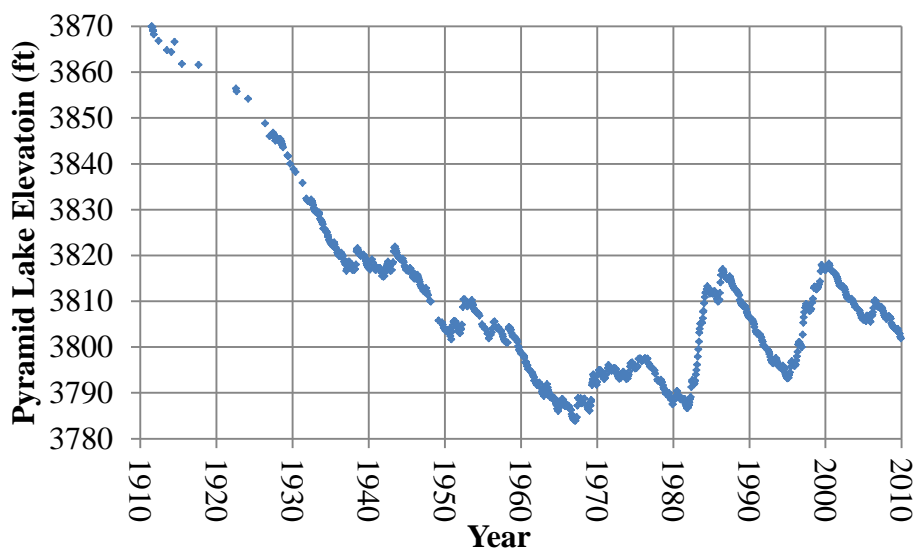
Figure 1 – Pyramid Lake elevation from 1910 to 2010

Historically Pyramid Lake elevations have fluctuated widely creating a unique challenge to keeping cui-ui and LCT from becoming extinct. Records dating sporadically from about 1844 indicate that the lake elevation remained relatively stable, with cyclical fluctuations of about 20 feet maximum until about 1910, when a general decline began. In the last 100 years, the lake elevation has dropped as much as 80 feet due to upstream diversions coupled with periods of drought (Figure 1). A declining lake elevation resulted in severe degradation of the Lower Truckee River and upstream passage problems for both cui-ui and LCT. Both species migrate up the Truckee River to spawn during high spring flows.

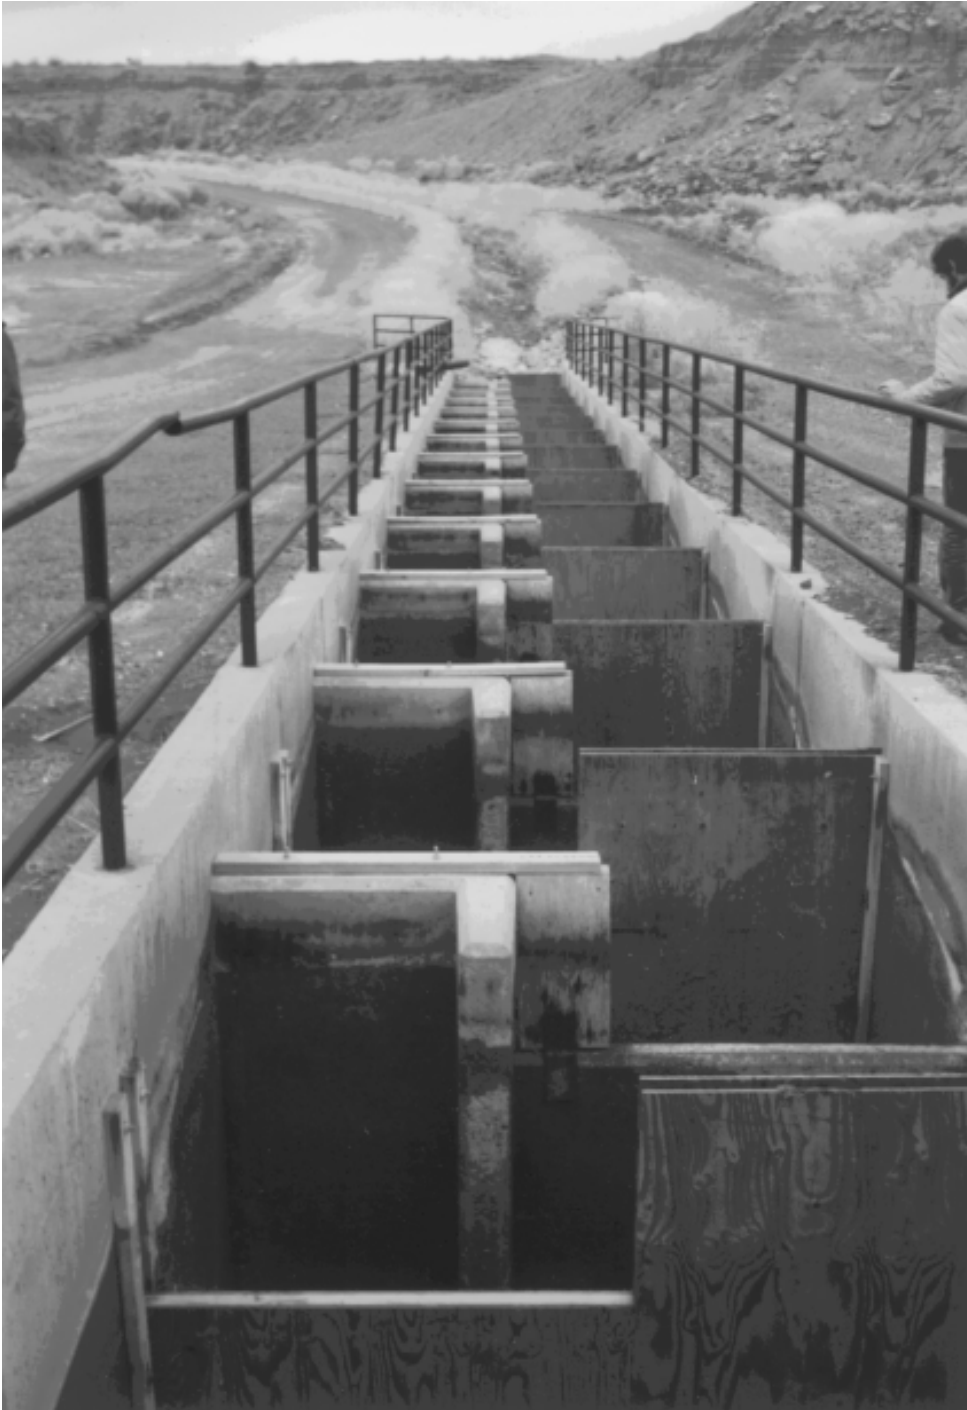
Figure 4 – Current intermediate fish ladder baffles with FWS modifications

During initial operation of the fishway, the ladder baffle design and head drop were found to be a poor match for cui-ui behavior and swimming strength. Cui-ui attempted to move up the ladders crowded near the fishway invert. The 8 ft/s passage velocity was found to be too high for efficient passage. In addition, the bottom oriented behavior of the cui-ui was contrary to passing over a weir that

forced them high in the water column. To improve passage, FWS added weirs half way between the original baffles. This reduced the drop over each baffle to 0.5 ft and reduced the pool length between baffles to 5 ft. Velocity over the baffles was reduced to about 5 ft/s. Passage of cui-ui improved; however fish passage efficiency remains low.

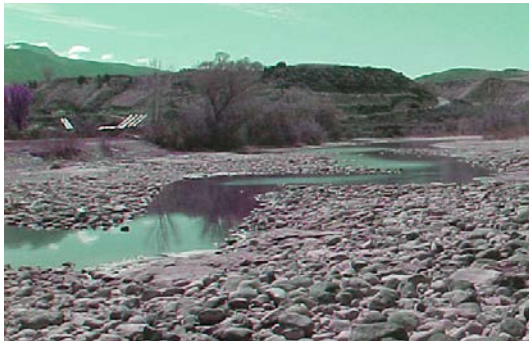
Figure 6 – Grand Valley Irrigation rock fishway at low river flow

In 1997, Reclamation constructed an in-stream rock channel fish pass on the Grand Valley Irrigation Dam located on the Colorado River near Grand Junction, Colorado, Figure 6. The fishway provides passage over a 5 ft high run-of-river dam for many native and non-native fish found in the Colorado River. The riffle sections are designed for an average velocity of 4 ft/s at a minimum flow and depth of 50 ft³/s and 1.5 ft, respectively. The design gradients for the fish pass are: riffle slope = 1.3 percent; thalweg slope = 0.7; and channel slope = 0.9 percent. The thalweg slope differs from the channel slope by the sinuosity of the channel. The channel is constructed of riprap laid on a filter fabric. During construction, voids in the riprap were filled with finer material to minimize interstitial flow. The sinuous pattern (meandering channel form) is used to maintain flow depths during low flows. As flow and depth increase the effect of the channel sinuosity on the flow decreases. After three years of operation under a wide range of river flows the riprap fishway channel has remained stable and has blended into the river environment.

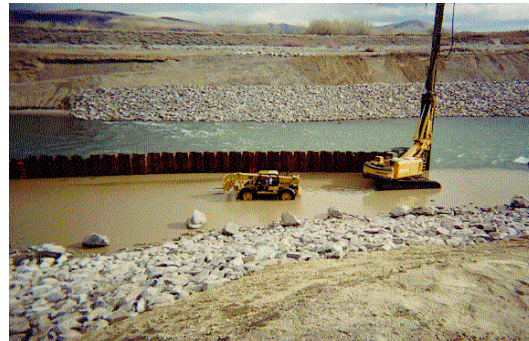
Figure 7 – Marble Bluff gradient restoration structure

In 1998, the river bed elevation below Marble Bluff Dam was raised about 2 ft and stabilized using a rock ramp design, Figure 7. The structure was designed to prevent further channel degradation downstream of the dam and raise the minimum water surface elevation to provide fish access to the fish lock entrance channel. The structure was designed based on a 4 ft/s average velocity to ensure fish passage for cui-ui and LCT. Large boulders were added on the north half of the channel to provide additional variability in the flow field. The structure performed well in 1999. An estimated 600,000 cui-ui passed over the structure during the spawning run in 1999 with no apparent delay (personal correspondence with FWS).

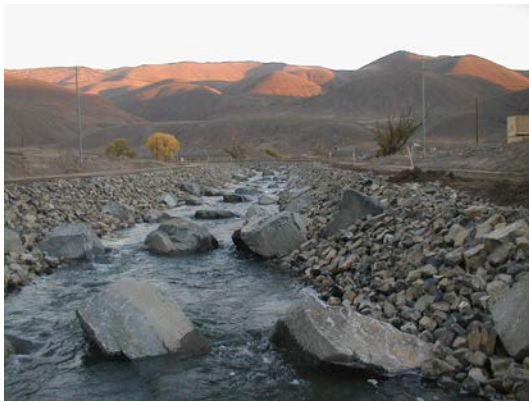
Figure 8 – Derby Dam rock fishway close-up view

In 2000, Reclamation designed a rock ramp fishway for Derby Dam located on the Truckee River approximately 30 miles upstream of Marble Bluff Dam. The 920 ft long rock fishway is designed to pass cui-ui lake suckers and LCT (Figure 8). The fishway slopes at a constant 0.0184 ft/ft with a riprap lined channel that is trapezoidal in shape with a 4 ft wide bottom and 2:1 side slopes. The fishway contains 47 boulder weirs positioned at 20 ft intervals along the fishway (Figure 9). Each weir is formed by placing boulders about 1 ft apart in an upstream pointing chevron pattern. The boulder weirs create a hydraulic control that produces a drop in water surface of about 0.4 ft producing a maximum passage velocity of about 5.0 ft/sec. The rock fishway concept is designed to convey approximately 10 percent of the downstream river flow within the range of 250 ft³/sec to 2,000 ft³/sec. For downstream flows less than about 150 ft³/sec up to 100 percent of the river flow may be passed through the fishway. The fishway was constructed in 2002.

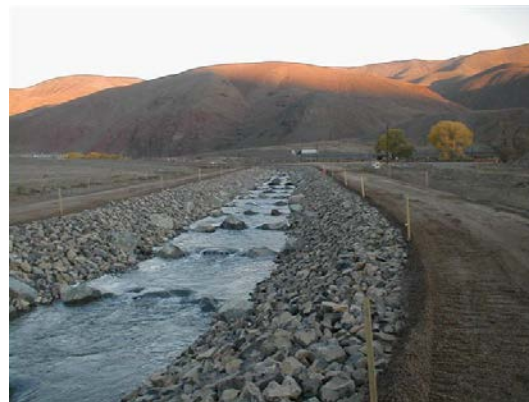
Figure 9 – Derby Dam rock fishway distant view

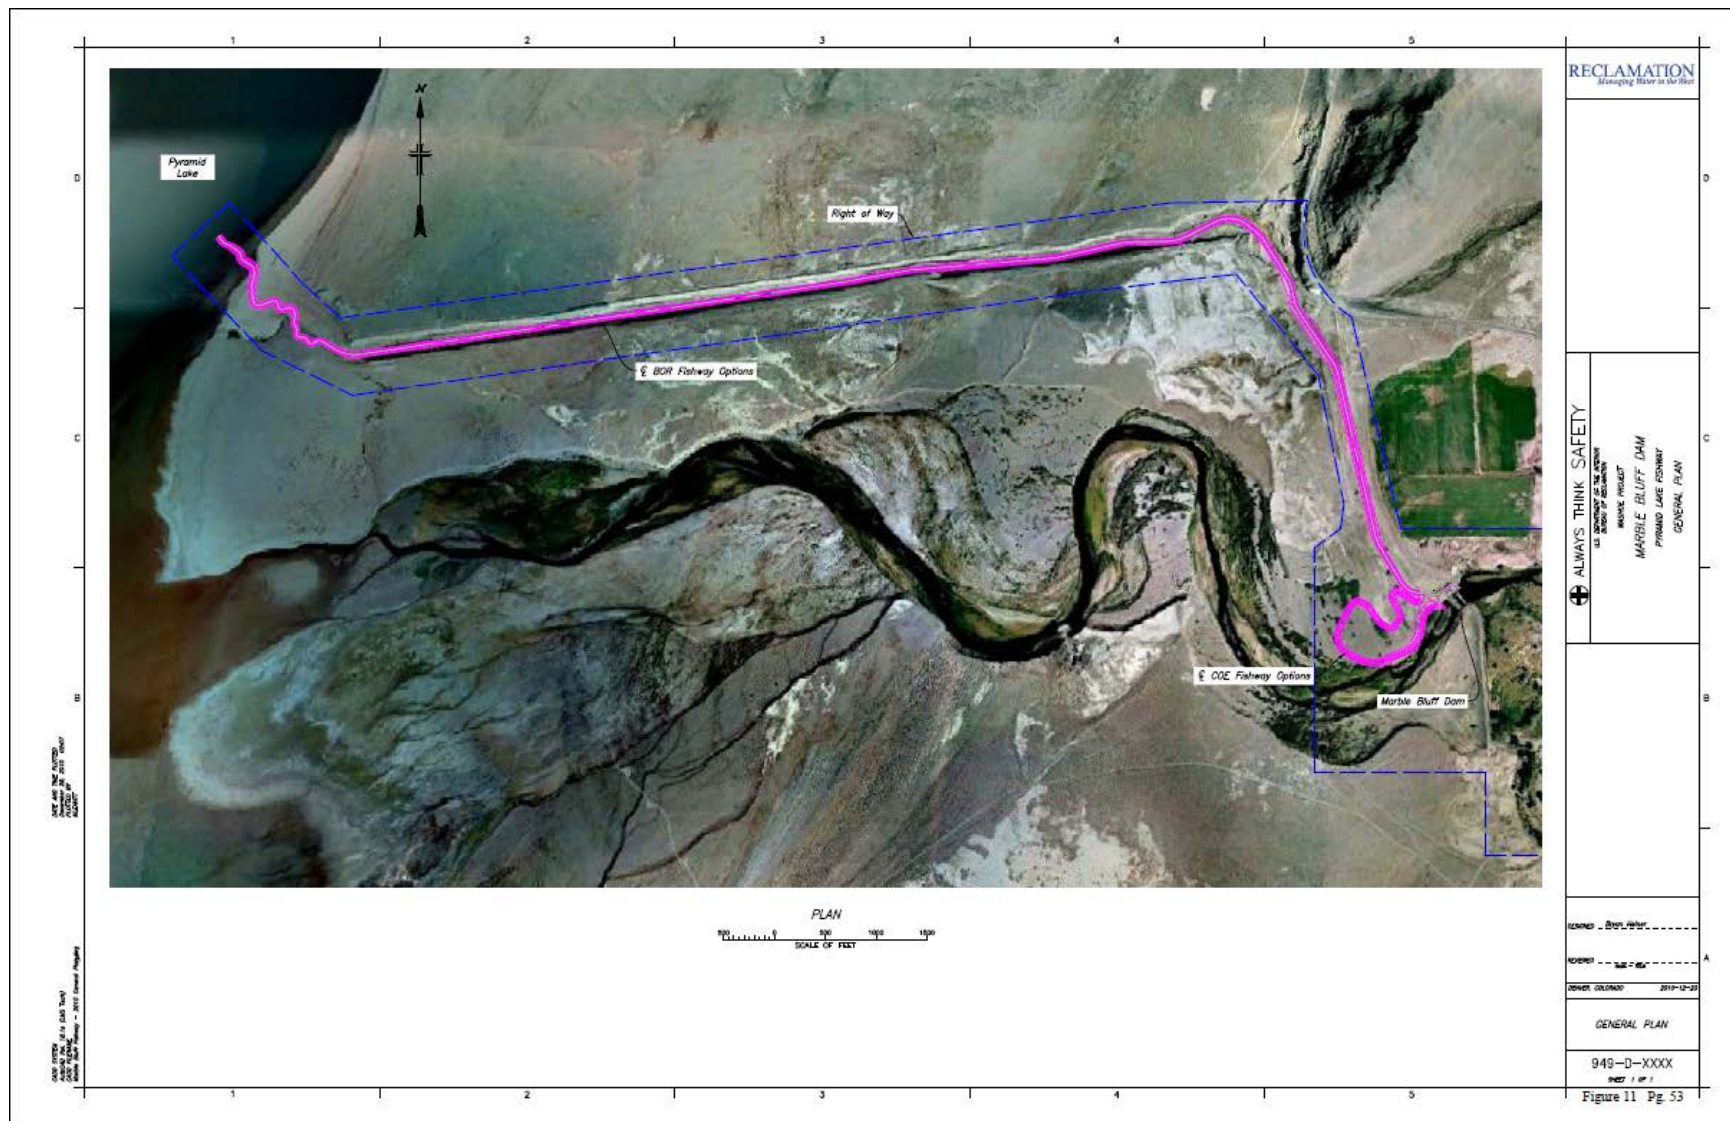
Figure 11 – General plan of Lake and River fishway designs

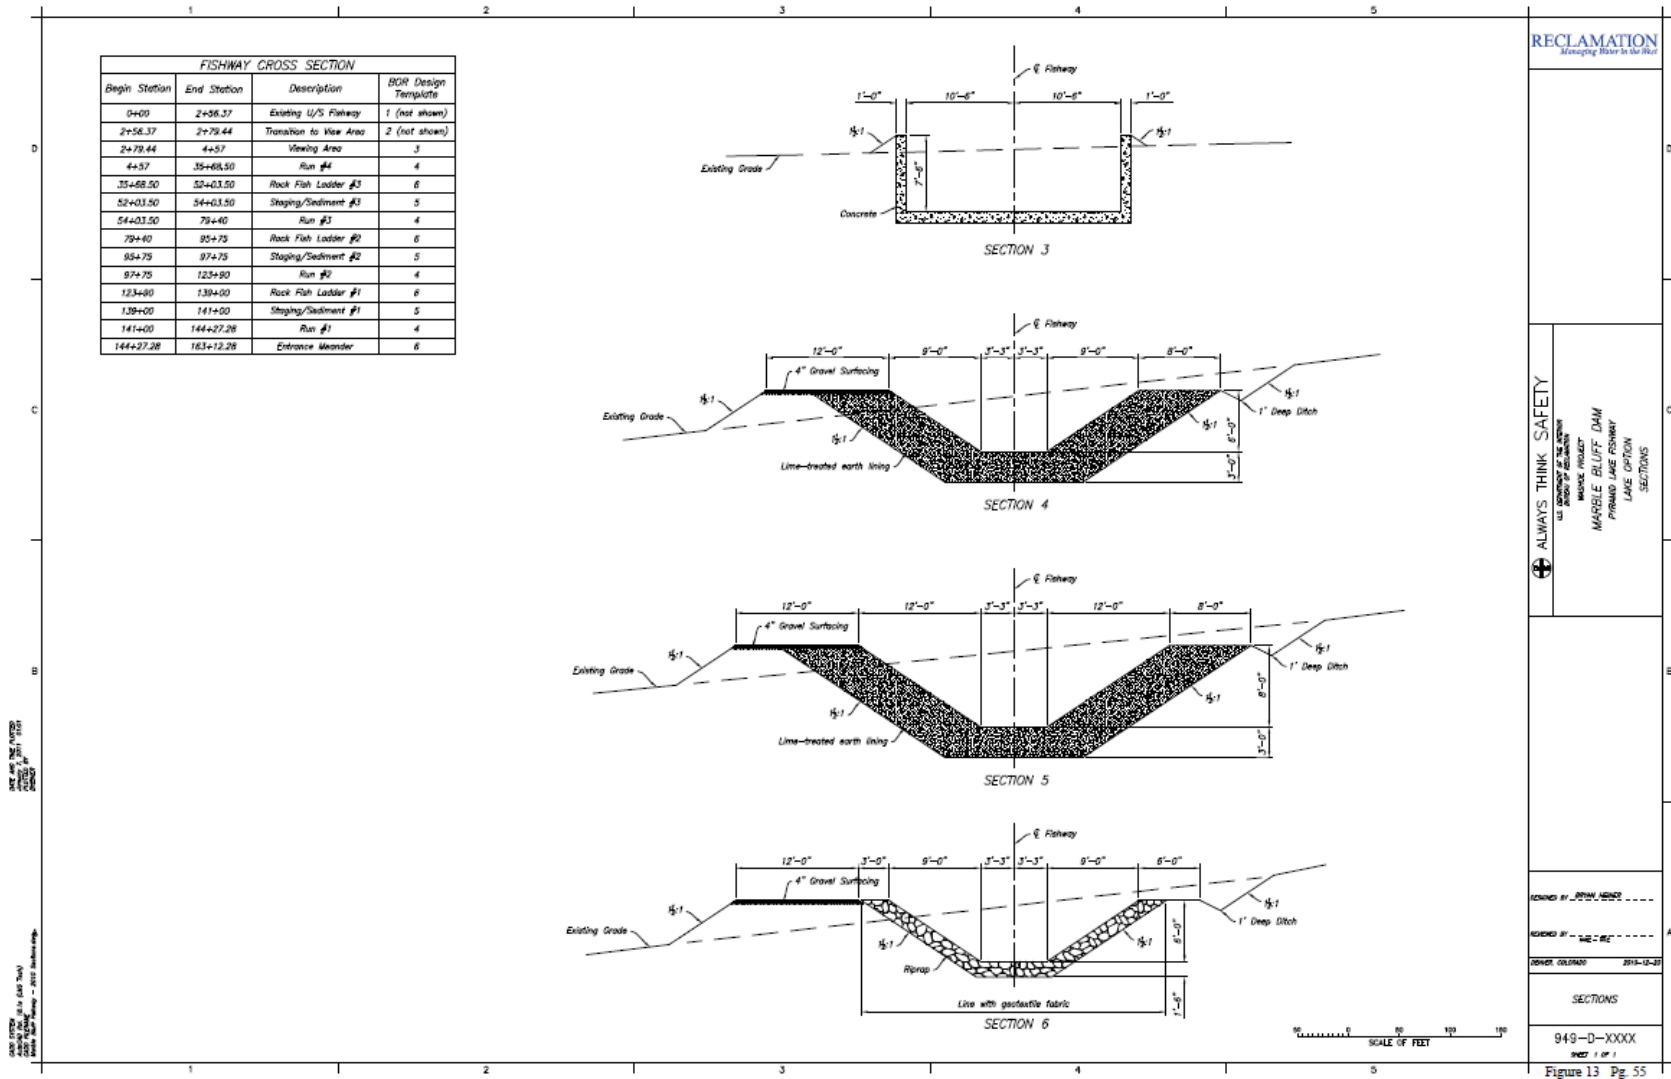
Figure 13 – Lake fishway – typical fishway sections

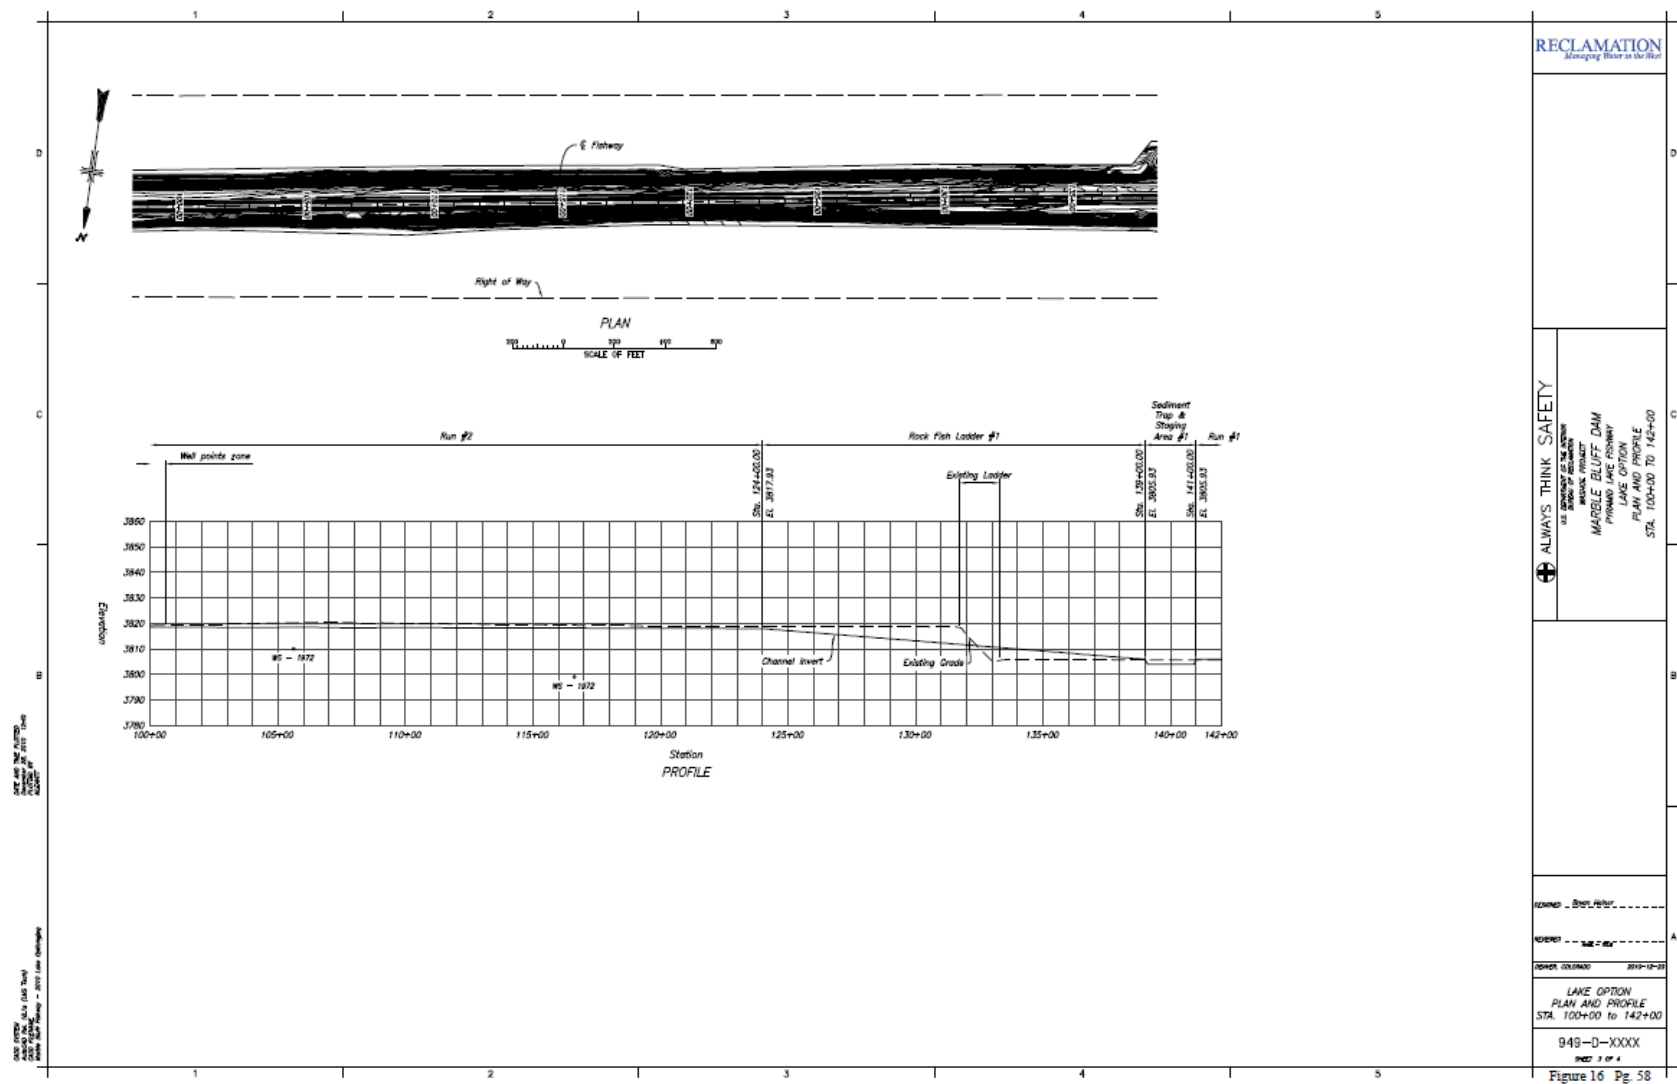
Figure 16 – Lake fishway – plan and profile – station 100+00 to 142+00

Dewatering near rock riffles 2 and 3 can be found in the profile views of the design. Where specified, fifteen feet long, 1-1/2 in diameter, self jetting well points should be installed. Each well point is estimated to flow at 0.6 gallons per minute. The points should be placed about 25 ft to each side and parallel to the fishway centerline, spaced 5 feet apart. Well points would be connected to a 3" ID Schedule 80 PVC pipe header pipe connected to a vacuum pump capable of 100 gpm. The vacuum pump would discharge to another pump or a sump. Either a 2-stage pump or a second low head pump would be needed to lift the sucked ground water out of the excavation.

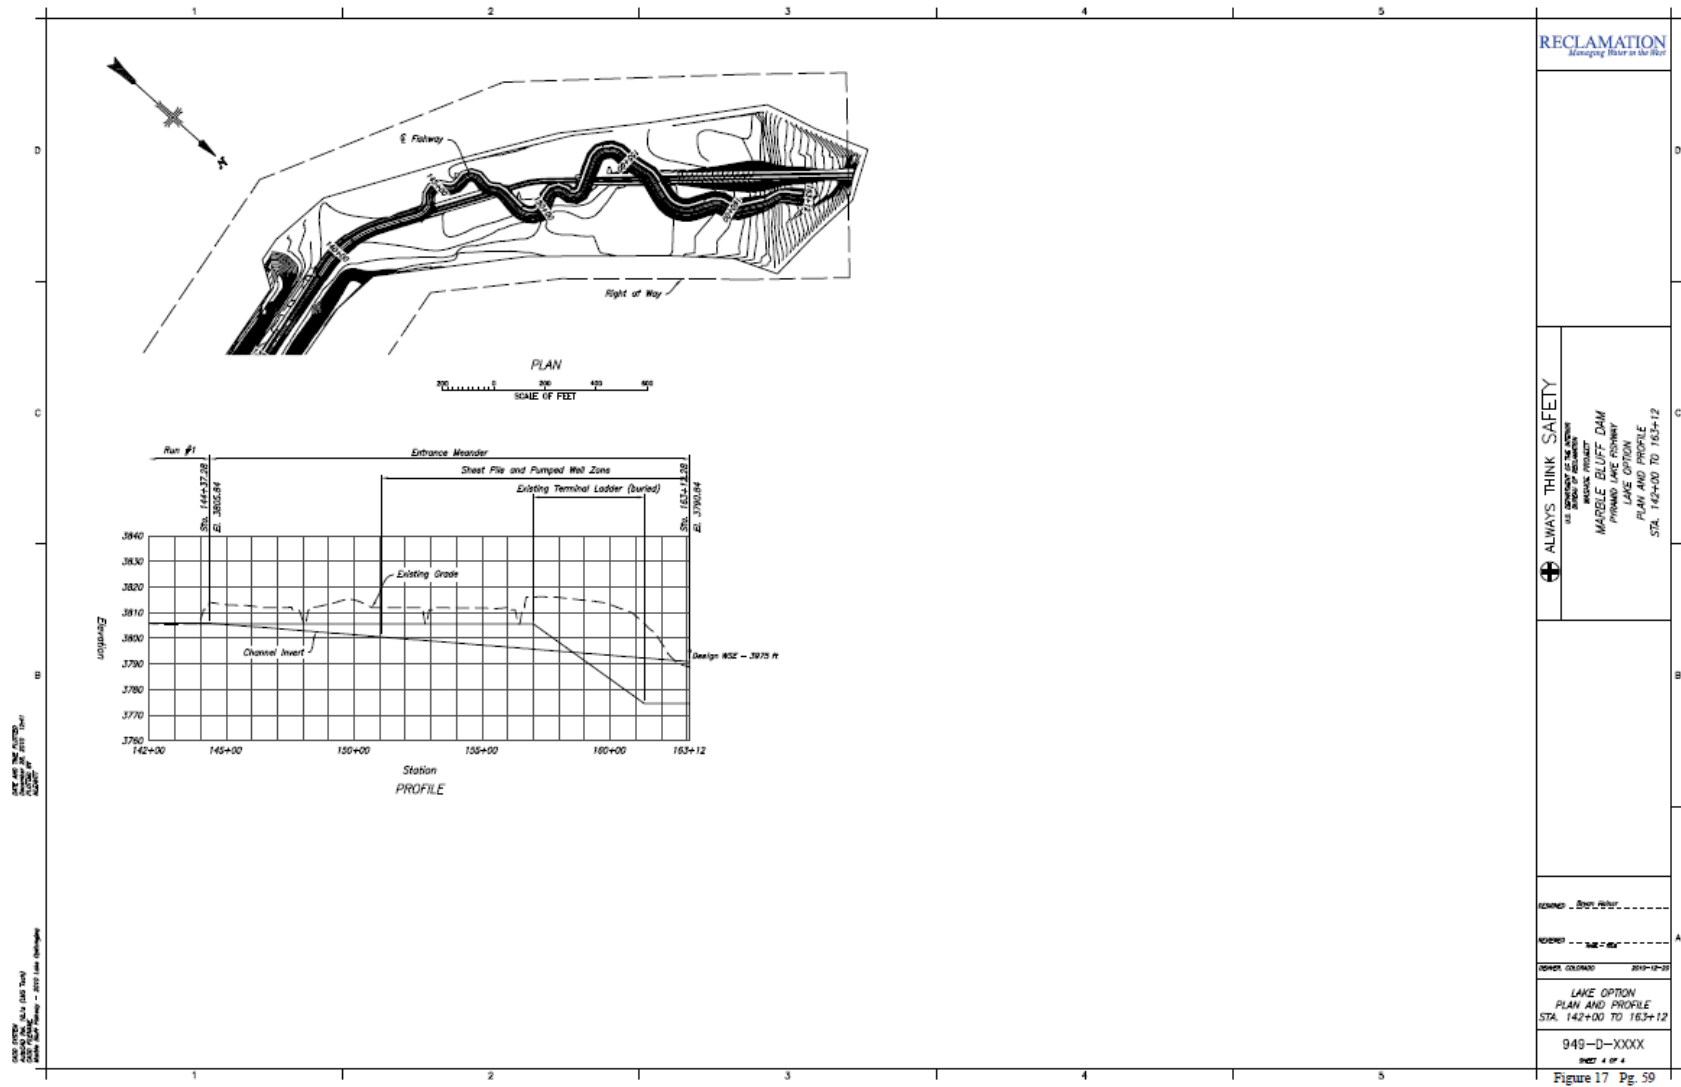
Figure 17 – Lake fishway – plan and profile – station 142+00 to 163+12

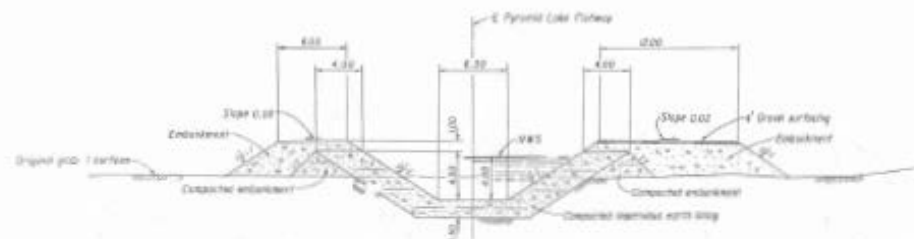
TYPICAL SECTION IN PARTIAL CUT

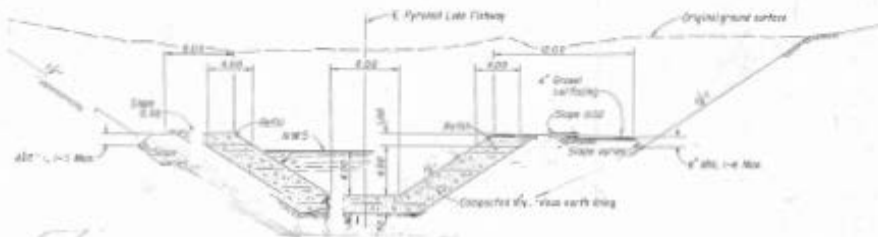
TYPICAL SECTION IN CUT

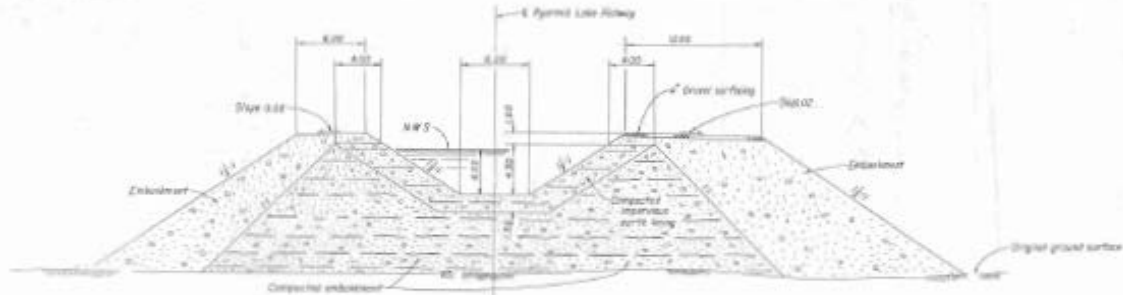
TYPICAL SECTION ON FILL
