Hydraulic Laboratory Report HL-2011-10

## Physical Hydraulic Modeling of Secondary Louver Replacement at the Tracy Fish Collection Facility

December 2011

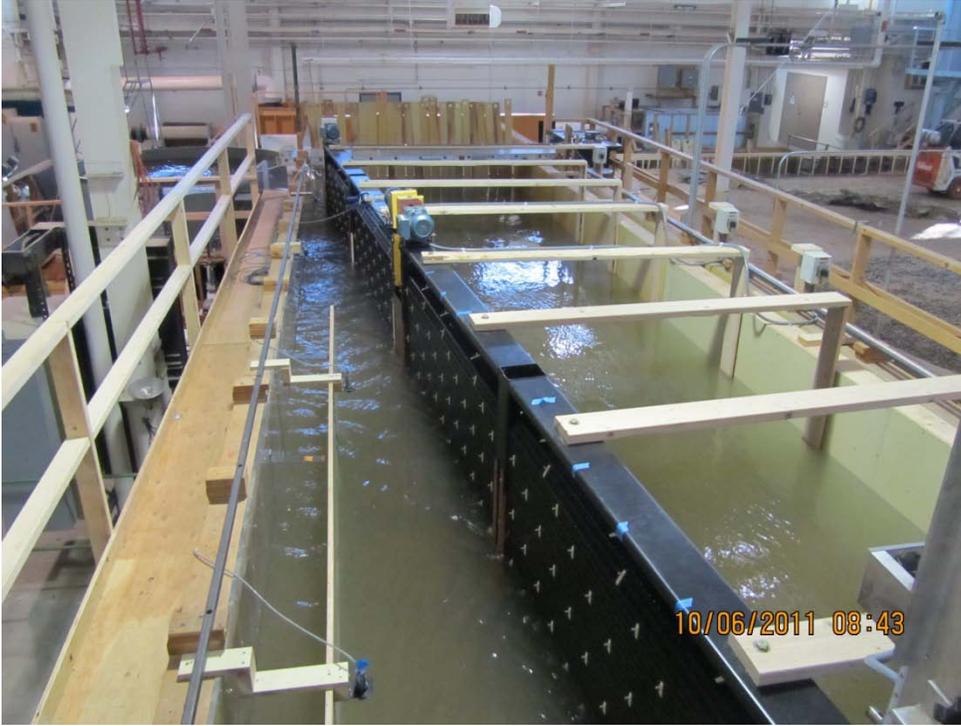
Figure A-1 - Close up overview of model (flow from bottom to top)

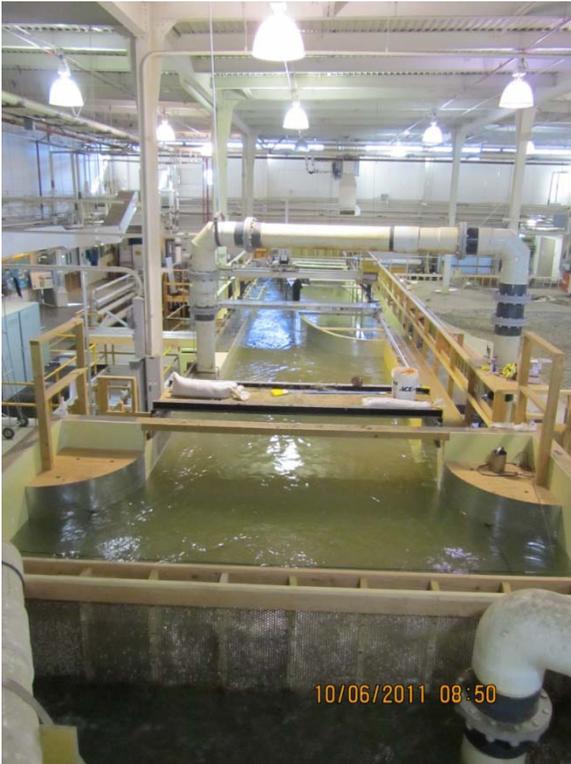
Figure A-2 - Overview of model (flow from bottom to top)

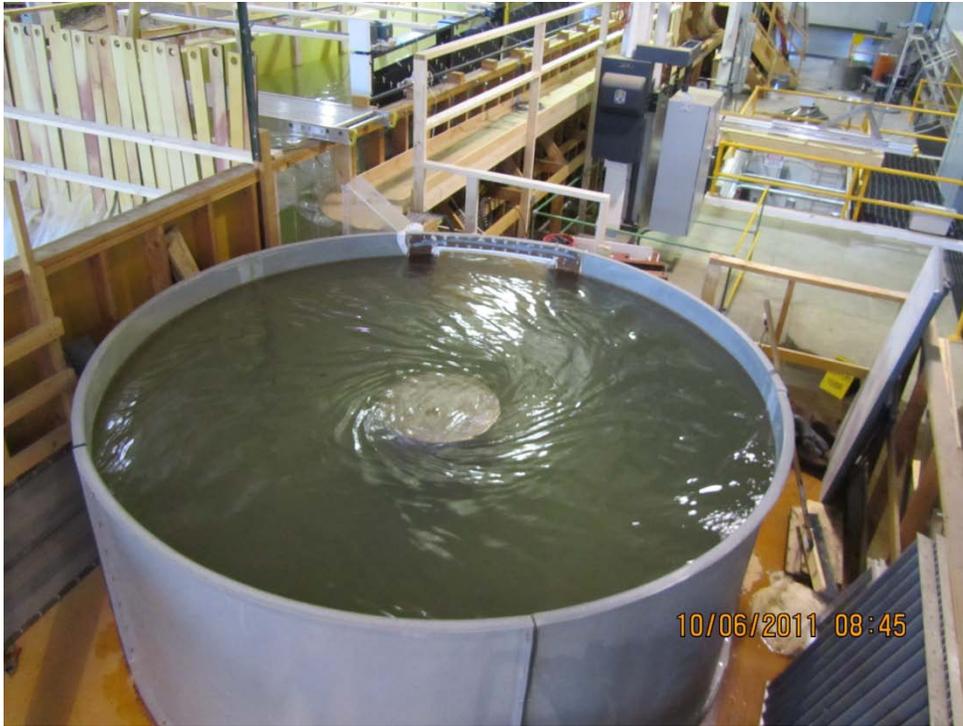
Figure A-3 - Holding tank during a test (flow entering the tank from the top)

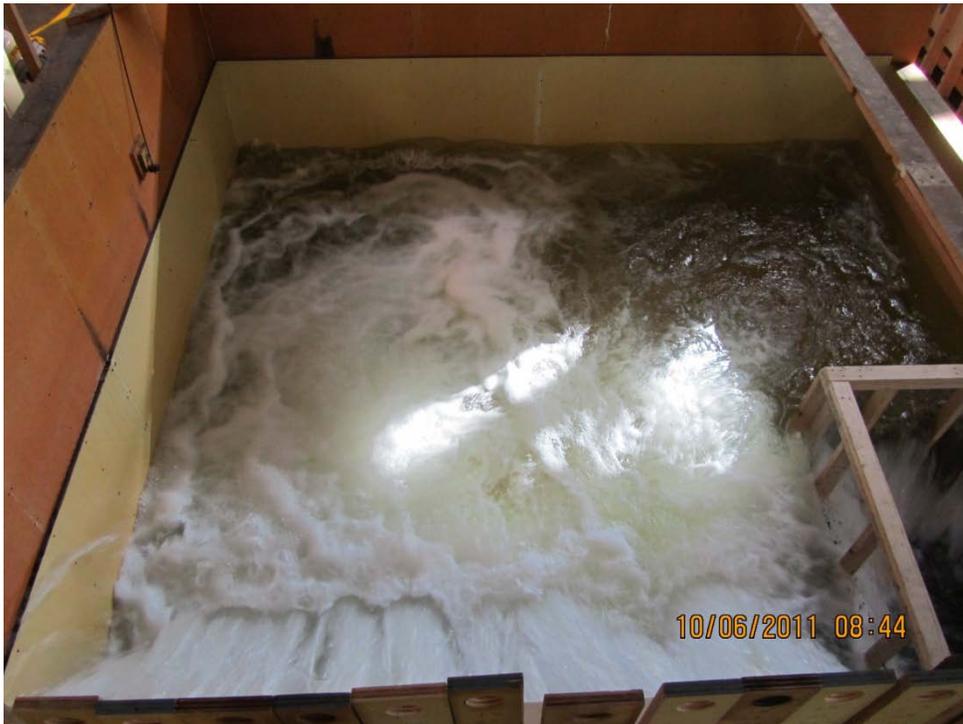
Figure A-4 - Tailbox during a test (flow from bottom to top)

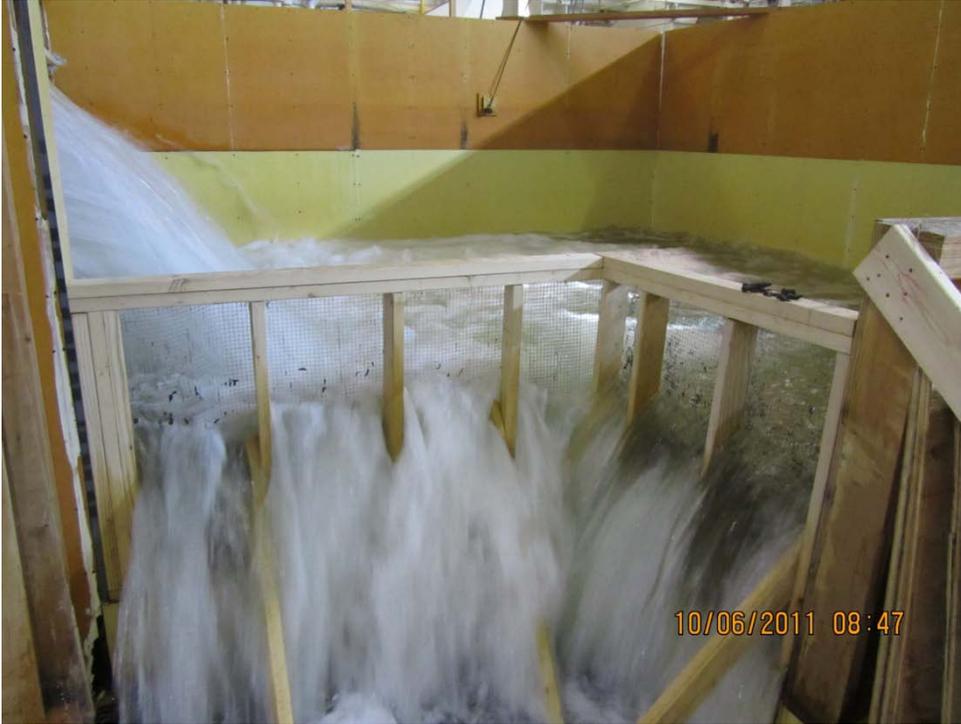
Figure A-5 - Tailbox during a test (flow towards reader)

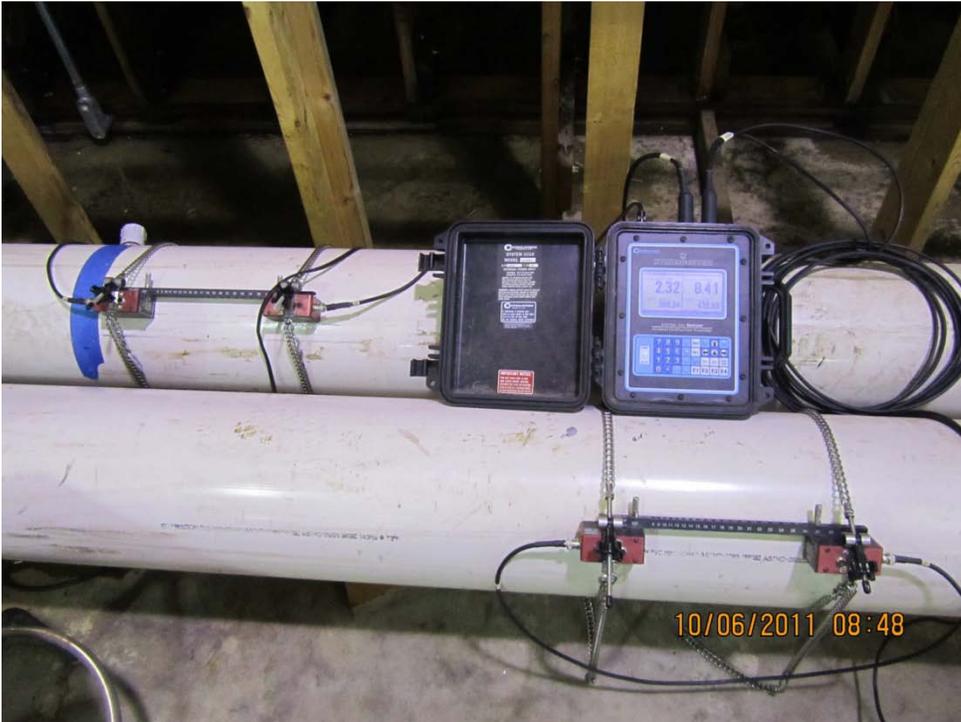
Figure A-6 - Ultrasonic flow meter on two inflow pipes (flow from right to left)

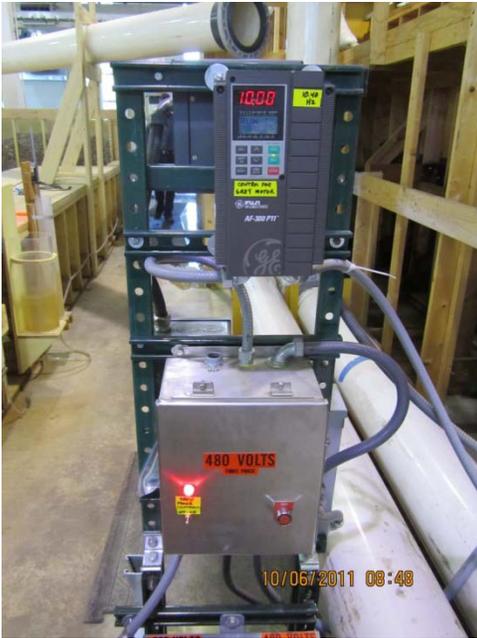
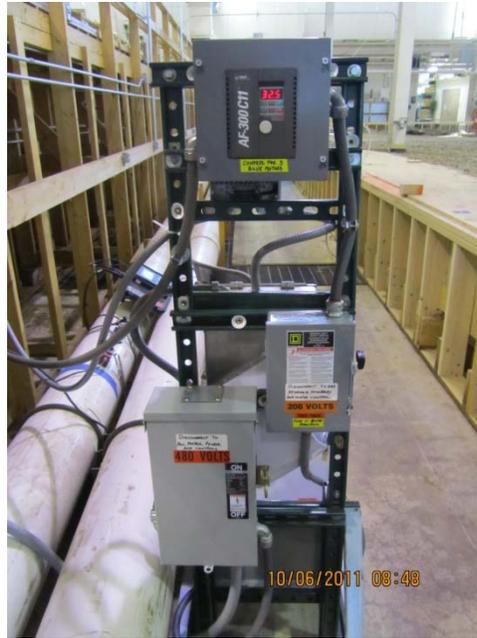
Figure A-7 - Variable frequency drive for screens

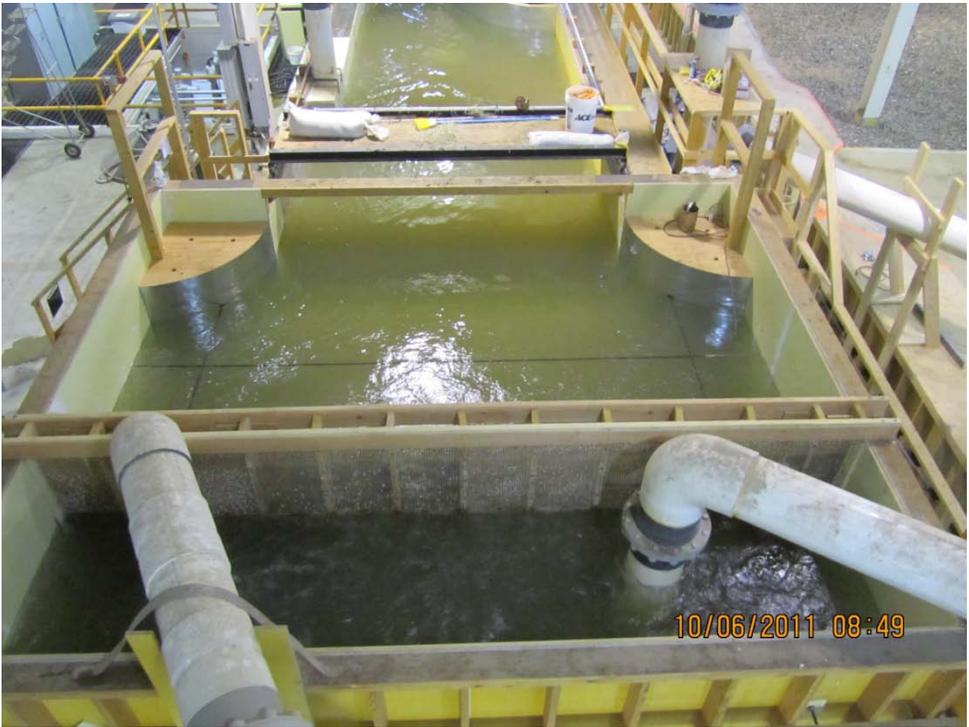
Figure A-8 - Headbox and inflow pipes 1 and 2 (flow from bottom to top)

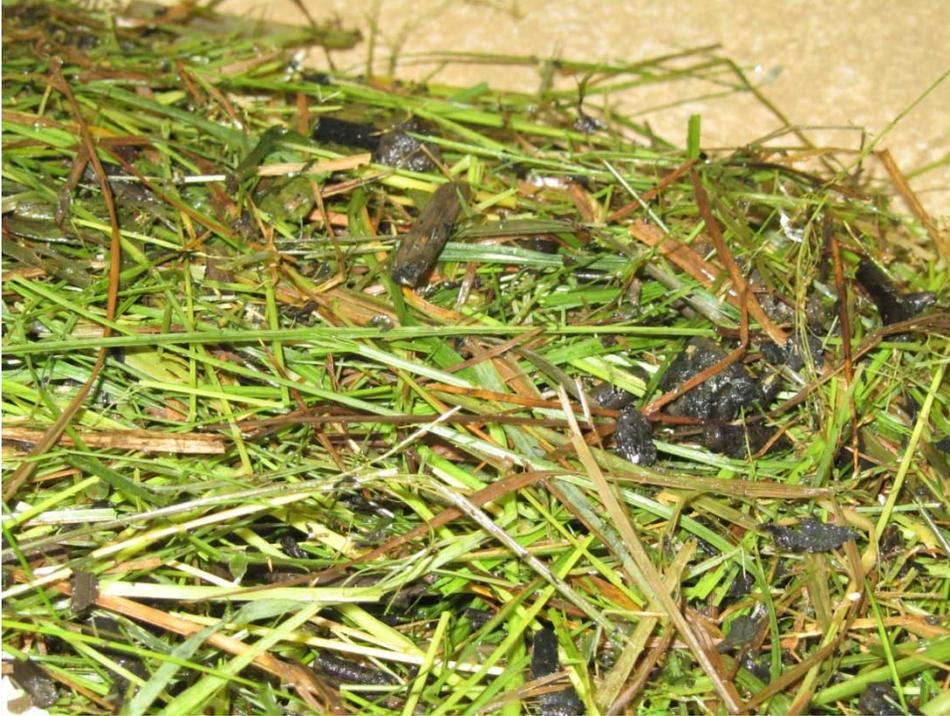
Figure A-9 - Close up of hay and woody debris collected downstream of the traveling screens

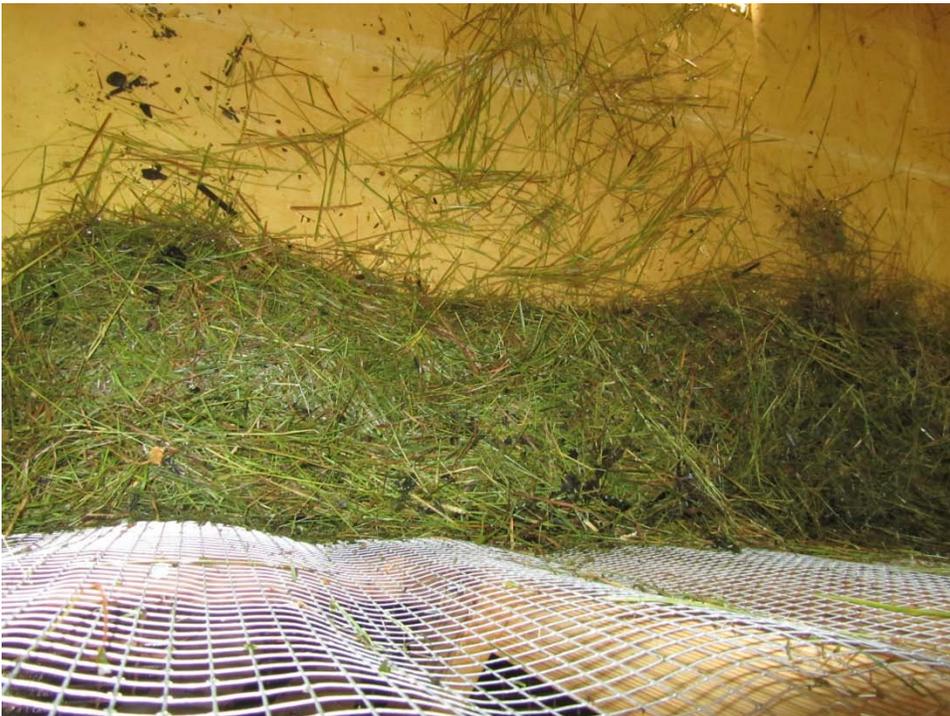
Figure A-10 - Collection of hay and woody debris in the tailbox downstream of the traveling screens

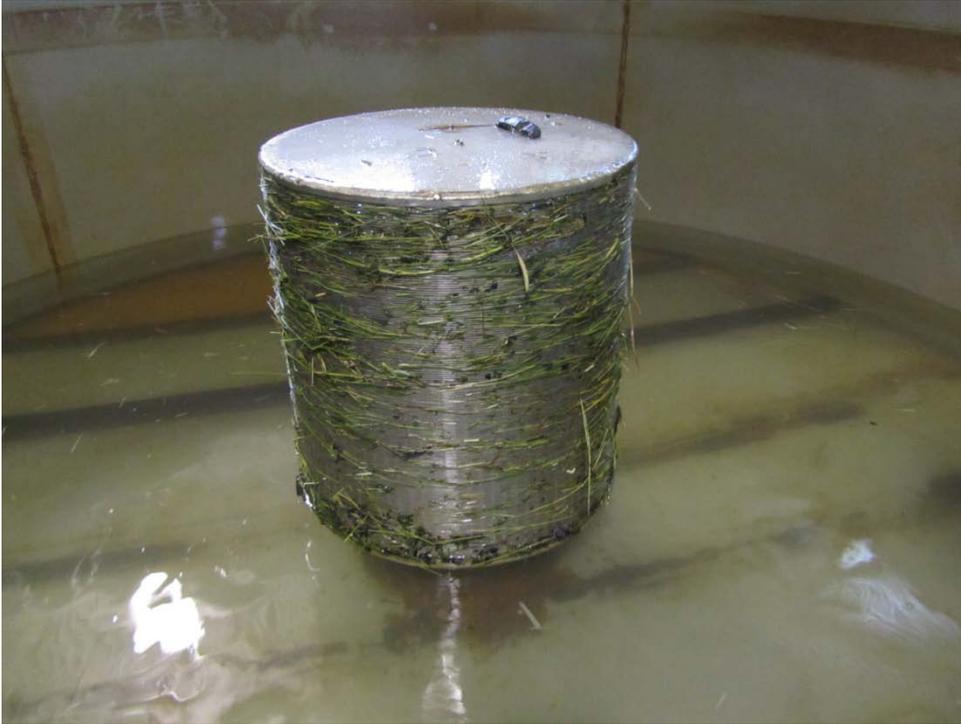
Figure A-11 - Hay and woody debris in the holding tank after a test is complete.

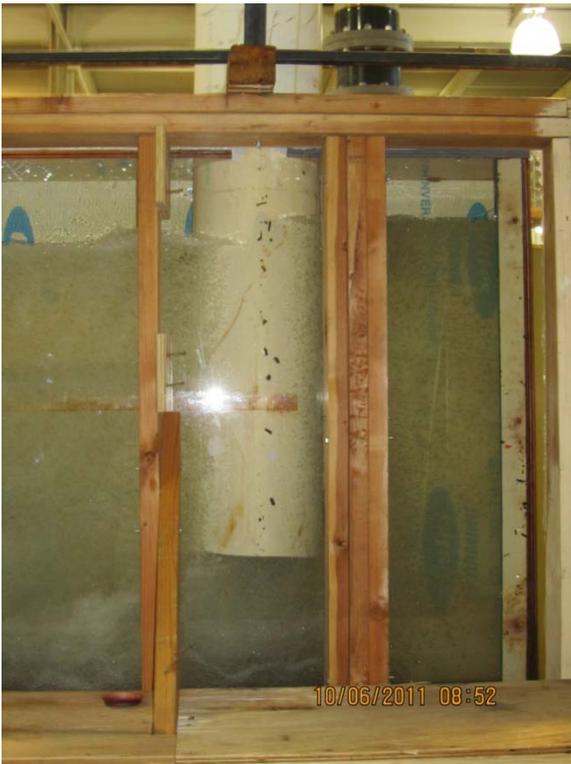
Figure A-12 - Inflow 4 into the clean water bypass (flow from right to left)

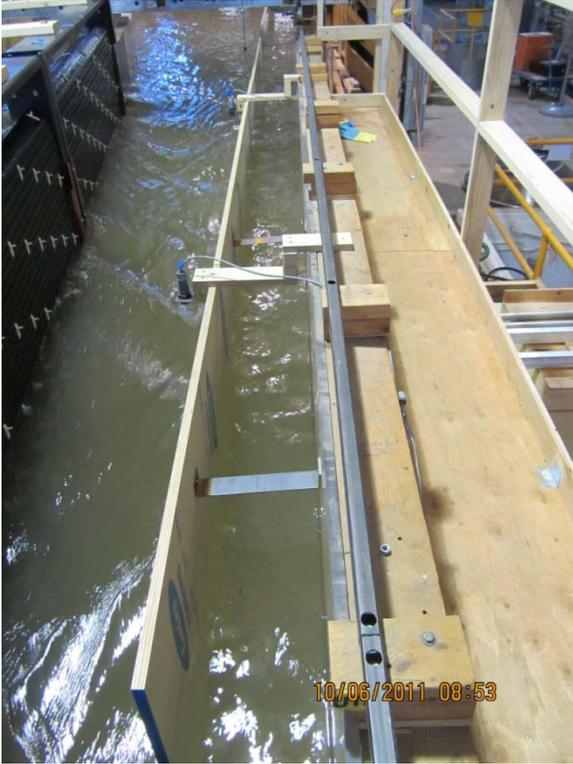
Figure A-13 - Clean water bypass (flow from top to bottom)

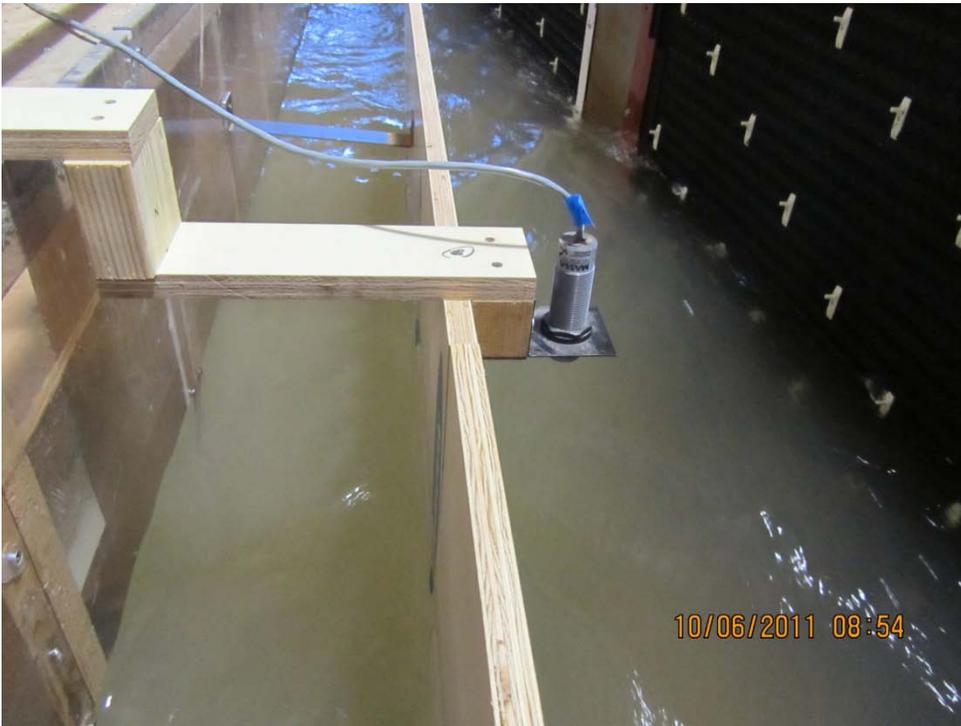
Figure A-14 - Ultrasonic downlooker to determine flow depth (1 of many)

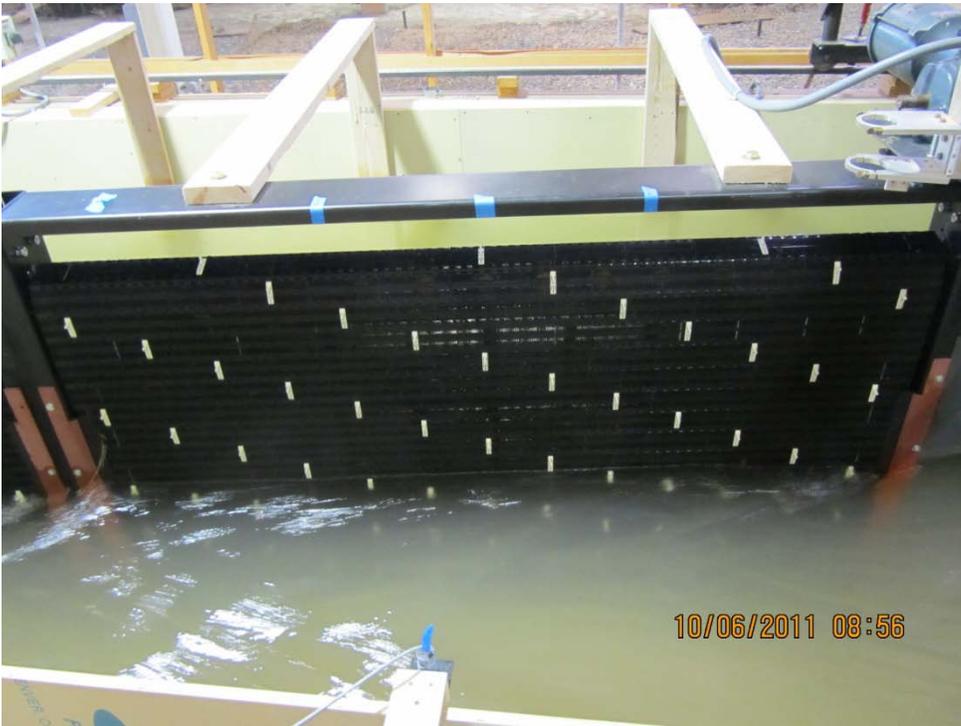
Figure A-16 - Debris peg layout on upstream side of screen (flow from right to left)

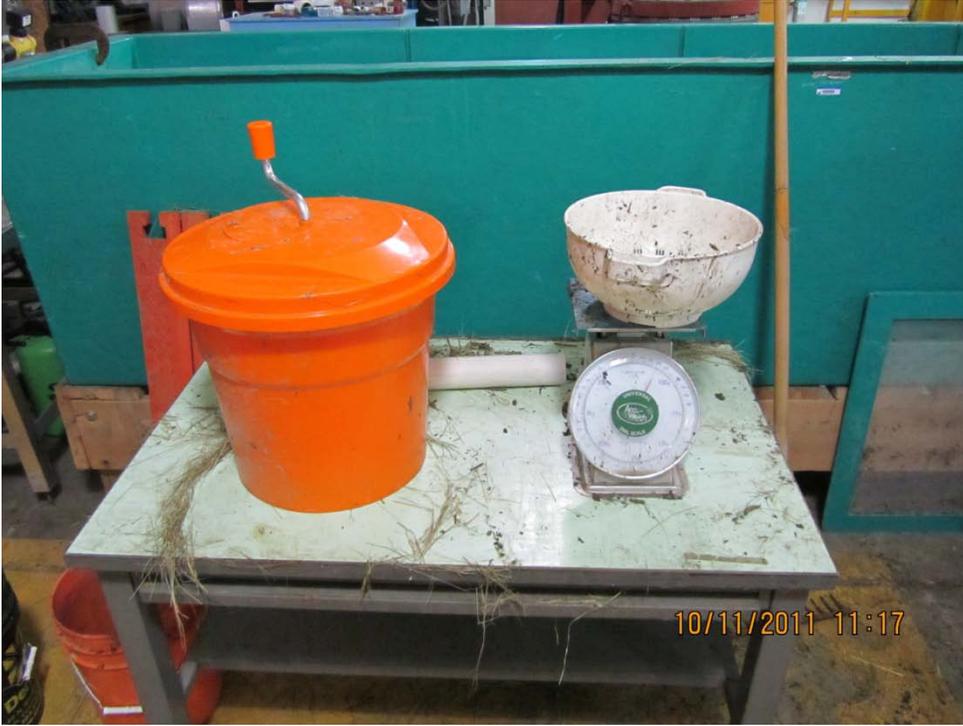
Figure A-17 - Debris weigh station
