Cavitation Detection – Method Development to Detect Damaging Cavitation

**Research and Development Office
Science and Technology Program
(Final Report) ST-2017-1708-01**

HL-2017-10

September 2017

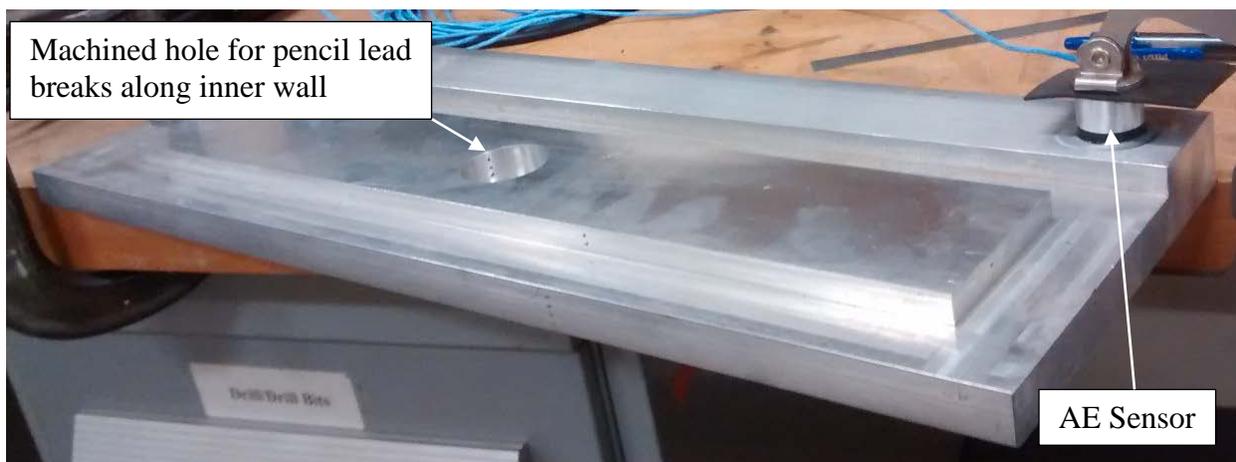
Figure 1 Aluminum plate used for bench testing of pencil lead breaks to produce acoustic waves on the surface and deeper into the material.

Bench testing on an aluminum plate in the dry was performed to compare sensor installation and data analysis methods with Dunegan (1995). Heat-treated annealed aluminum was chosen to be consistent with subsequent cavitation tests in the hydraulics lab. A broadband SE9125-M Acoustic Emission sensor from Score Atlanta Inc. was secured to an aluminum plate using acoustic couplant and vice grips (Figure 1). Data were collected at a sample rate of 1MHz with an Iotech Personal DAQ 3000 data acquisition system. 0.5mm mechanical pencil lead was broken near the surface and at several depths along the outside edge of the plate to produce an acoustic signal recorded by the sensor. Test plate dimensions were 6 x 18 x 1 inches.
