Hydraulic Concrete Surfaces for Water Resource Structures – Continued Collaboration

Science and Technology Program
Research and Development Office
Final Report No. ST-2023-21051
HL-2023-05

**Final Report No. ST-2023-21051
HL-2023-05**

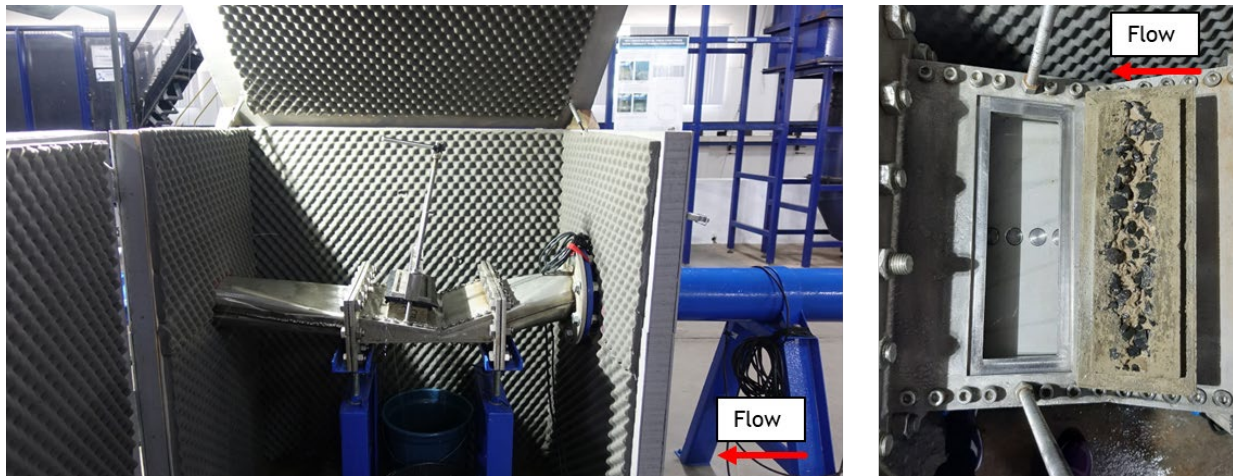
Figure 1. Photograph of the cavitation test machine at UFRGS within the soundproof box (left) and looking from the top where the cavitation sample is installed (right).

A cavitation test facility was constructed in the laboratory at UFRGS and used to test concrete samples which was completed in 2023. The test facility is very similar to the one used in Reclamation’s laboratory and tests concrete block samples of the same size (approximately 3-inch long x 12-inch wide x 3-inch deep) and is also limited to a single operating point and cavitation condition (Figure 1).

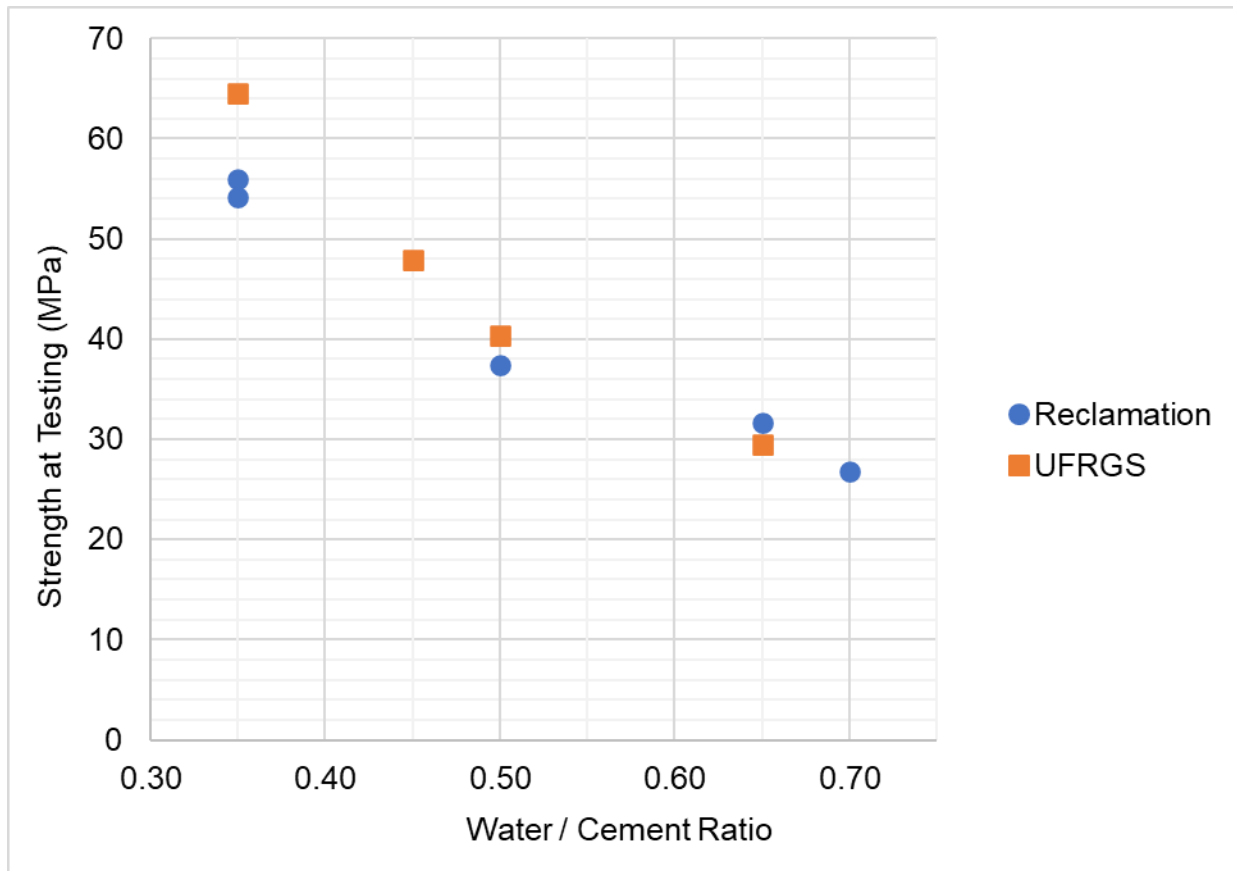
Figure 2. Compressive strength comparison of concrete samples during testing in Reclamation and UFRGS laboratories.

Testing at UFRGS included four concrete mixes (water/cement ratios of 0.35, 0.45, 0.50, and 0.65) which produced compressive strengths at time of testing in the same range as those tested in Reclamation’s lab (Figure 2). Also like Reclamation’s test plan, UFRGS tests included injecting air upstream of the cavitation machine to evaluate reduction in concrete damage with the percentage of air flow to water flow.

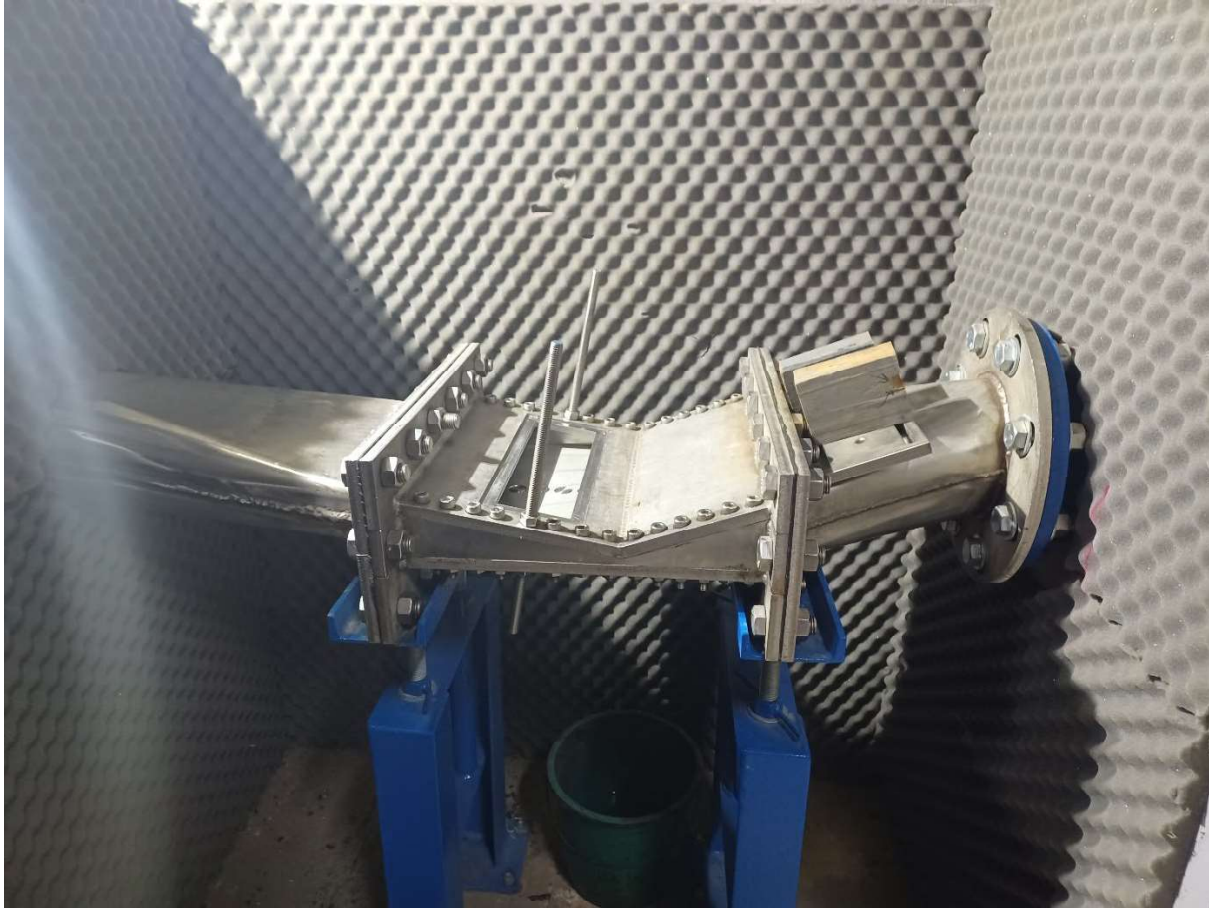
Figure 1. Cavitation machine at UFRGS (similar to Reclamation's) used to test durability of concrete to cavitation.

engineering lab. In the afternoon we inspected their cavitation test machine and instrumentation which are similar to those used in Reclamation's Hydraulics Lab. The machine was turned on and we witnessed its operation at various test conditions. We inspected various concrete test samples with damage from the cavitation machine. Engineers from IPH presented the latest test results compared to Reclamation's laboratory test results and discussed conclusions and gaps. See photos in Figure 1 through Figure 4.

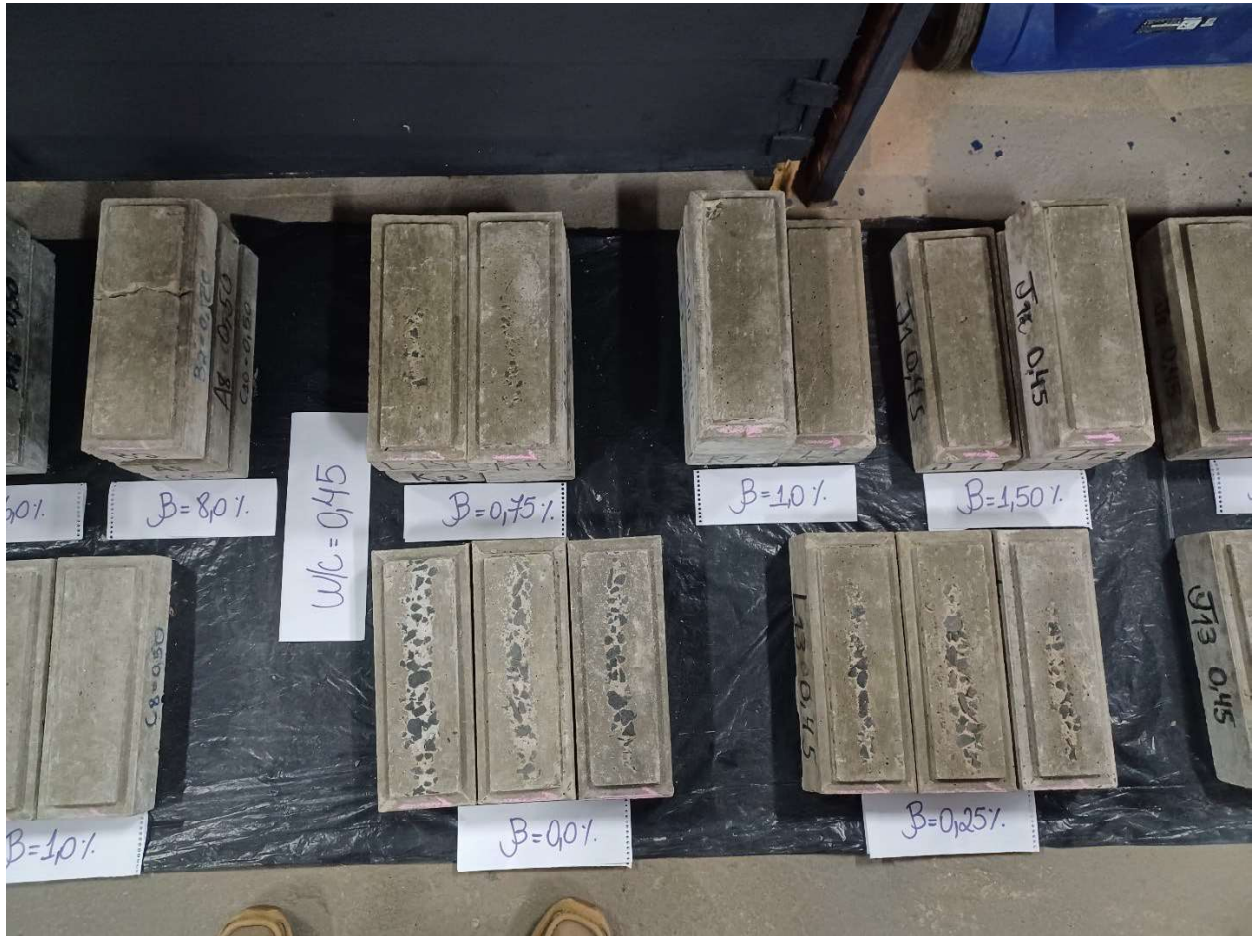
Figure 2. Concrete test samples after cavitation testing at UFRGS.

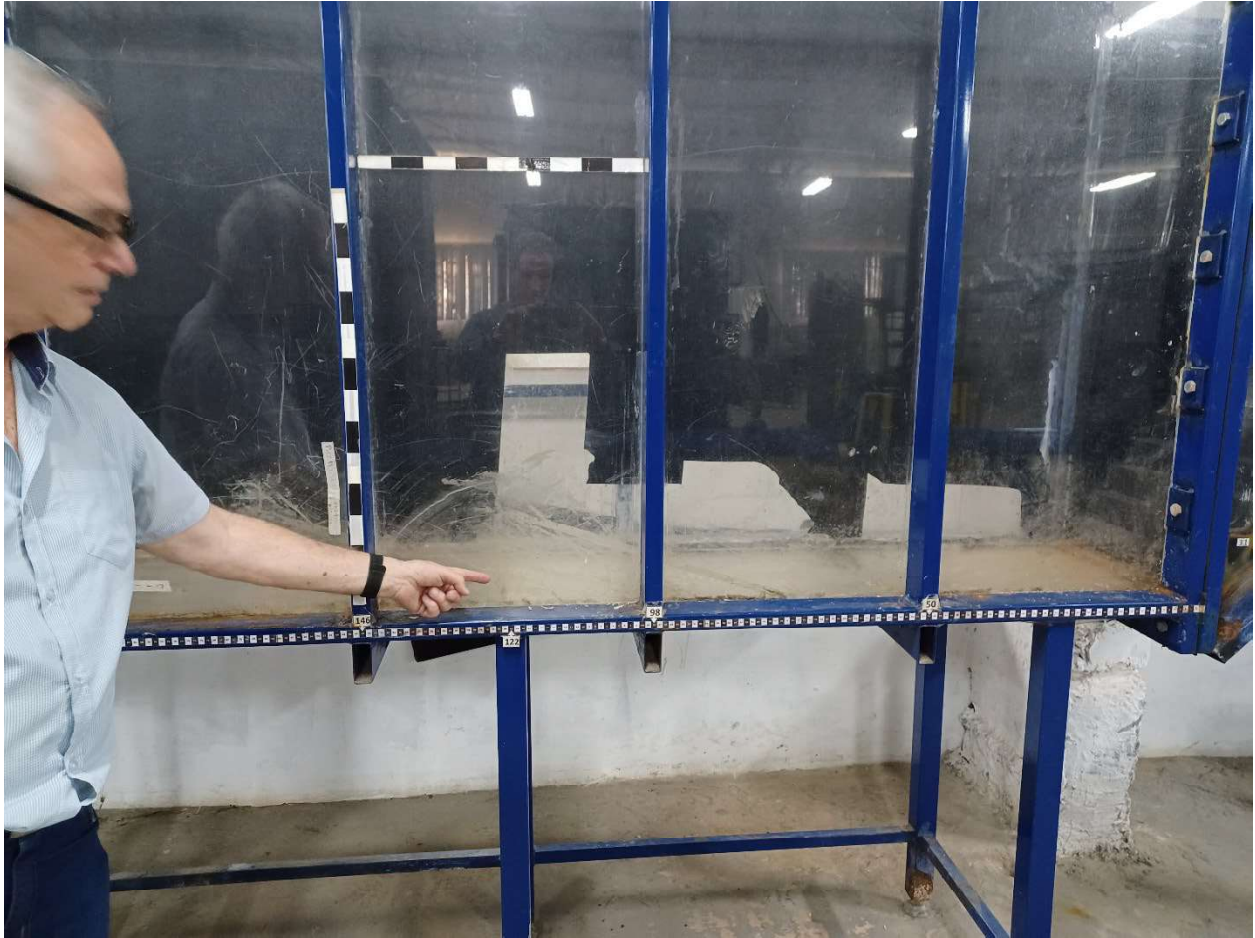
Figure 4. Prof. Marcelo Marques explaining past research of stilling basin design downstream of stepped spillways at UFRGS. Reclamation is at the beginning stages of this same research and the insights and information gained from this trip help boost our study.

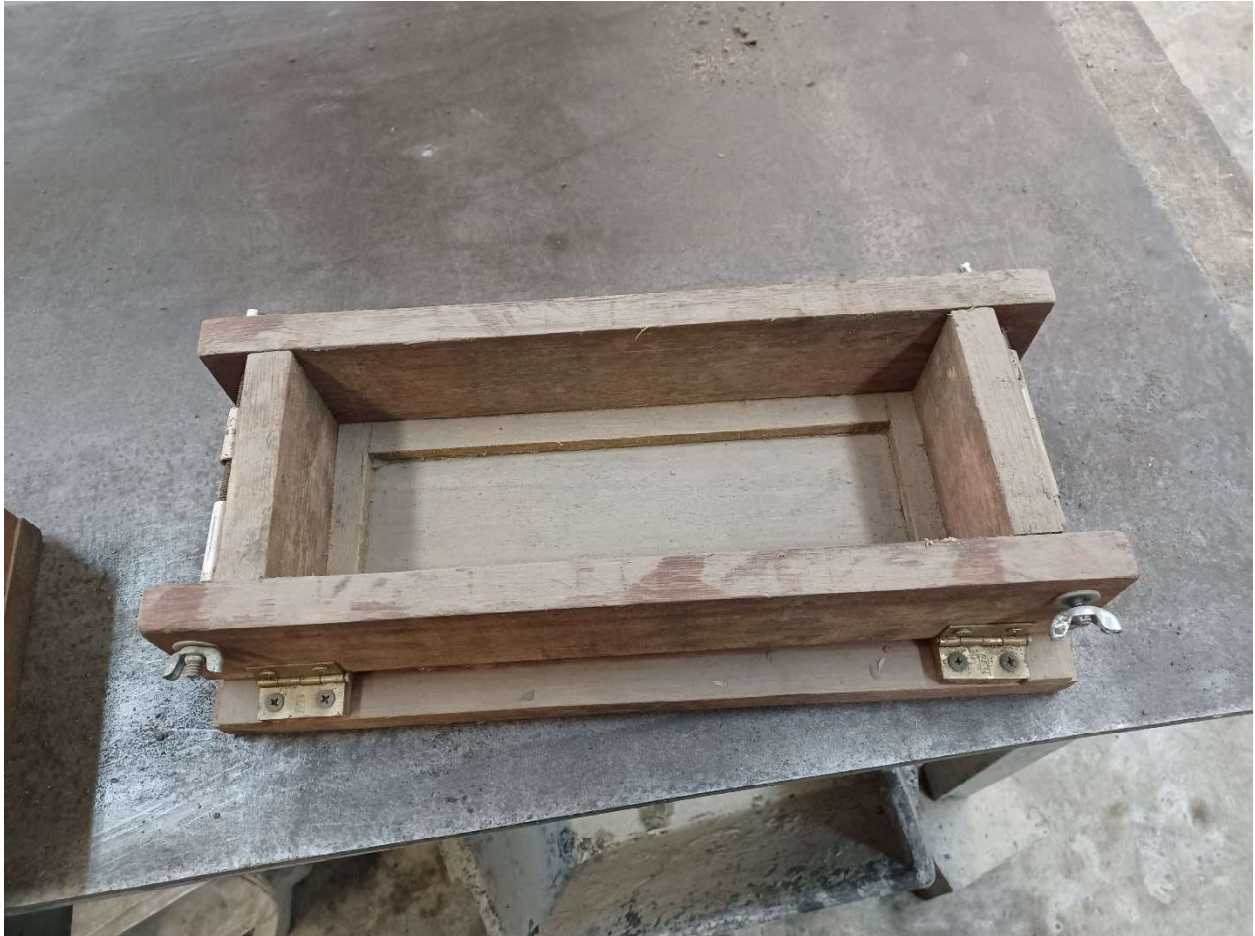
Figure 6. Mold used to form the concrete test samples of the current research in the Concrete and Structural Laboratory at UFRGS.

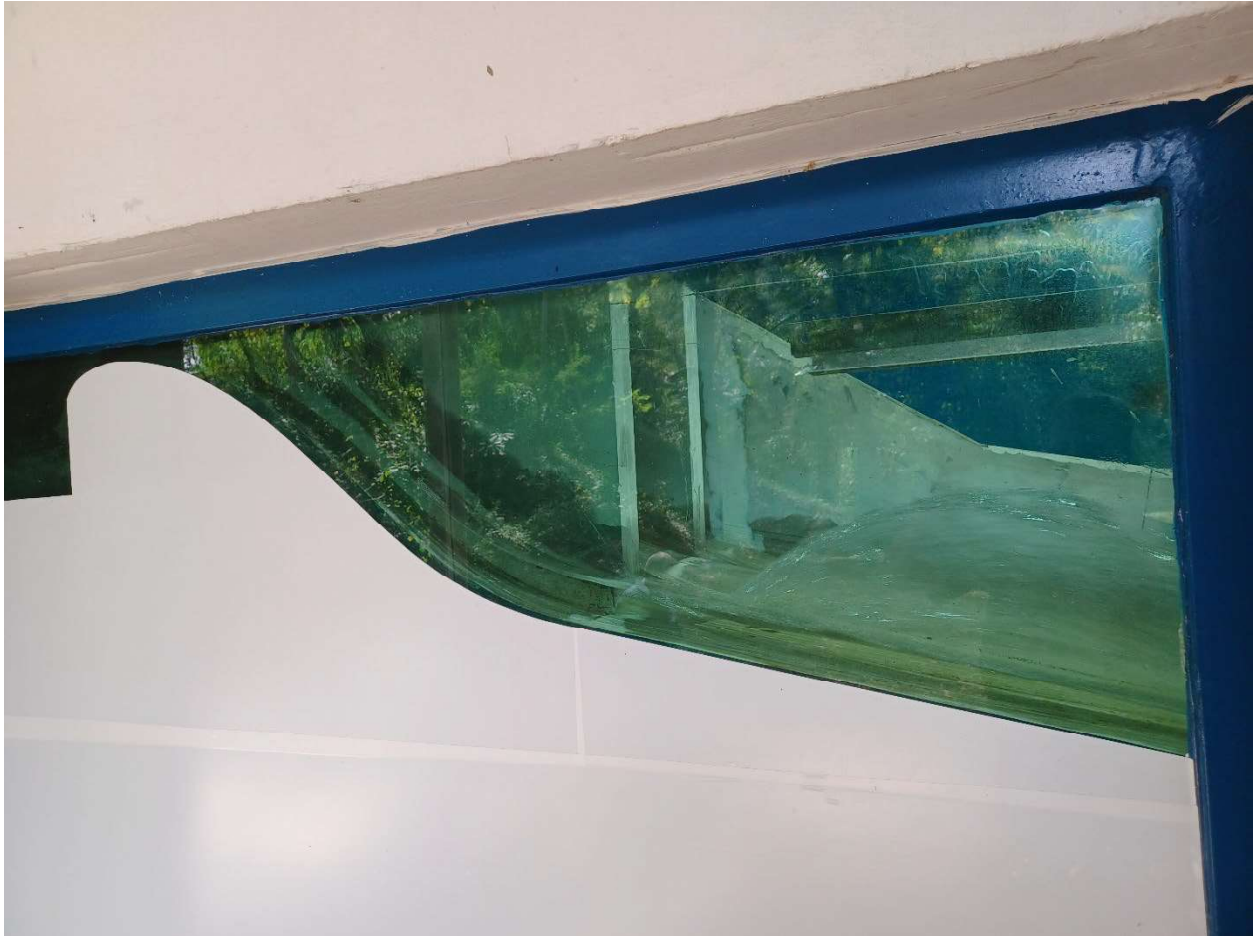
Figure 8. Physical model of the FURNAS facility spillway at the FURNAS hydraulics lab. This spillway has suffered cavitation damage and is an important case study of the current research.

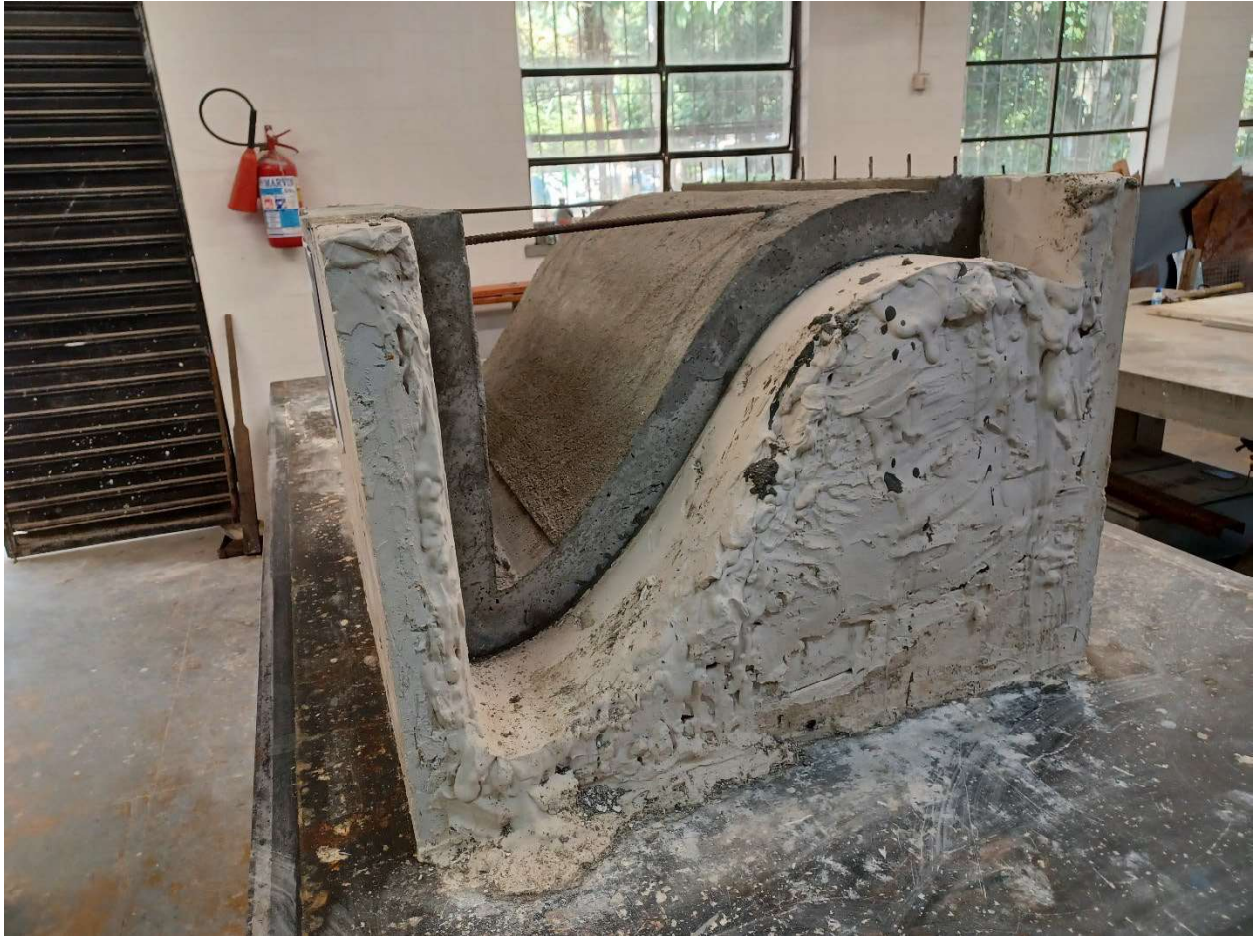
Figure 9. The model fabrication shop at the FURNAS hydraulics lab. This section is part of a spillway model that is made of concrete in a plaster mold. It was beneficial to learn of different model construction techniques used in Brazil compared to our methods in Reclamation.
