*
* UNITED STATES *
* DEPARTMENT OF THE INTERIOR *
* BUREAU OF RECLAMATION *
*
* - - - *
* HYDRAULIC LABORATORY REPORT NO. 119 *
*
* - - - *
* FIELD ACCEPTANCE TESTS *
* PUMPING PLANT "D", MODOC UNIT *
* TULE LAKE DIVISION - KLAMATH PROJECT *
*
* By *
* J. N. Bradley, Engineer *
*
* - - - *
* Denver, Colorado *
*
* January 21, 1943 *
*

Laboratory Report No. 119
Hydraulic Laboratory
Compiled by: J. N. Bradley

Subject: Field acceptance tests, on three pumping units furnished by the Morris Machine Works under specifications No. 1492-D, Pumping Plant "D" - Modoc Unit - Tule Lake Division, Klamath Project.

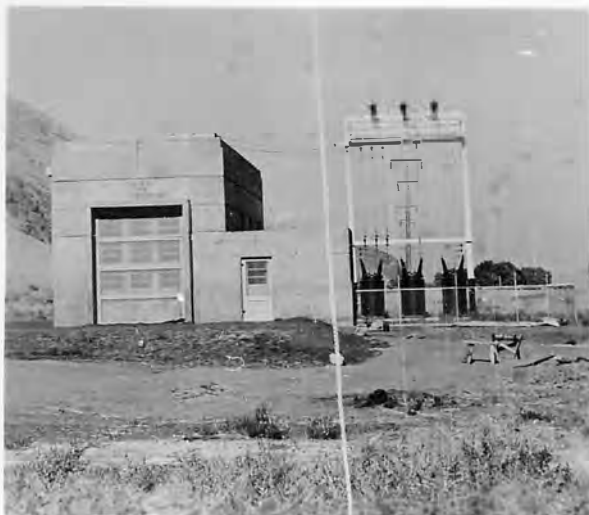
A - Pump house looking north.

The plant (figures 1A and 1B) is located on the west bank of Tule Lake, 5 miles west of the town of Tule Lake, California, and about 35 miles southeast of Klamath Falls, Oregon. Plant "D", although the largest, is one of a number of pumping plants which are used to control the level of Tule Lake. The lake, which at one time covered a vast area of swampy but very fertile land, has been gradually reduced and confined by dikes until it is now only a fraction of its original size and the reclaimed land resulting from the unwatering operations has been put under cultivation. This plant is necessary to insure against the water level overtopping the dikes during the wet season of the year. Plant "D" consists of three 450-horsepower units (figure 2). The pumps are of the vertical, single-suction type, measuring 24 inches in diameter at the suction throat and 30 inches at the discharge flange. They have a rated capacity of 50 second-feet each for a total pumping head of 64 feet and a speed of 600 r.p.m. (specifications

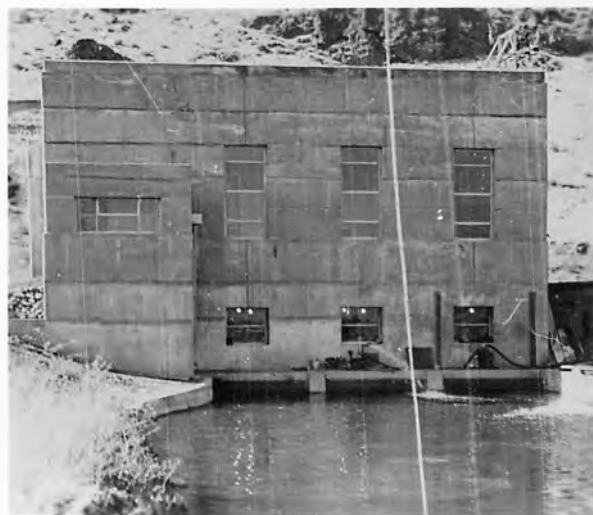
B - Pump house and intake channel

The pumps have individual suction tubes protected by single rack structures, which are supplied with water from a common unpaved intake canal (figure 1B). Each pump discharges through an expander from 30 to 36 inches in diameter, then through a short section of steel pipe to a reinforced concrete pipe. The three concrete pipes converge into a single three-barreled conduit, some 360 feet long, which conveys the water up an incline to a short section of open channel (figures 1E, 1F, and 2). To prevent the flow from reversing during a power outage, a 36-inch check gate is located at the outlet of each of the three conduits of the concrete barrel. These gates are also necessary during the priming operation. The short open channel section at the check gates serves as a transition to guide the water into a 5.75-foot horseshoe tunnel 6,700 feet in length. From this point on the flow is entirely due to the effect of gravity. The tunnel discharges into a trapezoidal canal from which the water can be routed to cultivated lands over the project for irrigation purposes or wasted into lower Klamath Lake and thence to the ocean via the Klamath River.

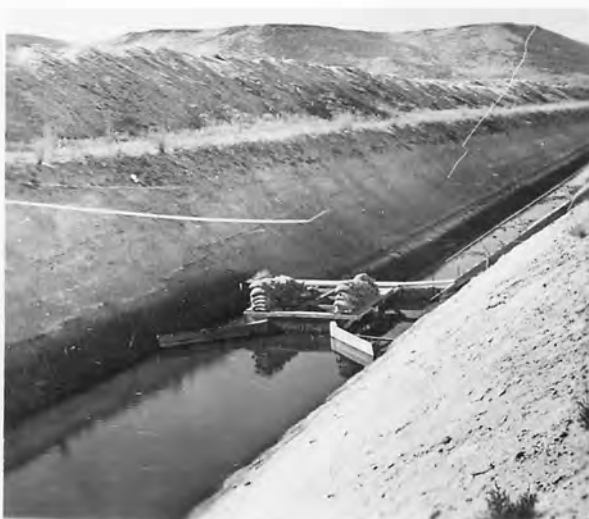
C - Weir structure in canal
looking downstream.

The discharge was measured over an 8-foot rectangular suppressed weir specially constructed for these tests and designed to strict accordance with the Standards of Hydraulic Institute code. This weir was located in the trapezoidal canal approximately 400 feet downstream from the outlet of the horseshoe tunnel a mile and a half from the plant as the crow flies, or 13 miles by road (figure 2). It was estimated that 25 minutes were required for a given volume of water passing through the pumps to reach the weir. Therefore, head measurements at the weir were commenced 25 minutes after corresponding observations were made at the pumps. The head on the weir was measured by some twelve observations, over a period of 30 minutes, by a hook gage reading to thousandths of a foot (figure 3C). The gage zero was determined immediately before and after the tests and was found to have changed but slightly during the period. Leakage past the weir together with canal seepage upstream was insignificant. Photographs of the weir are shown as figures 1C and 1D, and a discharge curve for this weir, computed according to the Hamilton Smith formula, is shown on figure 4. Nine runs were made on unit 3, seven on unit 2, and eight on unit 1. The head on the weir, discharge, and condition under which each run was made are shown in columns 3, 4, and 59, respectively, of table 4.

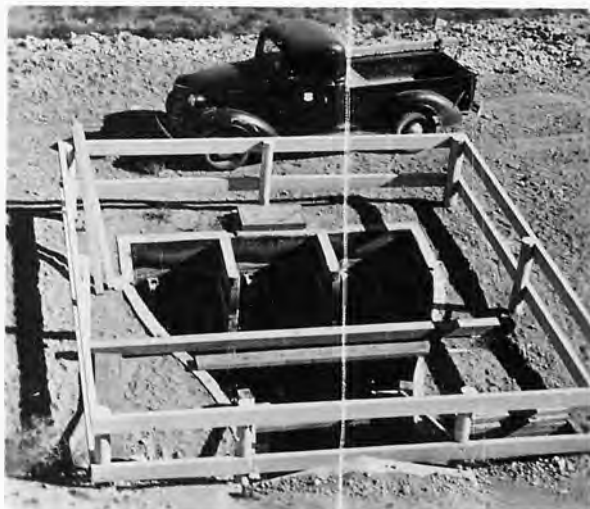
E - Open transition and 36-inch
check gates.

The check gates at the end of the concrete barrel provide the only means of sealing the units for priming. The "music note" rubber seals provided at the end of the pressure pipes are excellent with the exception of the joint. The rubber has evidently shrunk longitudinally leaving a crack from $1/4$ to $3/8$ inch where the two ends meet. Sufficient air enters through these cracks to drain the pipe lines overnight. It is suggested that these seals be cut to length and the ends vulcanized together at the factory for future installations.

The check gates together with the "music note" seals perform perfectly during starting and shut-down. As the pumps are started the gates swing open easily with a steady motion. On shut-down, the motion is again slow and steady in the opposite direction until the bottom of the gate approaches four inches of the seat. From here on the motion is quick, and the gate slams with sufficient impact to insure a good seal with the rubber.

The gate has one drawback, however, that was discovered while priming the pumps. After two days shut-down not one of the pumps could be primed until the gates were pushed against the rubber seals. In other words, these gates do not necessarily seal when hanging in their natural closed positions. The lower lips of the gates appeared to hang from $1/2$ to $1/4$ inch from the seats. It is therefore recommended that this type of gate, in future installations, be either counterbalanced to a greater extent or that the end of the pipe line and rubber seal be set at a flatter angle than shown in figure 3B. It is also suggested that the present gates

be weighted so that sealing in their natural closed positions will be assured.

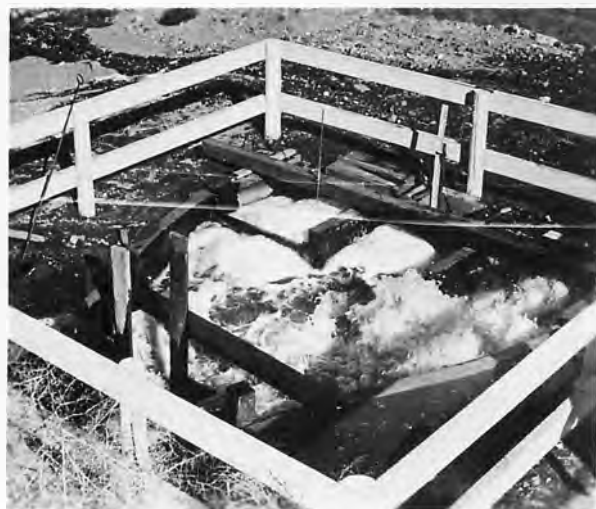
F - Open transition showing gages and
temporary needle dam. Unit No. 1
in operation.

Using gage 6, which consisted of a water tube connected to the air valves immediately upstream from the check gates (figures 1F and 3B), the total loss between this point and gage 3 was determined for the runs on units 1 and 2. The total energy at the U.S.B.R. taps was in this case computed using a velocity head correction factor $\alpha = 1.20$, which was based on experiments on single suction pumps. The corrected velocity heads are shown in column 25 (table 4) and the true total energy heads, expressed in elevation, are listed in column 27.

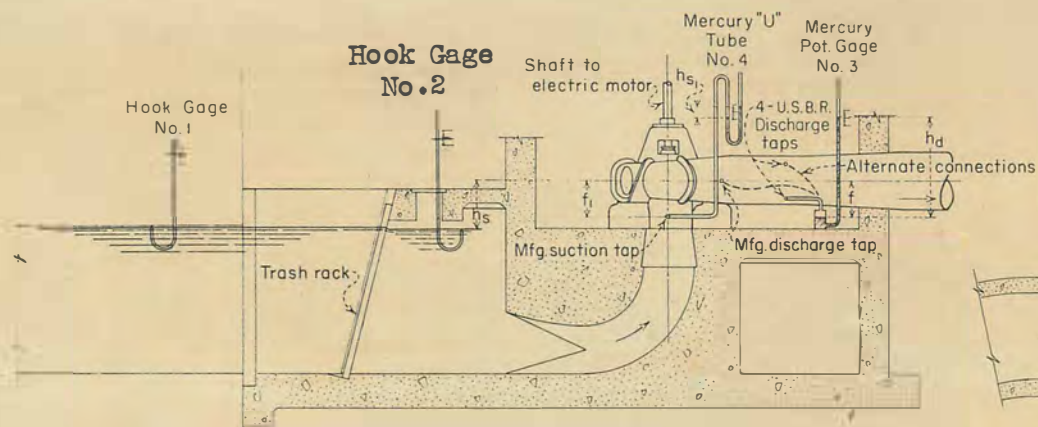
A-SECTION OF PUMP

The discharge head was observed from a mercury pot gage, connected in succession to four special taps, denoted as U.S.B.R. taps, located in the 30-inch pipe directly downstream from the pump (figure 3A). The suction head was taken as the difference between the center line of the pump and the energy of the water in the intake canal measured at gage 2 inside the trashracks (figure 3A). The total pumping head, H, was therefore determined as follows:

The losses through the single trashrack structures were obtained from the difference in energy measured at gages 1 and 2 (figure 3A). These are quite small, amounting to an average of 0.012 foot of water or $1.6 \frac{V^2}{2g}$, where V equals average velocity computed across the section at gage 2. The losses as measured for each run are tabulated in column 10 of table 4.

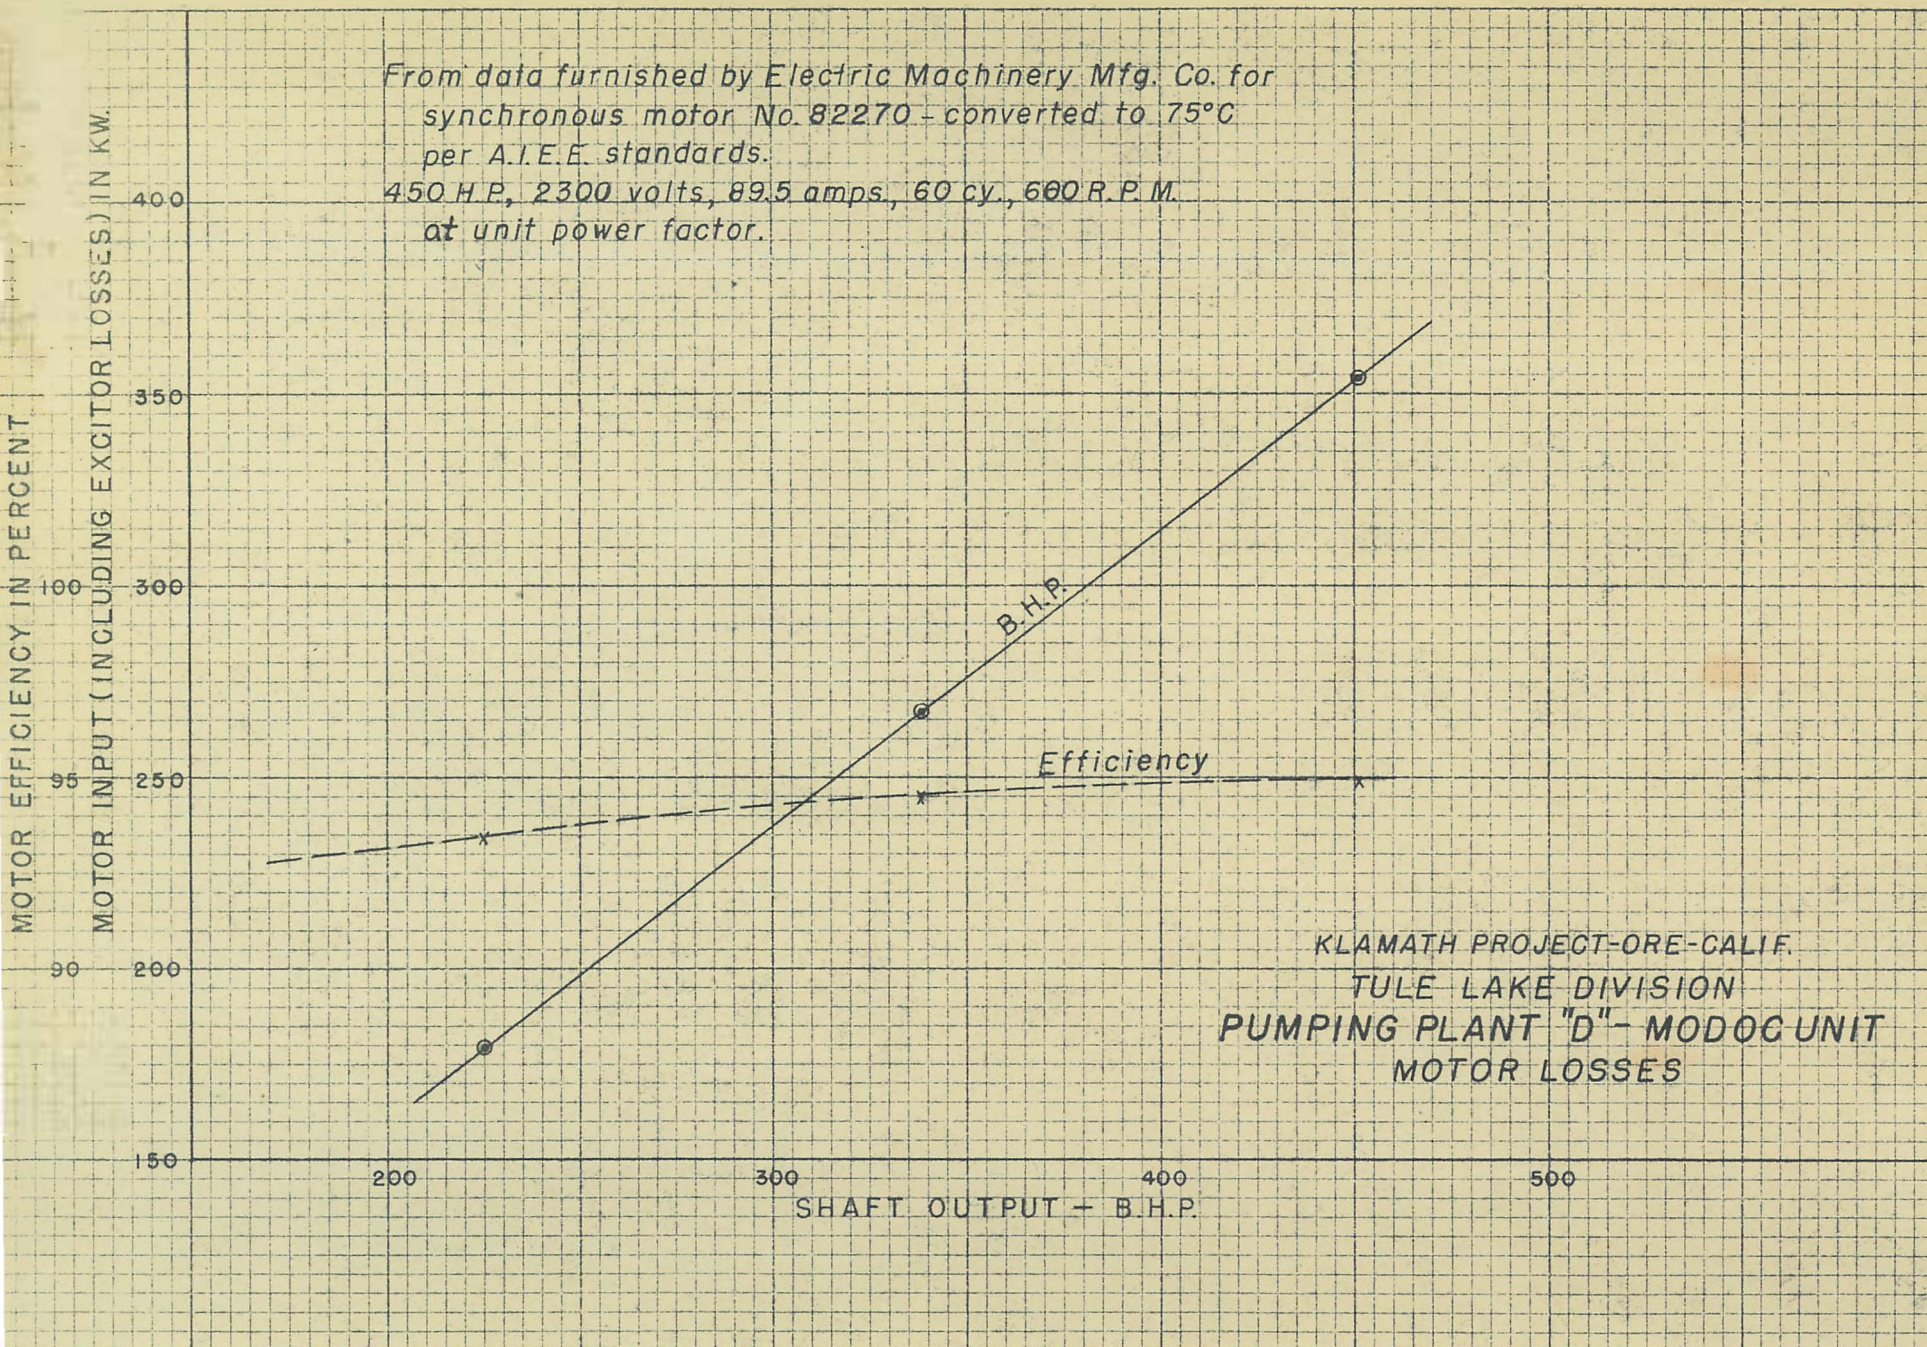
FIGURE 6

From the motor manufacturer's test curve (figure 6) the actual horsepower delivered to the pump shaft, designated as B.H.P., was obtained and this is shown tabulated in column 46. The actual pump efficiencies are listed in column 24. The extent of the pump characteristics obtained from these tests is shown plotted, by full lines, for units 1, 2, and 3 on figures 7, 8, and 9, respectively. The dotted curves were taken from Morris Machine Works print No. 32254 which was submitted by the manufacturer prior to delivery of the pumps. Unit 1 is one percent less than the over-all guaranteed
