HYDRAULIC MODEL STUDIES OF THE SPILLWAY  
AND OUTLET WORKS--HEART BUTTE DAM  
MISSOURI RIVER BASIN PROJECT

Hydraulic Laboratory Report No. Hyd-326

January 16, 1952

Subject: Hydraulic model studies of the spillway and outlet works--Heart Butte Dam--Missouri River Basin Project

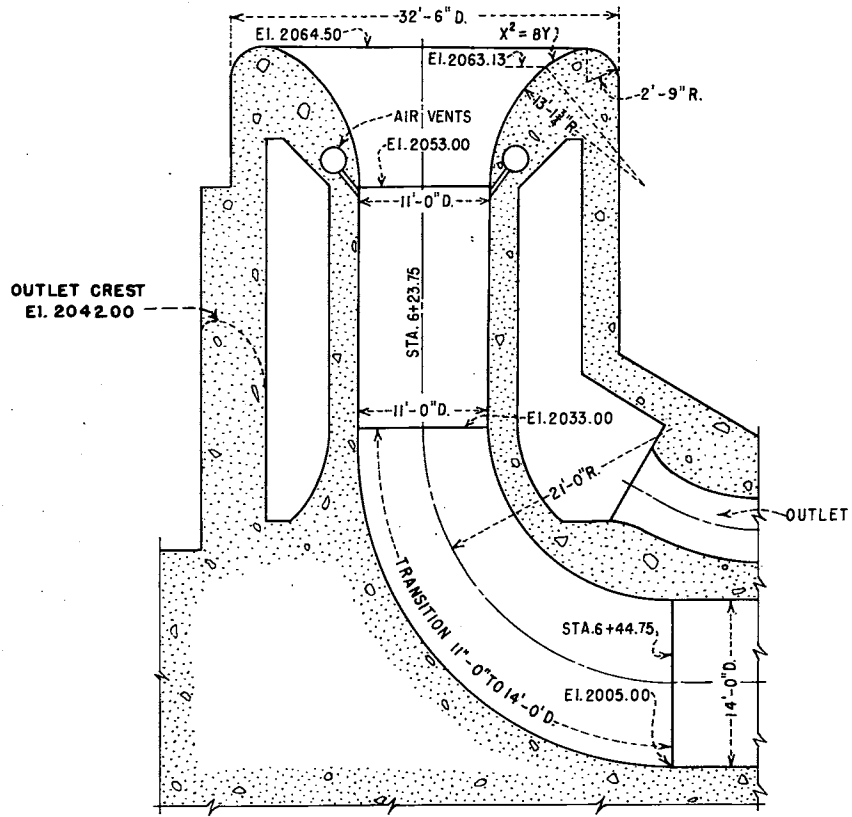
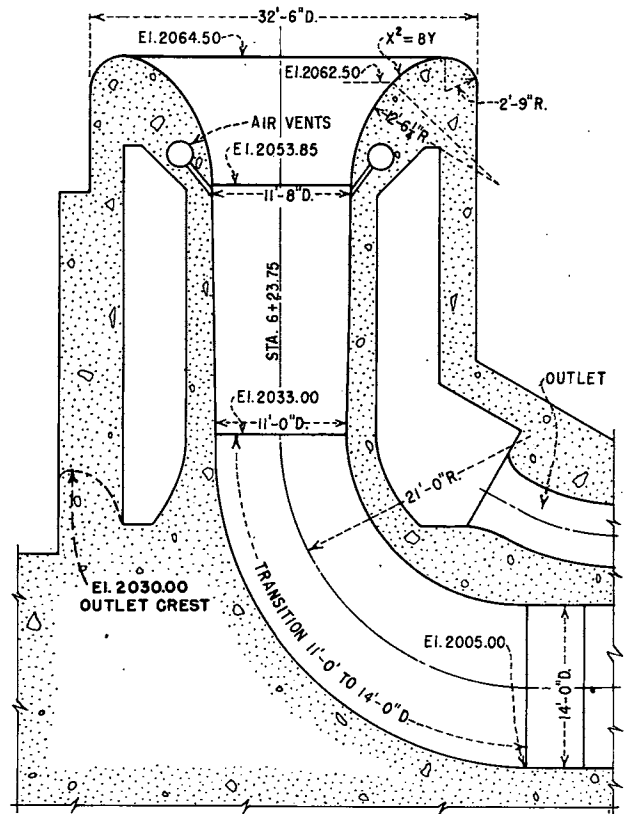
HEART BUTTE DAM  
SPILLWAY INLET STRUCTURES

SECTION  
A. No. 1-PRELIMINARY

SECTION  
B. No. 2

SECTION  
C. No. 3-RECOMMENDED

Tests were started using the preliminary spillway entrance shown in Figure 6A. With the crest submerged, vortex action occurred over the entrance and the tunnel ran full while subatmospheric pressures occurred in the spillway shaft. Tests showed six piers placed on the crest reduced the vortex action to minor proportions. Studies were made on modifications to the shape of the crest, the shaft, and the vertical bend. The tunnel was prevented from flowing full by using a flow deflector at the base of the shaft. This also prevented dangerously low pressures from occurring in the shaft. The elevation of inlet crest for the outlet works was lowered 12 feet to increase the amount of water available for irrigation. The basic entrance shape selected from these studies is shown in Figure 6C.

Operation. The preliminary morning-glory spillway entrance, Figure 6, had a maximum diameter of 32 feet 6 inches. The shaft, with a diameter of 11 feet, was connected by a transition bend to the 14-foot-diameter tunnel. There were nine air inlets equally spaced around the shaft at elevation 2053.0. The spillway was operated throughout all ranges of discharge up to the maximum of 5,600 second feet, and the appearance of the flow through the entrance, bend and tunnel was satisfactory. Figure 7 shows the flow in the bend and tunnel with the maximum discharge of 5,600 second feet. The tunnel is only partially full, but by closing the air inlets the tunnel would run full and open channel flow could not be re-established without reducing the spillway discharge. Full tunnel operation in the prototype must be avoided since the spillway would act as a siphon which would increase the head and result in excessive discharge. Low pressures would occur which, together with the large flow, might endanger the spillway structure. Methods used to insure against the tunnel running full are discussed in the pressure tests on the spillway entrance.

Operation. Entrance 2 was changed from the preliminary by installing a bend of constant diameter, Figure 6, instead of the transition bend. Flow through the entrance and shaft appeared similar to that which occurred with the preliminary entrance; however, the water surface in the tunnel was rough due to the disturbance created by the abrupt increase in diameter at the junction of the bend and tunnel. The smaller diameter of the bend, at the downstream end, prevented the horizontal tunnel from running full since the water surface could not strike the roof of the 14-foot tunnel. The constant diameter bend was not accepted because of the rough flow in the tunnel, but pressure studies on the bend were made both with and without flow deflectors on the downstream side of the shaft.

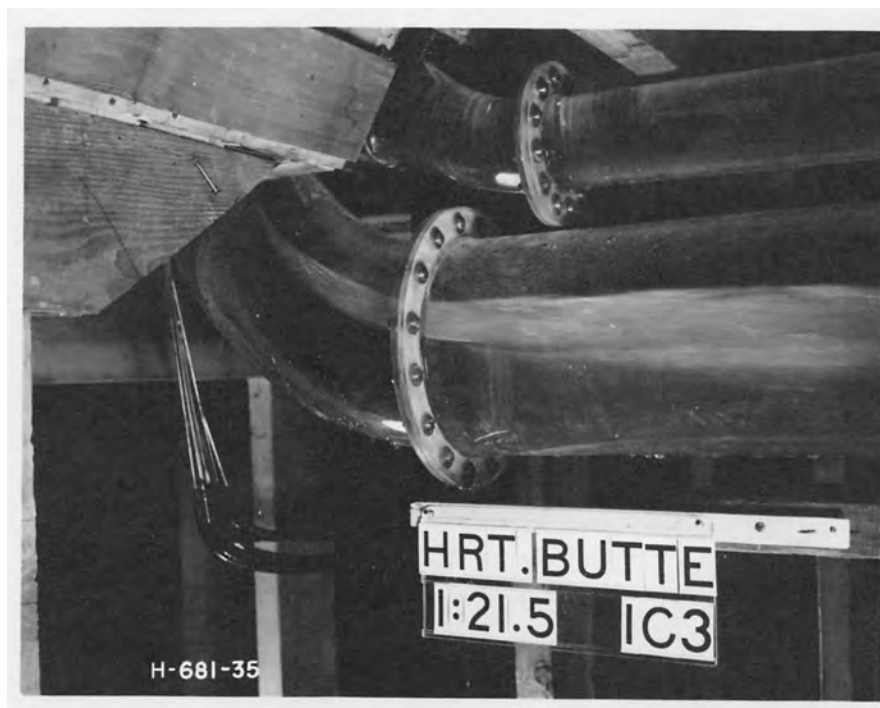
**PRELIMINARY TRANSITION BEND  
1:21-1/2 MODEL HEART BUTTE DAM**

**Discharge 5,600 second-feet  
Flow through bend**

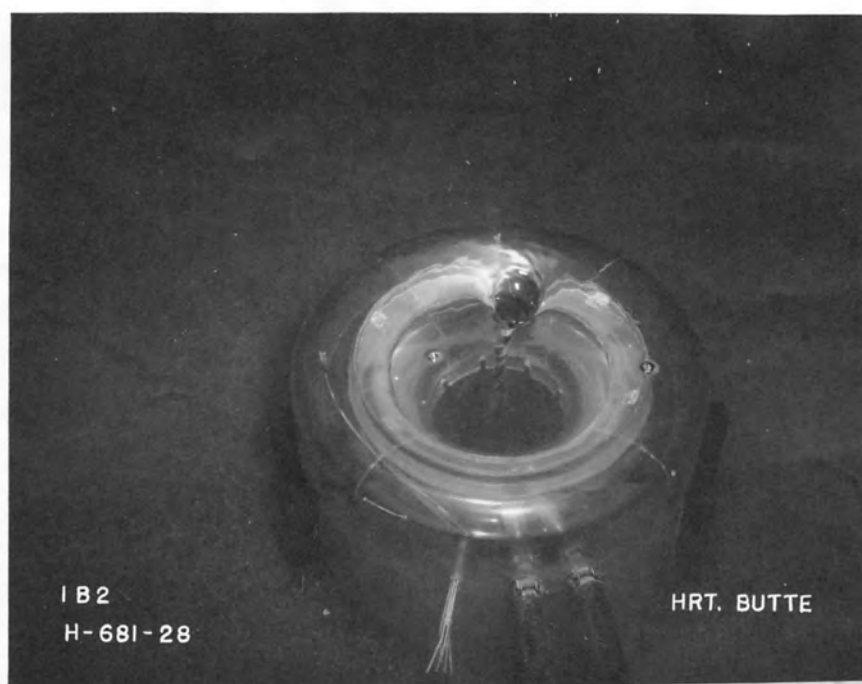
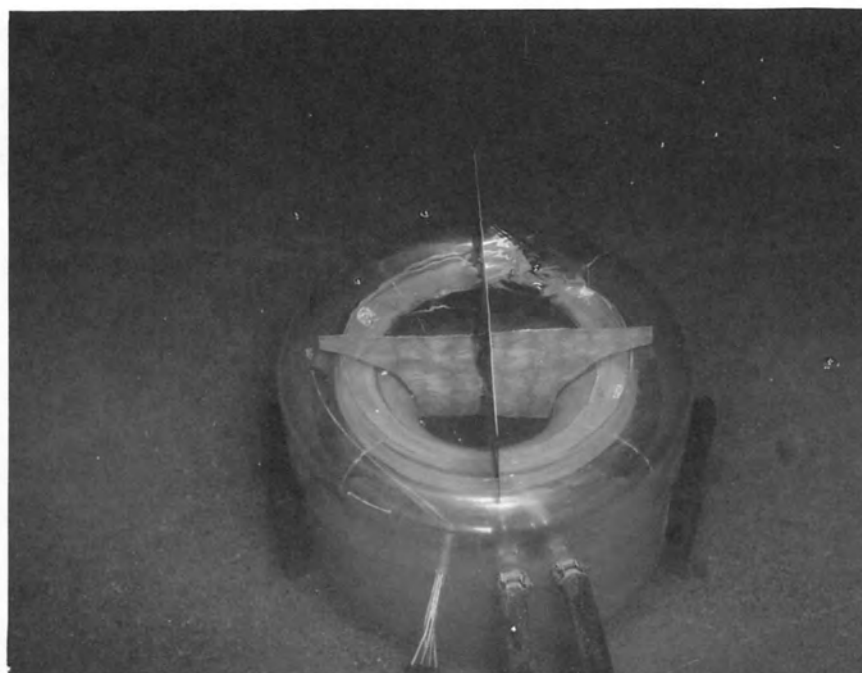
**SPILLWAY ENTRANCE  
1:21-1/2 MODEL HEART BUTTE DAM**

**A. Crest without piers  
Discharge 3,750 second-feet  
Reservoir at Elevation 2077**

**B. Crest with Pier No. 1  
Discharge 3,750 second-feet  
Reservoir Elevation 2077**

The photograph, Figure 8A, shows the upper portion of the vortex which extended down the shaft and bend to the horizontal tunnel. A vortex, especially a large one, is undesirable because it reduces the spillway discharge, and being subject to change in size it produces unsteady flow which can result in vibration to the structure.

According to the theory of hydraulic models, the vortex could be expected to occur in the prototype, so studies were made with five pier structures to determine the most practical means of eliminating or reducing the vortex. The first arrangement tested, Pier 1, consisted of two intersecting walls placed on the crest as shown in Figure 9. The vortex action occurred over the same range of reservoir elevation as occurred without piers, but the size of the vortex was reduced, Figure 8B. The use of a single wall was of little value in vortex reduction.

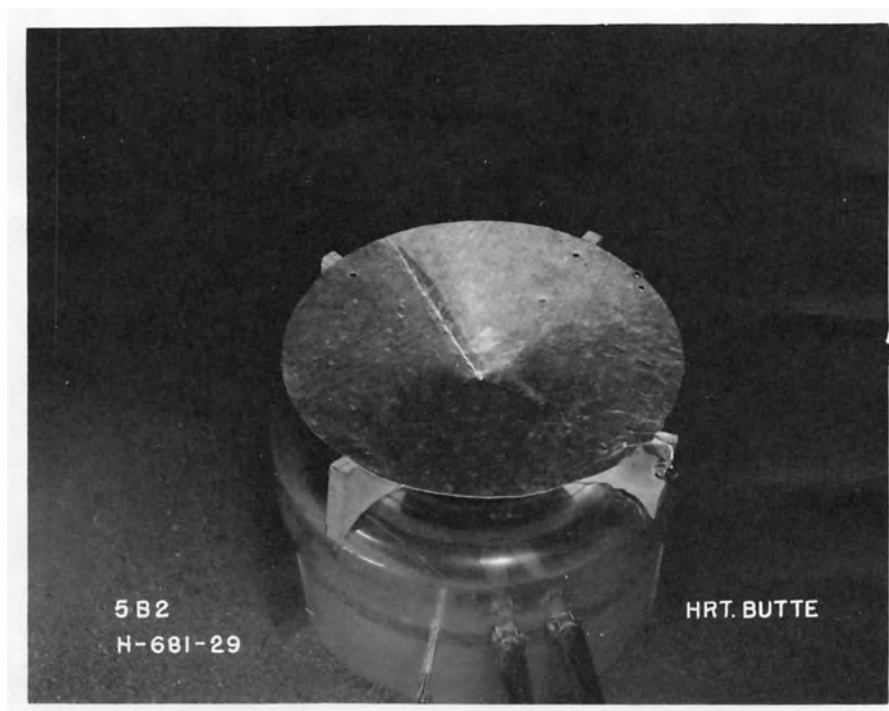
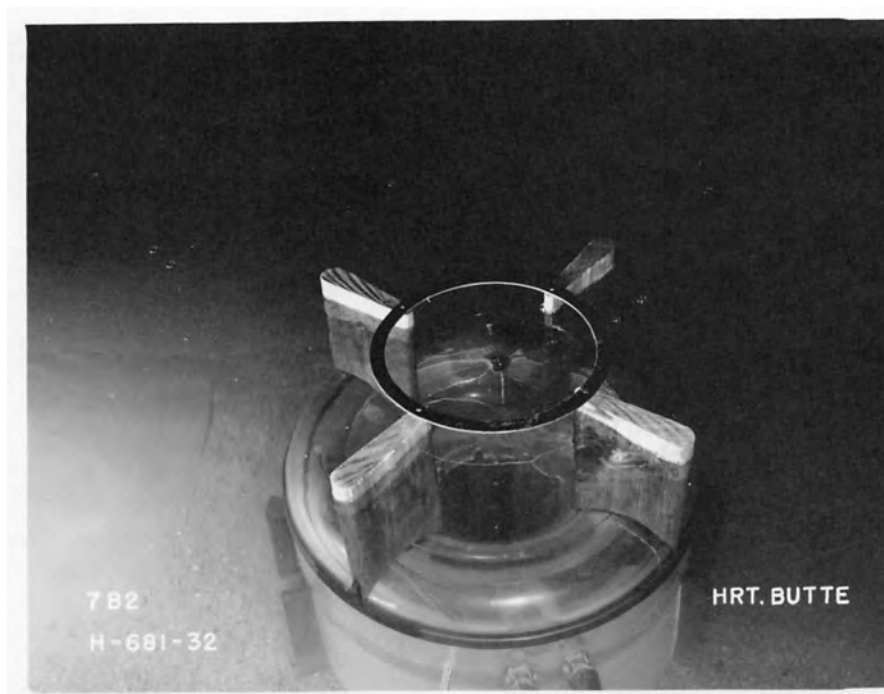
SPILLWAY ENTRANCE  
1:21-1/2 MODEL HEART BUTTE DAM

A. Crest with Pier No. 2  
Discharge 3,750 second-feet

B. Crest with Pier No. 3  
Discharge 3,750 second-feet

Pier 2 had four piers supporting a conical-shaped cover plate, Figure 9. Vortex action was minor at all reservoir elevations as shown in Figure 10A with a discharge of 3,750 second feet. The cover plate, while giving good suppression to vortex action, was not a practical structure, so the studies were continued using only piers on the crest.

Pier 3, Figure 9, consisted of four piers 14 feet high. Vortex action occurred at the same reservoir elevations as it had in the previous tests. The size of the vortex was less than that occurring with Pier 1 and it was located over the center of the entrance as shown in Figure 10B with a discharge of 3,750 second feet.

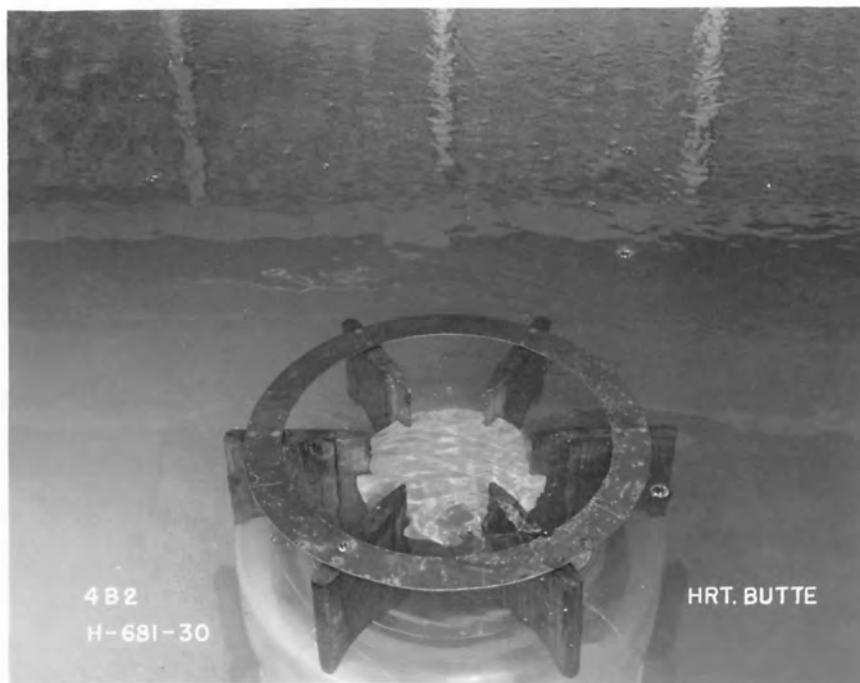
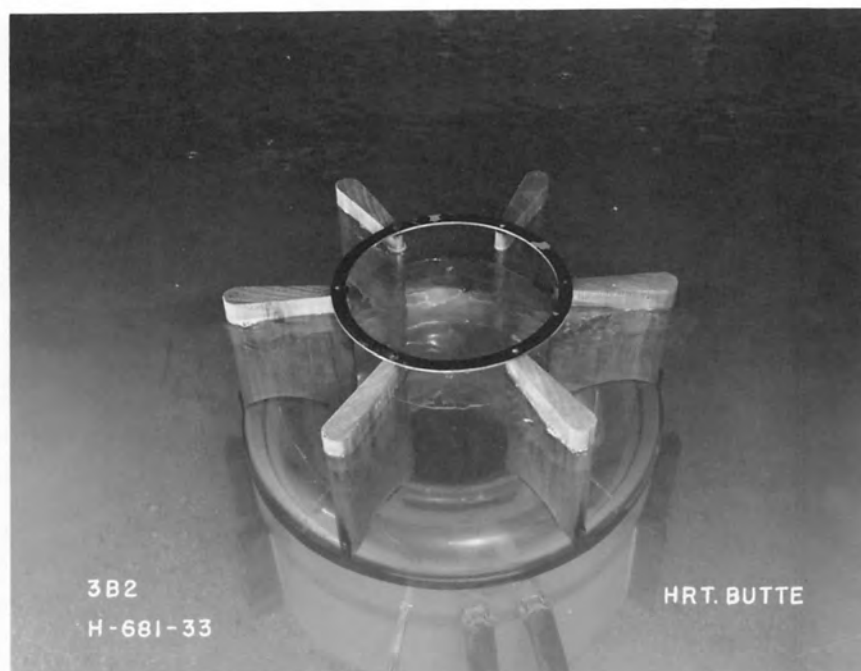
**SPILLWAY ENTRANCE  
1:21-1/2 MODEL HEART BUTTE DAM**

A. Crest with Pier No. 4  
Discharge 3,750 second-feet

B. Crest with Pier No. 5--Recommended  
Discharge 3,750 second-feet

For Pier 4, six piers were installed on the crest, Figure 9, and a cover plate was used in the central area of the piers. Vortex action occurred as in all previous tests, but the size of the vortex was smaller than that with Pier 3, and it was located at the edge of the cover plate as shown in Figure 11A with a discharge of 3,750 second feet. The test of Pier 4 demonstrated for the second time that a cover plate, though giving good results, would not eliminate vortex action, since a vortex formed at the edge of the plate and extended down the shaft.

For Pier 5, Figure 9, six piers were used similar to Pier 4, but without a central cover plate. With the entrance submerged, vortex action occurred over the center of the spillway similar to that with Pier 3, but the vortex was smaller. Flow conditions at a discharge of 3,750 second feet, Figure 11B, were considered satisfactory so Pier 5 was recommended for construction on the prototype.

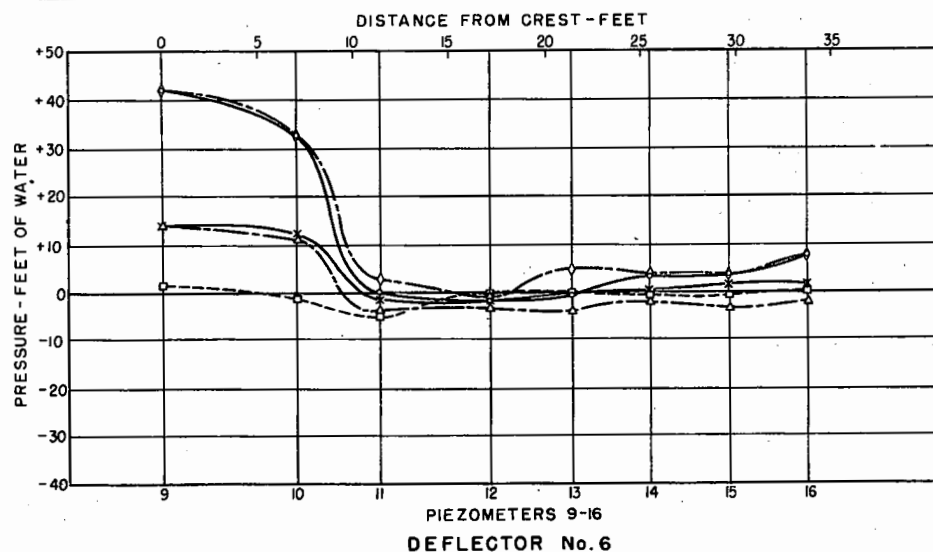
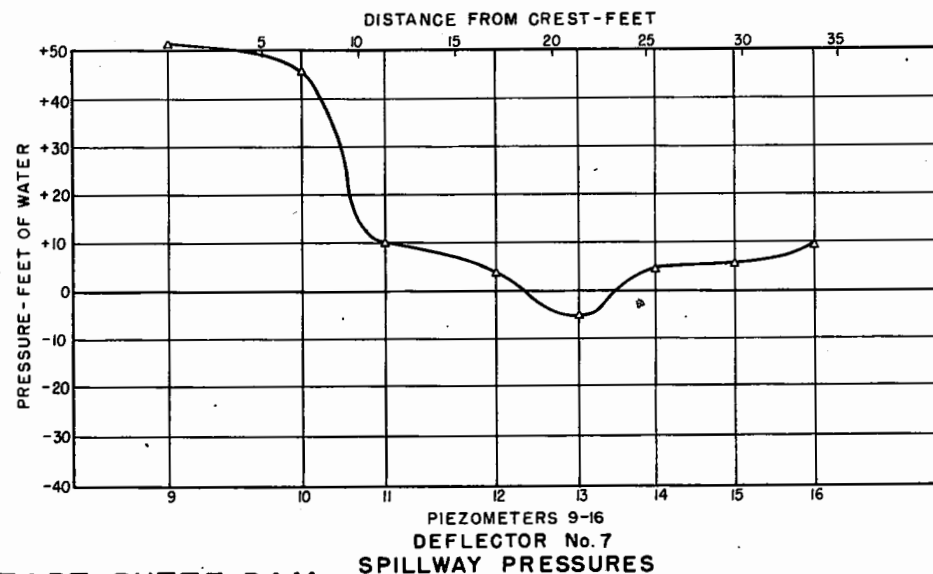
# HEART BUTTE DAM SPILLWAY PRESSURES

TEST No. 7 - PRELIMINARY - DEFLECTOR No. 6 AND No. 7

In Test 7, two deflectors proposed by the design section were studied. These deflectors, 6 and 7, Figure 18, were installed on the upstream side of the shaft, covering the piezometers so pressures were not measured on Piezometers 1 through 8. The minimum pressures were 5 feet of water below atmospheric, but the water surface in the tunnel was not as smooth as that obtained when the deflectors were located on the downstream side of the shaft.

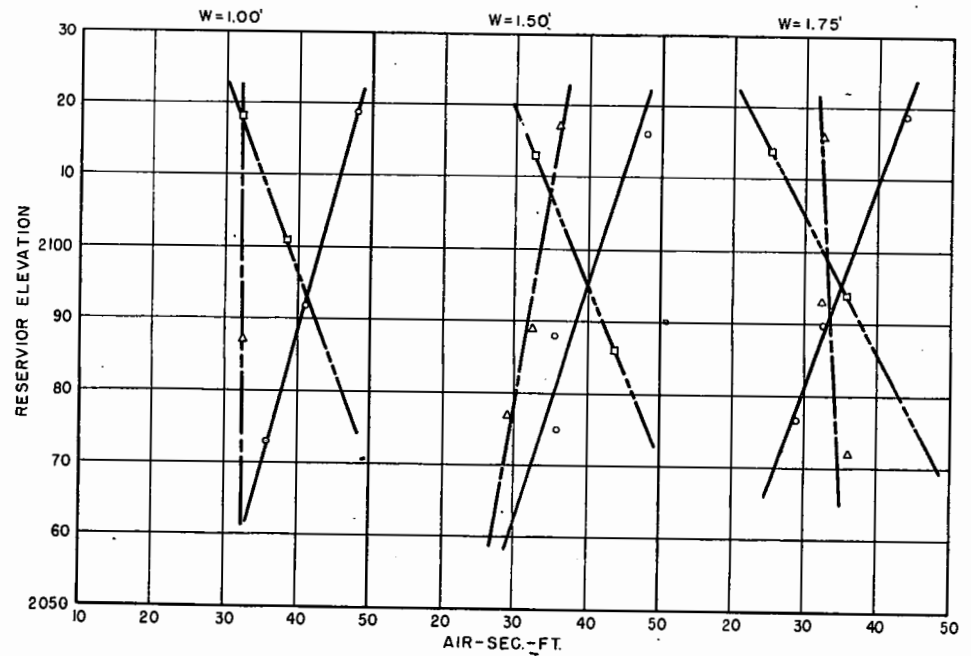
HEART BUTTE DAM  
AIR TEST No. 4-AIR DEFLECTOR WIDTH AND  
ANGLE VERSUS AIR DISCHARGE  
SPILLWAY No. 1-DEFLECTOR Nos. 14-22

AIR DISCHARGE CAPACITY CURVES

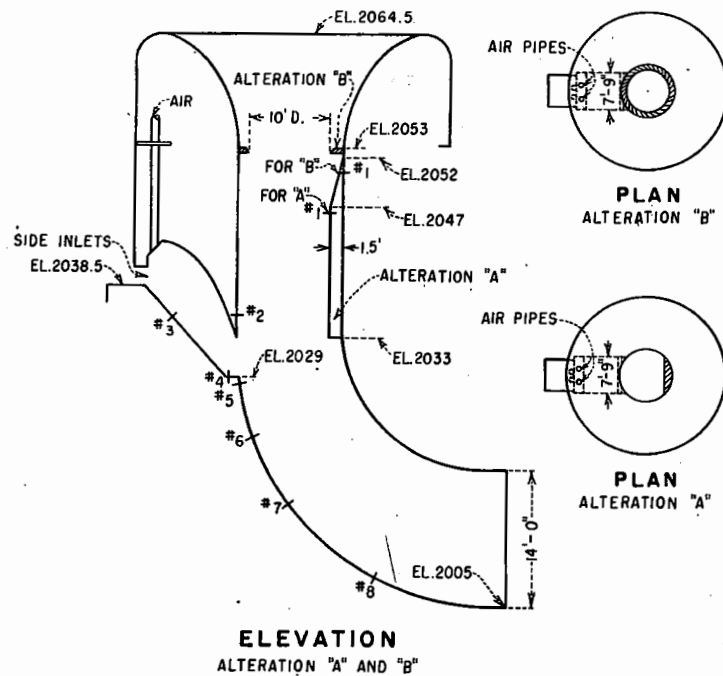
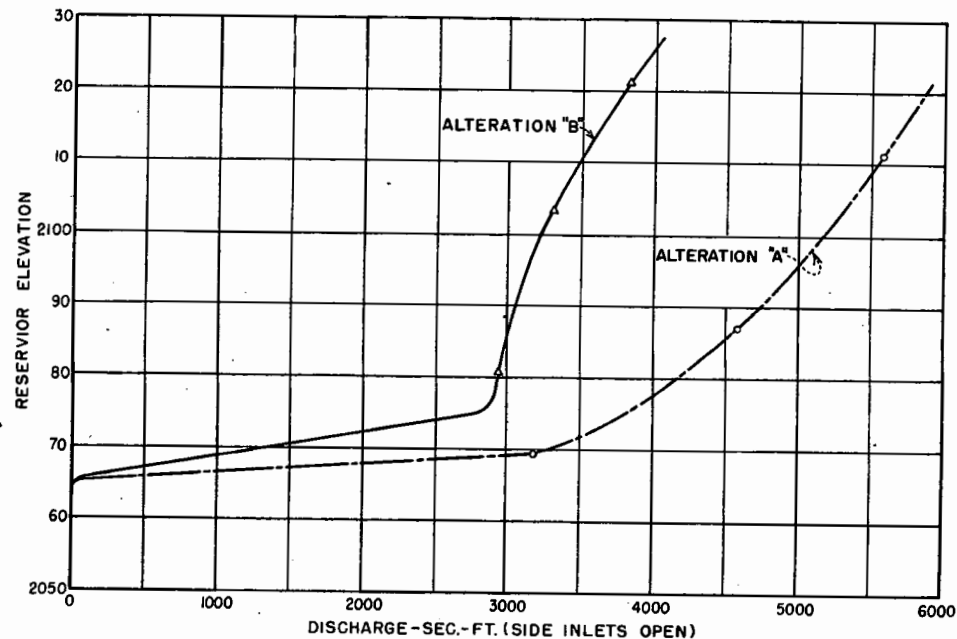
**HEART BUTTE DAM**  
AIR TEST No.6-AIR AND WATER DISCHARGE  
CALIBRATION AND PRESSURES  
SPILLWAY No.1- WITH SIDE ENTRANCE  
ALTERATION A AND B

**NOTE**  
THERE WAS NO AIR SUPPLIED BY THIS DESIGN

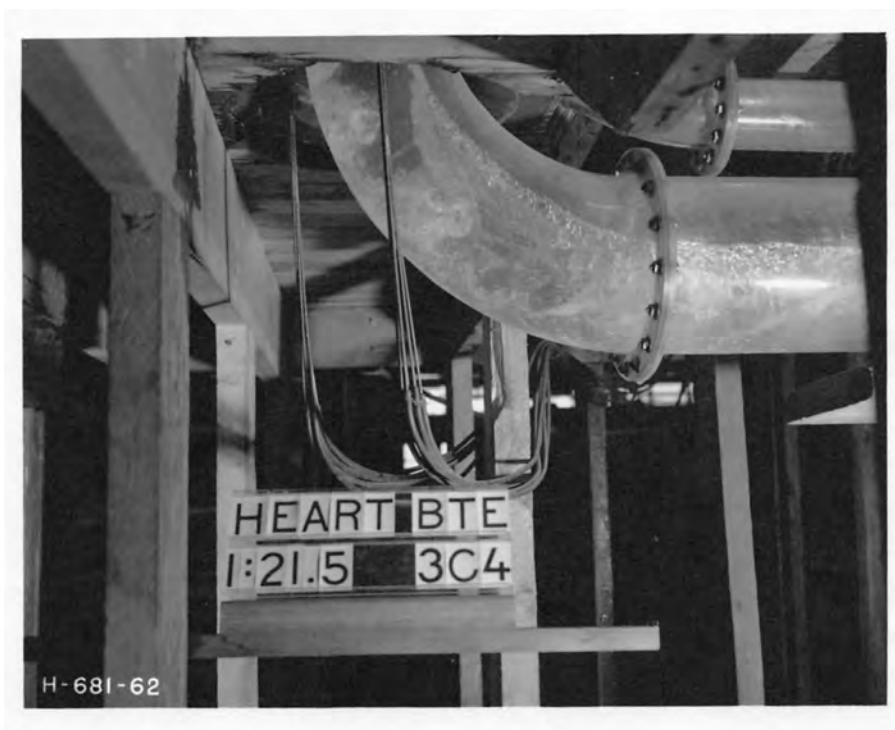
**RECOMMENDED TRANSITION BEND  
1:21-1/2 MODEL HEART BUTTE DAM**

**Discharge 5,450 second-feet  
Flow of water and air through bend.**

Test 7, Figure 32, used Air Deflector 23 which was installed on the recommended intake structure. Air capacity curves were obtained using Deflectors 8 and 9 at the bottom of the shaft. The curves, Figure 32, showed an increase in air discharge with an increase in reservoir elevation. More air was supplied with Deflector 9, and this deflector was recommended because the water discharge was also greater. From the model results, the air discharge using Deflector 9 was 1 percent of the value of the water discharge. The air contained in the water flowing through the bend is shown in Figure 33.

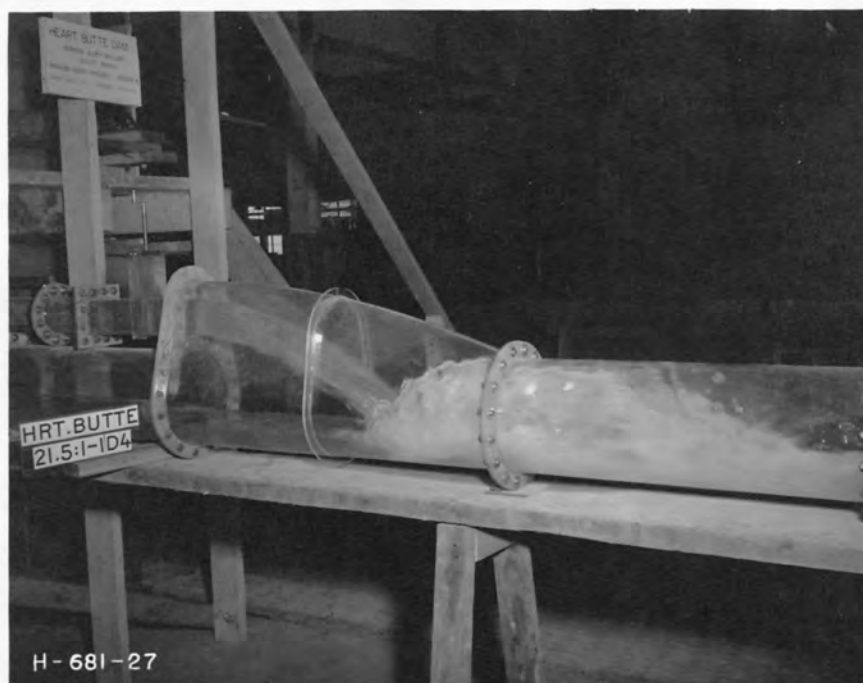
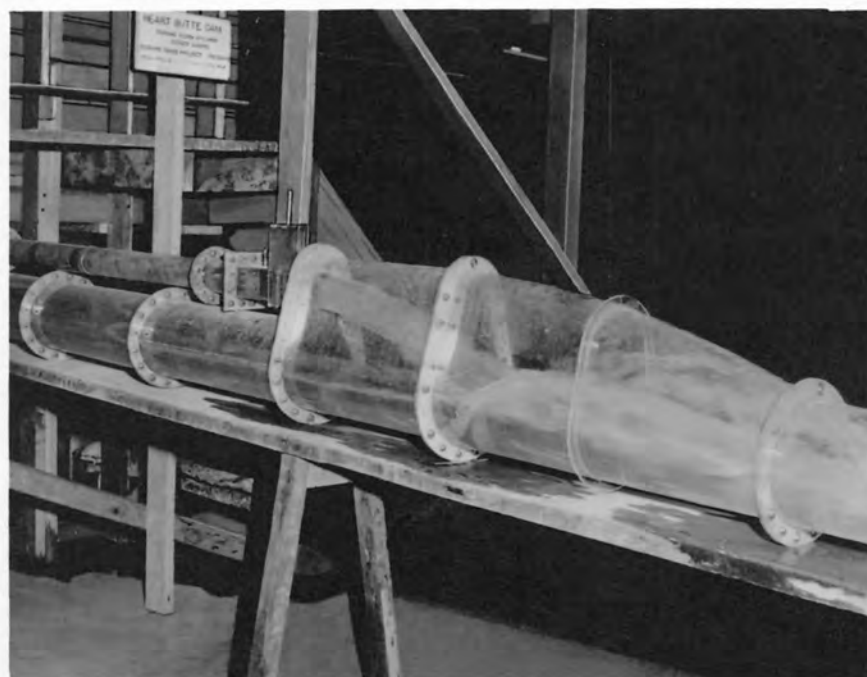
OUTLET TRANSITIONS  
1:21-1/2 MODEL HEART BUTTE DAM

A. Transition No. 1, Outlet discharge 850 second-feet

B. Transition No. 2, Outlet discharge 850 second-feet

connecting the outlet tunnel with the spillway tunnel, is shown in Figure 34. The transition was 54 feet long to provide room for the jet from the outlet conduit. Flow in the transition section and tunnel is shown in Figure 35A with the outlet discharging 850 second feet. The 4- by 5-foot outlet gate was fully open with the reservoir water surface at the spillway crest elevation 2064.5, and no flow from the spillway. As shown in the photograph, the wave occurring from the jet striking the floor filled the tunnel section at the end of the transition. This flow condition was not objectionable except that it sealed the tunnel to the free passage of air, and when the model was operated with both the spillway and outlets discharging, the tunnel ran full with resulting low pressures in the spillway shaft. However, this condition would not occur in the prototype since it was not intended that the spillway and outlet works would operate simultaneously.

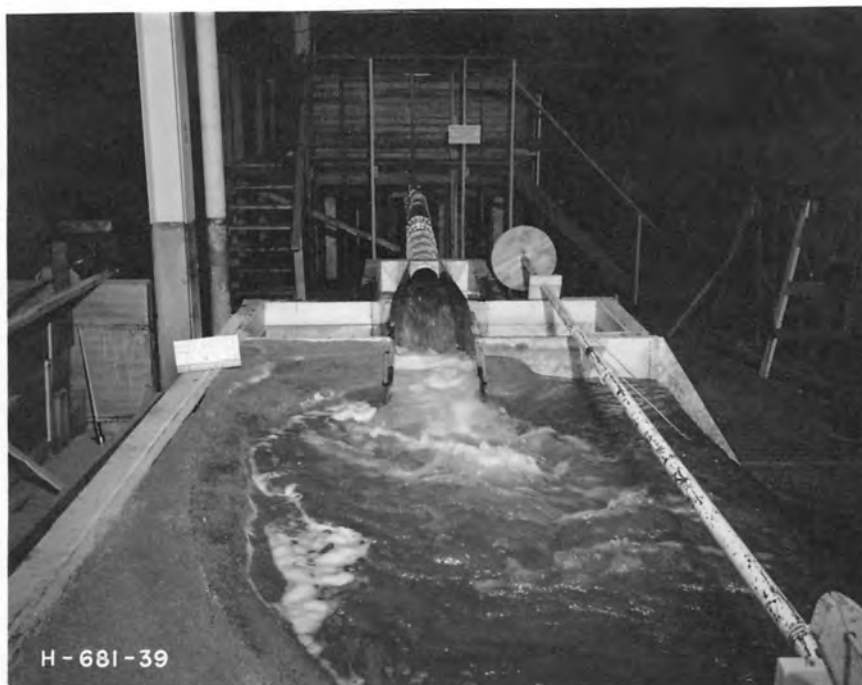
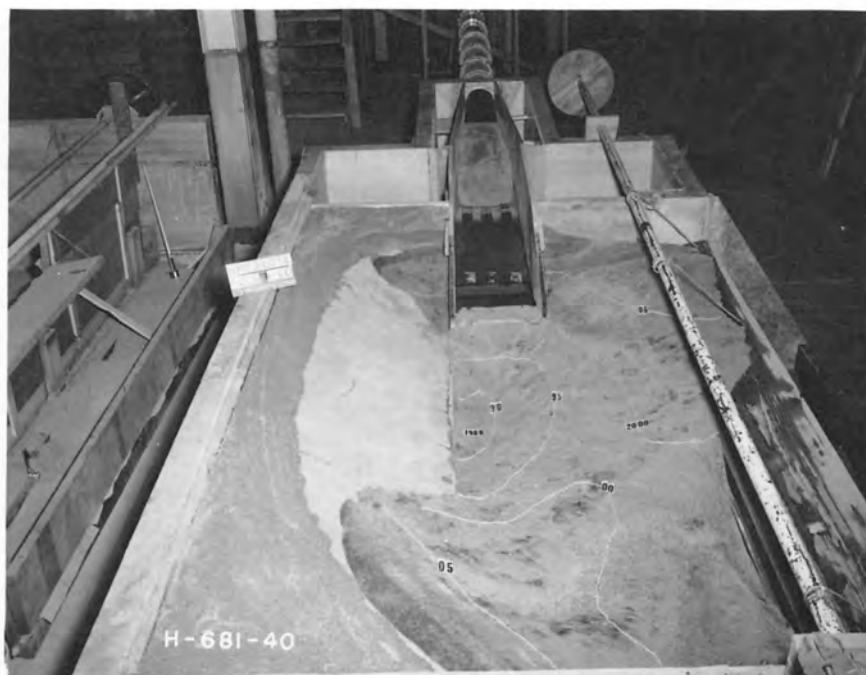
**STILLING BASIN NO. 1  
1:21-1/2 MODEL HEART BUTTE DAM**

**A. Discharge 5,600 second-feet**

**B. Scour after 1/2 hour at 5,600 second-feet  
T.W. 2012**

Stilling Basin 1. Stilling Basin 1 is shown in Figure 36. A transition section at the end of the tunnel gave a horseshoe-shaped portal 14 feet wide at the bottom. The stilling-basin width was 26.5 feet, and a chute with a hump rising 5 feet above the tunnel portal connected the tunnel and stilling basin. Operation of the basin at the maximum discharge of 5,600 second feet, Figure 37A, showed high velocities and a rough water surface in the stilling basin and river channel. Lowering the tail water 1-1/2 feet caused the jump to sweep out of the basin. Scour was severe after 1/2-hour operation at 5,600 second feet with the tail water at elevation 2012, Figure 37B. The 3-inch layer of sand covering the right bank was washed off by the wave action, and in the stream bed the greatest depth of scour was 12 feet lower than the end of the basin. In this basin, the 3:1 sloping floor at the downstream end reduced the area so that the average velocity at the sill was 17.6 feet per second, which contributed to the rough water surface in the river channel.

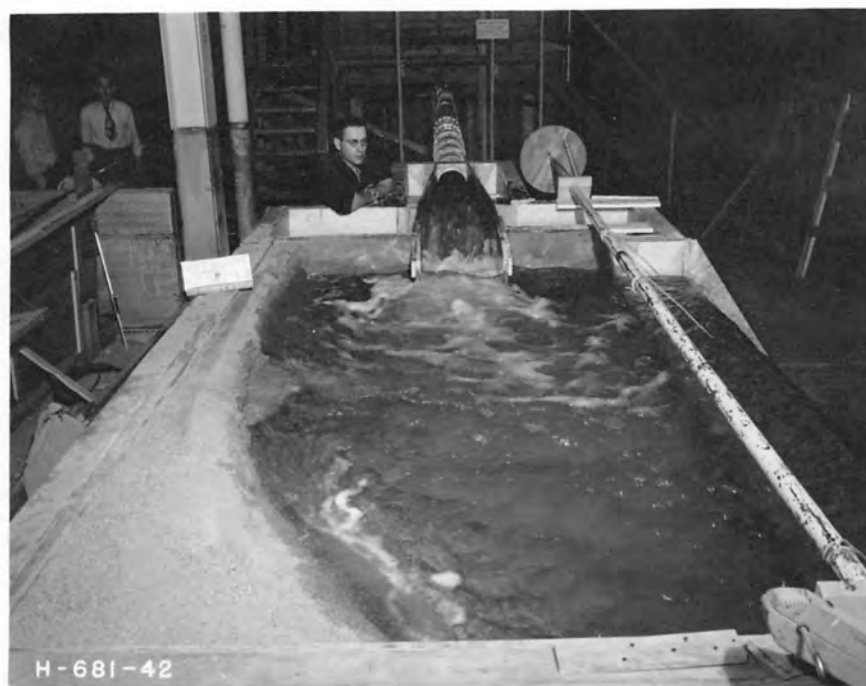
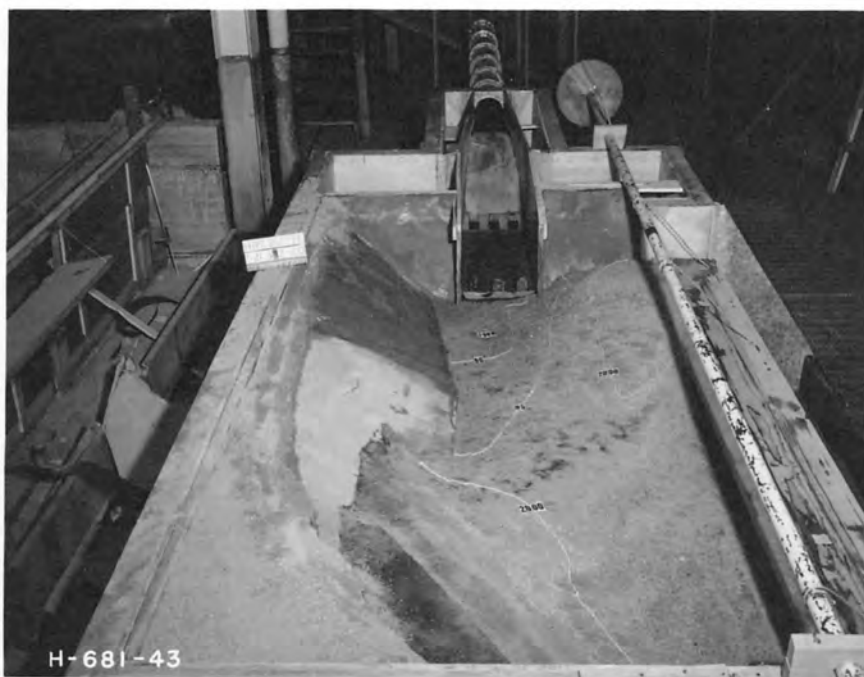
STILLING BASIN NO. 2  
1:21-1/2 MODEL HEART BUTTE DAM

A. Discharge 5,600 second-feet

B. Scour after 1/2 hour at 5,600 second-feet  
T.W. 2012

wave height in the river channel over that occurring with Basin 1. Scour after 1/2-hour operation at 5,600 second feet and tail-water elevation 2012, showed the lowest stream bed elevation to be 1988, Figure 38B. This was the same as the elevation of the lowest scour obtained with Basin 1. Though Basin 2 showed an improvement in flow conditions, the scour test showed the basin was unsatisfactory.

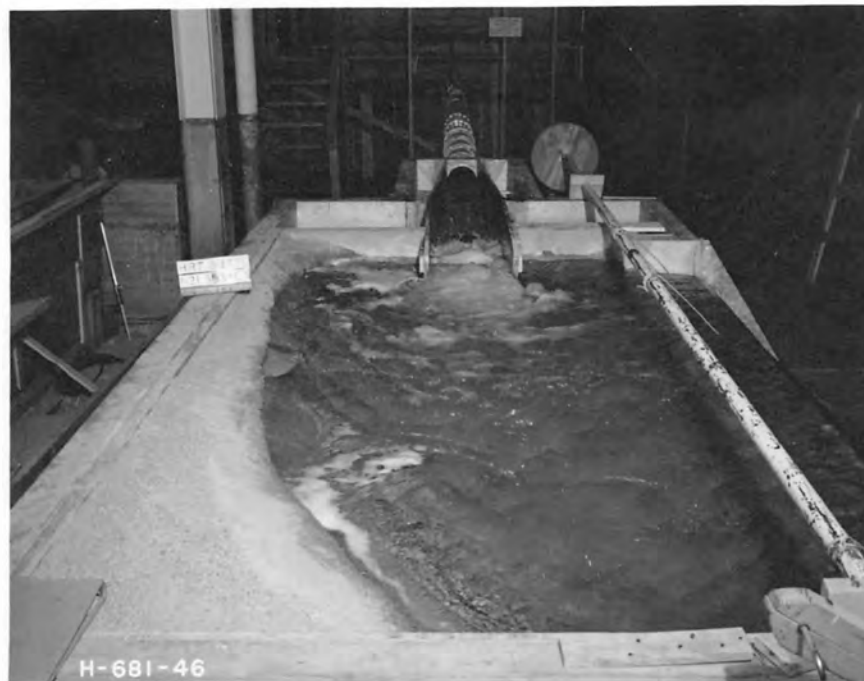
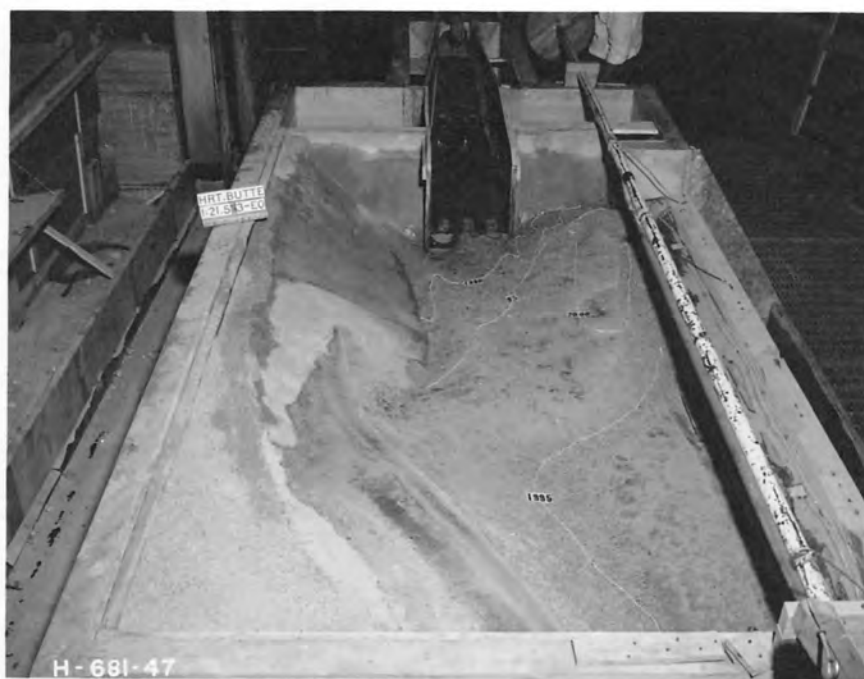
**STILLING BASIN NO. 3  
1:21-1/2 MODEL HEART BUTTE DAM**

**A. Discharge 5,600 second-feet**

**B. Scour after 1/2 hour at 5,600 second-feet  
T.W. 2012**

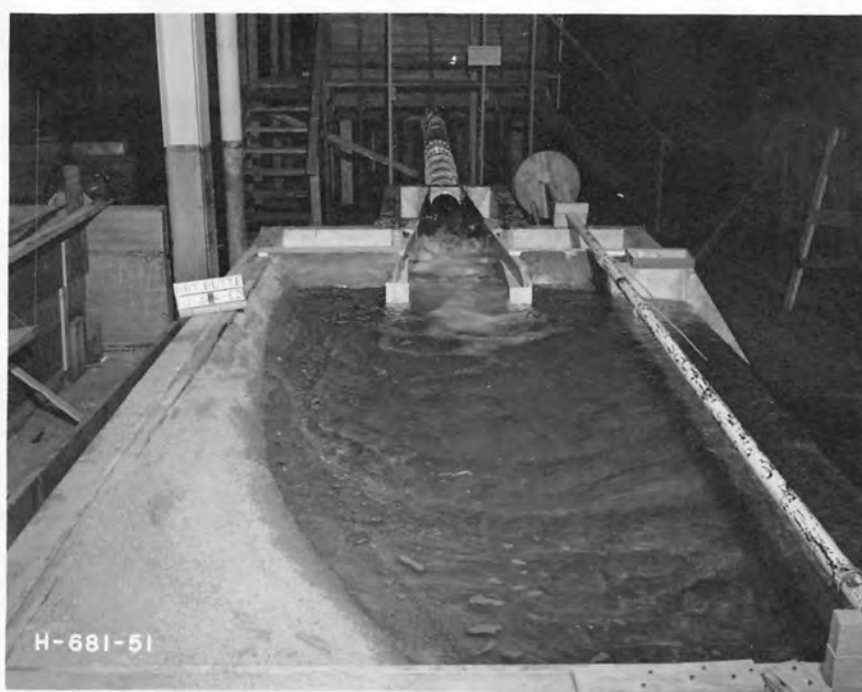
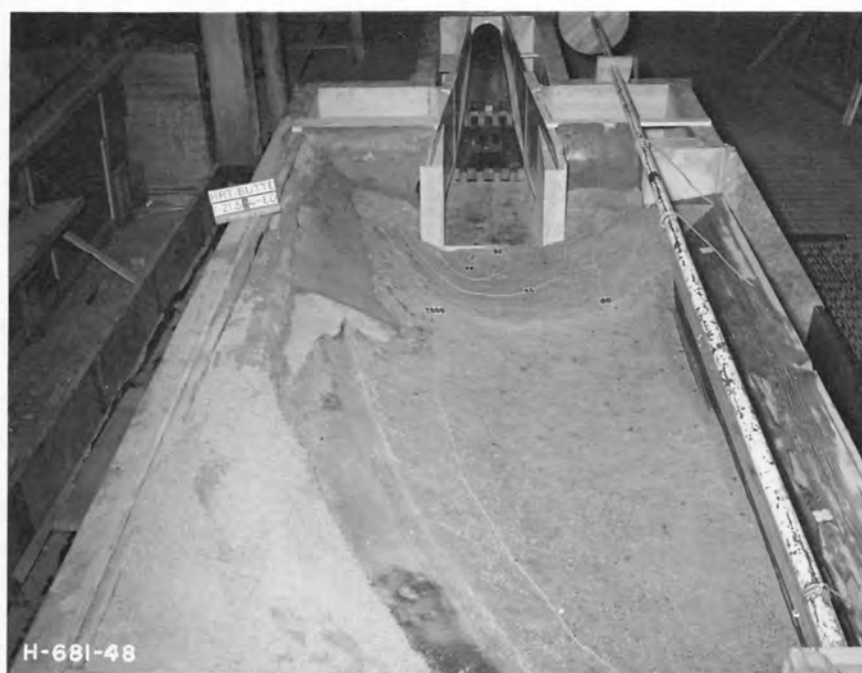
STILLING BASIN NO. 4  
1:21-1/2 MODEL HEART BUTTE DAM

A. Discharge 5,600 second-feet

B. Scour after 1/2 hour at 5,600 second-feet  
T.W. 2012

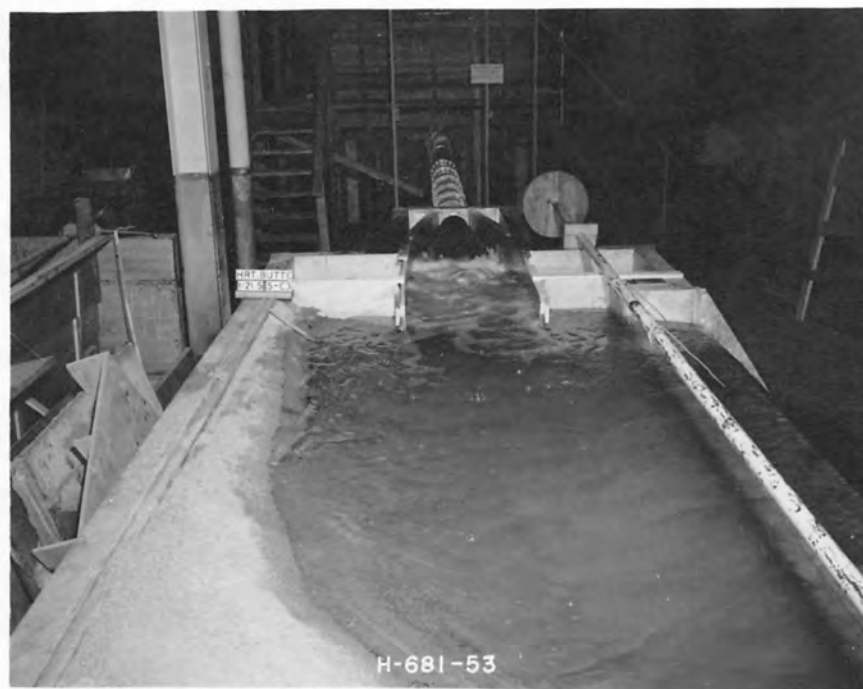
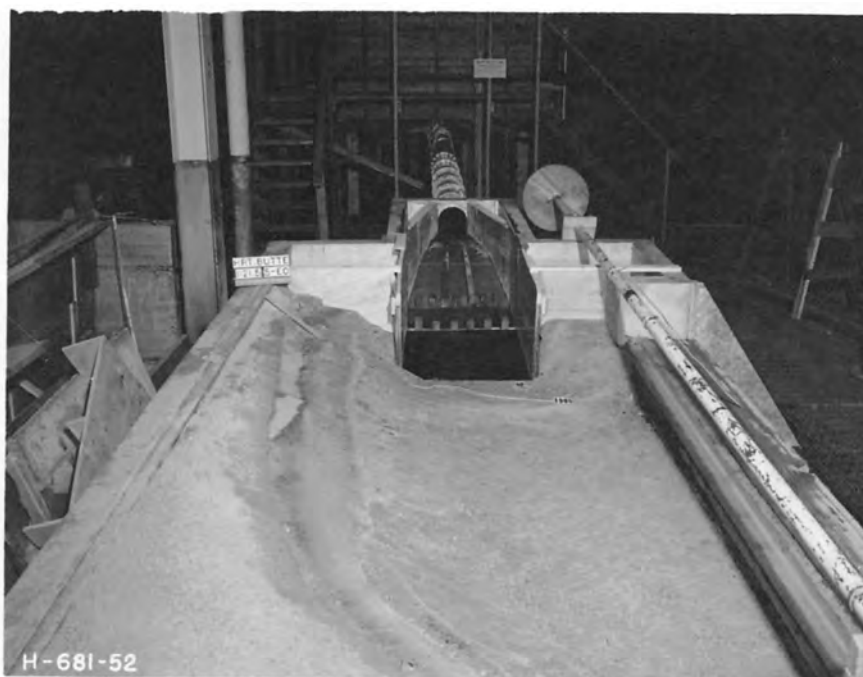
**STILLING BASIN NO. 5  
1:21-1/2 MODEL HEART BUTTE DAM**

**A. Discharge 5,600 second-feet**

**B. Scour after 1/2 hour at 5,600 second-feet  
T.W. 2012**

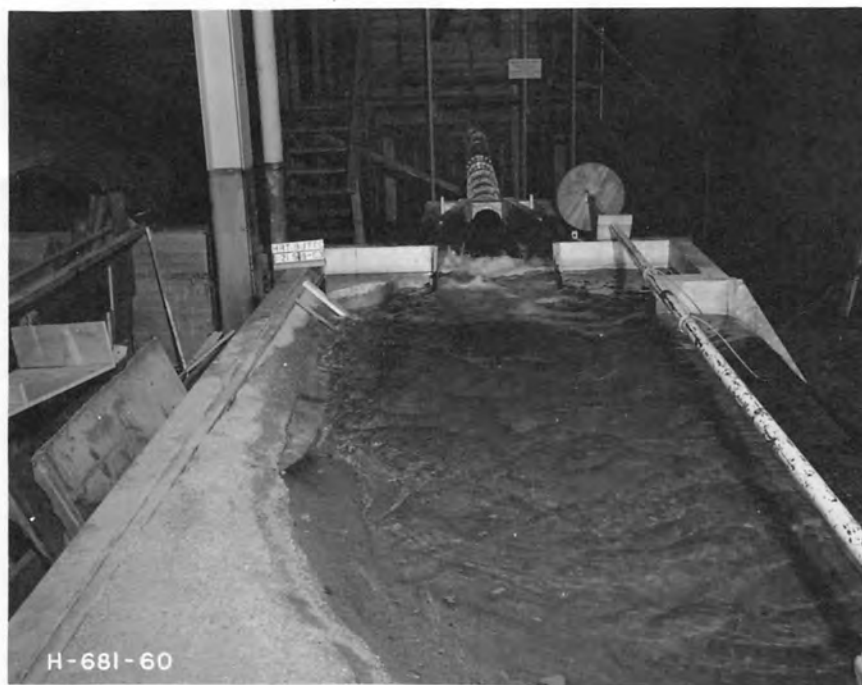
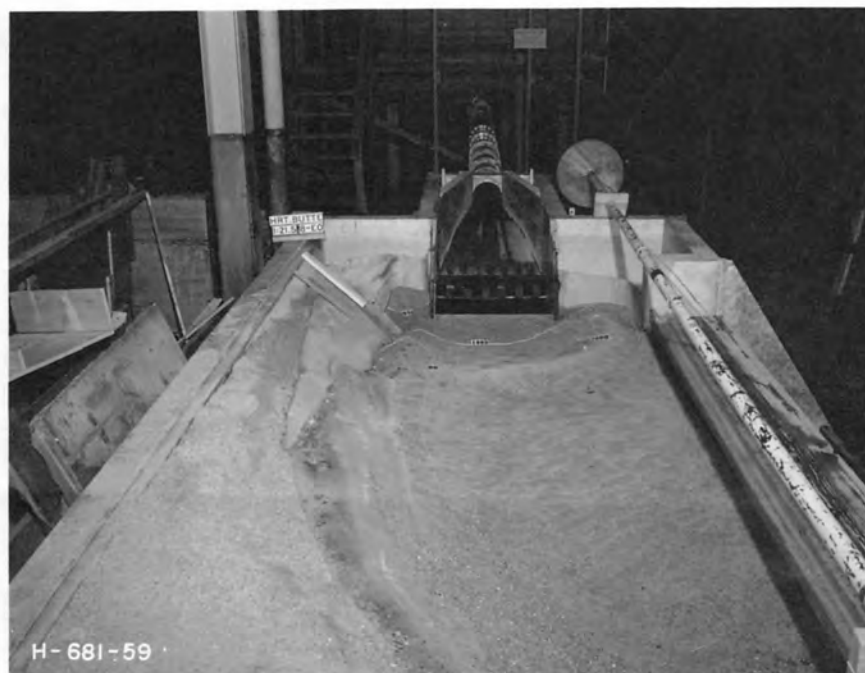
STILLING BASIN NO. 7  
1:21-1/2 MODEL HEART BUTTE DAM

A. Discharge 5,600 second-feet

B. Scour after 1/2 hour at 5,600 second-feet  
T.W. 2012

Stilling Basin 7. For Basin 7, an additional 15 feet was removed from the downstream end, leaving 65 feet of horizontal apron, Figure 41. Operation at the maximum discharge, Figure 44A, showed the water surface in the river channel to be rougher than occurred with Basins 5 or 6, and lowering the tail water 1-1/2 feet caused the jump to sweep out of the basin. Erosion after 1/2-hour operation at 5,600 second feet, Figure 44B, was greater than obtained with Basin 6, and more sand was washed off the right bank.

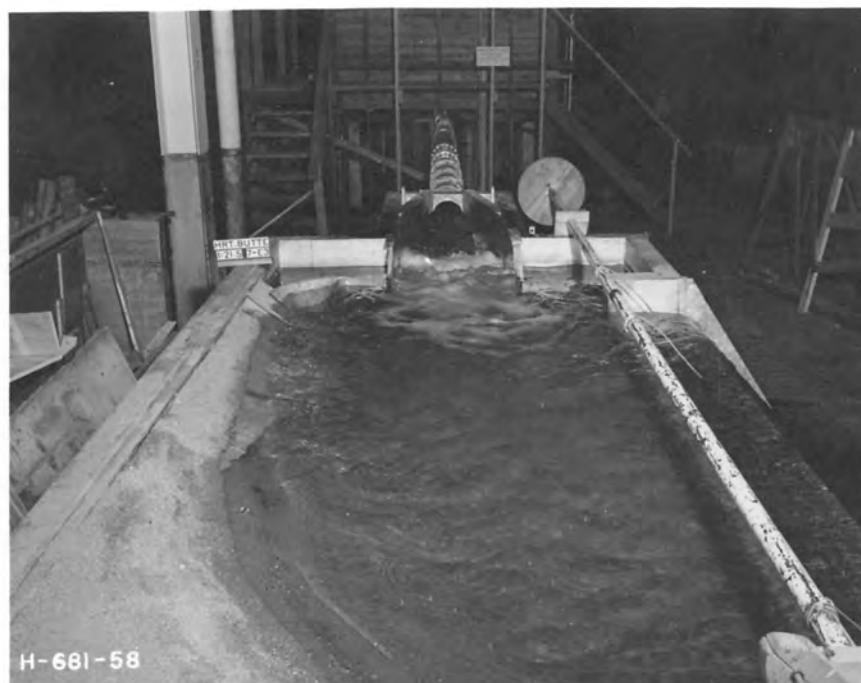
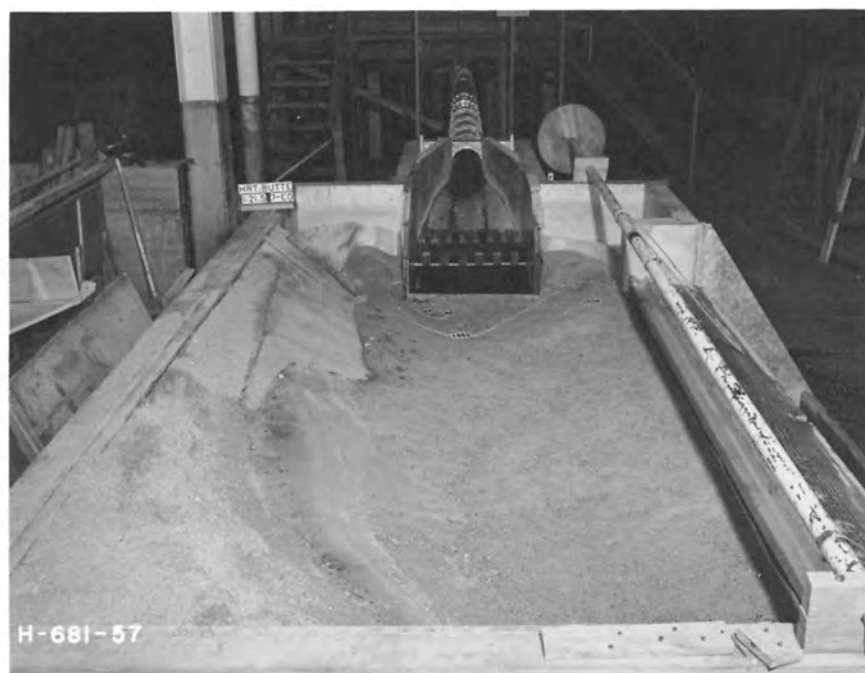
**STILLING BASIN NO. 7**  
**Without Spreader Walls**  
**1:21-1/2 MODEL HEART BUTTE DAM**

A. Discharge 5,600 second-feet

B. Scour after 1/2 hour at 5,600 second-feet  
T.W. 2012

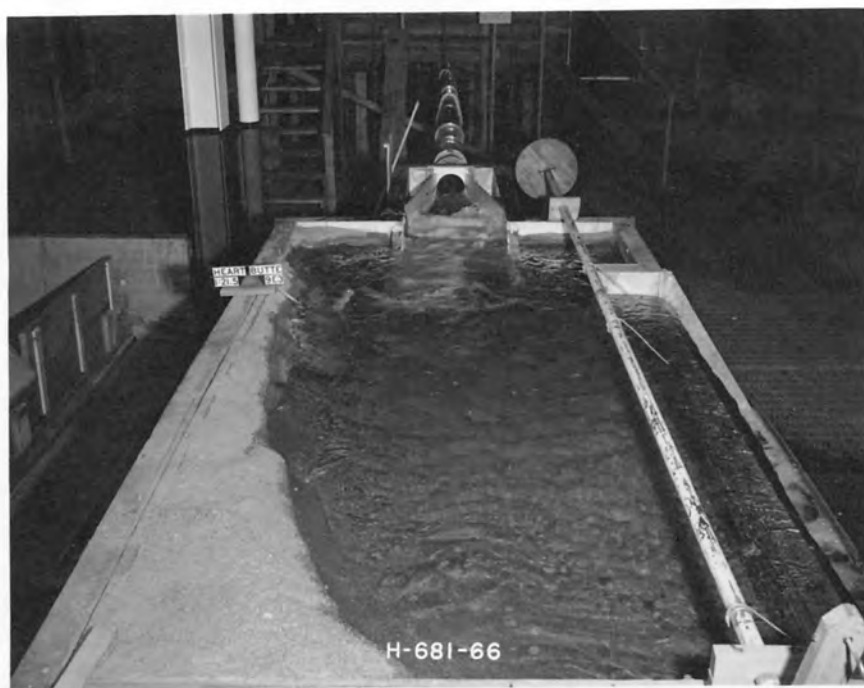
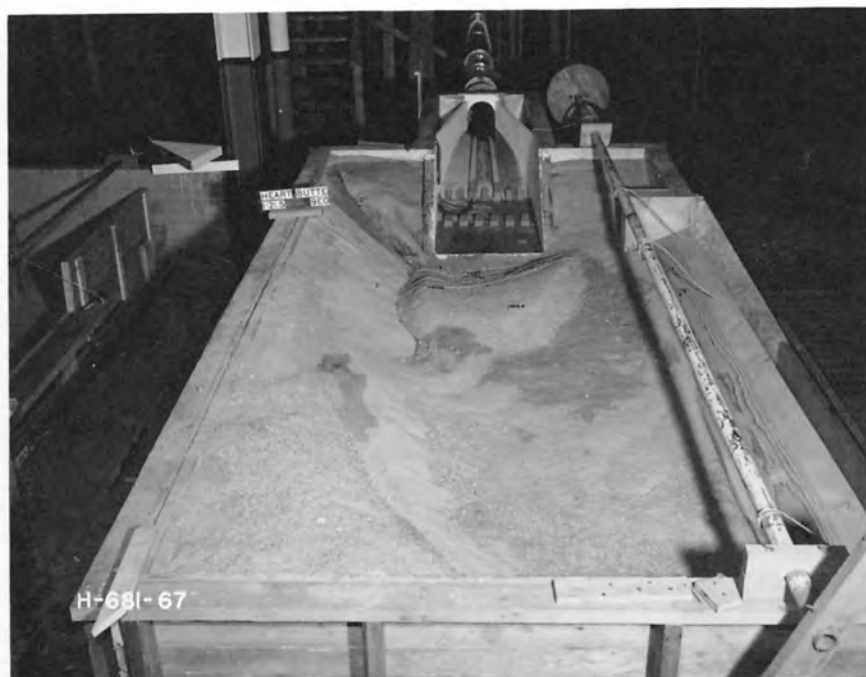
**STILLING BASIN NO. 8--RECOMMENDED  
1:21-1/2 MODEL HEART BUTTE DAM**

**A. Discharge 5,600 second-feet**

**B. Scour after 1/2 hour at 5,600 second-feet  
T.W. 2012**

At the maximum discharge of 5,600 second feet the tail water could be lowered 4 feet before the jump would sweep out of the stilling basin. These tests on Stilling Basin 8 indicated the basin was satisfactory, and it was recommended for construction.
