HYDRAULIC MODEL STUDIES OF THE SPILLWAY  
AND OUTLET WORKS--HEART BUTTE DAM  
MISSOURI RIVER BASIN PROJECT

Hydraulic Laboratory Report No. Hyd-326

January 16, 1952

Subject: Hydraulic model studies of the spillway and outlet works--Heart Butte Dam--Missouri River Basin Project

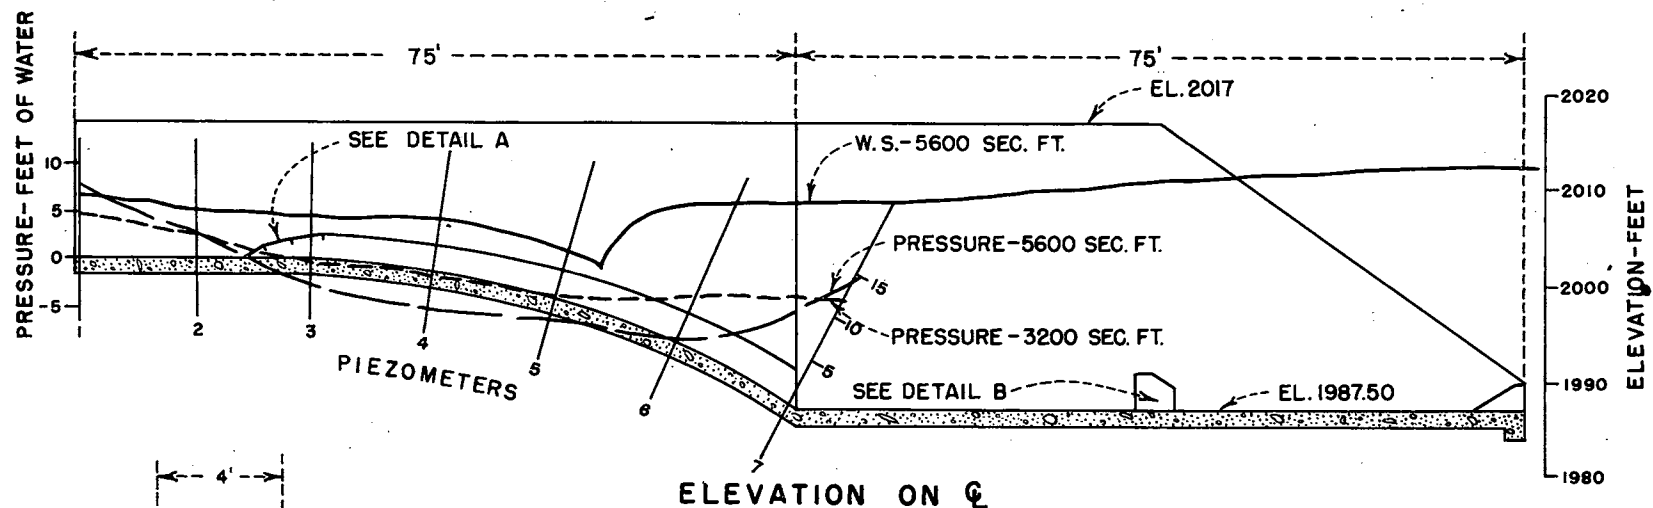
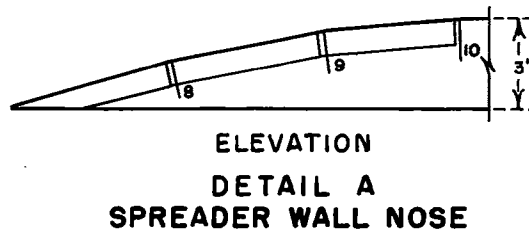
**PRESSURES**  
FEET OF WATER FROM ATMOSPHERIC

Two rows of piezometers were placed along the morning-glory entrance and shaft, Figure 12, and piezometers were also used for pressure studies on the stilling basin chute, spreader walls, and baffle piers, Figures 45 and 48.
