HIGH HEAD MODEL TESTS FOR THE FLATIRON
AND POLE HILL FRANCIS -TYPE TURBINES
AND TWO TURBINE BYPASS ENERGY ABSORBERS

Hydraulic Laboratory Report No. Hyd-348

March 12, 1956

Subject: High head model test for the Flatiron and Pole Hill
Francis-type turbines and two turbine bypass energy
absorbers--Colorado-Big Thompson Project, Colorado.

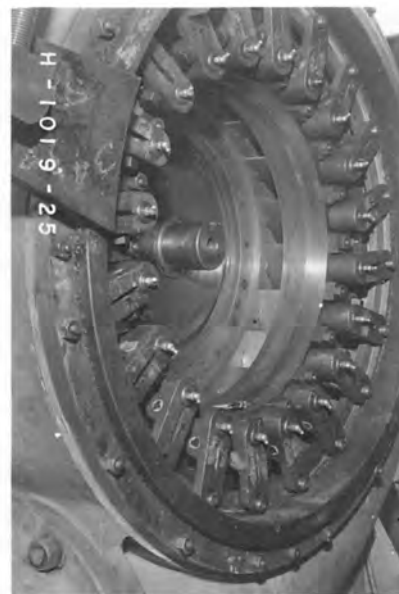
B. Wicket gate assembly, runner removed.

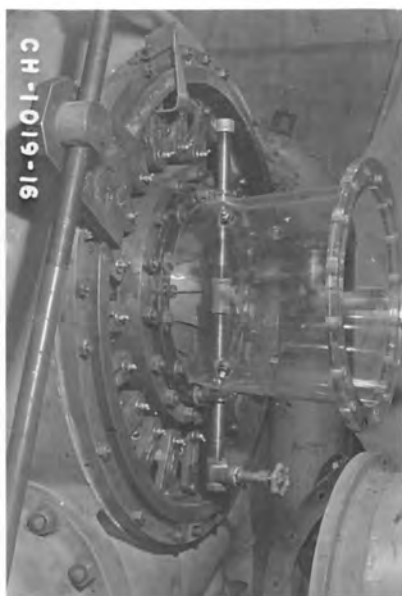
C. Wicket gate assembly with runner and spool to draft tube installed. This spool was replaced by a steel spool when the 1/2-inch thick plastic shattered. Pipe for admitting air into draft tube is shown.

Tests were made in which air was admitted into the turbine draft tube through the piping shown in Figure 17C. No noticeable effect was found on the turbine efficiency and the piping was removed. All the test data reported above were obtained without air admission into the draft tube and with the piping removed from the tube.

The 1/2-inch-thick transparent plastic spool used by the manufacturer in the low head test to connect the turbine outlet to the draft tube was used for the preliminary tests at Estes Powerplant (Figure 17C). The section ruptured after only a few minutes of testing, and tests were discontinued until the metal spool that had been shipped by the manufacturer arrived at Estes Park. Upon receiving the spool, it was found that no holes had been drilled in the spool flanges, and it was therefore necessary to lay out and drill bolt holes at the proper radius and spacings to match the turbine case and the draft tube inlet.

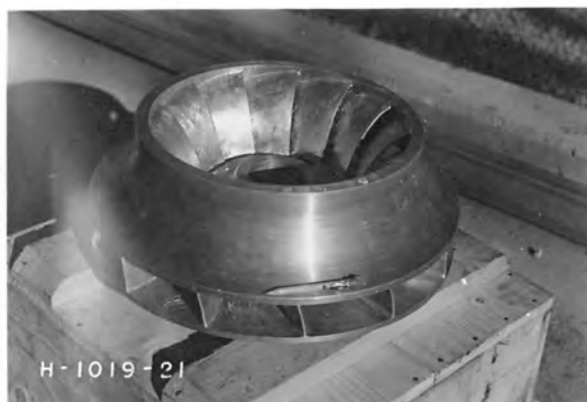
D. SF-1 turbine runner

Two turbine runners, designated SF-1 and SF-4, were tested at Estes Park. The SF-1 runner was used in low head tests conducted at the manufacturer's plant, and only a few tests were made with it at Estes Park for the purpose of correlating the high head data with the low head data. Good correlation was obtained and the runner was removed from the test rig and the SF-4 runner was installed.

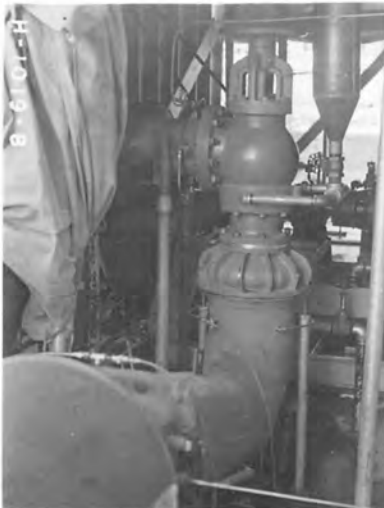
**A. Pelton energy absorber
installed for testing.**

6. The Pelton energy absorber (pressure regulator) vibrated and made a great deal of noise when it was operated (Figures 20, 21, and 22). The admission of air, as is required by the manufacturer, quiets the conditions appreciably, but at the larger valve openings the air inlet system seemed to be inadequate (Figure 23).

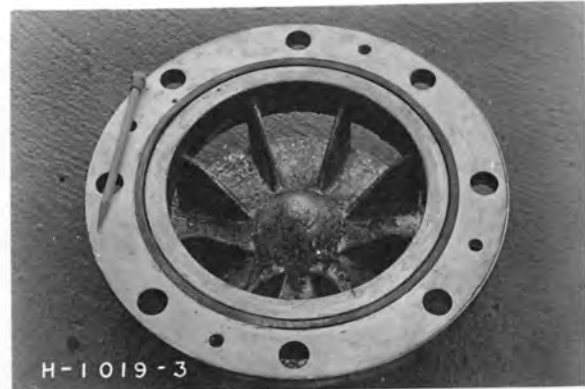
B. Flow spreader looking downstream.

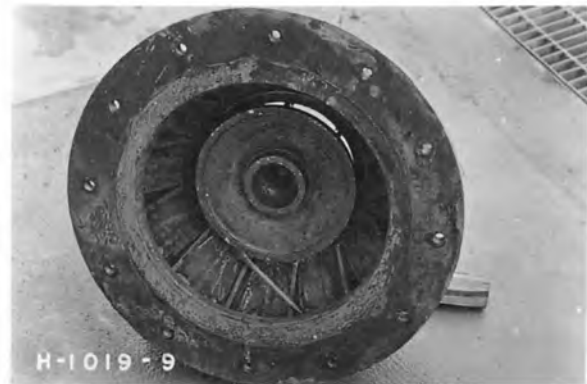
**C. Bowl and flow spreader
looking upstream.**

After the absorber had been operated about 2 hours under various valve openings, with and without air, it was removed and disassembled for inspection. Much of the paint and some scale had been removed from the baffle and bowl and at the discharge tube entrance, but there was no evidence of cavitation damage to the metal (Figure 22). A much longer test would be required to show cavitation damage, if any damage were to occur.

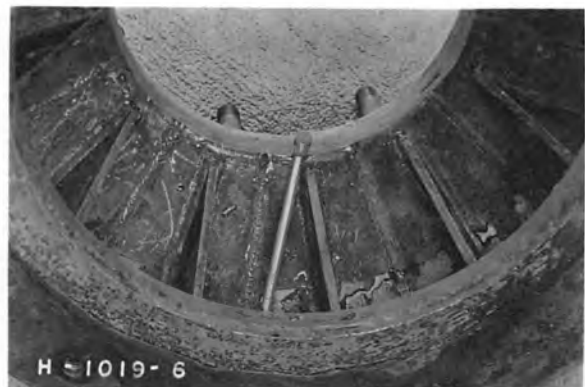
D. Bowl looking upstream.

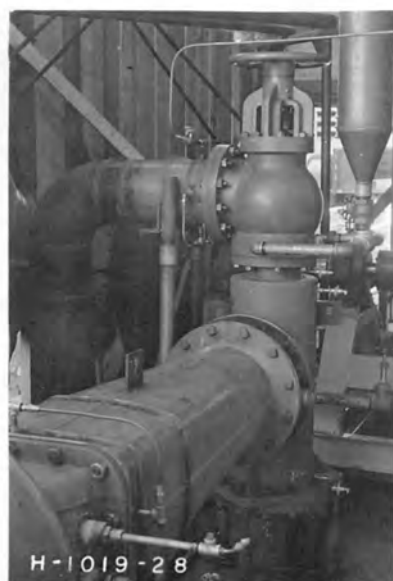
A. Three-stage energy absorber installed for testing.

9. The three-stage energy absorber vibrated very severely and made much more noise than the Pelton absorber (Figures 24 and 25). Air was admitted just below the relief valve (Stage 1) in the tests with small valve openings; but due to the presence of higher pressures in this region at large valve openings, the air inlet was sealed off. Air admission below Stage 3 under all operating conditions quieted the vibration and noise to some extent.

In general, the 3-stage absorber was noisier and vibrated with greater intensity than the Pelton absorber. When air was admitted at the third stage, there seemed to be a small decrease in the violence of these conditions, but there was little or no dissipation of energy within the third stage of the absorber.

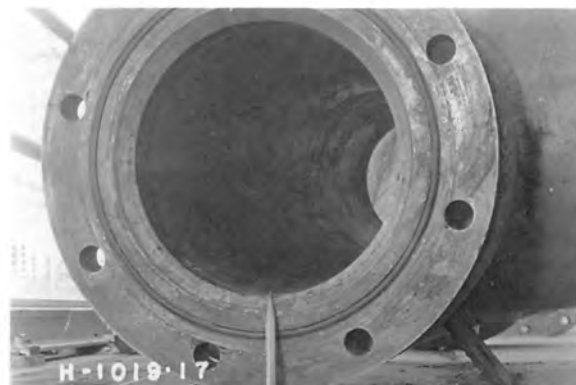
B. Inlet of absorber looking downstream.

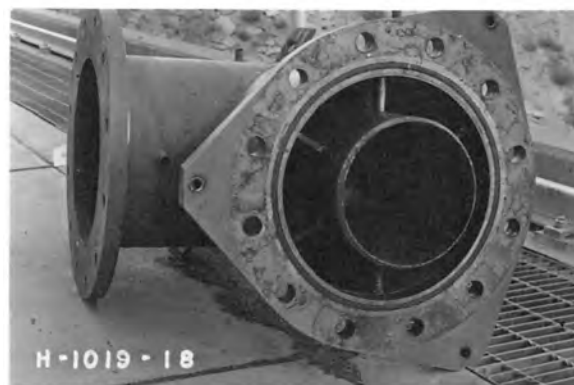
C. Stage 2 of absorber with bottom cover removed.

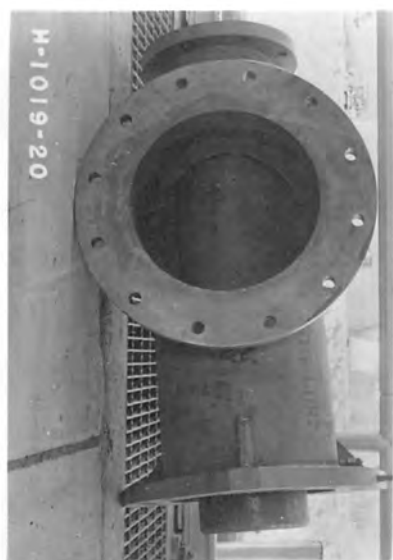
E. Outlet of main absorber at point where orifice for stage 3 is attached. Stage 2 is at bottom of photo.

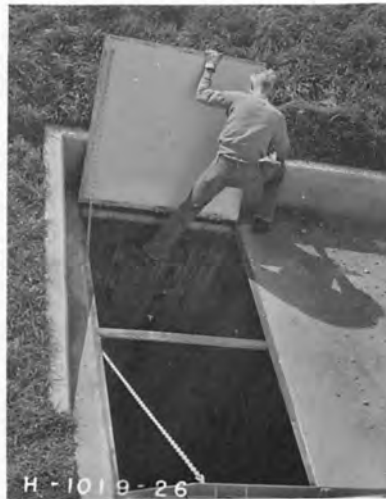
A. Unhandy entrance to valve pit.

Entry into the valve pit was difficult and hazardous because of inadequate handholds and the fact that the open cover had to be grasped in order to reach the ladder rungs (Figure 29A). This difficulty has largely been eliminated by the addition of more handholds.

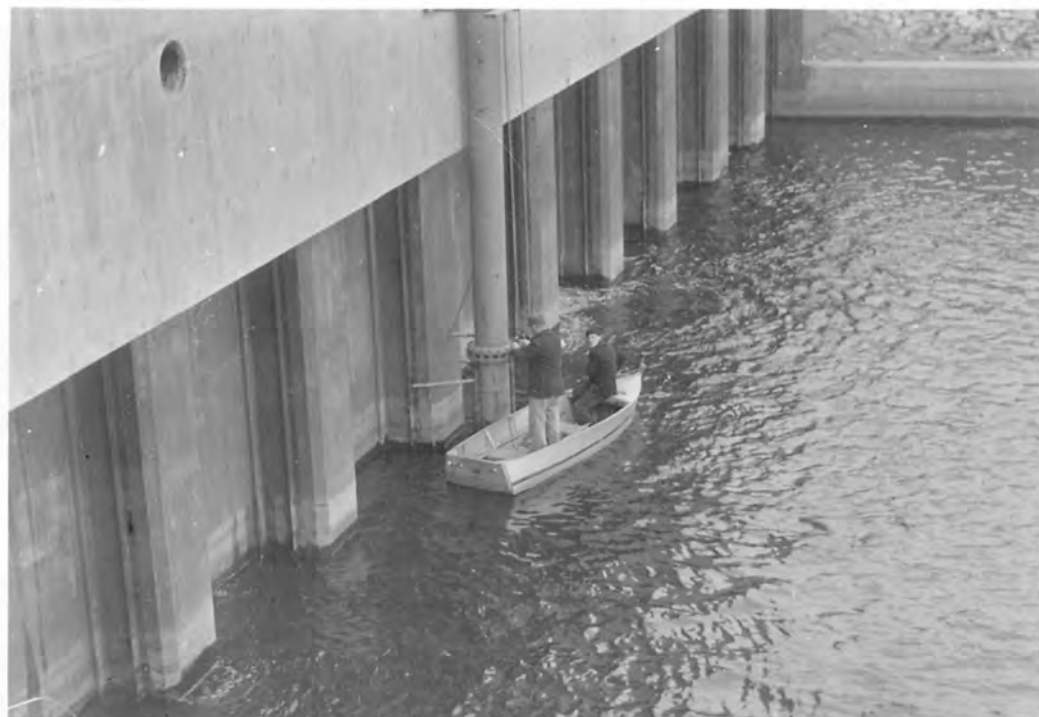
B. Repairing butterfly valve from rowboat.

The 16-inch butterfly valve located in the discharge line a few feet above the tailrace caused more trouble and delay in the test program than any other item. The loads that were imposed upon this valve were greatly underestimated, and, as a result, a relatively lightweight valve was installed. Almost every conceivable type of failure occurred on the valve. After the shaft broke, it was replaced with a new shaft of higher quality steel. When the cast iron valve leaf broke a new leaf was made of 1/2-inch boiler plate and a much heavier shaft was installed. This was followed by repeated shearing of the pin which held the worm gear to the shaft. When heavier pins were installed, the teeth of the cast iron worm gear failed. This gear was replaced with a steel one which lasted just long enough so that the tests could be completed. Each time repairs were required, it was necessary to row a boat into the tailrace, remove the valve while working from this boat, and row back down to the dock (Figure 29B). The valve was then transported to the machine shop of the powerplant, where repairs were made. To reinstall the valve, it was necessary to repeat the boat trip. This consumed a great deal of time and entailed considerable risk to the men working from the boat in the powerplant tailrace.
