HYD 401

FIELD AND LABORATORY TESTS TO DEVELOP
THE DESIGN OF A FISH SCREEN STRUCTURE
DELTA-MENDOTA CANAL HEADWORKS
CENTRAL VALLEY PROJECT, CALIFORNIA

Hydraulic Laboratory Report No. Hyd-401

March 21, 1955

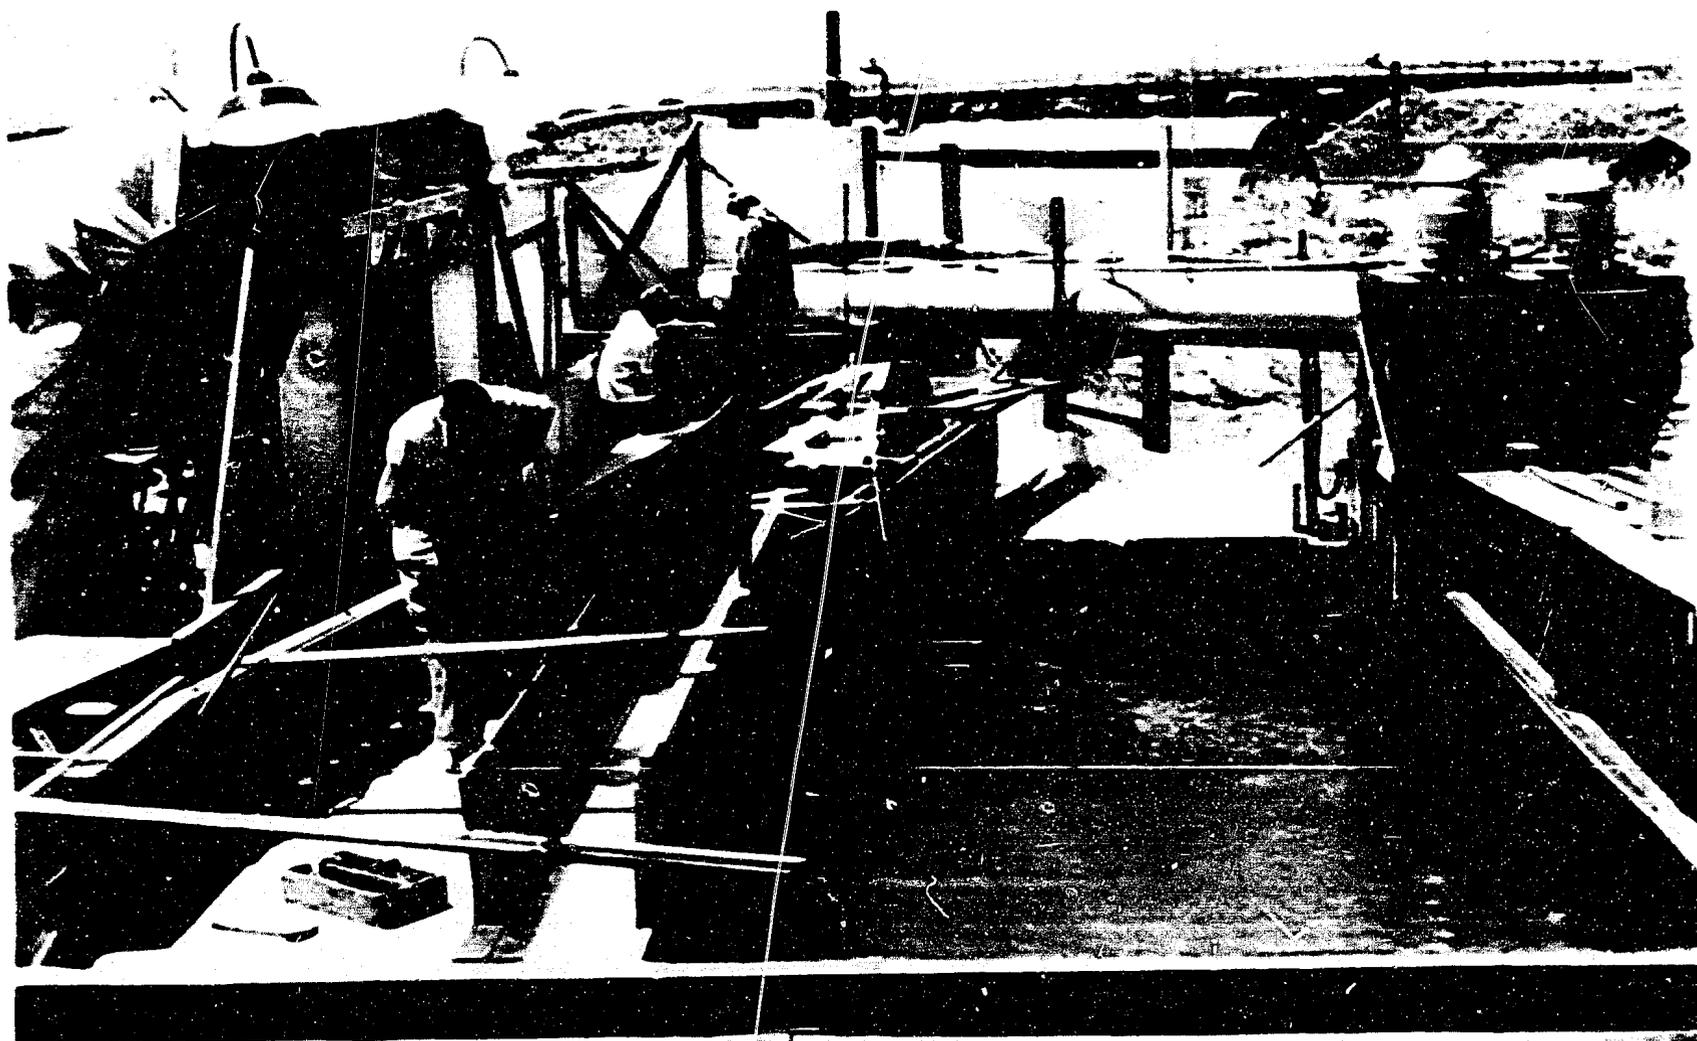
Old Test Flume. Delta-Mendota Canal Headworks.

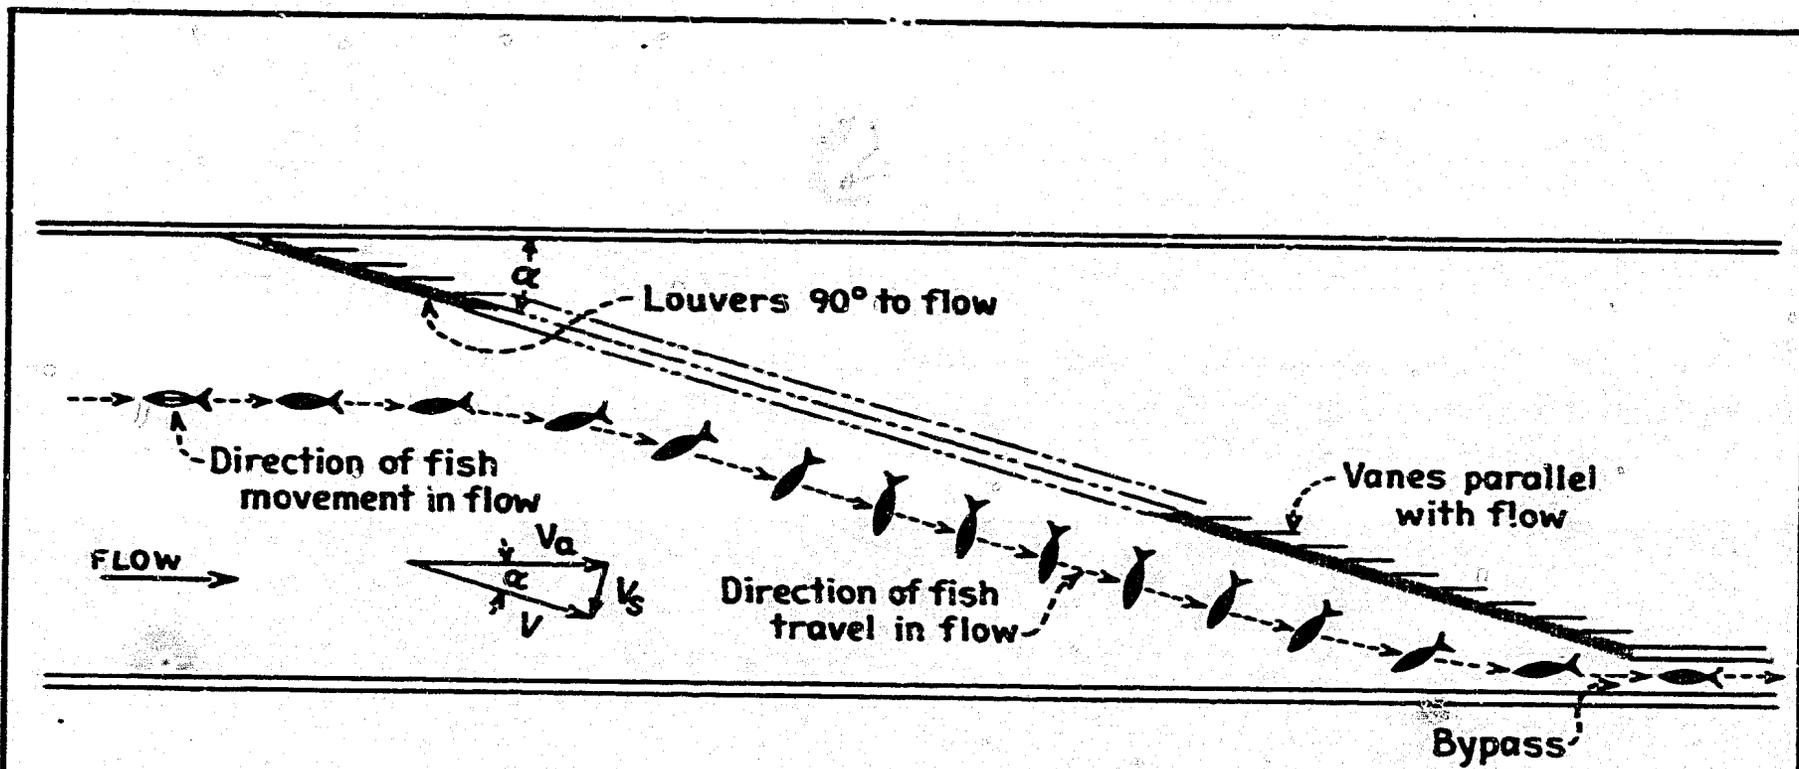
FIGURE 13
 REPORT HYD. 401

DELTA-MENDOTA CANAL HEADWORKS
 CENTRAL VALLEY PROJECT
 PILOT FISH SCREEN STRUCTURE - 1954
 REACTION OF FISH TO LINE OF LOUVERS

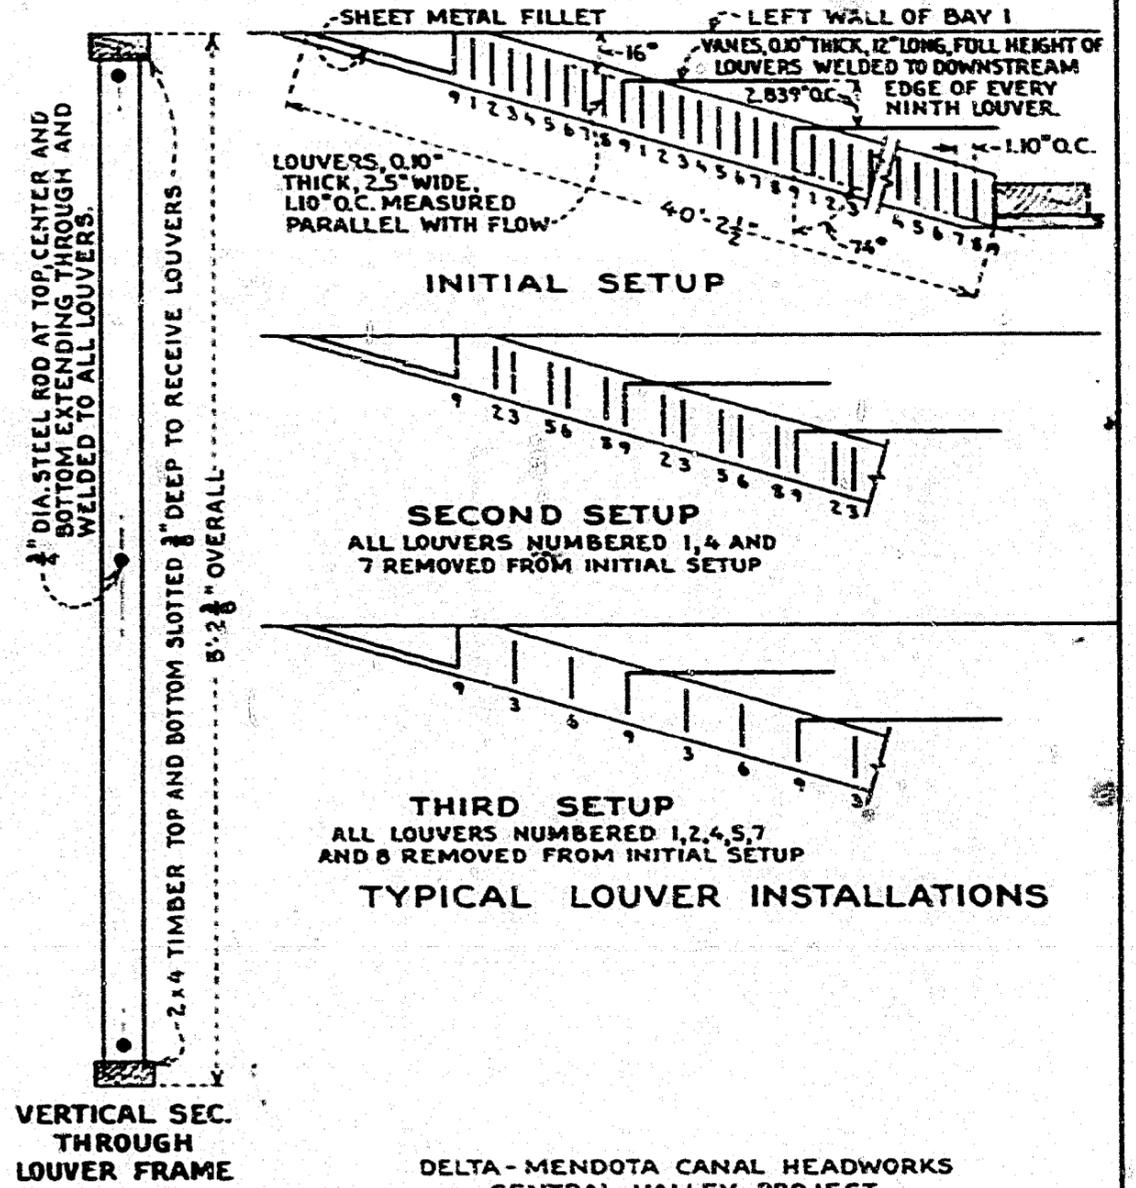
DELTA - MENDOTA CANAL HEADWORKS
CENTRAL VALLEY PROJECT
PILOT FISH SCREEN STRUCTURE
BAY-1 LOUVER TEST LAYOUT - 1954

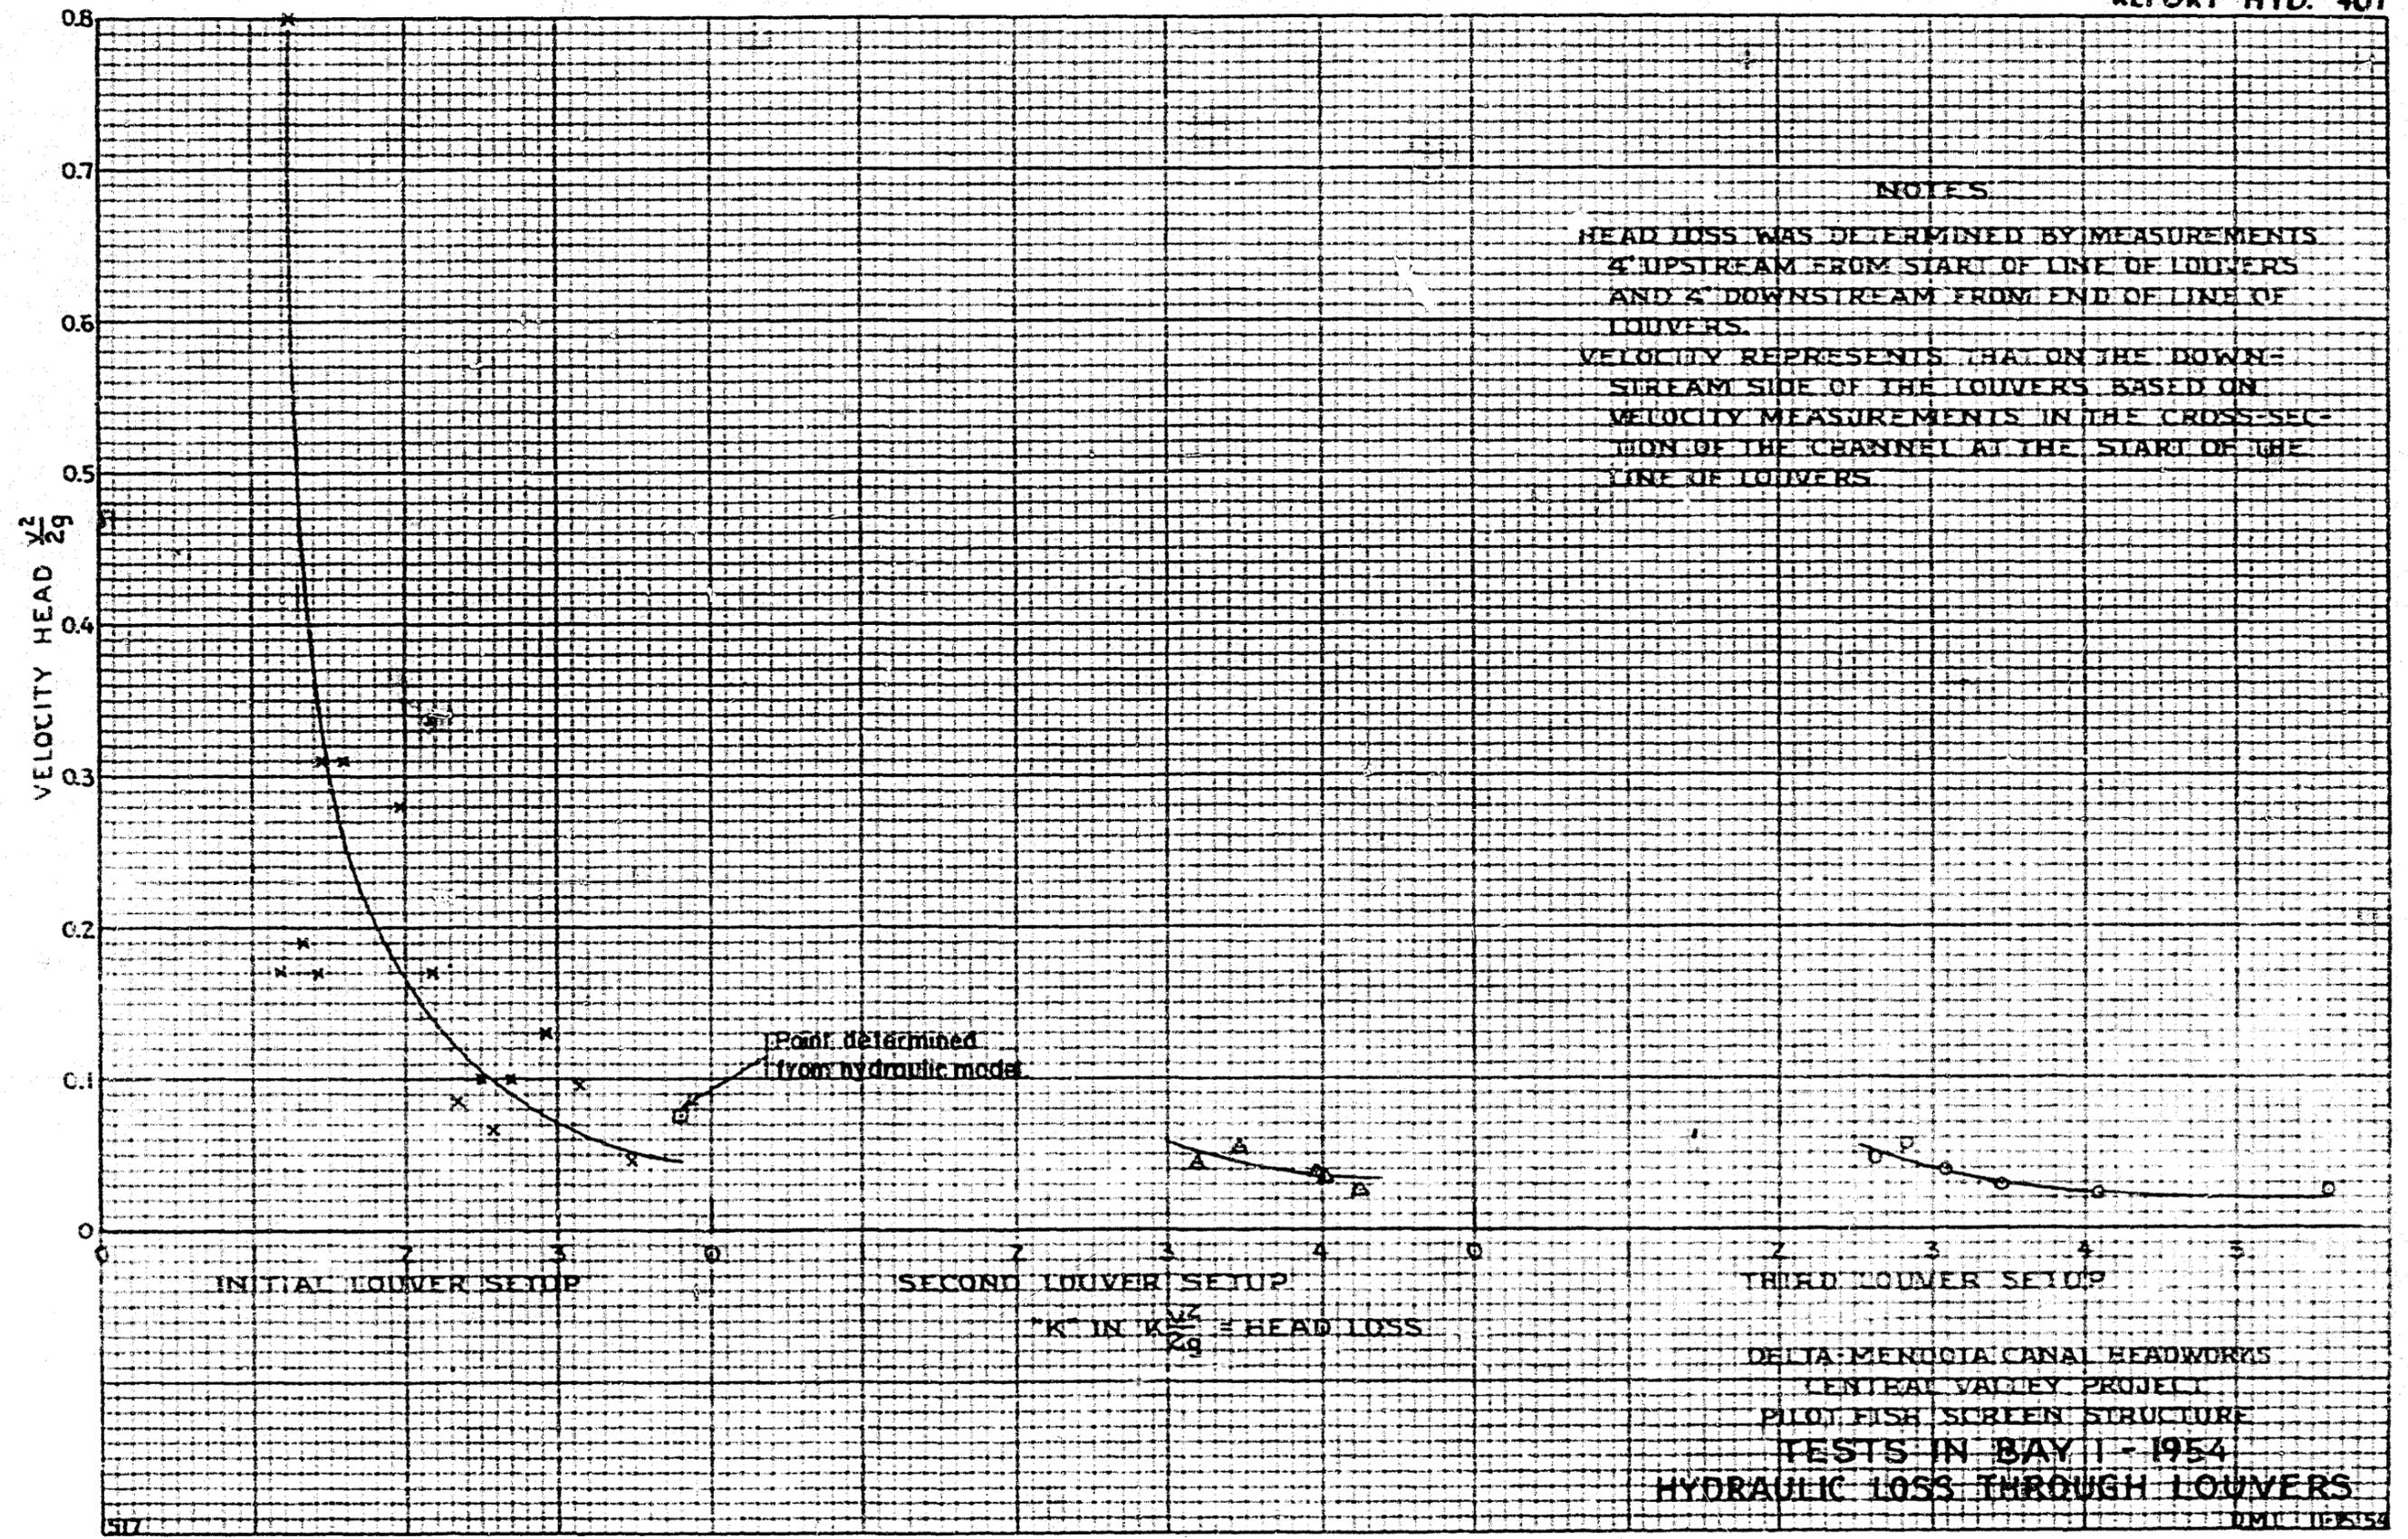
FIGURE 16
REPORT HYD. 401

HEAD LOSS WAS DETERMINED BY MEASUREMENTS 4' UPSTREAM FROM START OF LINE OF LOUVERS AND 3' DOWNSTREAM FROM END OF LINE OF LOUVERS.
VELOCITY REPRESENTS THAT ON THE DOWNSTREAM SIDE OF THE LOUVERS BASED ON VELOCITY MEASUREMENTS IN THE CROSS-SECTION OF THE CHANNEL AT THE START OF THE LINE OF LOUVERS.

DELTA-MENOCIA CANAL HEADWORKS
CENTRAL VALLEY PROJECT
PILOT FISH SCREEN STRUCTURE
TESTS IN BAY 1 - 1954
HYDRAULIC LOSS THROUGH LOUVERS

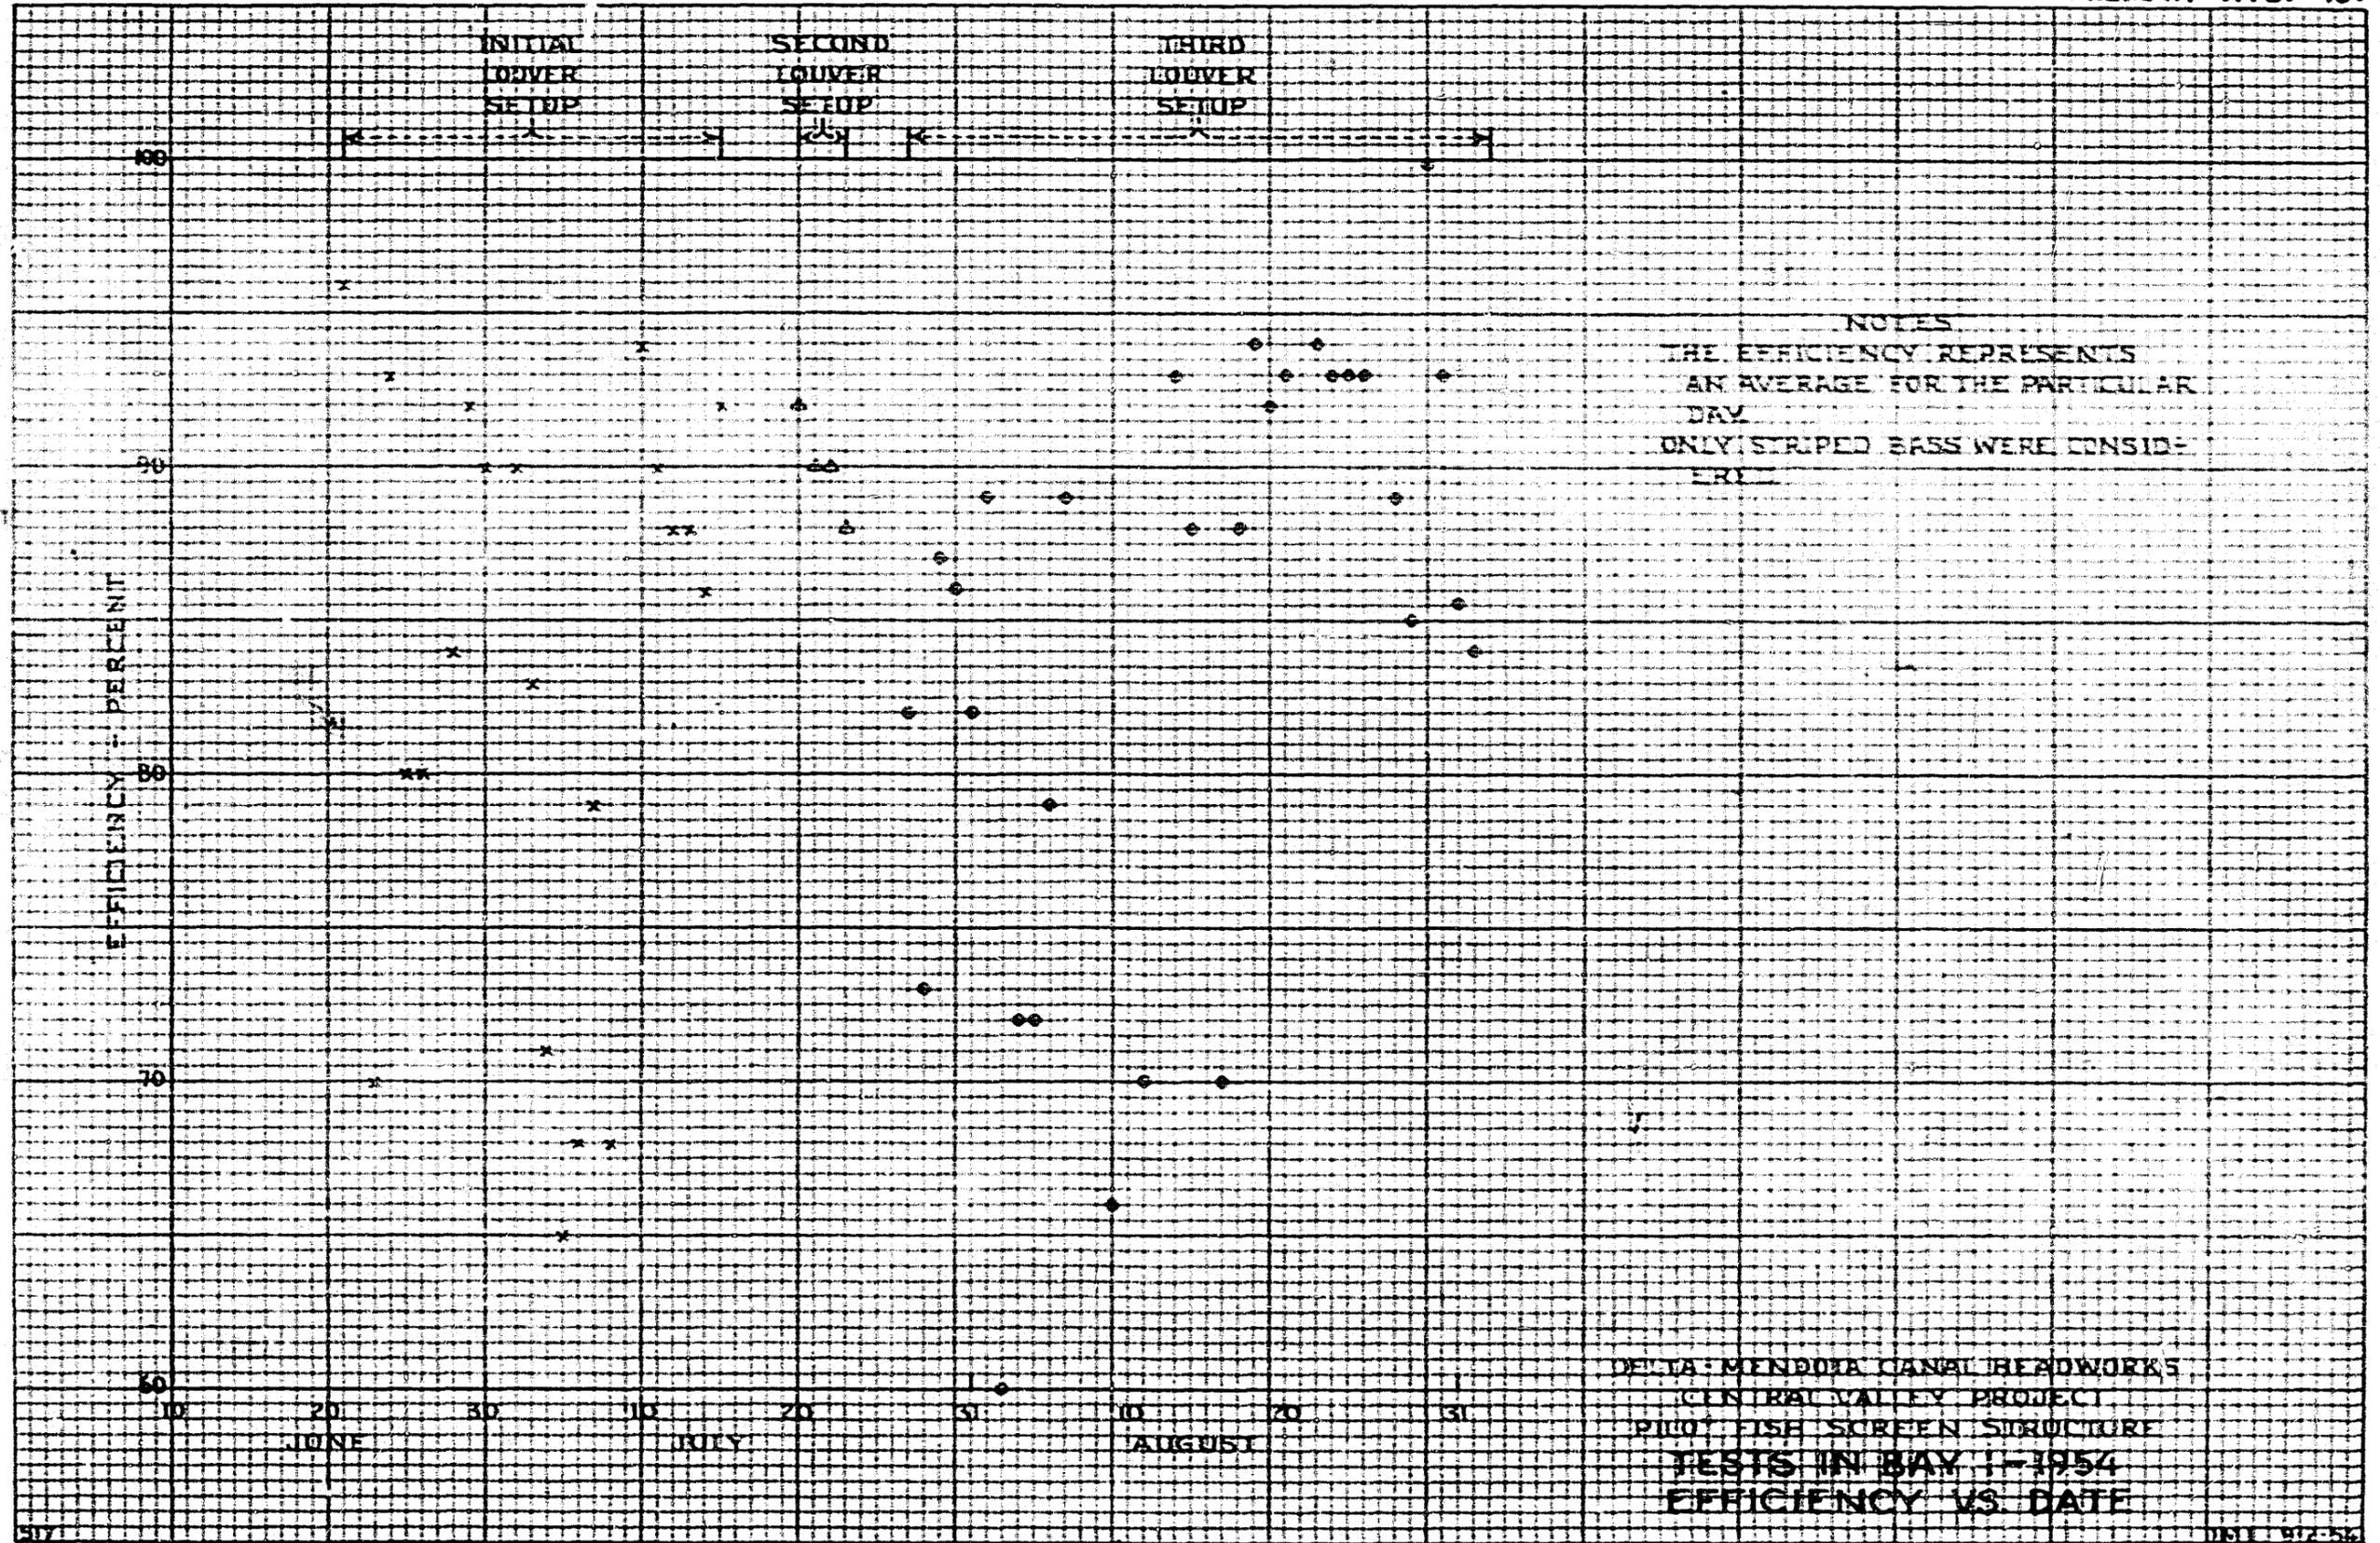
NOTES
THE EFFICIENCY REPRESENTS
AN AVERAGE FOR THE PARTICULAR
DAY
ONLY STRIPED BASS WERE CONSID-
ERED

DELTA-MENDOTA CANAL HEADWORKS
CENTRAL VALLEY PROJECT
PILOT FISH SCREEN STRUCTURE
TESTS IN BAY 1-1954
EFFICIENCY VS. DATE

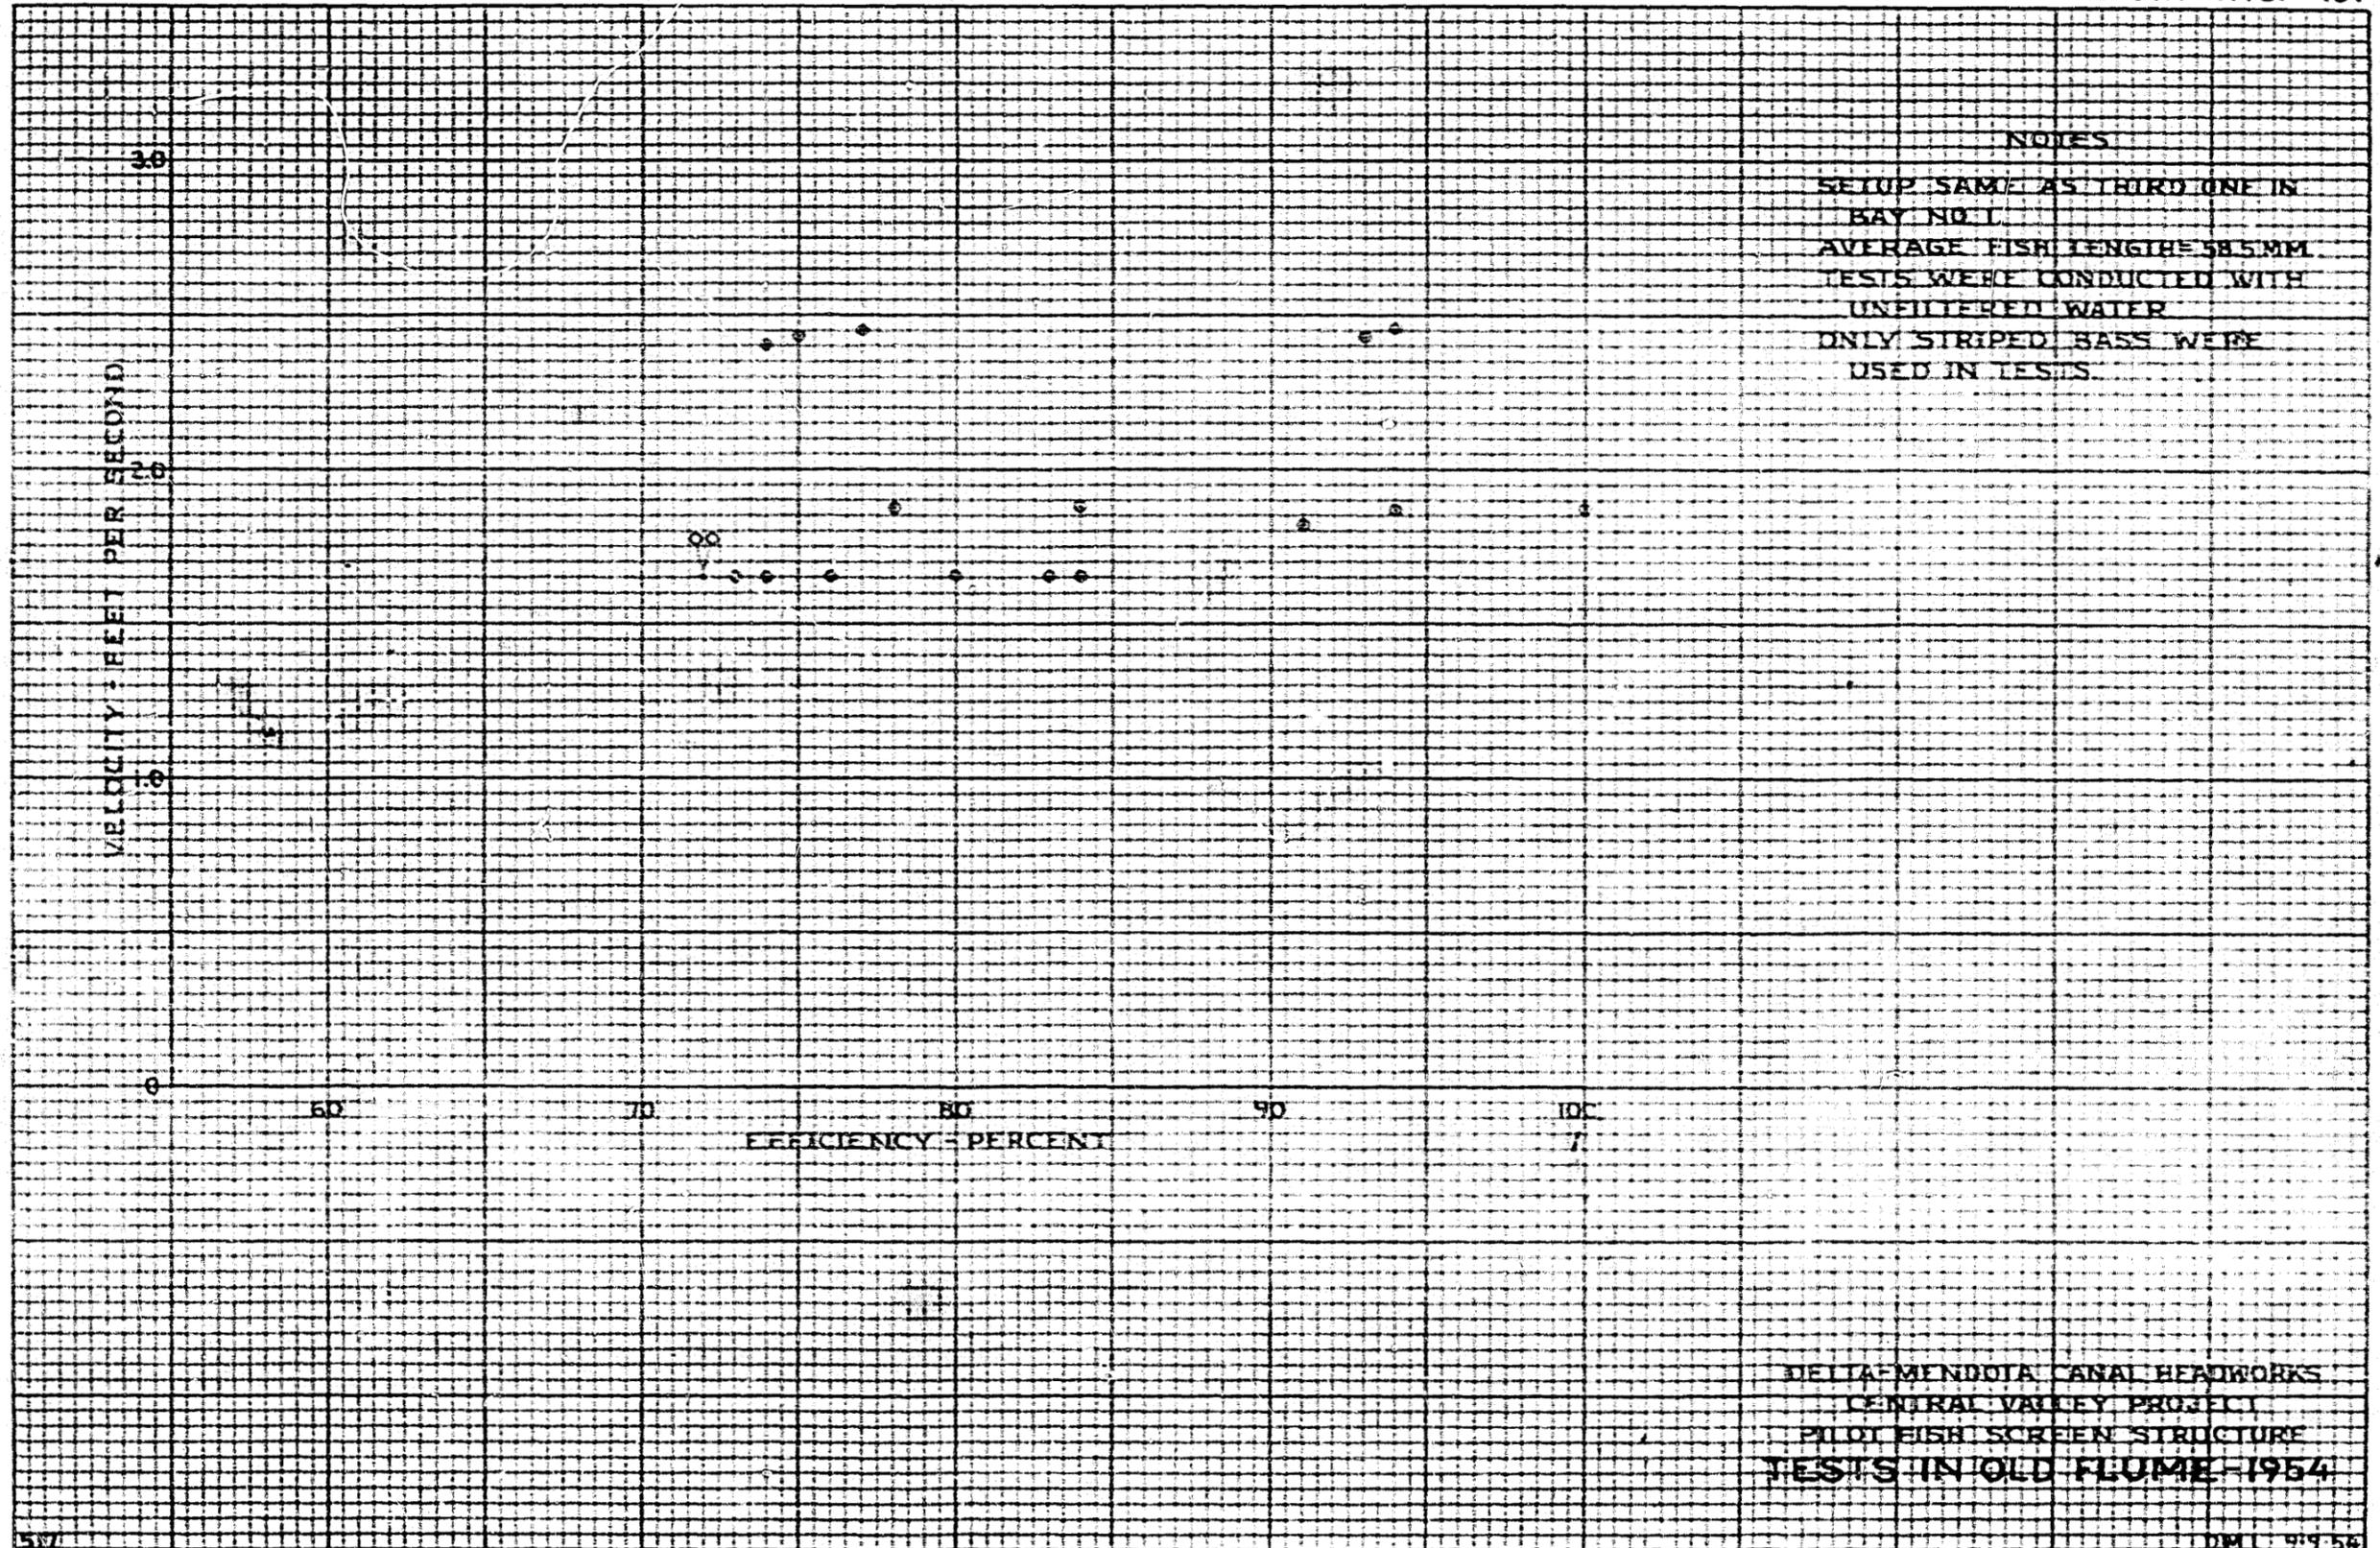
FIGURE 22
REPORT HYD. 401

SETUP SAME AS THIRD ONE IN BAY NO. 1
 AVERAGE FISH LENGTH = 58.5 MM
 TESTS WERE CONDUCTED WITH UNFILTERED WATER
 ONLY STRIPED BASS WERE USED IN TESTS

DELTA-MENDOTA CANAL HEADWORKS
 CENTRAL VALLEY PROJECT
 PILOT FISH SCREEN STRUCTURE
 TESTS IN OLD FLUME - 1954

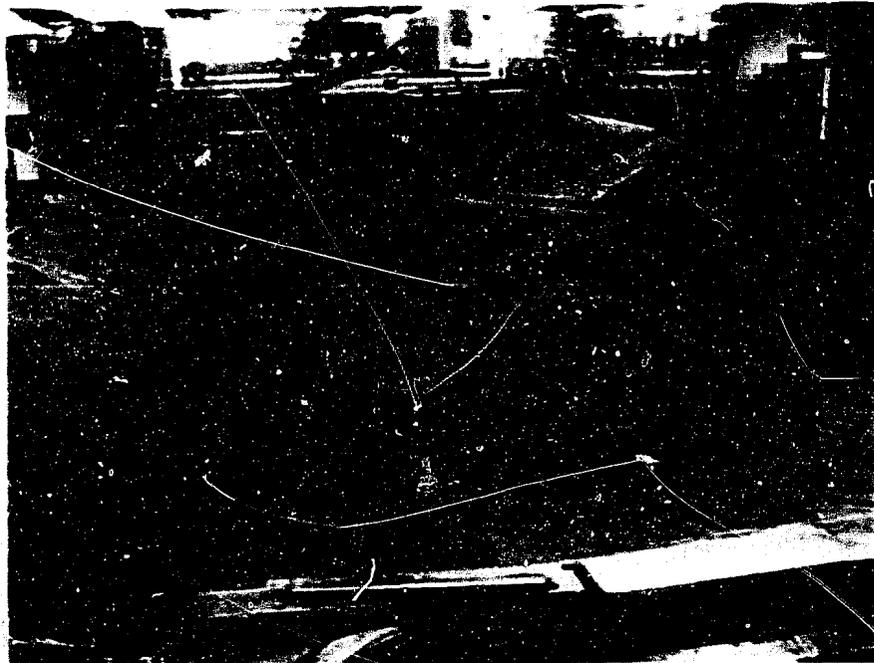
A - CHANNEL REVISION NO. 1.
White Cord Shows Outline of Existing
Channel.

Test No. 2. The first channel revision followed recommendations made by the project office. Figures 34B and 36A show the outline of this revision; the upstream section of the channel was widened about 60 feet by excavating along the left bank. The right bank of the downstream section was moved back so as to eliminate all of the projecting curve and thus permit nearly a straight approach to the main canal.

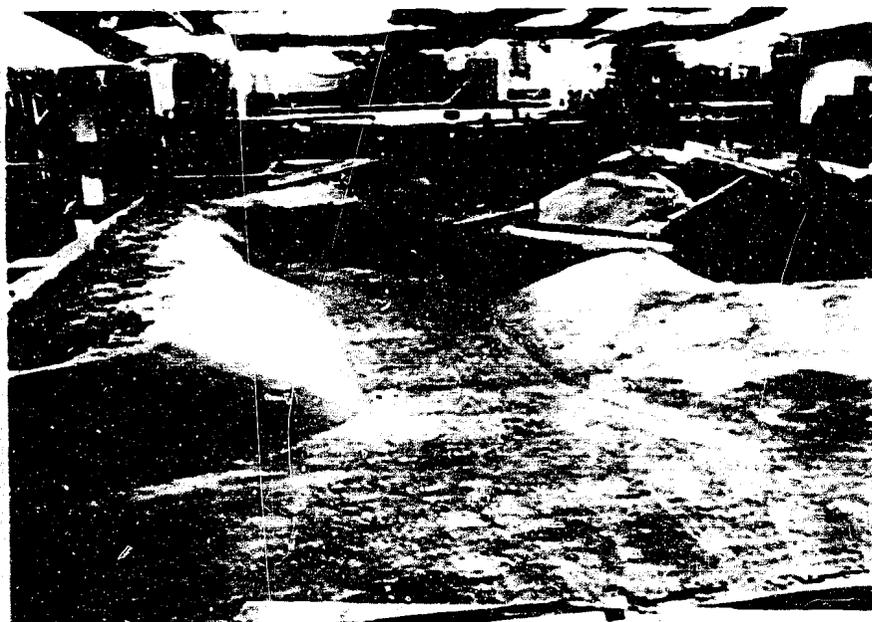
B - CHANNEL REVISION NO. 2.

Test No. 3. The smooth flow conditions and lack of bank erosion indicated that it might be possible to make the channel narrower and thereby considerably reduce the amount of excavation necessary in the large channel. Accordingly, the upstream channel width was reduced from 92 to 62 feet. The downstream section was re-formed so as to form a channel about halfway between the original channel and the one tested in Test No. 2. Figures 36B and 38A show the channel investigated in Test No. 3.

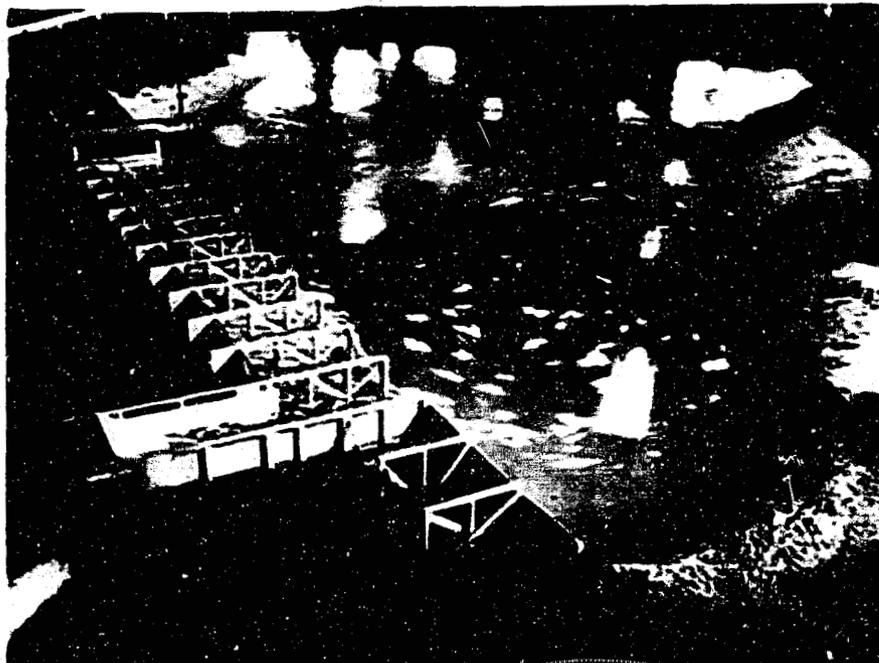
A - Flow Appearance Upstream from Fish Screen
Structure - Channel Modification No. 1.
Discharge - 4,600 cfs at Mean Tide.

condition it would provide a more severe test. The eddy in front of the sloping screen bay was not as severe as in the previous test and would probably disappear if there were flow through the sloping screen bay, Figure 37A. In the downstream section the only sign of an adverse flow condition was the slight eddy along the left bank; this also was probably due to the lack of flow through the sloping screen bay and in any case was not damaging to the channel banks.

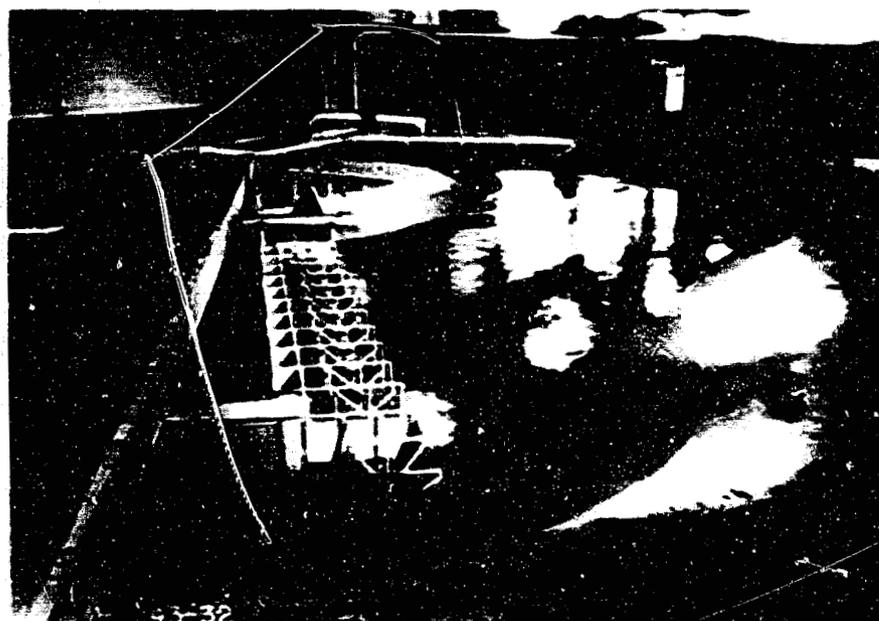
B - Flow Appearance Upstream From Fish Screen
Structure for Channel Modification No. 2.
Discharge = 4,600 cfs at Low Tide.

This test was also made at 6-pump operation; however, the upstream water surface elevation was lowered to correspond to low tide since the resulting increased velocity would tend to cause more severe erosion. Figure 37B shows the flow appearance for this channel alinement. In the upstream section the flow near the structure was very smooth; a slight eddy in front of the sloping screen bay was still noticeable but did no harm. The flow in the downstream section was very smooth through most of the channel; however, there was a slight water surface roughness along the right bank that indicated the bank protruded too far into the channel. The extent of the erosion showed that the channel was adequately wide but that the approach curve along the right bank would benefit by being streamlined.

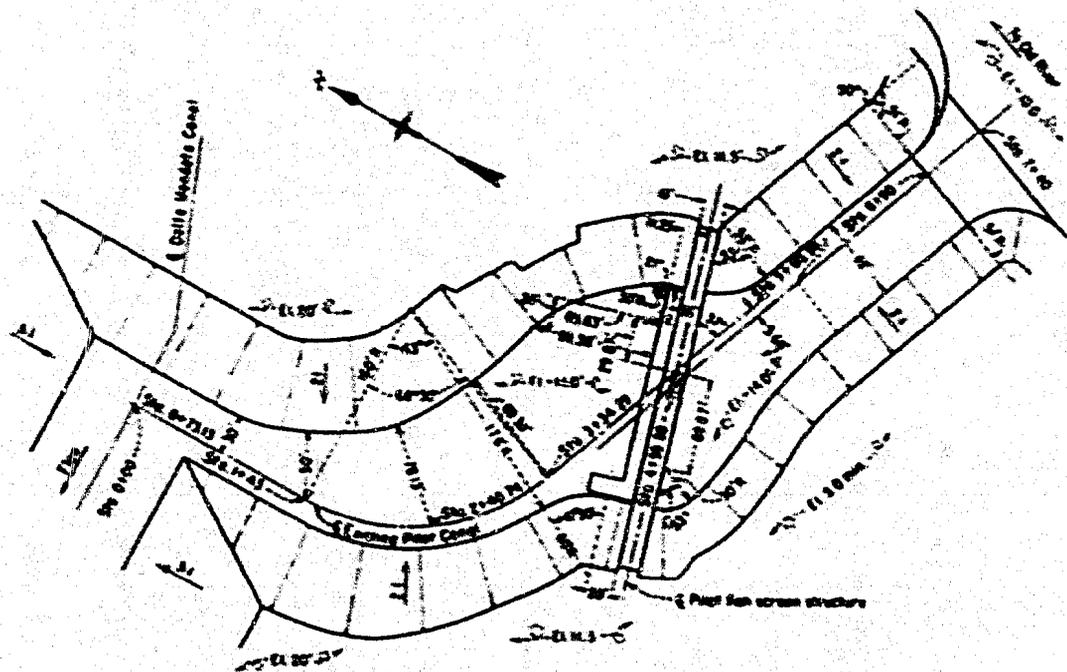
A. CHANNEL MODIFICATION No. 2

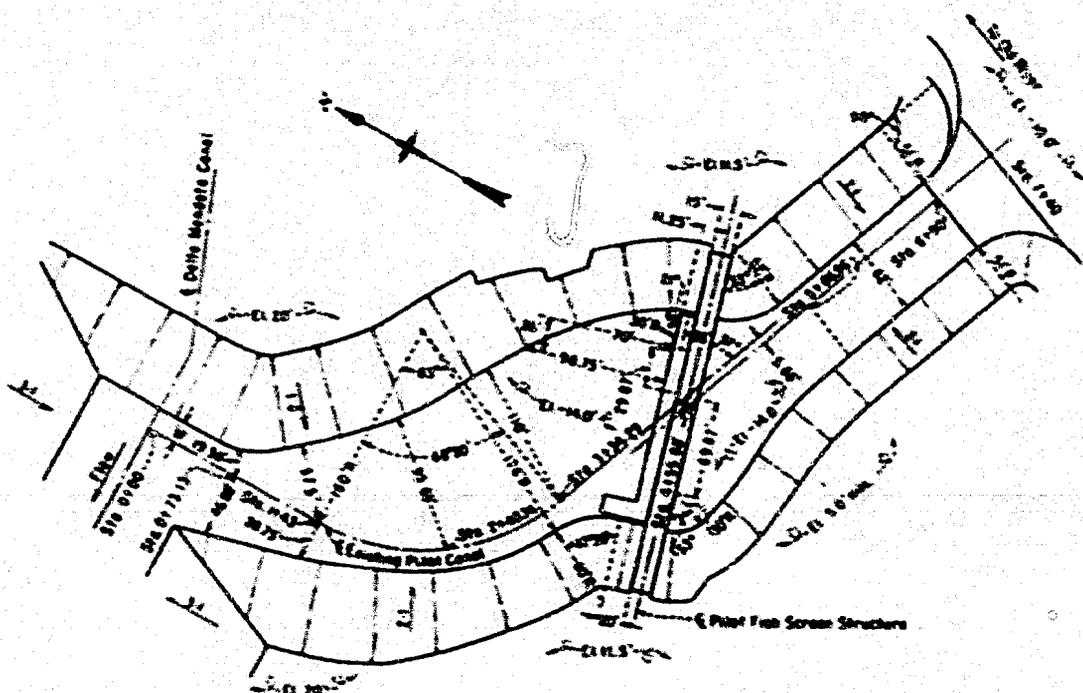
B. CHANNEL MODIFICATION No. 3, RECOMMENDED

Test No. 4--Recommended channel. From the above three tests the recommended channel alinement was derived, Figure 38B. For the recommended channel the upstream section remained 62 feet in width and the right side approach was not further streamlined. The downstream section was widened so that it was a compromise between the channels of Test No. 2 and Test No. 3. The changes in the downstream section also included a modification of the downstream end of the left bank. It had been noticed in the previous tests that the left bank had a tendency to erode in this vicinity. Although in each individual test the amount of erosion was slight, collectively after several tests it had accumulated to a significant amount that indicated the bank should be moved back about 10 feet at the junction with the main canal. From the appearance of the flow and the condition of the channel banks after 4 hours operation the channel alinement was judged to be satisfactory for the prototype installation.
