HYD 401

FIELD AND LABORATORY TESTS TO DEVELOP
THE DESIGN OF A FISH SCREEN STRUCTURE
DELTA-MENDOTA CANAL HEADWORKS
CENTRAL VALLEY PROJECT, CALIFORNIA

Hydraulic Laboratory Report No. Hyd-401

March 21, 1955

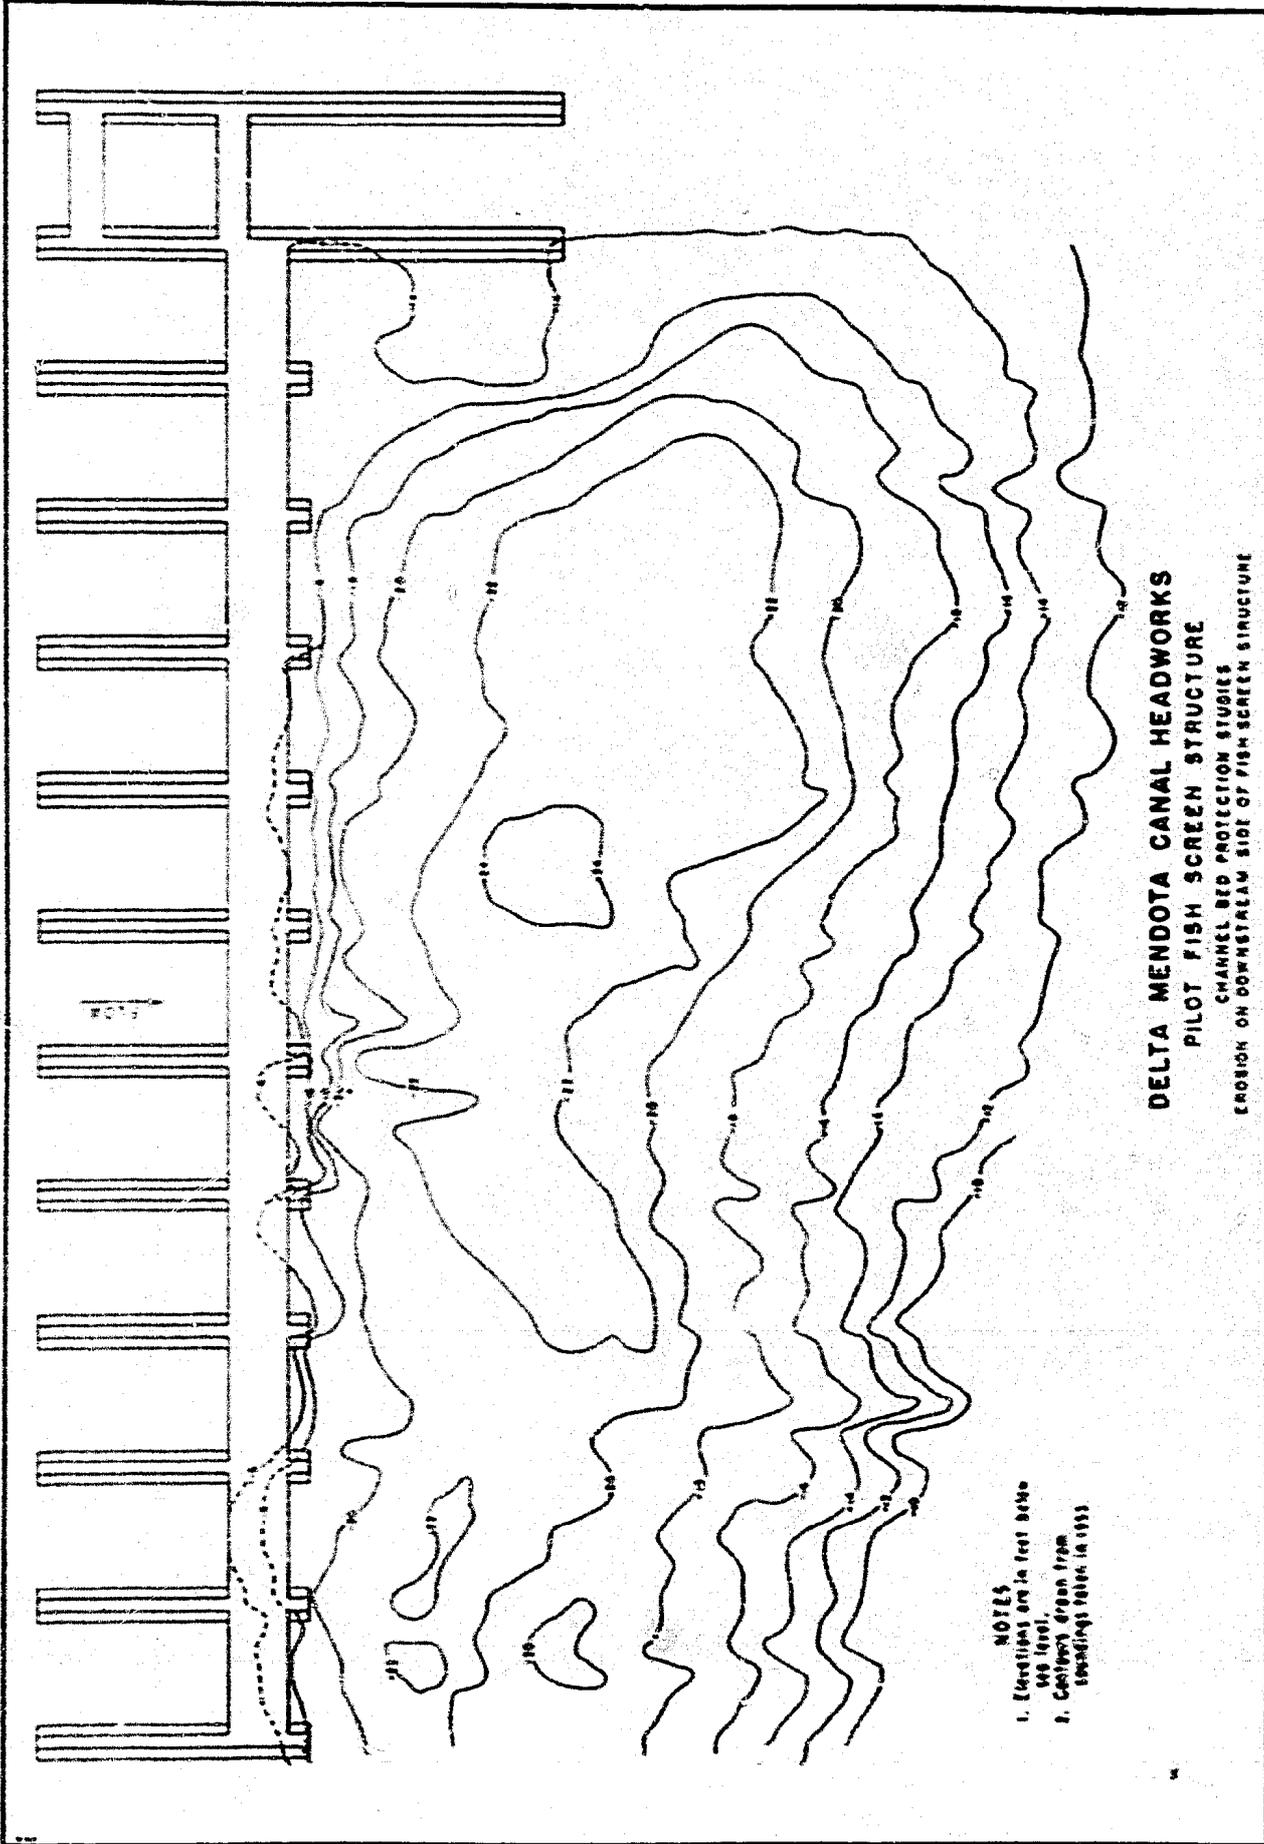
- NOTES
1. Elevations are in feet above sea level.
 2. Contours drawn from soundings taken in 1953.

DELTA MENDOTA CANAL HEADWORKS
PILOT FISH SCREEN STRUCTURE
CHANNEL BED PROTECTION STUDGES
EROSION ON DOWNSTREAM SIDE OF FISH SCREEN STRUCTURE

It was apparent that the sluicing action of the flow under the screen was the cause of the prototype erosion. Figure 39 shows the extent of prototype erosion. The lack of erosion downstream from the first three bays can be explained by the fact that there was no flow through the sloping screen bay and the next two bays were equipped with self cleaning traveling screens which did not need to be raised for cleaning. The remaining eight bays had to be raised in order to clean them.

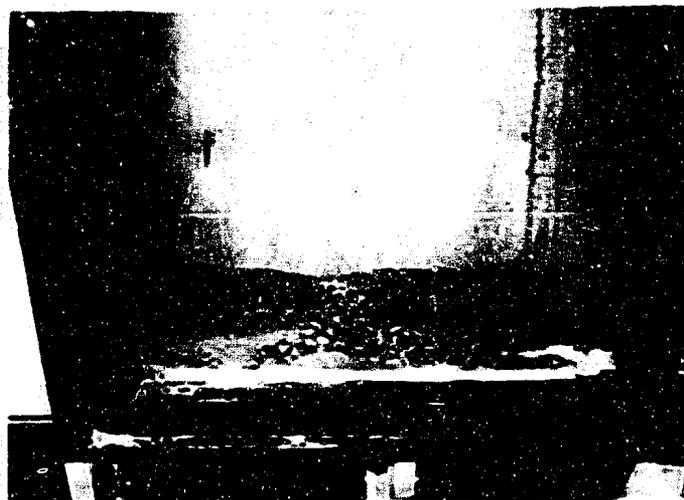
A - Riprap Placed Downstream From
Apron - Erosion After 20 Minutes
Operation.

The erosion was negligible after 10 minutes operation so the amount of screen opening was altered to find a more severe operating condition. Starting with the screen raised 5 feet, it was lowered by 1 foot increments. At 1 foot open the bed movement was greatest so the model was allowed to operate at this opening for 20 minutes, Figure 41A shows the amount of bed movement at the end of this period. The riprap reduced the amount of erosion; however, it was thought that the structure would receive better protection if some type of deflector or end sill were placed on the concrete apron under the screens.

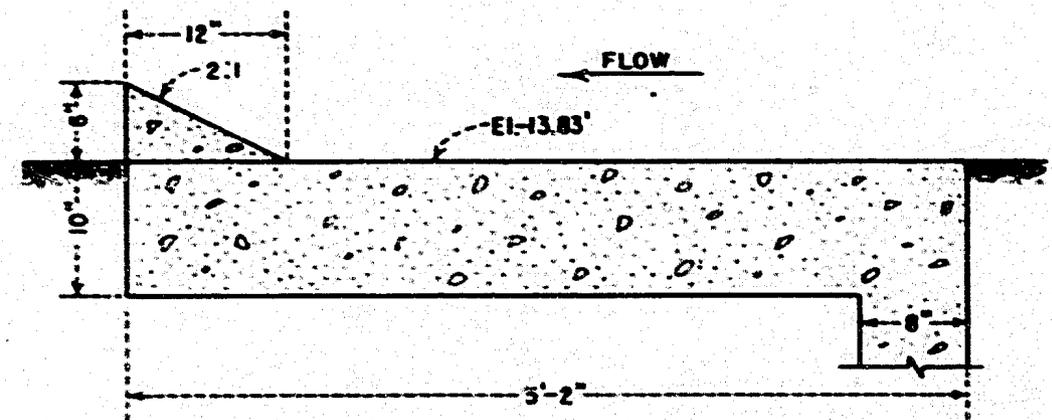
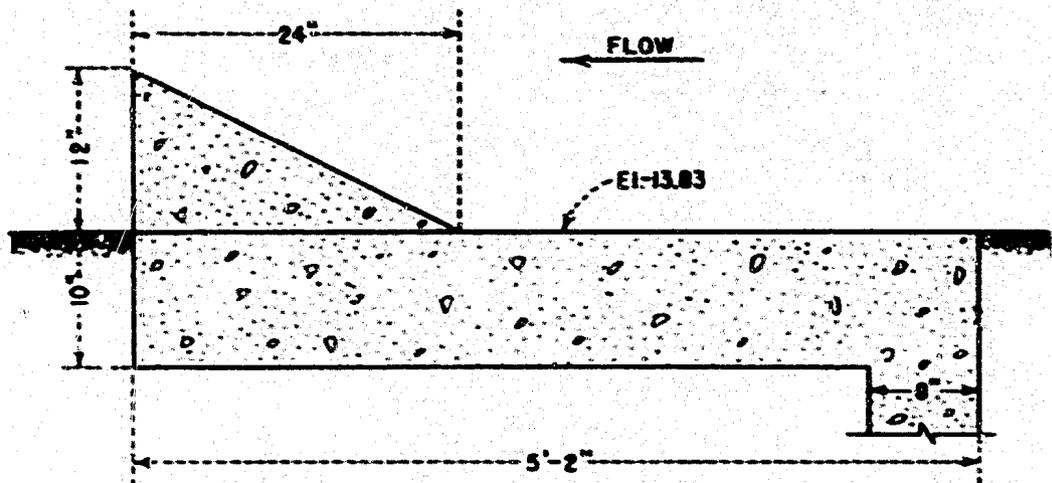
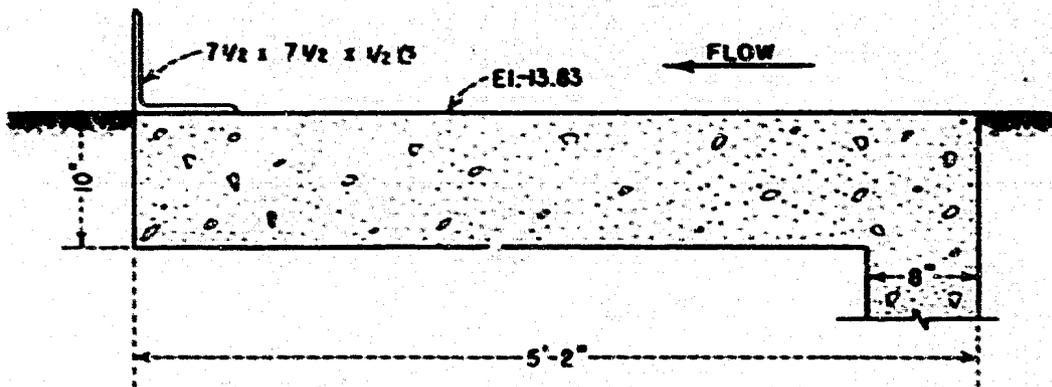
A. 6" SILL

B. 12" SILL

C. 7 1/2" ANGLE IRON SILL

DELTA MENDOTA CANAL HEADWORKS
PILOT FISH SCREEN STRUCTURE
CHANNEL BED PROTECTION STUDIES
END SILLS

Tests No. 3, 4, 5, and 6, end sills. Four types of end sills were investigated and all were found to be effective in reducing the erosion. The tests are summarized below:

Any of the end sills that were investigated would protect the structure from excessive erosion but since the installation of a sill would have to be done under 20 feet of water, the angle iron end sill was recommended as it would be the easiest for prototype installation. It was also recommended that a 1 foot thick layer of 2-1/2- to 4-inch riprap be installed for 10 feet downstream from the structure.

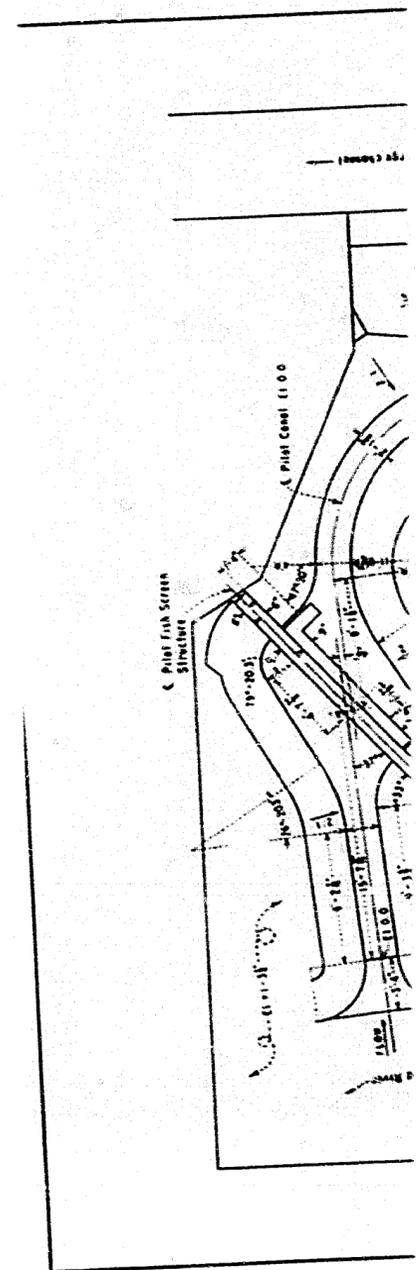
3 That Occurred During Screen Raising Procedures.

4 Occurred When Screens were Modified.

DELTA MENDOTA CANAL HEADWORKS
SCREEN STRUCTURE
PROTECTION STUDIES
SCREEN RAISING PROCEDURES

Screen raising studies. As previously discussed, the screen raising methods during cleaning operations seemed to have a definite bearing on the cause of the prototype erosion. A test was made on the 1:10 scale model to show that a simple change in the prevailing methods would benefit the structure as much as the end sill and riprap would benefit it. The discharge and water surface elevation were the same as were used for the other tests, and no end sill or riprap was used to protect the channel bed. Two screens were used, one was the same as in the previous tests and this is referred to as the dirty screen; the second screen had less than 1/4 foot head loss through it and is referred to as the clean screen.

In the second test the position of the screens were reversed, which put the clean screen on the downstream side of the dirty screen. When the dirty screen was raised there was little erosive action of the channel bed. Figure 45B shows the condition of the channel bed after 30 minutes operation with the screen raised 2 feet.

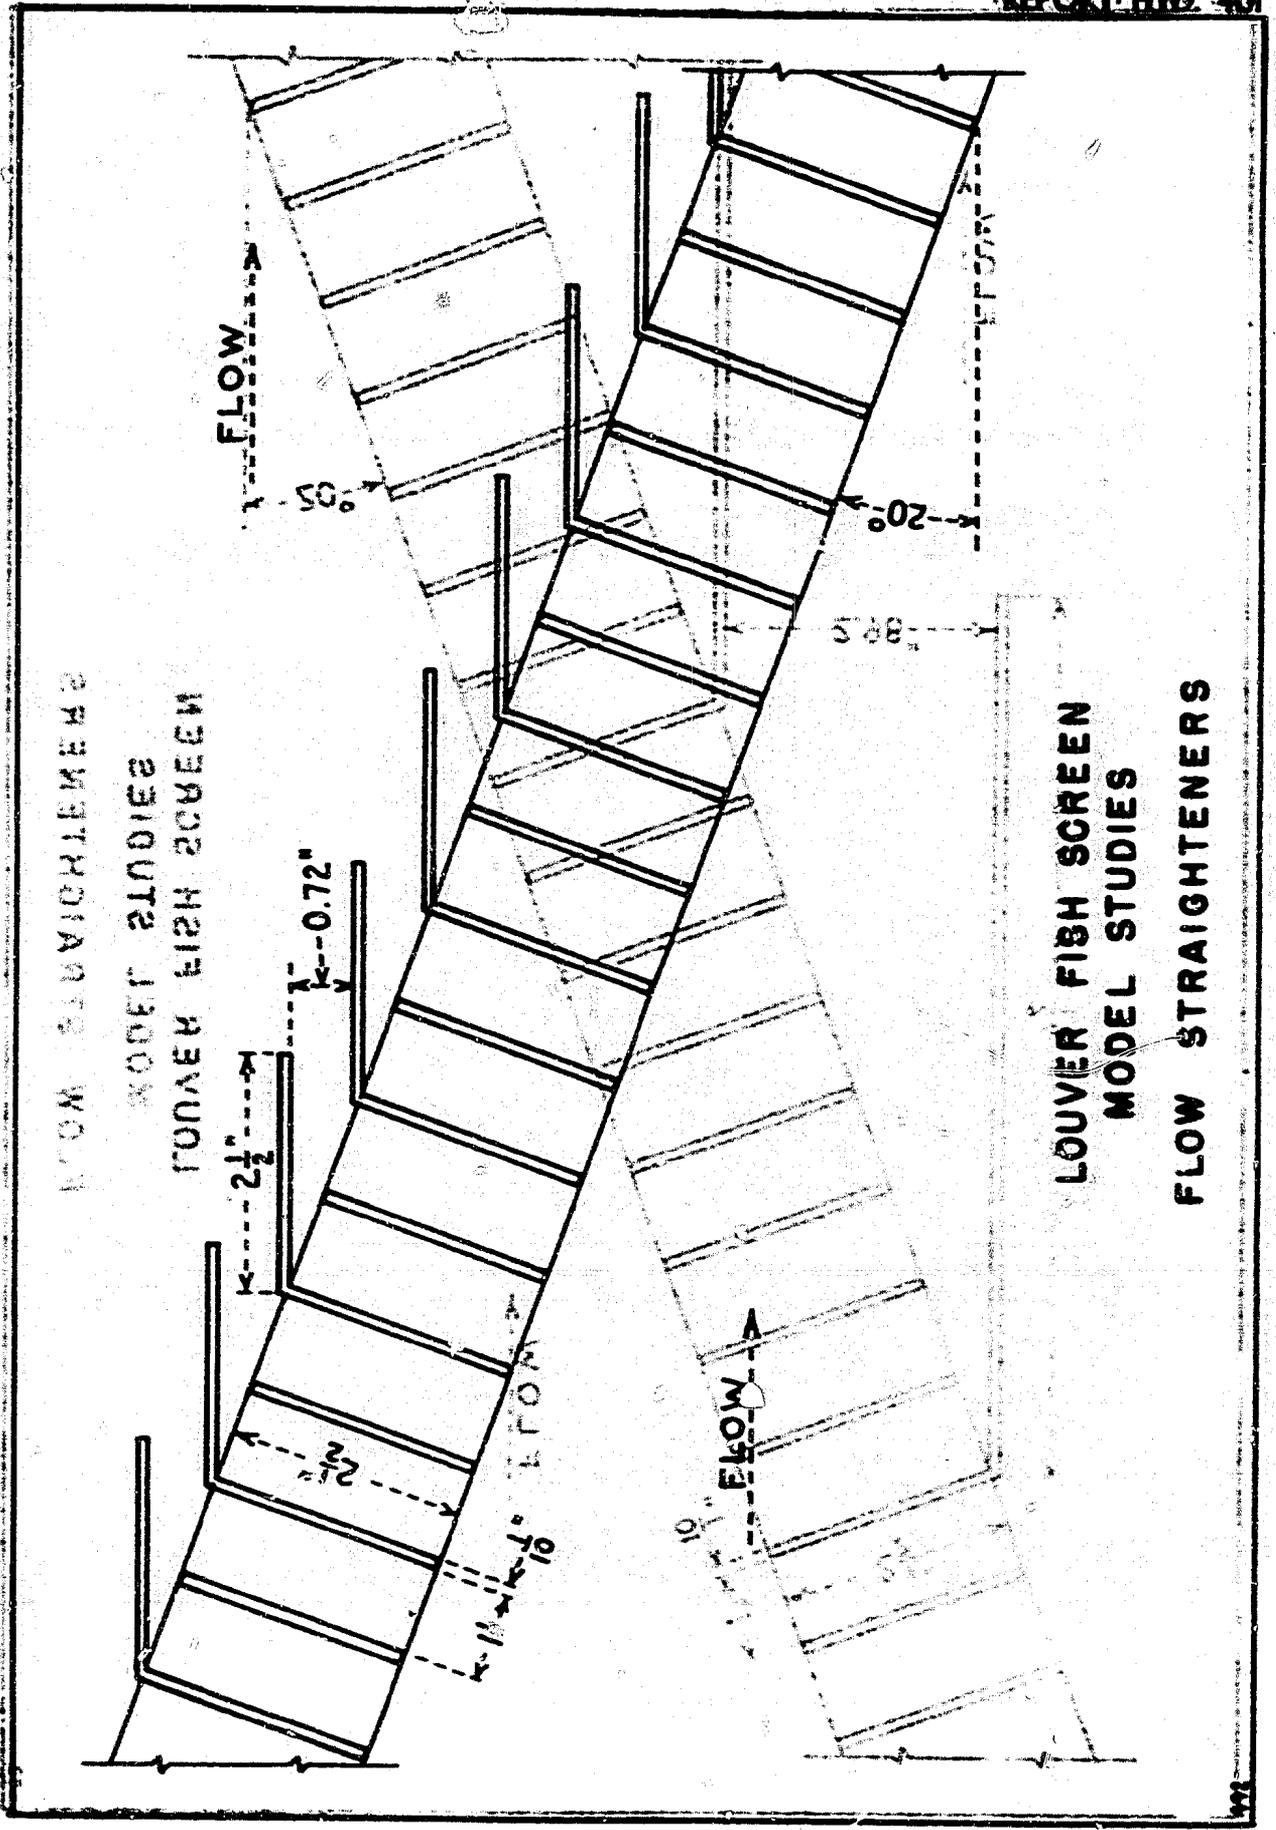
FIGURE 48
REPORT HYD. 401

LOUVER FISH SCREEN
MODEL STUDIES
FLOW STRAIGHTENERS

The upstream side of the louvers could not be altered since it was thought that the fish repelling characteristics might be changed; therefore, the modifications were developed on the basis that they had to be placed on the downstream side. Preliminary tests showed that if the flow emerging from the louvers were forcibly turned so that it flowed in the proper direction the backwater buildup was minimized and good approach flow resulted. Good outflow conditions might also be accomplished by downstream channel realinement but obviously would be very expensive, so all further tests were made to determine the length and spacing of flow straighteners placed on the downstream side of the louvers. The length of the flow straighteners would depend on their spacing since in order to completely turn the flow the straighteners must overlap. The flow had to be turned about 70° which set the minimum spacing as one vane for every two louver spaces.

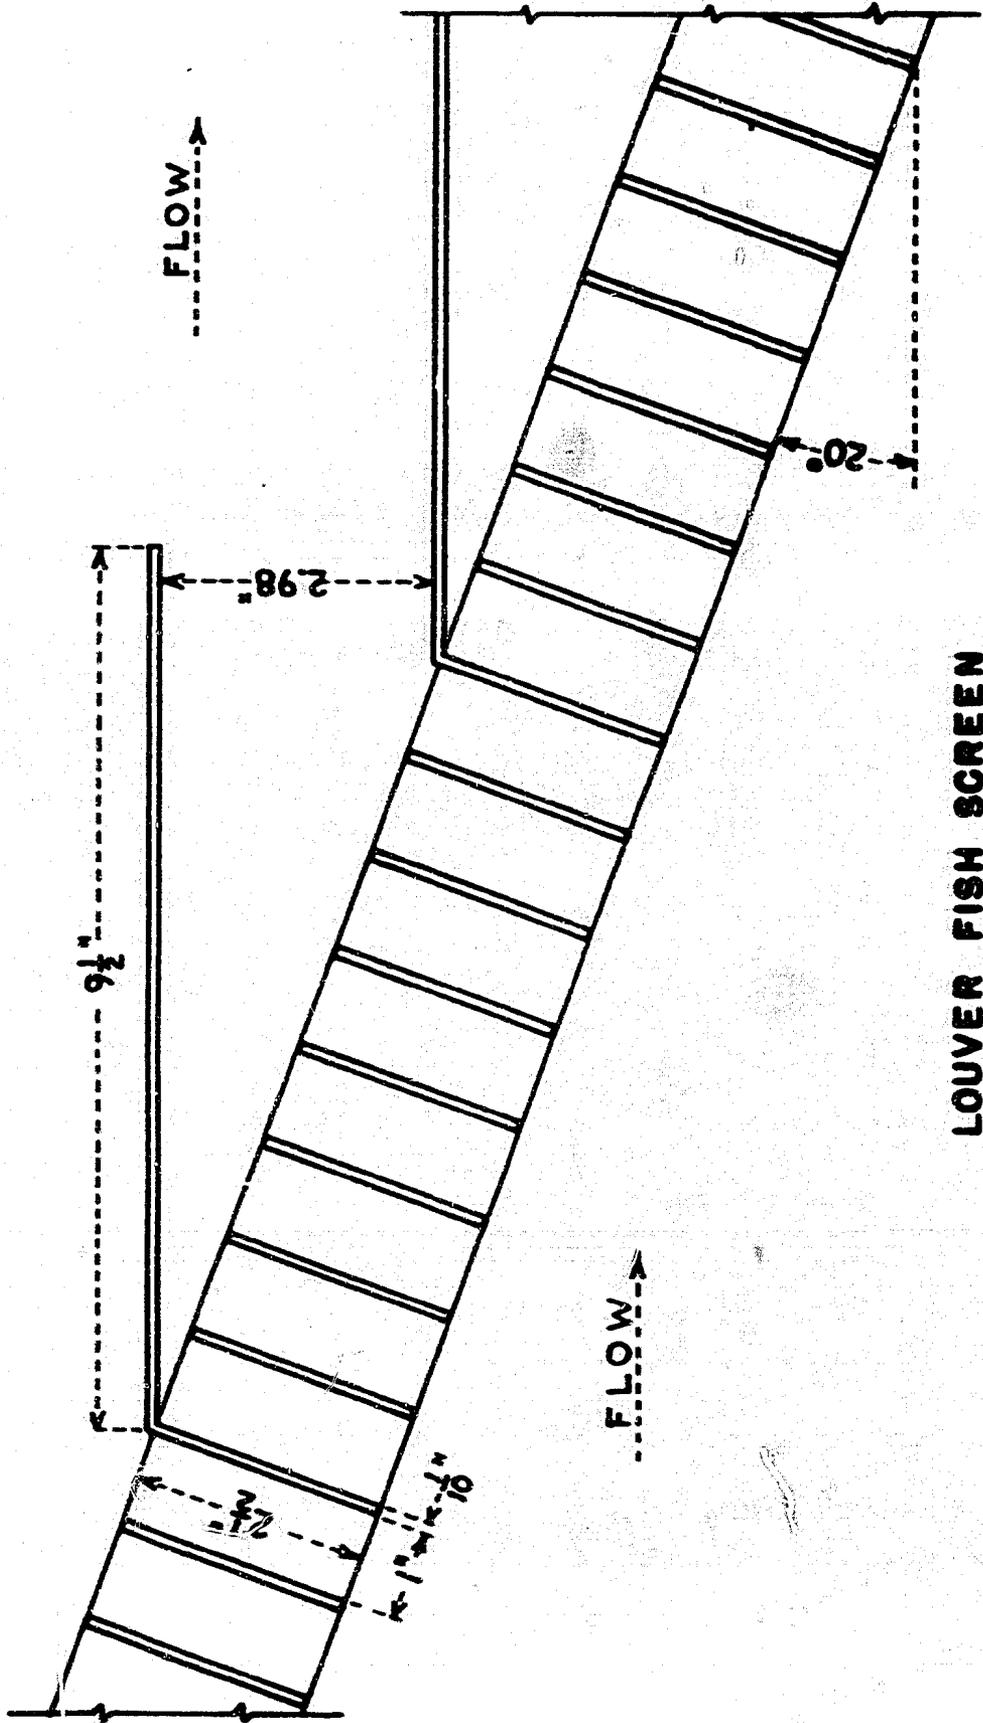
LOUVER FISH SCREEN
MODEL STUDIES
FLOW STRAIGHTENERS

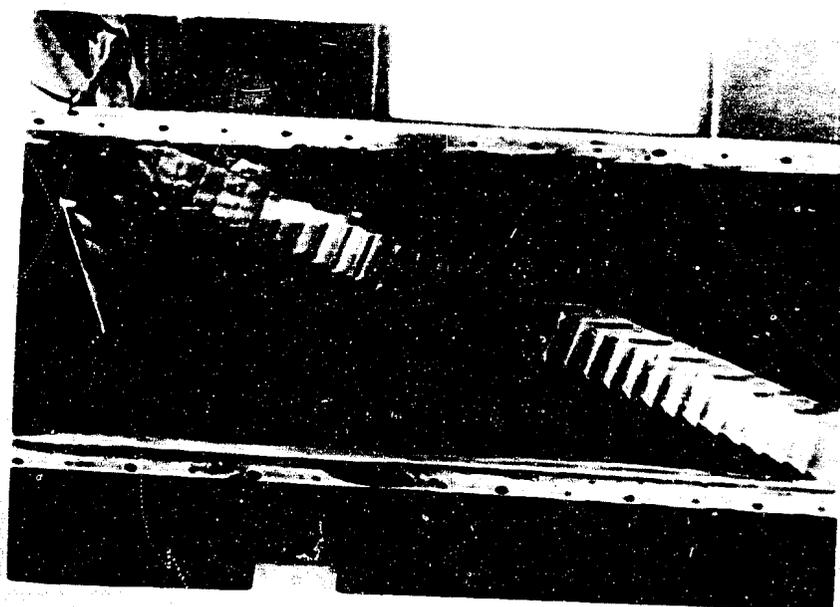
A - Flow Lines Through Louvers - Close-Spaced Flow Straighteners in Place.

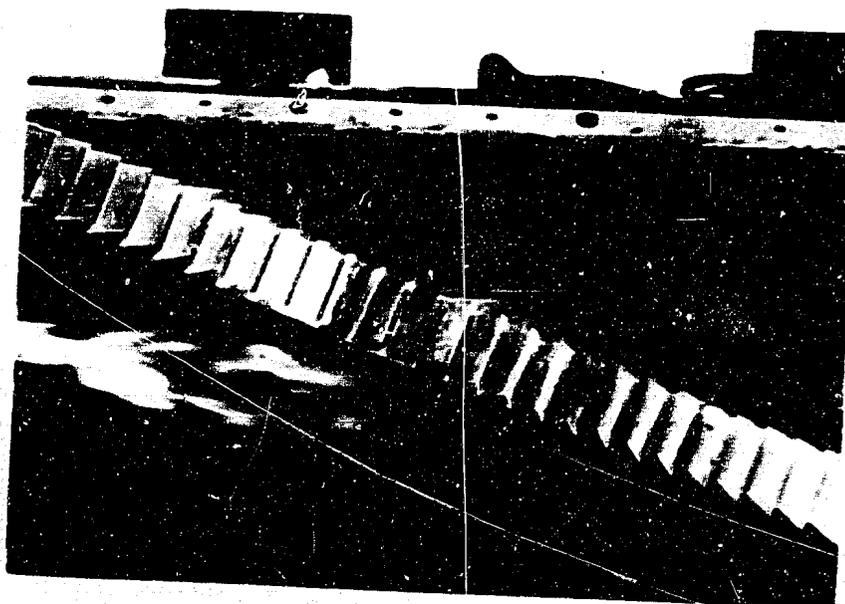
B - Flow Lines Through Louvers - Wide-Spaced Flow Straightener in Place.

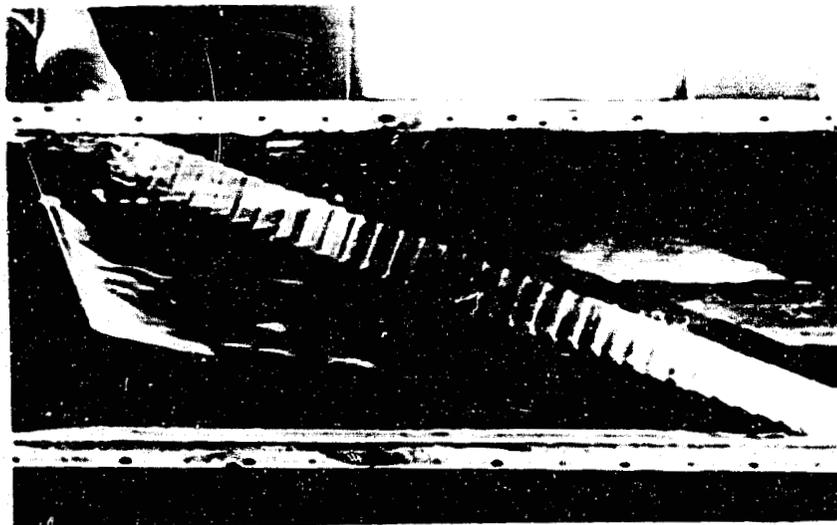
A - Flow Lines Through Louvers - Wide-Spaced Flow Straightener Separated From Louvers by About 2 Inches.

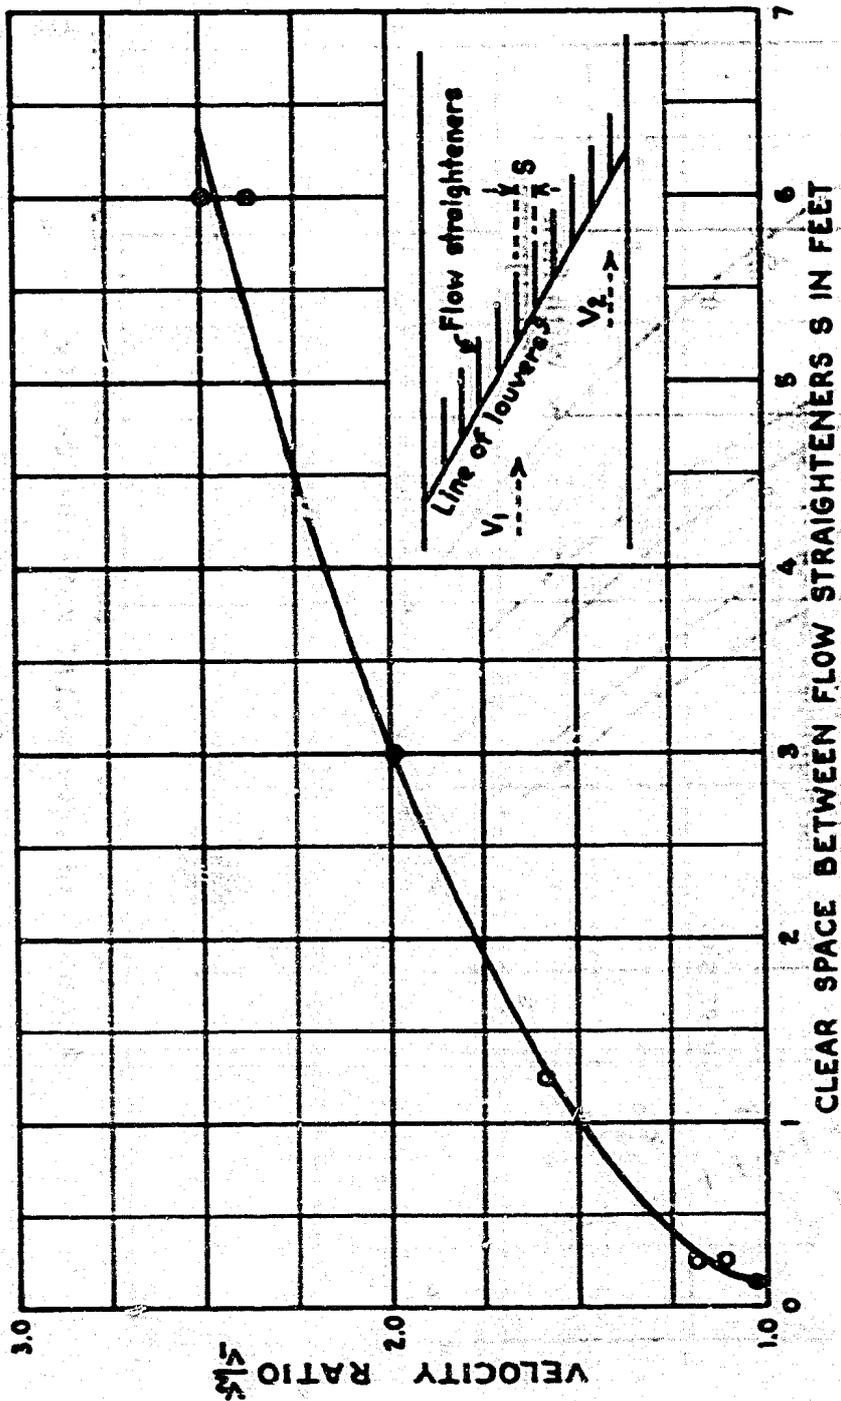
FIGURE 52
 REPORT HYD. 401

RELATION OF FLOW STRAIGHTENER SPACING
 TO VELOCITY INCREASE ALONG UPSTREAM SIDE OF LOUVERS

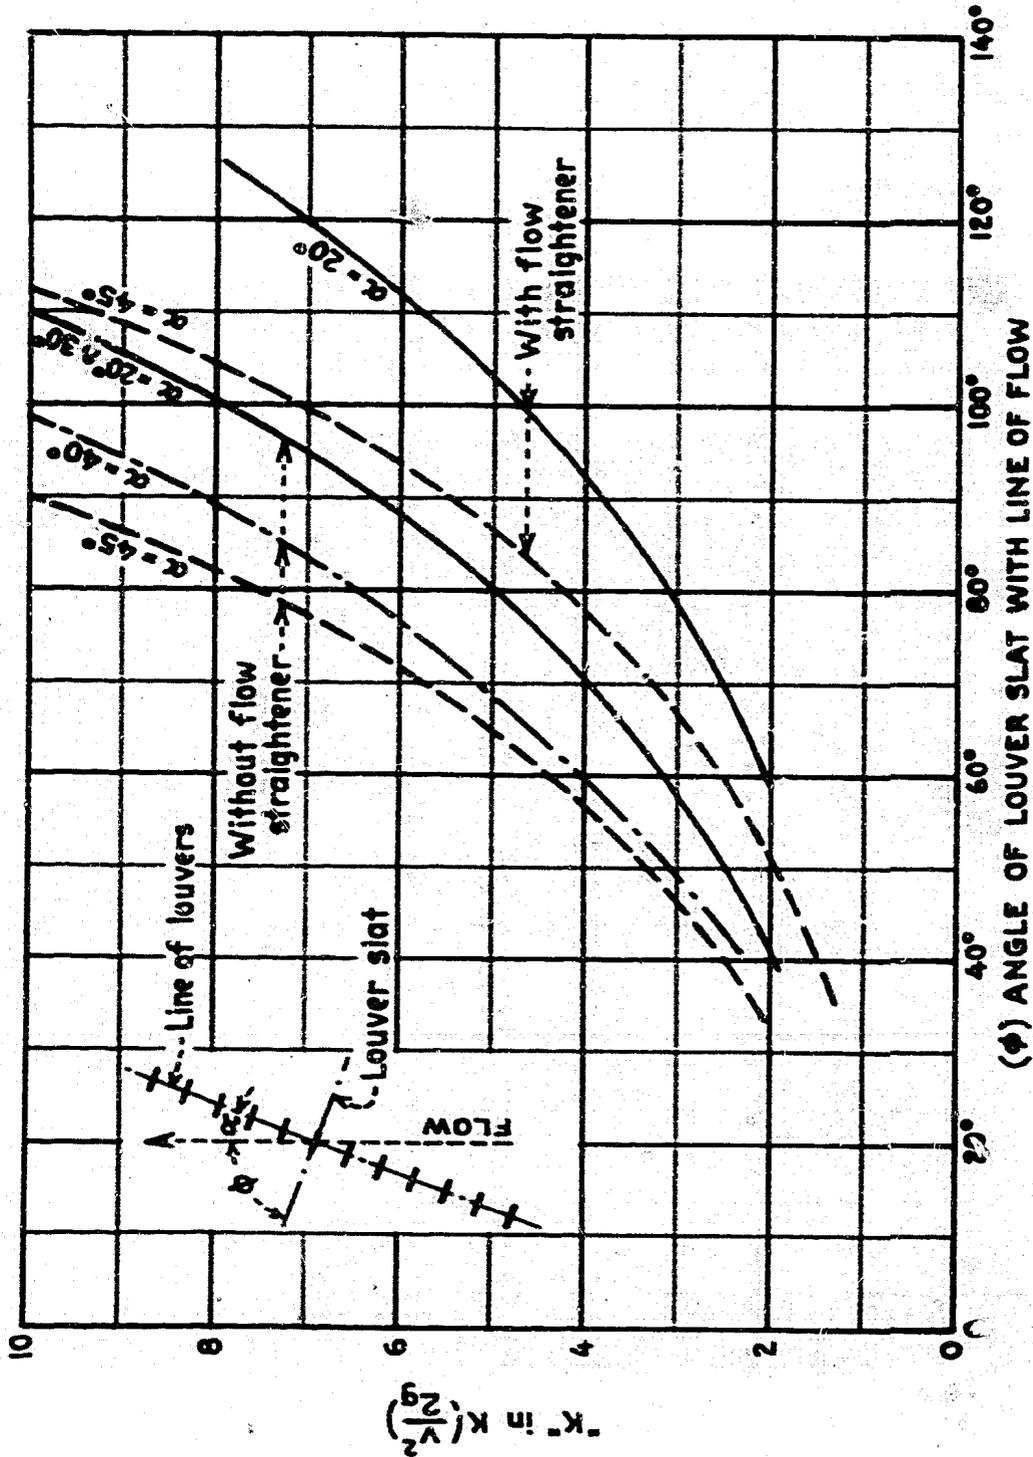
LOUVER FISH SCREEN
 HEAD LOSS STUDIES

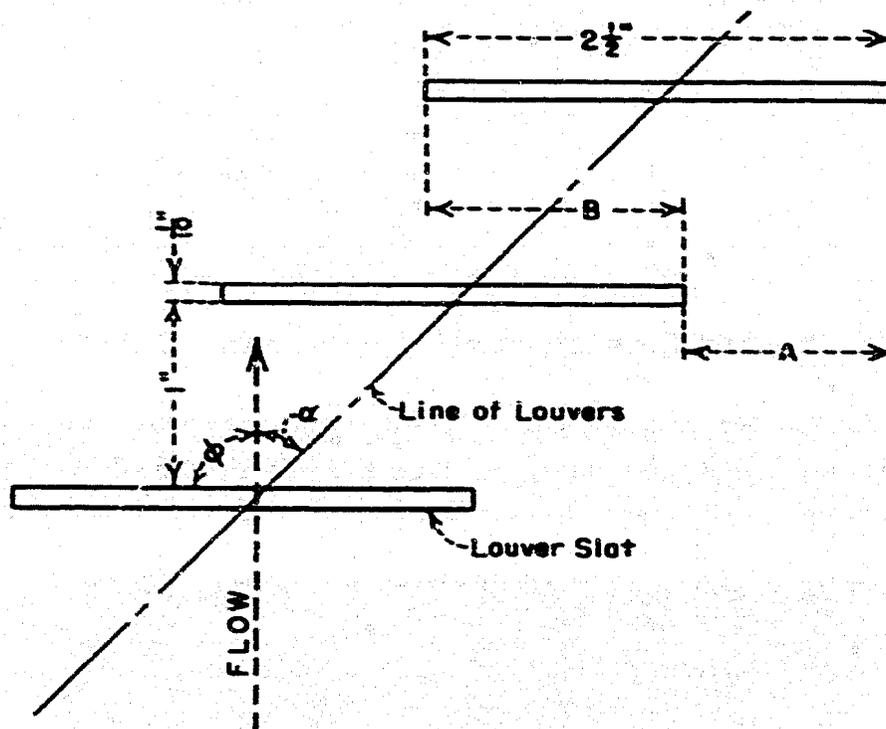
FIGURE 54
REPORT HYD. 401

ϕ	α	A	B	$\frac{B}{A}$	HEAD LOSS
90°	20°	0.40"	2.10"	5.25	$6.3 \frac{V^2}{2g}$
90°	30°	0.64"	1.86"	2.93	$6.3 \frac{V^2}{2g}$
90°	40°	0.92"	1.58"	1.71	$8.2 \frac{V^2}{2g}$
90°	45°	1.10"	1.40"	1.26	$10.0 \frac{V^2}{2g}$
90°	40°*	0.92"	2.58"	2.65	$6.5 \frac{V^2}{2g}$

*Slot length increased to $3\frac{1}{2}$ ".

DELTA MENDOTA CANAL HEADWORKS
PILOT FISH SCREEN STRUCTURE
LOUVER FISH SCREEN
HEAD LOSS STUDIES

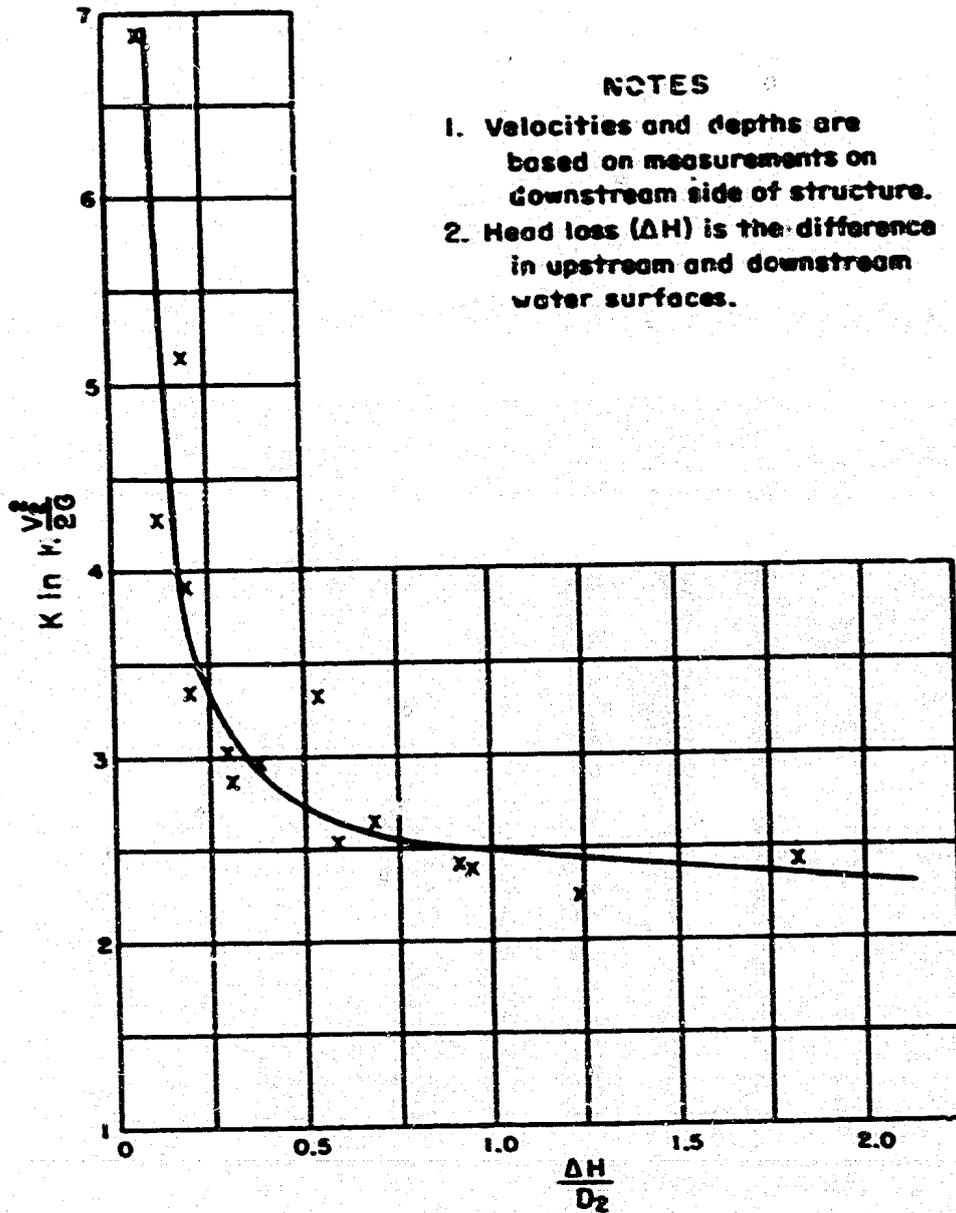
DELTA MENDOTA CANAL HEADWORKS
PILOT FISH SCREEN STRUCTURE
LOUVER STUDIES
HEAD LOSS - DEPTH - VELOCITY RELATION
