UNITED STATES
DEPARTMENT OF THE INTERIOR
BUREAU OF RECLAMATION

EXPERIENCES OF THE BUREAU OF RECLAMATION
WITH FLOW-INDUCED VIBRATIONS

Laboratory Report No. Hyd-538

September 30, 1964

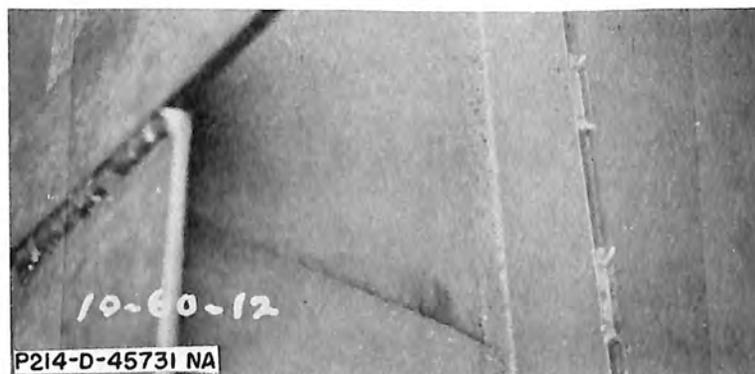
C. The second from the bottom 12-inch WF beam was cracked through the web and downstream flange.

In ensuing years, reports of vibration in a number of other radial gates were received. In some instances, conditions had been so severe that fracturing had occurred in secondary and even in primary structural members. One example is provided by Little Dry Creek check in the Friant-Kern Canal in California. During annual maintenance of the structure in 1960, the left gate of this three-gate check was found to be damaged (Figure 1A). Three of the 4- by 3/8-inch vertical tie bars were fractured, and the 12-inch WF beam second from the bottom was cracked through the entire web and through the downstream flange (Figures 1B and 1C).

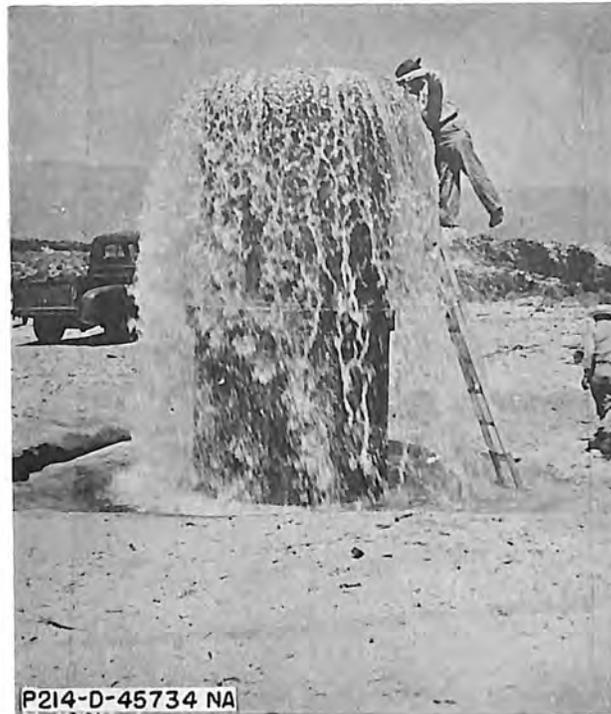
A. Pipe stand overflowing due to surging in pipeline system.

The surges appeared as periodic variations of flow in a pipeline. The period of these changes ranged from about 60 to 100 seconds. In their most violent form the surges caused the pipe stands to be completely emptied when the waters receded, and overflowing when they returned (Figure 7A). In their mild form little could be observed other than a periodic increase and decrease in the depth of water

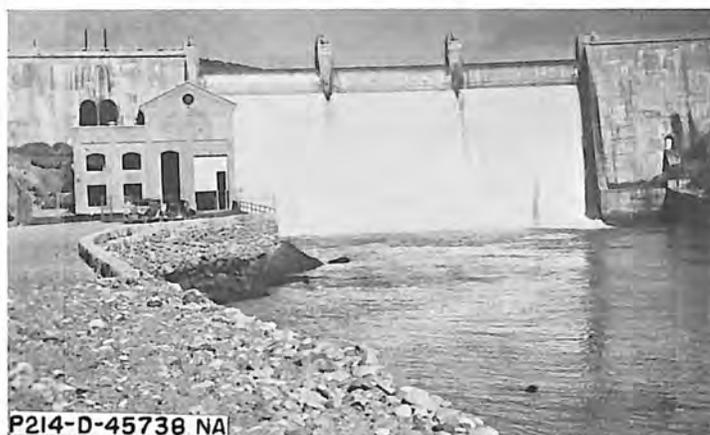
A. Black Canyon Dam Spillway.

Black Canyon Dam is a concrete gravity section and has a three-bay spillway located near the left abutment (Figure 9A). Drum gates 64 feet long by 14 feet 6 inches high are used to control the quantities of water released. When maximum flows are required through the spillway, the gates are fully lowered and the top surfaces of the gates act to complete the normal surfaces of the ogee crest (Figure 10A). When no flow is desired, the gates are raised by rotating them around hinges at their upstream corners to the extent needed so overtopping will not occur (Figure 10B). When controlled rates of flow are desired, the gates are positioned so that water may pass over the downstream lips and fall freely to the concrete surfaces below (Figure 10C). During this type of operation with certain specific depths of water present over the gate lips, fluttering occurred (Figure 9B).

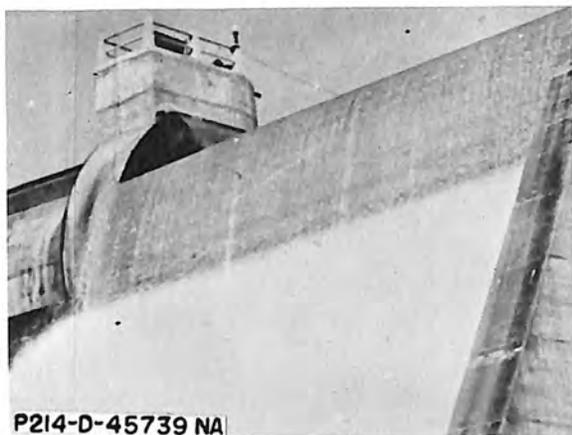
B. Fluttering nappe with 0.4-foot head.
