HIGH HEAD GATE SEAL STUDIES

Report No. HYD-582

HYDRAULICS BRANCH
DIVISION OF RESEARCH

MARCH 1968

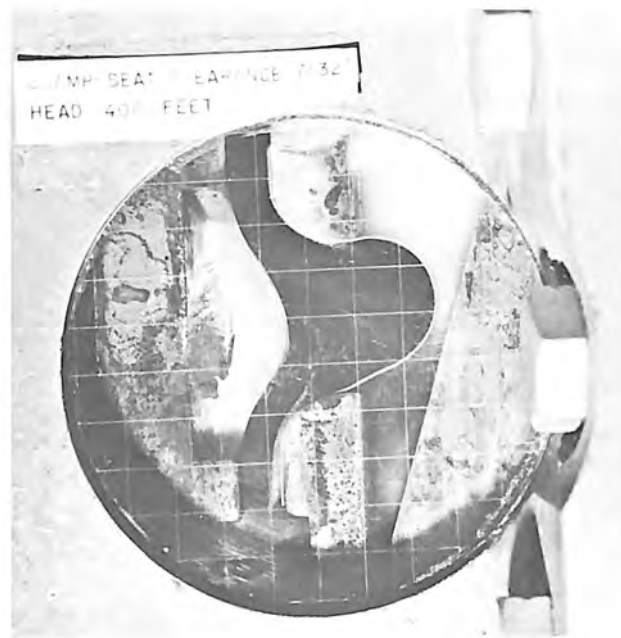
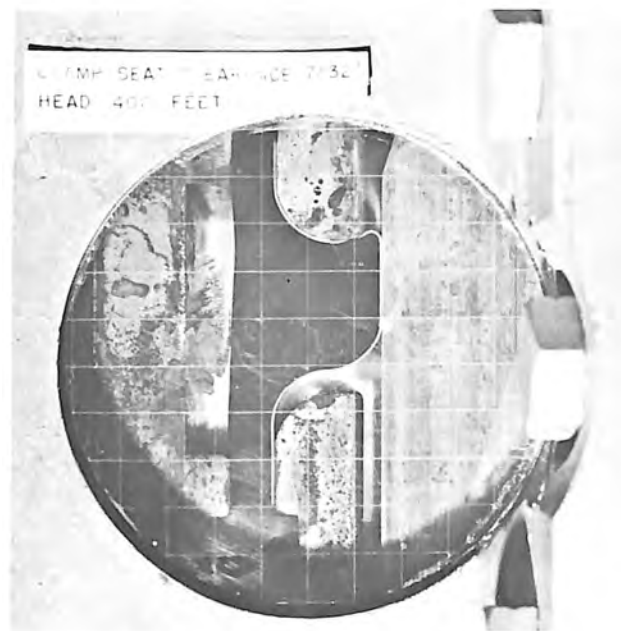
Specimen 7 in Test Rig

A. Seal bulb extended during closing cycle.
Photo PX-D-60635

B. Gate in closed position. Photo PX-D-60636

Specimens 7 and 8 (Figures 8, 9, and 11) were tested up to 425 and 400 feet (129.54 and 121.92 m) of head, respectively, before the bulbs were pinched enough to put a permanent crease in the fluorocarbon cap. It was noted with each successive run to a higher head that a permanent set was imparted to the seals. (The bulb remained displaced about 0.05 inch [1.27 mm] from its initial position after the pressure had been up to 400 feet [121.92 m] and then reduced). The set was apparently due to stretching the fluorocarbon beyond the elastic limit. The extent of this set is shown in Figure 11B.

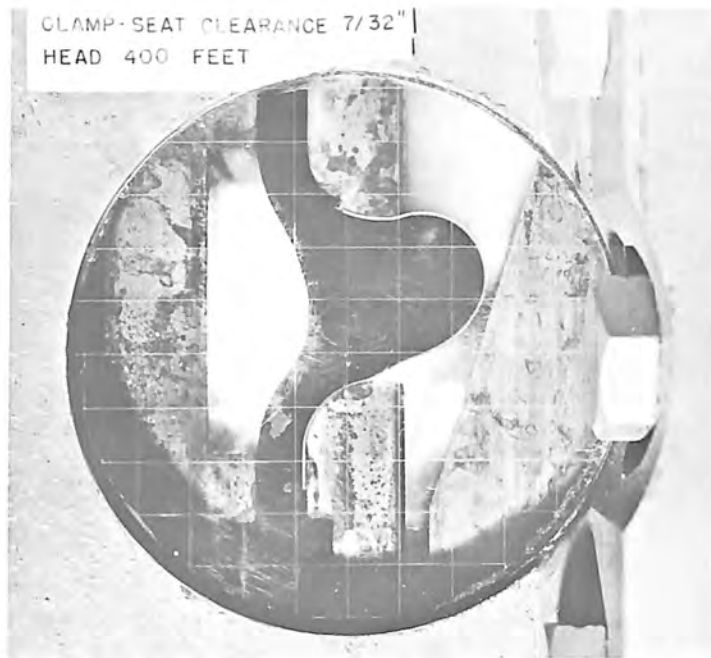
Specimen 8 in Test Rig

A. Seal bulb extended during closing cycle.
Photo PX-D-60637

B. Gate in closed position. Photo PX-D-60638
