BUREAU OF RECLAMATION
EXPERIENCE WITH FLOW-INDUCED
VIBRATIONS

Henry T. Falvey
Hydraulic Research Engineer

U.S. Department of the Interior
Bureau of Reclamation

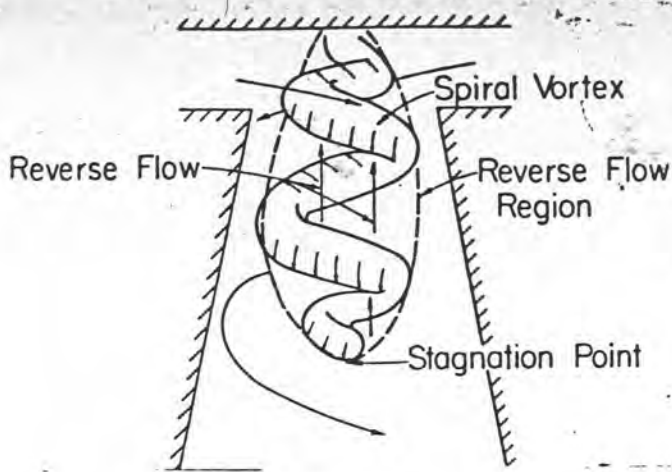
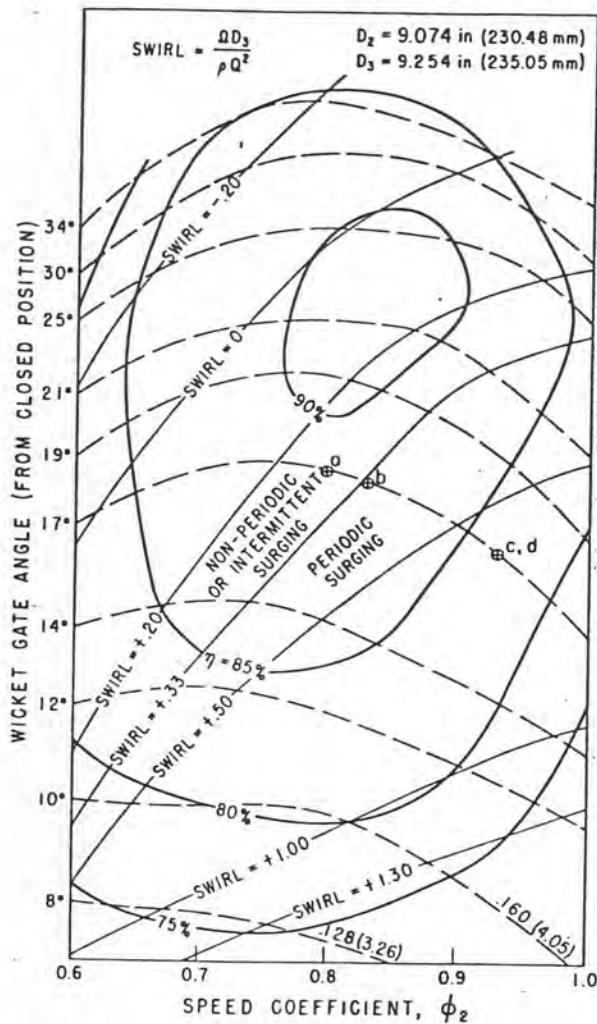
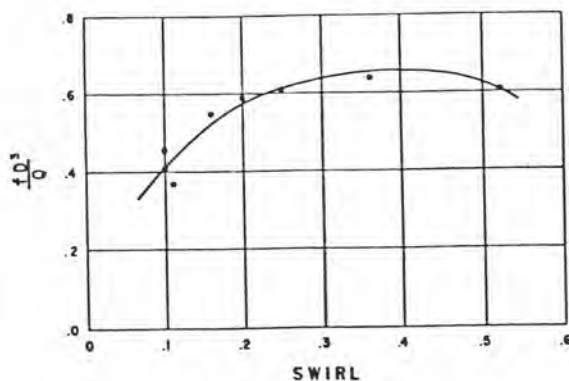
DRAFT TUBE SURGE

Geometry: An idealized sketch of the spiral vortex is shown in sketch.

Flow conditions: The spiral vortex occurs over a limited range of the ratio of angular momentum to linear momentum in the draft tube, (Swirl). See figure.

Vibrations: Frequencies can be given as a function of the momentum ratio. See figure.

The draft tube surge has been found to be a function of the ratio of the angular to linear momentum of the flow entering the draft tube [4]. For a typical turbine, constant values of this ratio, called swirl, define the surging range of the unit, Chart A. All reaction turbines exhibit surging characteristics. The three most significant parameters affecting the swirl are the wicket gate geometry, the runner performance characteristics, and the draft tube geometry. Corrective measures to reduce the surging have included changing the runner characteristics; stabilizing the point of new disturbances by cones rising from the draft tube floor; eliminating the feedback path by filling the reverse flow region with air, water vapor, or solid cores; dissipating the angular momentum with fins on the draft tube walls; introducing counter rotating swirl [5]; and changing the draft tube shape.

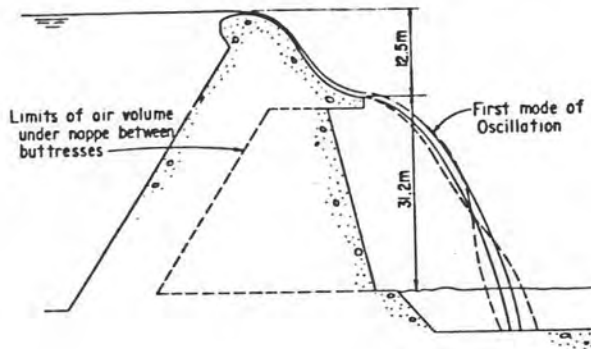
SPILLWAY NAPPE VIBRATION

Geometry: See sketch.

Operating conditions: Fall height of nappe was 560 mm. Oscillations observed up to a discharge of 1.23 L/m·s.

Vibration: Two modes of vibration were observed. The frequencies of the modes were approximately 3, 4 and 6.6 Hz. The frequency increased with discharge.

Cures: A very rough surface on the spillway crest stopped the vibration. Spoilers on the lip broke the nappe into 8 segments for flows less than 2.5 L/m·s. Spacing between model spoilers 430 mm. Prototype has not operated.

The vibration problems of overflow nappes at small discharges are well known. Therefore, the Bureau investigates this type of vibration in every new hydraulic structure that contains an overflow nappe [6], chart B. For these vibrations, the sensitive site is located where the nappe leaves the structure. The site of the new disturbances is located where the nappe strikes the downstream pool. The disturbances are fed back through the air column beneath the nappe. Experiments have shown that the vibrations can be eliminated by disrupting the feedback path. One method of accomplishing this is to break the nappe into short segments through the use of spoilers.

The fall height of the nappe in the model was 560 mm. With this fall height, oscillations were observed with a discharge up to 1.23 (liters/s) per meter width of crest. Two modes of vibration were observed. The frequencies of these modes were approximately 3.4 and 6.6 Hz. The frequency was found to increase with discharge. The vibration was stopped by the addition of spoilers to the lip of the spillway. The spacing between the spoilers was 430 mm in the model. This solution has not been verified as water has never passed over the prototype spillway. A curious phenomenon was noted in the model. Quite accidentally the model spillway surface was roughened by an overspray of paint droplets. This additional roughness apparently acted upon the location which is sensitive to disturbances and stopped the vibration.

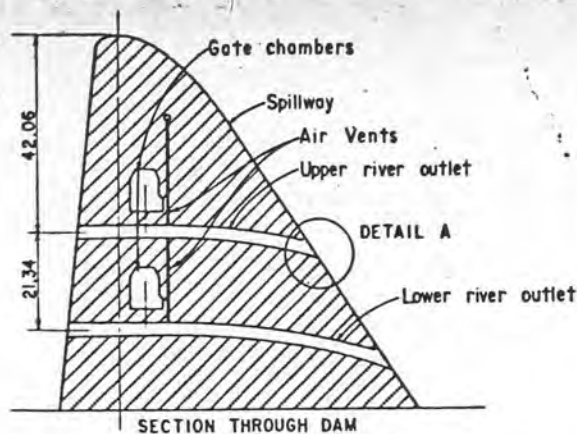
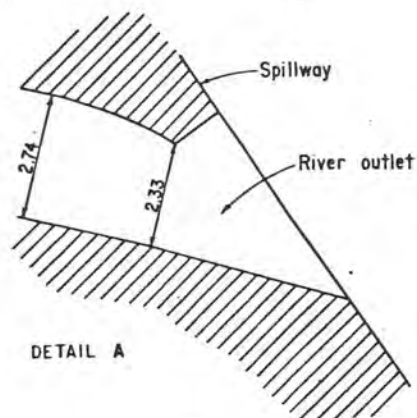
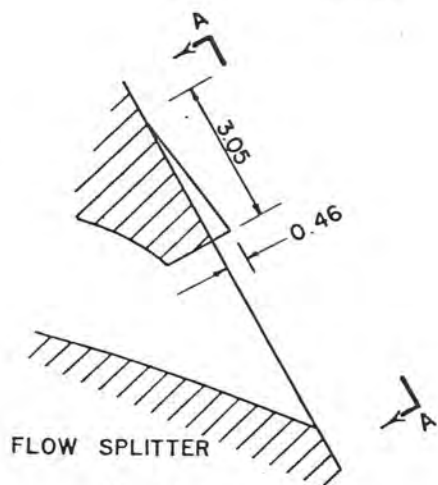
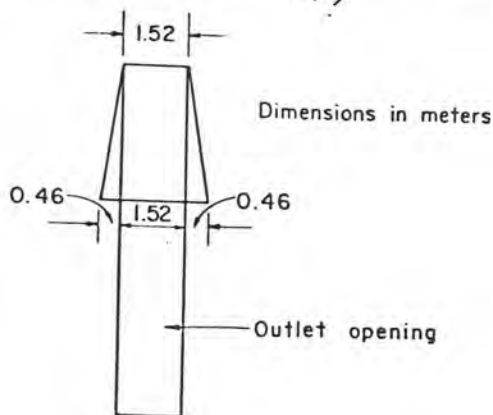
SPILLWAY-OUTLET JUNCTION

Dimensions in meters

Geometry: See sketch.

Flow conditions: Surging occurred for spillway flow only. Outlet gates closed. Outlets contained water only near intersection of outlet and spillway. A separation zone exists at crown of outlet tunnel.

Vibrations: Frequencies of 0.025 to 0.042 Hz. The model pressure head fluctuations (scaled to prototype values) exceeded 25 m near the impact zone.

Cures: An eyebrow over the outlet works caused the jet to impinge downstream of the outlet invert and it kept the nappe at the crown of the outlet aerated.

Hydraulic model studies of spillway flow passing over a nonoperating outlet portal revealed an unsuspected flow vibration [7], chart C. The intersection between the crown of the outlet portal and the spillway face was the location of the sensitive site. When the pressure at this location is low, the spillway jet is deflected somewhat into the outlet portal. The point where it impacts is the source of the new disturbances. Water from the deflected spillway jet gradually fills the outlet conduit causing pressures at the sensitive site to increase. When the pressures at the sensitive site become sufficiently large, the spillway jet is deflected out of the outlet portal and the water in the outlet conduit quickly drains. This process decreases the pressure at the sensitive point and the cycle repeats. It may just be coincidental, but the largest pressure fluctuations in the structure coincided with the most heavily damaged areas in the prototype. The frequency of the oscillations was in the range of 1.5 to 2.5 cycles per minute (prototype). During the surging, heavy audible pulsations were noted in the model air vent. The solution of this problem was to eliminate the site of new disturbances by adding an eyebrow over the outlet. The effect of the eyebrows is to always keep the impact point of the spillway jet downstream of the outlet. The eyebrows also provided aeration to the sensitive area at all times thus preventing the formation of low pressures.

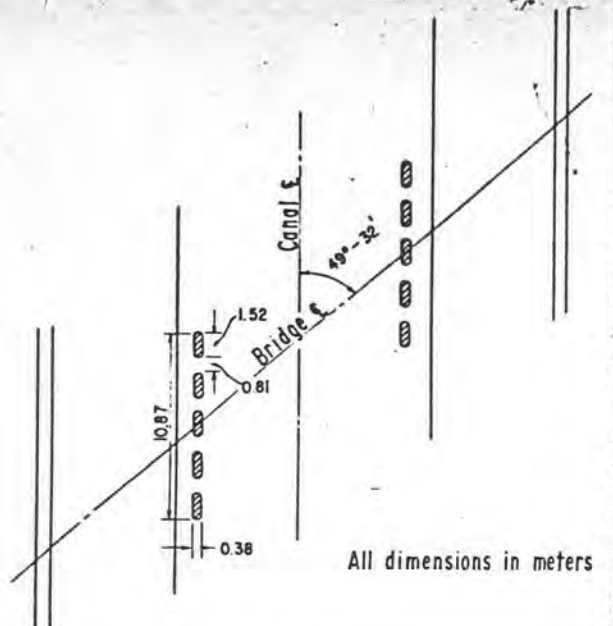
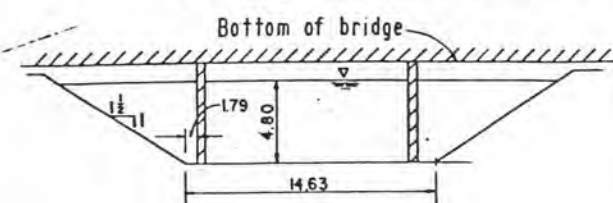
WAVE FORMATION BY BRIDGE PIERS

Geometry: See sketch.

Vibrations: Trough to crest amplitude of 600 mm at a frequency of 0.38 Hz and a wavelength of 7.5 to 10.5 m. A beat frequency of 0.07 Hz was observed. Vortex shedding from piers not reported, but probably was present.

Cures: The pier geometry was altered by filling in the spaces between the piles.

The occurrence of waves traveling upstream of bridge piers in canals has been studied both in the field and in the laboratory [8]. In this case, the bridge pier consisted of five identical rectangular piles separated by short spacings, chart D. It has been shown that the cause of these waves is the alternate vortex shedding at the trailing end of the pier or pier elements [9]. If the shedding frequency matches the resonant frequency of the space between the row of piers and the canal bank, then large amplitude waves can be formed. In the case of rectangular cross sections, the resonant frequency can be predicted analytically. However, with trapezoidal sections, model studies must be used to predict the resonant conditions.

In the field, crest to trough amplitudes of about 600 mm were observed. The frequency of the waves was about 0.4 Hz for a mean flow velocity of 1.1 m/s and a flow depth of 4.8 m. The distance between wave crests was between 7.5 and 10.5 m. In addition to the waves, a beat frequency of about 0.07 Hz was observed in the wave trains.

The problem was cured by filling the spaces between the piers. The effect of this modification is to eliminate all but the most downstream source of disturbances at the pier.

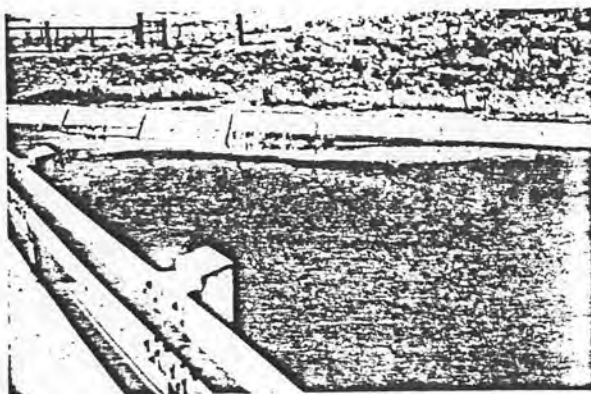
Wave at canal bank upstream of bridge

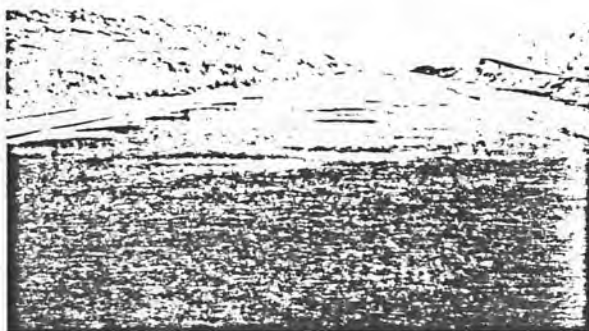
Waves progressing upstream of bridge for about 1 km

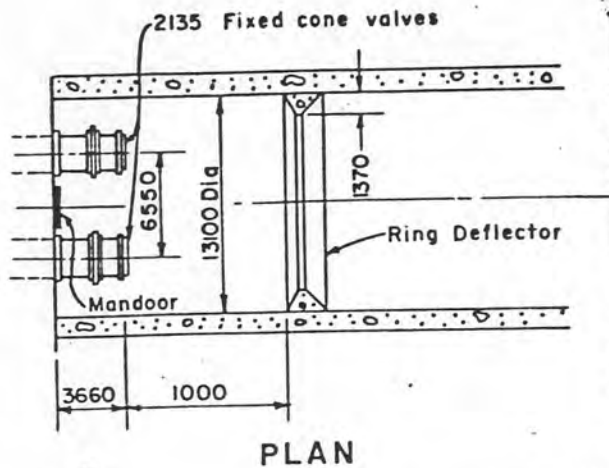
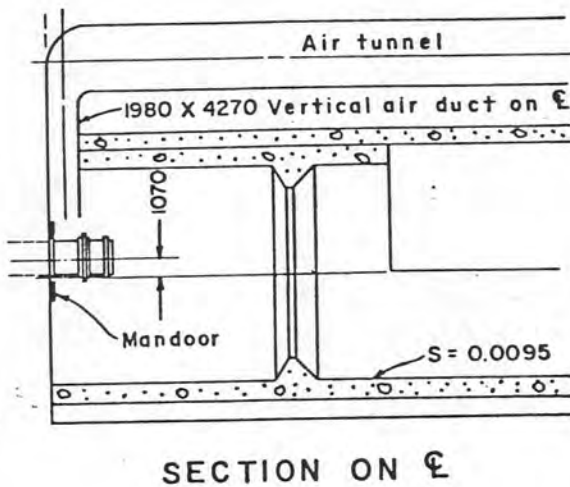
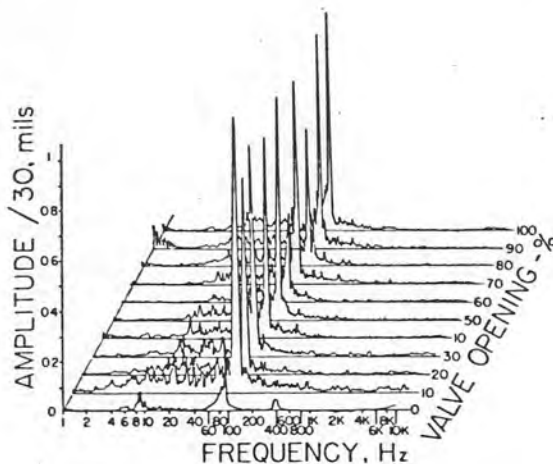
CHART E

Geometry: See sketch.

Vibration: Measurements made at steel man-door, (see sketch). The observed 85-Hz frequency correlates well with estimates of natural vibration based on paper by Mercer. This frequency not observed in model study. Elasticity of valve not simulated.

Cures: In prototype, valve opening restricted to 80 percent.

A fixed cone valve is a flow-regulating device which consists of a cone supported by a series of vanes. Closure of the valve is accomplished by a sleeve which passes over both the vanes and the fixed cone. The vanes and the fixed cone represent a spring-mass system within the flow which can react with fluctuations within the flow. This reaction causes new disturbances which then interact with the valve and the entire fluid-elastic system locks on to a specific frequency. Hydraulic model studies were made of two fixed cone valves discharging into a long circular tunnel [10], Chart E. In the model studies all geometric scales were similar, but no effort was made to scale the elasticity of the valve. Pressure traces taken in the valve chamber did not reveal any significant periodic disturbances.

Subsequent field tests indicated a very large pressure fluctuation occurred with a frequency of about 85 Hz, chart E. This frequency coincided very closely with that which can be predicted from the elastic vibration of the fixed cone in a torsional mode [11]. It is reasonable to expect that the vibration of the valve caused discharge fluctuations from the valve. These manifested themselves as pressure fluctuations in the valve chamber. The only solution to this problem would be a redesign of the valve to change its elastic properties. In this particular field installation severe vibrations of the operating mechanism were observed for valve openings exceeding 80 percent. Therefore, the valve travel was limited to this value.

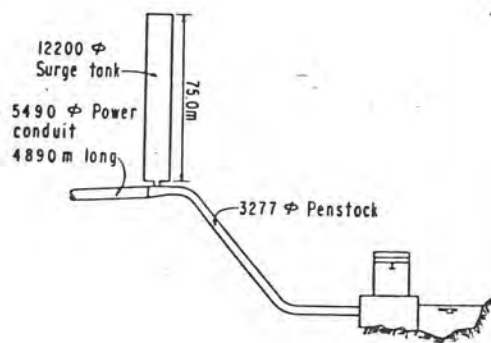
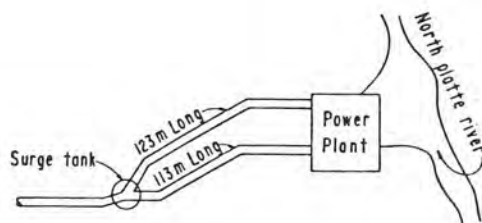
PENSTOCK RESONANCE

Geometry: See sketch.

Boundary conditions: Surge tank essentially decouples inlet conduit from penstock. Two turbines whose penstocks branch immediately downstream of surge tank.

Vibrations: The resonance occurred for gate openings of 78 to 100 percent. The resonant frequency matched the draft tube surge frequency between 1.4 and 1.9 Hz. When the draft tube surge frequency dropped below about 1.4 Hz, the resonance disappeared. At resonance, the amplitude of pressure head fluctuations in penstock was 16.9 m for a mean pressure head of 84.4 m.

The Fremont Canyon Powerplant in Wyoming consists of two units located at the end of a very long power conduit, chart F. Each unit could cause severe pressure fluctuations to occur in its respective penstock when operated at gate openings greater than 78 percent. This is normally a smooth operating range for a reaction turbine. However, field measurements eventually showed that the exit area of the turbines was about 14 percent too small for this particular installation. The original units exhibited draft tube surges with frequencies ranging between approximately 1.0 and 1.9 Hz.

When the draft tube surge frequency was between 1.4 and 1.9 Hz, the penstocks would resonate. The amplitude of the penstock pressure fluctuations was 16.9 m with a mean pressure head of 84.4 m.

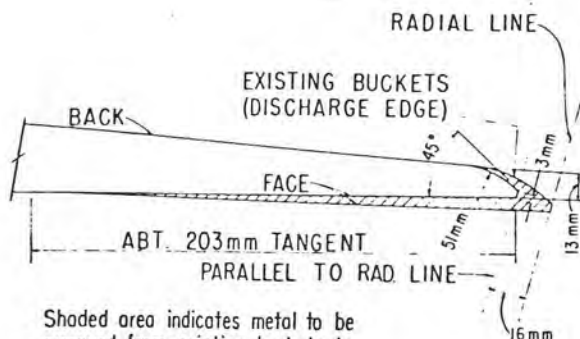
Shaded area indicates metal to be removed from existing buckets to increase vent openings approx. 12 %

Cures: Turbine characteristics changed by trimming 25 mm off trailing edge of each blade. Air admission and fins on draft tube throat were of small benefit.

A large number of remedies were tried to eliminate the resonance before it was discovered that the discharge area of the runner was too small. None of these remedies were successful. The cure for this problem was to trim the trailing edges of the turbine blades, chart F. This essentially changed the runner characteristics so that it ran smoothly above 95 percent gate. Resonance still occurs for gate openings between 85 and 95 percent. However, this plant is operated in such a fashion that it can rapidly pass through this rough zone.

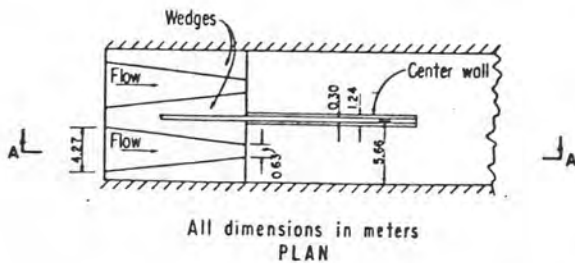
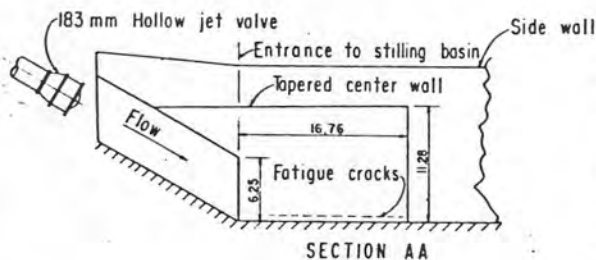
CHART G

Geometry: See sketch.

Flow conditions: Separation zone and abrupt increase in section of entrance of basin. Head on valve is about 110 m. Highly turbulent flow and large surface boils in basin. Vortex action at wedges. Air entrainment along center wall. No standing waves were observed in basin.

Structural dynamics: Natural frequency of wall matches frequency of pressure fluctuations. Movement of wall does not contribute to the flow induced pressure fluctuations.

Vibrations: Frequency and amplitude of pressure fluctuations a function of discharge and tailwater elevation. Frequency varied from 3.0 to 4.6 Hz.

Cures: Remove wedges causing abrupt section change of basin entrance. Remove wall.

Hydraulic model studies were made of a hollow-jet valve stilling basin following extensive damage to the center wall [12], chart G. This basin contains two hollow-jet valves that discharge into a common structure. Since the valves may operate either singly or together, their respective flows were kept separate in the basin by a center wall. The annular flow from each valve is transformed into a solid jet before entering the stilling basin by wedges located on the walls just downstream of the valves. The wedges create separation zones on each side of the basin. Vertically oriented air-entraining vortices form within the separation zones. These vortices coupled with the horizontally oriented vortices in the hydraulic jump, which forms in the basin, create a very turbulent three-dimensional flow pattern. The spectrum of this turbulence can be characterized as being narrow-band low-frequency noise [13]. Fatigue cracks have been found at the bottom of the center walls of several basins. The natural frequency of the wall lies within the narrow-band turbulent pressure fluctuation spectrum. The solution at Navajo Dam was to eliminate both the center wall and the wedges. This solution eliminated the damage but now symmetrical operation of both valves is required.

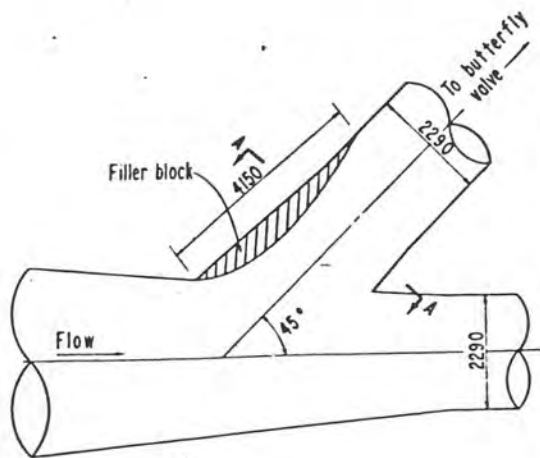
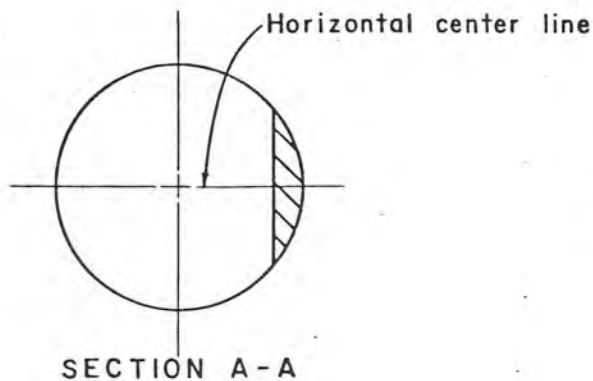
Y-BRANCH AND DOWNSTREAM BUTTERFLY VALVE

Geometry: See sketch.

Vibrations: Period of butterfly valve motion was reported to be between 2 and 3 s. Oscillograph records of model studies show a predominant 0.4 s, low amplitude pressure head fluctuation and an intermittent, high amplitude fluctuation with 1- to 2-s periods. Spectral analysis not performed.

Cures: Streamlining the Y-branch eliminated the noise and vibration, see sketch.

The final example of extraneous control deals with the vibration of a butterfly valve located downstream from a Y-branch [14], chart H. The butterfly valve vibrated with a period of 2 to 3 seconds at a discharge of $165 \text{ m}^3/\text{s}$ and a head of 37 m at the Y-branch. In addition, the valve tended to vibrate toward a closed position at these flow conditions. Laboratory studies showed that the source of the problem was nearly random excitation of the valve. The random excitations were created by separation of the flow in the Y-branch. The problem was eliminated by streamlining the Y-branch through the addition of filler blocks.
