HYDRAULIC MODEL TESTS OF ROCK MATERIAL IN THE CANYON FERRY
DAM SPILLWAY STILLING BASIN
FEBRUARY, 1980

Subject: Hydraulic Model Tests of Rock Material in the Canyon
Ferry Dam Spillway Stilling Basin
(Your Memorandum Dated February 17, 1978)

SUBJECT: Hydraulic Model Tests of Rock Material in Canyon Ferry Dam Spillway
Stilling Basin

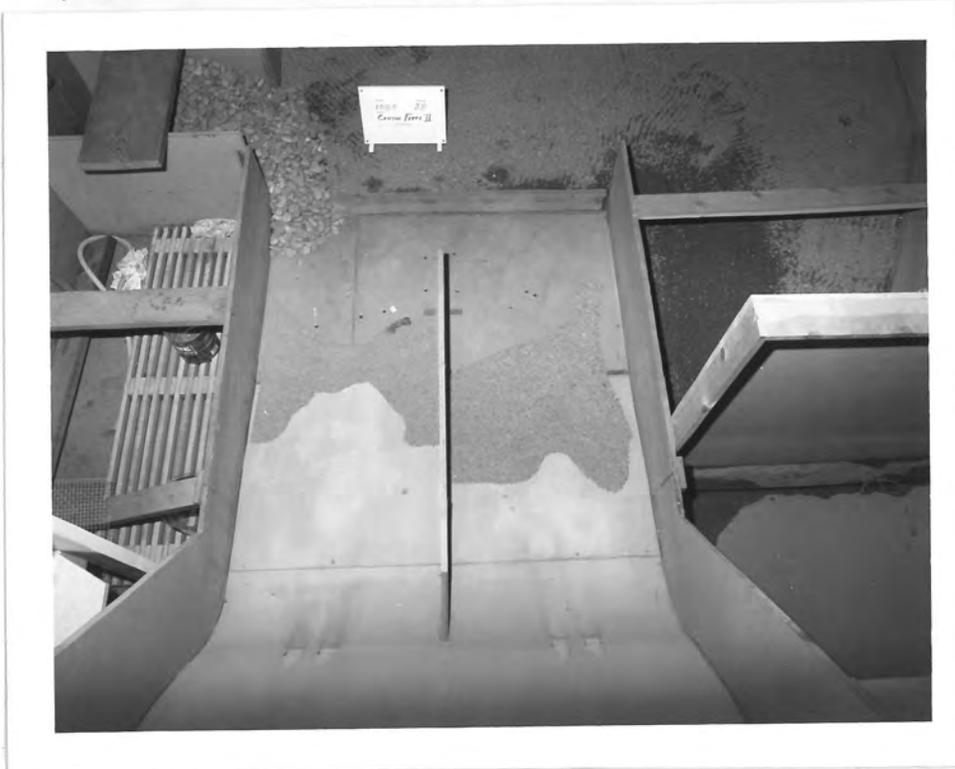
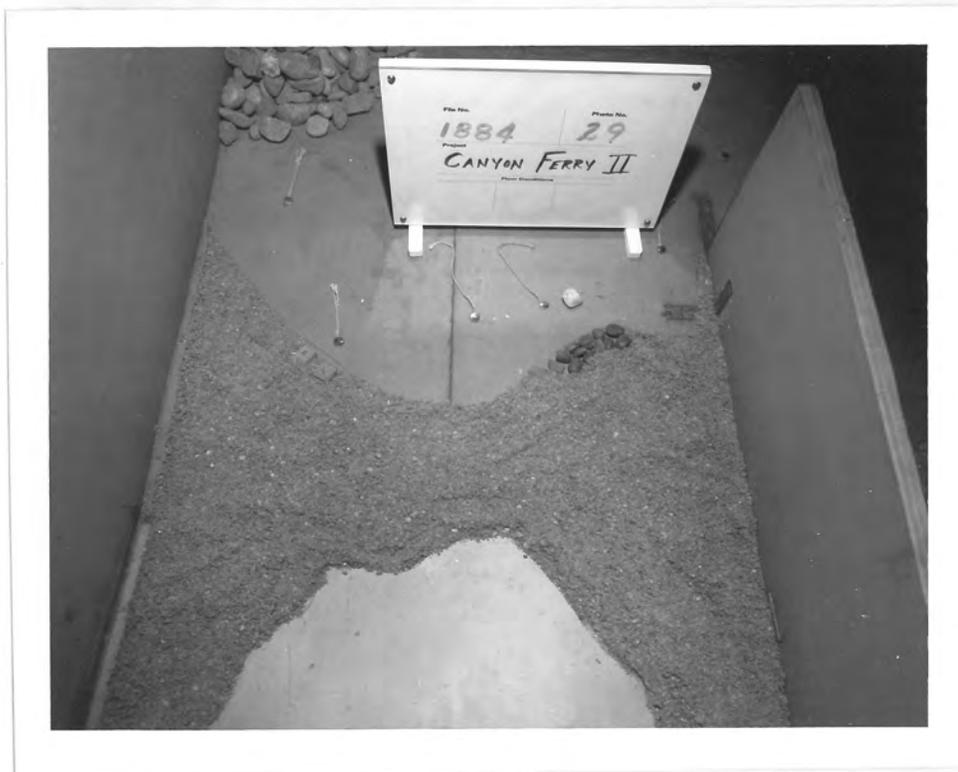
(a) General view

(b) Large debris in left bay

Figure 2. Deposit of rock material in model stilling basin

provisions were not made for water flow from either the powerplant or pumping plant. Before each test series the prototype gravel deposit, figure 1, was placed in the model stilling basin, figure 2. The identification of large debris in the model was: the concrete slabs by their shape, the 1-m (3-ft) diameter rock was painted yellow, and the twelve 0.6-m (2-ft) diameter rocks were painted red.

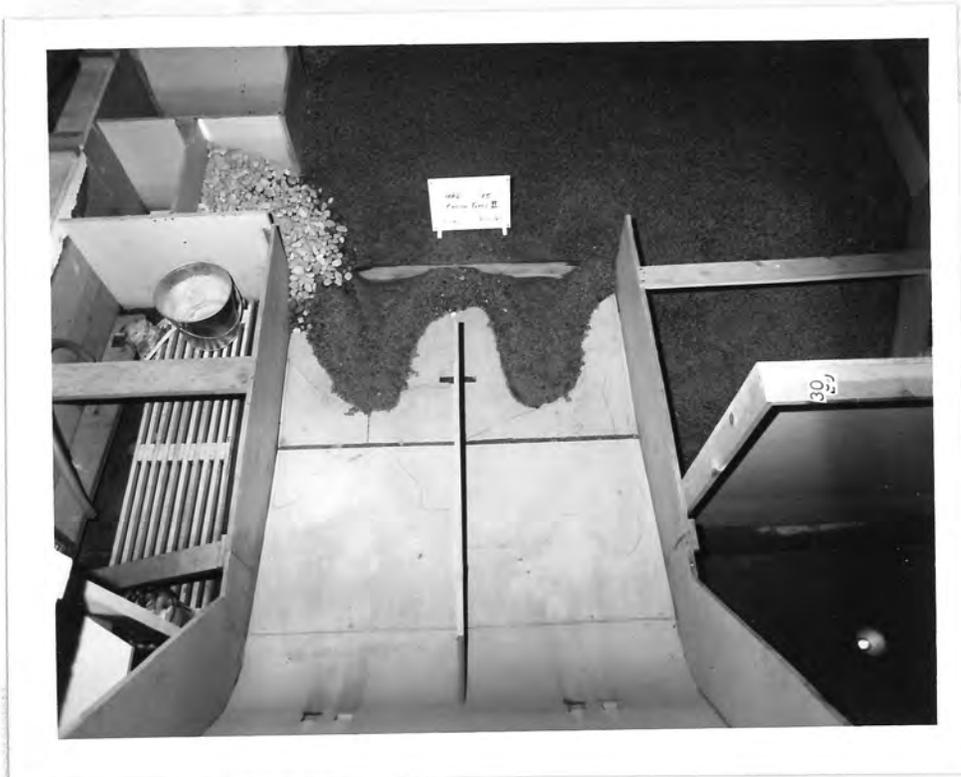
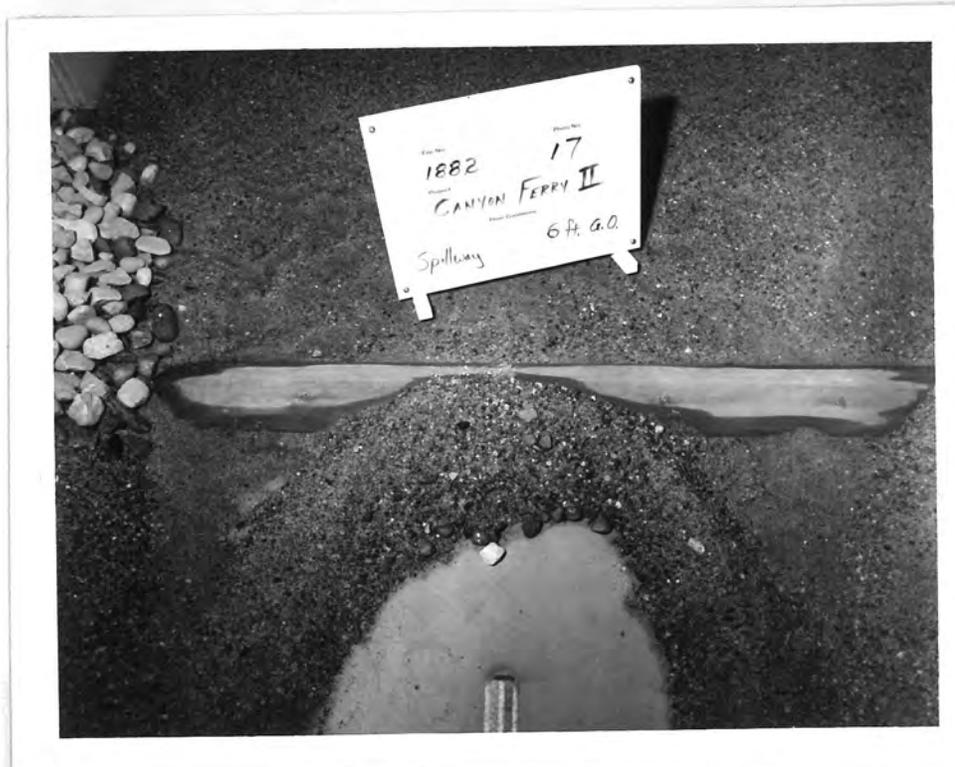
(a) General view.

(b) Some of the large rocks which have moved.

Figure 5. Model deposit for spillway test with 1.8 m gate opening and $600 \text{ m}^3/\text{s}$ (6.0 ft G.O., $21,200 \text{ ft}^3/\text{s}$).

In figure 5 the thicker upstream portion of the deposit can be seen, and some of the large rocks. Again, note the furthestmost upstream location of the deposit was the central area of each bay. This feature was consistent for all gate openings, and some back-and-forth movement of the model sand occurred in the central area. Even a 2.7-m (9-ft) gate opening with an 894-m³/s (31 600-ft³/s) discharge did not remove the deposit from the center bay area, figures 4b and 6. Free flow operation at 1013 m³/s (35 800 ft³/s) discharge left the deposit nearly the same as shown in figure 6.

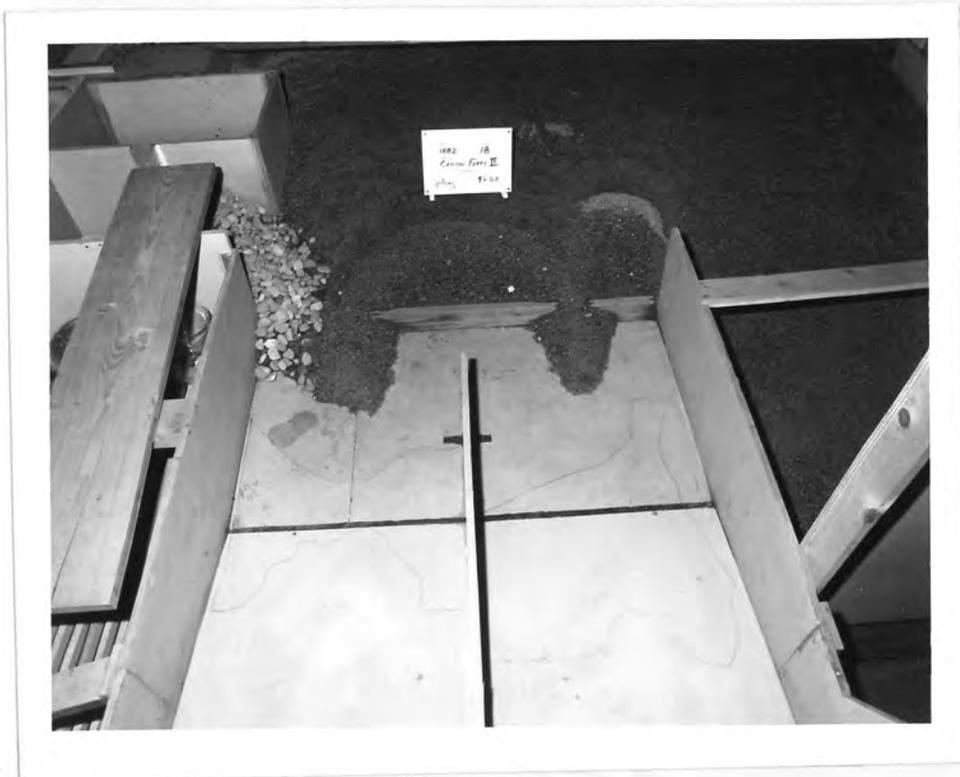
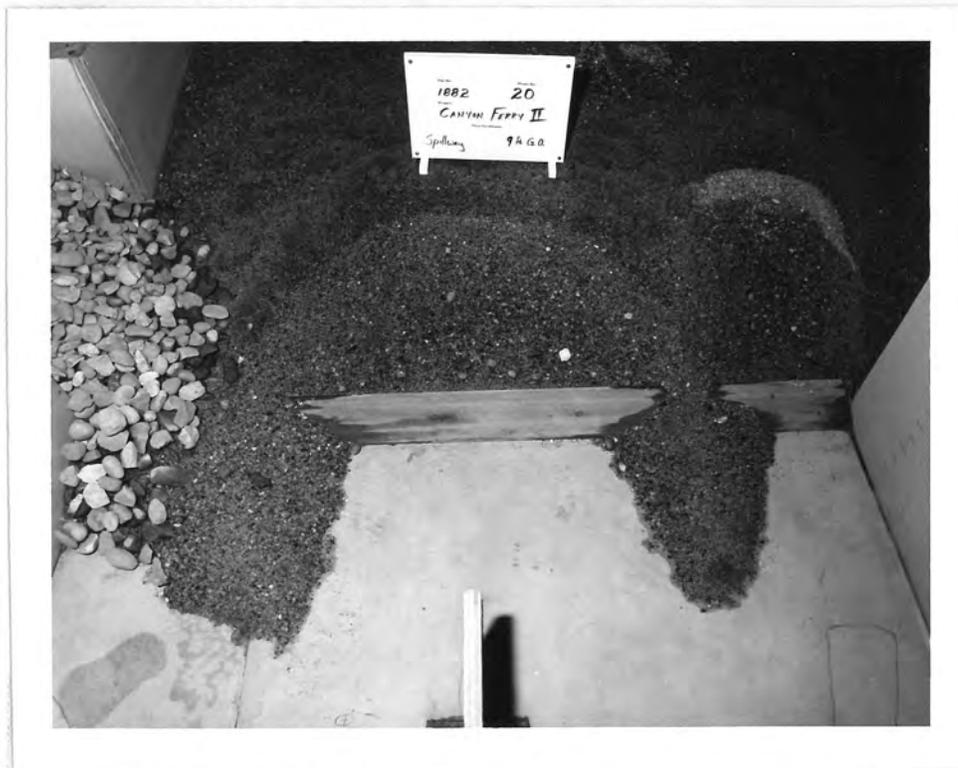
(a) General view.

(b) Most of the large rocks have been removed from the basin

Figure 6. Model deposit for spillway test with 2.7 m gate opening and $894 \text{ m}^3/\text{s}$ (9.0 ft G.O., $31,600 \text{ ft}^3/\text{s}$).

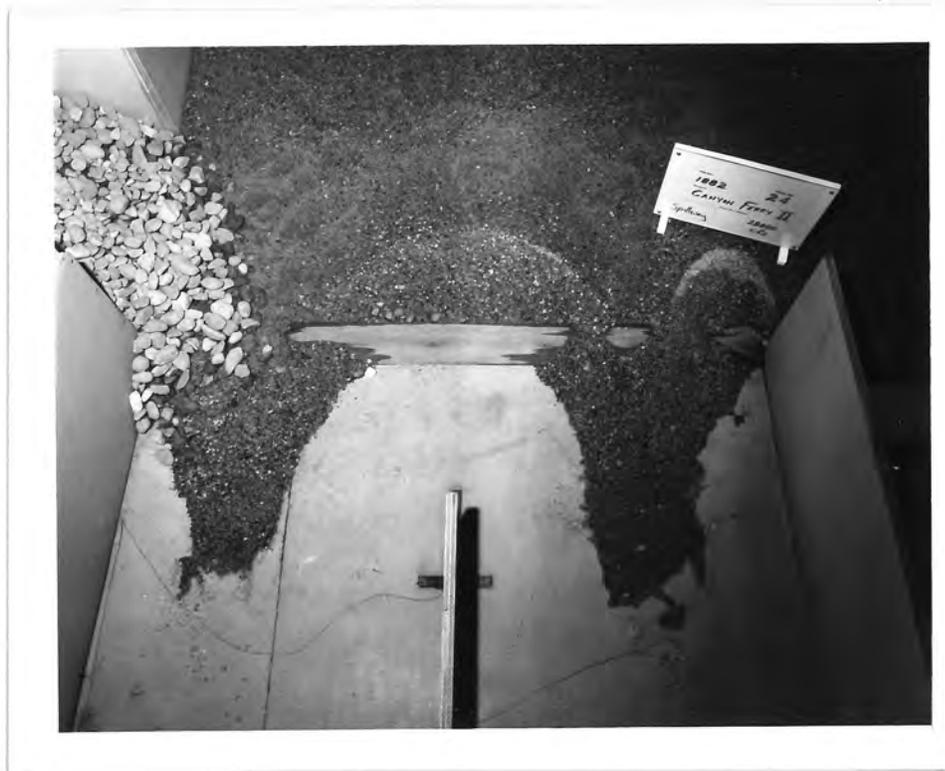
Figure 7. Model deposit for spillway test with $792 \text{ m}^3/\text{s}$ ($28,000 \text{ ft}^3/\text{s}$) discharge and 3 hour prototype time operation.

During May 1974, the prototype spillway discharged 798 m³/s (28 200 ft³/s) for 3 hours. Larger discharges or longer operation times would probably cause excessive downstream riverbank damage, and thus model test conditions greater than these prototype conditions are probably unrealistic. Therefore, a model erosion test was made with prototype conditions of 790-m³/s (28 000-ft³/s) spillway discharge, 3-hour operation time, and at a 1156-m (3794-ft) reservoir water surface elevation. Test results are shown in figure 7. Considerable erosion occurred in the model stilling basin during the first hour, figure 7b. Afterwards, the sand remaining in the model stilling basin was collected and measured. There were 260 m³ (340 yd³) in the left bay and 180 m³ (240 yd³) in the right bay. In the left bay sand was removed from the rock of the pumping plant cofferdam and included in the measurement.
