SECOND SERIES OF HYDRAULIC LABORATORY FILTER  
TESTS FOR CORDELL PUMPING PLANT - OROVILLE-  
TONASKET UNIT - CHIEF JOSEPH DAM PROJECT,  
WASHINGTON

EUGENE ZEIGLER

OCTOBER, 1980

PAP-399

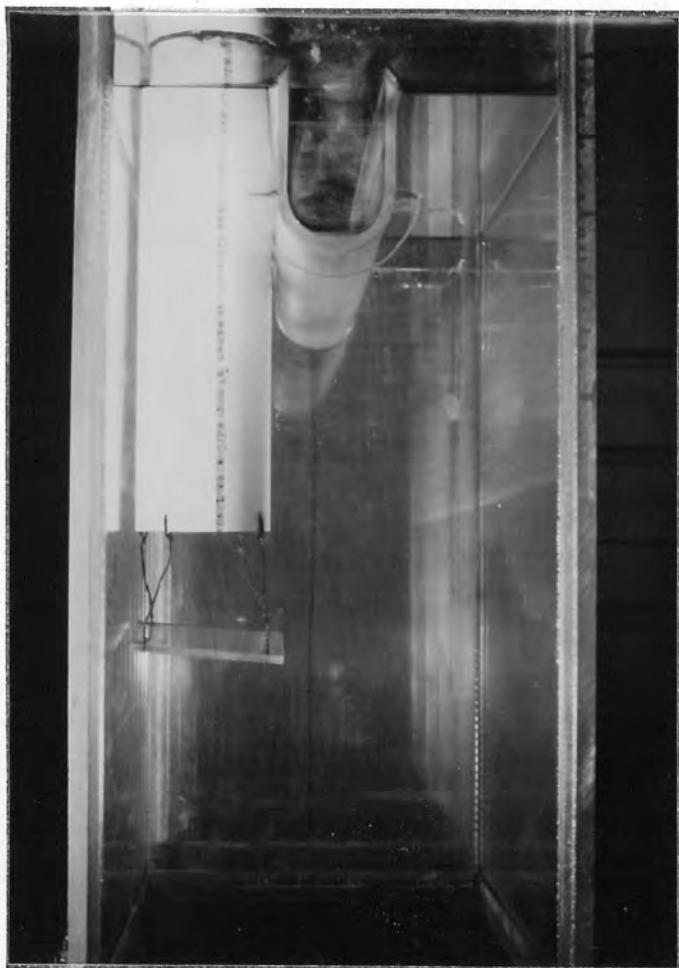
Fig. 1a. Inlet pipe with flow deflector.

Modifications were made to improve the test apparatus. Previously water entered the plastic test box from a weir on top of the box, spilled into the box, and entrained air bubbles. The inlet was changed to a pipe which had a deflector for preventing flow impingement upon the filter bed, figure 1a. Plumbing changes were also made in the water storage box. The pump bypass flow pipe was extended 0.46 m (1.5 ft) below the water surface and filtration flow was directed farther from the pump intake. The above changes were made to prevent the minute air bubbles in the water passing through the filter. Six additional piezometer taps were installed on the side wall at 75-mm (3-in) intervals above the previous taps.

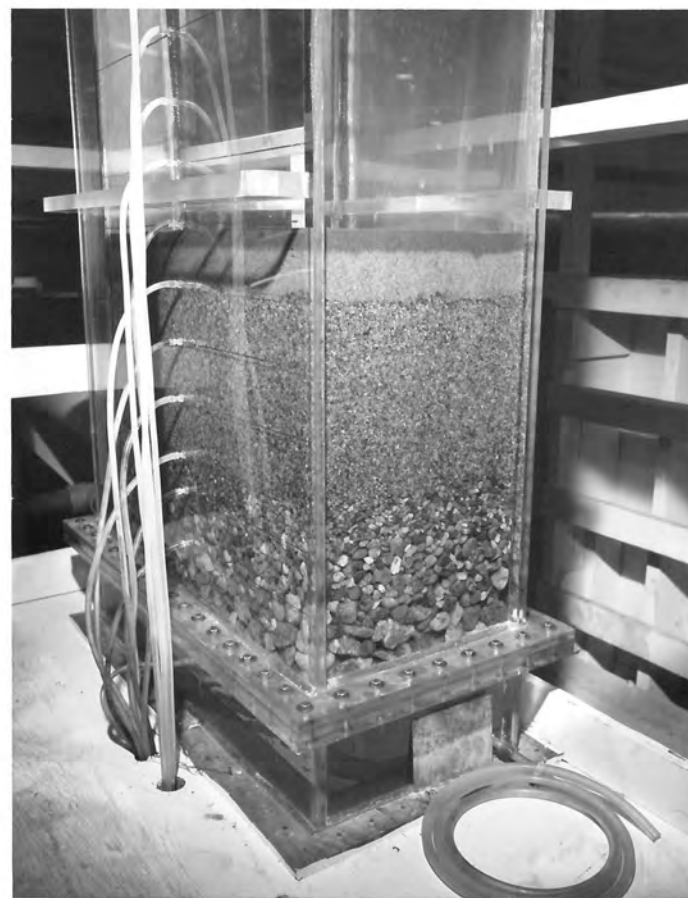
Fig. 1b. Filter configuration II.

Figure 1. - Plastic test box.

To capture finer suspended sediment, finer filter sand was required. The protective gravel layer, the intermediate layer, and 0.08 m (3 in) of the filter sand were removed and replaced by two layers of fine sand placed in the test filter-filter configuration II, figures 1b and 3.
